**GENERAL DYNAMICS ON-SITE CHILD SAFETY SEAT FATALITY
INVESTIGATION
SCI TECHNICAL SUMMARY REPORT**

CASE NO: CA04-022

VEHICLE: 1991 CHEVROLET LUMINA APV

CRASH DATE: NOVEMBER 2003

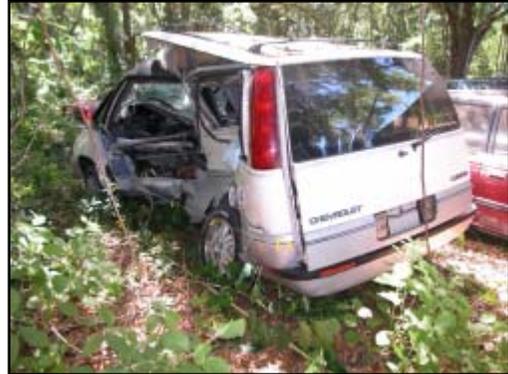
Figure 1. Damaged 1991 Chevrolet Lumina

mph). The driver of the Lumina proceeded into the intersection across the path of the Toyota Tundra. The front of the Tundra struck the left side aspect of the Lumina and deflected the Lumina onto the northwest corner. The severe impact was sufficient to deploy the frontal air bags in the Tundra. As the Lumina rotated and traveled to rest, the rear left unrestrained 7-year-old female passenger was most likely partially ejected from the vehicle. She sustained a diffuse axonal injury, right frontal contusion, bilateral lung contusions with pneumothorax, a left foot fracture and contusion, and multiple lacerations and abrasions. The 3-year-old male passenger who was restrained in the CSS sustained lacerations and contusions of the left basal ganglia, several skull fractures, subarachnoid hemorrhage, compression of ventricles and incisural cisterns, post-traumatic pneumocephalus, pulmonary contusions with bilateral hemo/pneumothoraces, a splenic rupture, and minor soft tissue extremity injuries from the severe left side intrusion and crash forces. The driver sustained multiple fractures of her pelvis, sacral and lumbar fractures, a Grade IV spleen laceration, fractured ribs, and contusions. The 10-year-old female front right passenger sustained hyphemia of the left eye and nasal bone fractures. All of the Lumina's occupants were transported to a regional trauma center for treatment. The 3-year-old male child was pronounced dead four hours after the crash.

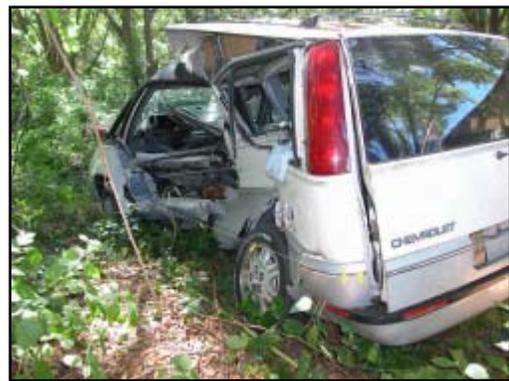
The 1991 Chevrolet Lumina APV sustained severe left side damage as a result of the impact with the Toyota Tundra pickup truck (**Figure 4**). The direct contact damage began 78.0 cm (30.7") rear of the left front axle and extended 180.3 cm (71.0") rearward along the left side plane. The maximum crush measured 78.1 cm (30.8") and was located 194.9 cm (76.8") rear of the left front axle. The composite body panels were fractured in multiple locations as a result of the direct contact. The left front exterior door panel was completely separated, although the reinforcement bar and latch/striker assembly showed no signs of failure. The left side exterior panel exhibited scuff marks and was separated from the left B- and C-pillars at the belt line from direct contact with the front of the Toyota Tundra. The direct contact extended 8.9 cm (3.5") vertically beyond the beltline. The left sill was crushed laterally from direct contact. The combined direct and induced damage began 45.1 cm (17.8") rear of the left front axle and

Figure 4. View of left side damage

extended 298.5 cm (117.5") rearward along the left side plane. The severe left side crush resulted in the bowing of the Lumina.

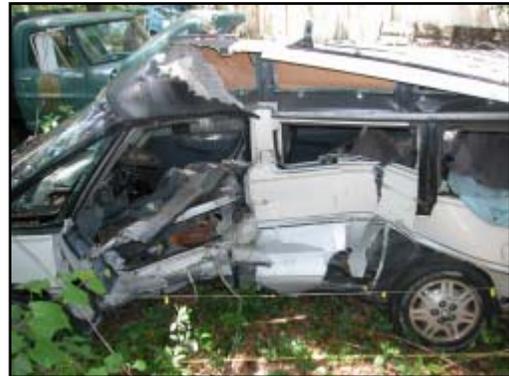
The lateral crush resulted in the separation of the roof from the left roof side rail (**Figure 5**). The separation began at the left B-pillar and extended rearward to the left rear corner of the roof side rail. From the separation at the B-pillar, the composite roof sustained a lateral fracture that measured 50.8 cm (20.0") in length from the roof side rail. The maximum vertical separation of the roof measured 36.2 cm (14.3") and was located 10.2 cm (4.0") forward of the B-pillar centerline. The left rear body panel was deformed and fractured as a result of direct and induced damage. The lower rear aspect sustained an induced fracture as a result of the crush to the forward aspect. Six crush measurements were documented along the left side aspect at the mid-door level, and were as follows: C1 = 0.0 cm, C2 = 19.1 cm (7.5"), C3 = 63.2 cm (24.9"), C4 = 69.9 cm (27.5"), C5 = 64.8 cm (25.5"), C6 = 0.0 cm. Additional crush measurements were documented at the sill at the respective C-locations. The crush measurements along the sill were as follows: C3 = 36.8 cm (14.5"), C4 = 49.5 cm (19.5"), C5 = 49.5 cm (19.5"). Since there was no latch, pillar, or hinge failure, the mid-door and sill measurements were not averaged. The Collision Deformation Classification for the left side impact with the Toyota Tundra was 09-LPAW-5.

Figure 5. Overhead view of left side damage and roof separation

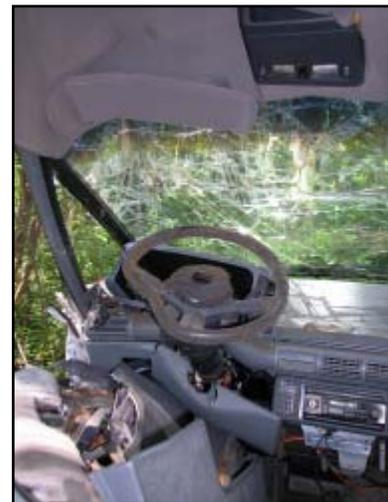
The Chevrolet Lumina sustained severe interior damage as a result of passenger compartment intrusion (**Figure 6**). The driver's plastic knee bolster was compressed laterally, partially separated, and fractured below the steering column. The left face of the knee bolster also exhibited a transfer from contact with the composite body panel of the left front door. The lower left quadrant of the steering wheel rim was deformed 7.0 cm (2.8") inward and exhibited a crease in the area of the deformation as a result of direct contact with the intruded left front door. The intrusion also resulted in the lateral deflection of the steering column to the right and the 0.3 cm (1/8") forward displacement of the right shear capsule. The left instrument panel sustained fractures and displacement due to intrusion. The left front interior door panel and armrest were fractured in multiple locations and located 7.6 cm (3.0") left of the vehicle centerline. The driver's seat cushion and outboard seat track were rotated 90 degrees inboard about their longitudinal axis as a result of the sill crush and lateral intrusion. The driver's seat cushion was compressed against the front right seat. The driver's seat back was deflected to the right and overlapped the front right seat back by 12.7 cm (5.0"). The front left floor was buckled upward 6.4 cm (2.5") due to the lateral intrusion of the

Figure 6. View of deformation and intrusion into the driver's position

left sill. The front right sun visor mirror was fractured and the visor was in the ‘down’ position at the time of the vehicle inspection.

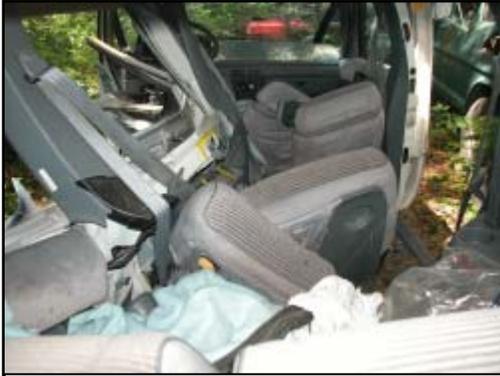
Figure 7. Longitudinal view from rear showing severe deformation and intrusion

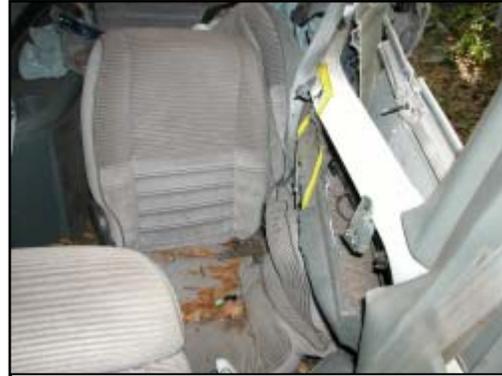
Figure 8. View of second row bench seat showing rotation and compression of the left seat

The left aspect of the second row split bench seat was also rotated inward 90 degrees about its longitudinal axis, as a result of the sill crush and severe lateral intrusion (**Figures 7 and 8**). The top aspect of the left seat cushion was crushed against the left side aspect of the right seat cushion. The intrusion also deflected the left seat back to the right and slightly rearward. The left seat back overlapped the right seat back by 25.4 cm (10.0”). The post-crash distance between the second row left side panel (at the beltline) and the vehicle centerline was 3.8 cm (1.5”). Specific intrusions were documented as follows:

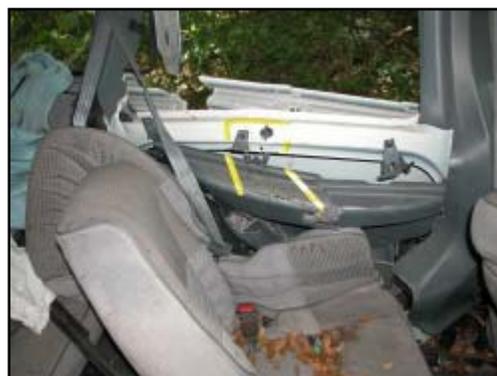
Faint clear fluid-like residue was present at multiple locations on the headliner, although it could not be determined if this was related to any of the occupants. Body fluid (blood) from the 3-year-old child was present on the left side panel adjacent to the second row seats (**Figure 9**). The transfer was located 54.6 cm (21.5") aft of the left B-pillar and extended 19.1 cm (7.5") rearward on the plastic panel and 13.3 cm (5.3") rearward on the sheet metal at the beltline. The transfer began at the bottom of the window frame and extended downward 21.6 cm (8.5").

Figure 9. View of occupant contact on the left side panel

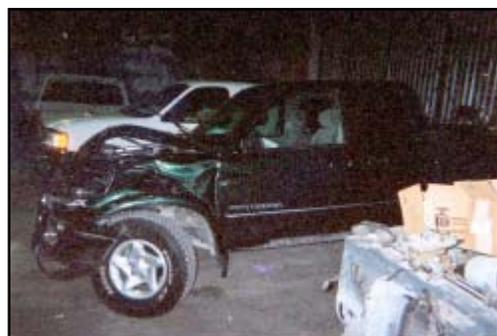
The damage to the 2000 Toyota Tundra pickup truck was based on photographs taken at a body shop after the crash (**Figure 10**). The pickup truck had been sold from a salvage yard and could not be located at the time of the on-site investigation. The direct contact damage extended across the entire frontal width of the Tundra. The aftermarket brush guard was deformed and the entire frontal structure was crushed rearward. The direct contact damage wrapped around the front left corner, evidenced by white paint transfers and abrasions. The combined direct and induced damage involved the entire frontal plane and measured approximately 165 cm (65"). Both front fenders sustained induced rearward buckling and rearward displacement. The hood was buckled rearward and upward. The right front tire was debeaded, and it appeared that the right front wheel may have been displaced rearward, reducing the right wheelbase. Six crush measurements were estimated along the front bumper of the Toyota Tundra as follows: C1 = 18.0 cm (7.0"), C2 = 18.0 cm (7.0"), C3 = 18.0 cm (7.0"), C4 = 18.0 cm (7.0"), C5 = 20.0 cm (8.0"), C6 = 20.0 cm (8.0"). The CDC for the frontal impact with the Chevrolet Lumina APV was 12-FDEW-1.

Figure 10. Damaged 2000 Toyota Tundra pickup truck

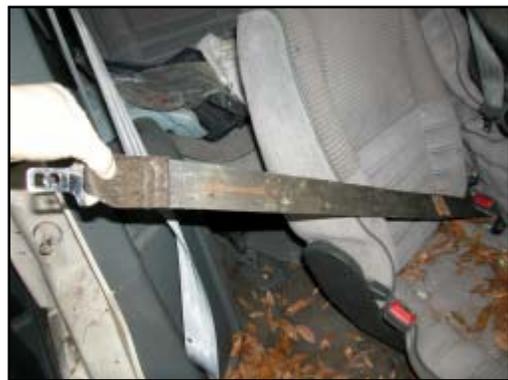
Figure 11. View of fully extended lap belt for the second row center position

configured with an integrated lap belt (**Figure 11**) that was fixed to the outboard aspects of the seat cushion. The lap belt was configured with a sewn-on latch plate and an Automatic Locking Retractor (ALR) mounted on the left aspect of the cushion. The retractor and buckle were mounted slightly forward of the seat bight and the lateral distance between the retractor and buckle measured 38.1 cm (15.0") across the seat cushion. When fully extended, the length of the lap belt measured 88.9 cm (35.0"). The lap belt was used to secure the forward-facing convertible CSS in the second row center seat. There was no loading evidence present on the lap belt webbing from the CSS; however, the retractor operated in a sluggish manner at the time of the vehicle inspection.

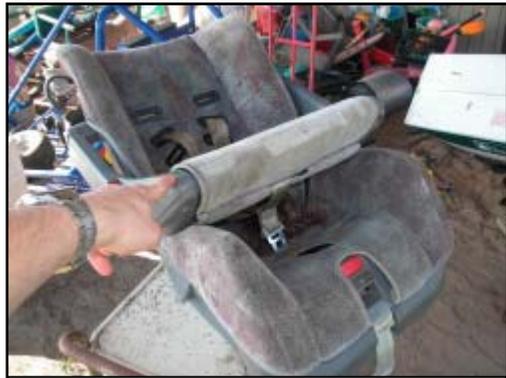
A convertible Century CSS (**Figure 12**) was positioned in the second row middle seat and secured by the lap belt with the ALR. It appeared to be consistent with a Century STE 3000, but it could not be confirmed. The labeling on the CSS had been removed, and the model number and date of manufacture were unknown. A warning on the plastic shell stated: “Do not use this car seat after December 2004.” The CSS was configured with an adjustable plastic tray shield that was positioned in the full-rear position (relative to the CSS). The parents stated that the CSS was purchased new approximately seven years ago, and had been used for the other children in the family. The parents also stated that the owner’s manual had been consulted when the

Figure 12. Century convertible CSS

Based on an exemplar CSS in a rear-facing orientation, the CSS was rated for children who weighed less than 9 kg (20 lb) and measured less than 71 cm (28”) in height. In a forward-facing orientation, the CSS was rated for children who weighed 9 – 18 kg (20 – 40 lb) and whose height was 69 – 102 cm (27 – 40”). Based on official height and weight data from the Medical Examiner and the trauma center, the child’s height was 104 cm (41”) and his weight as was 19 kg (42 lb), which was above the manufacturer’s recommended height and weight guidelines.

At the time of the CSS inspection, the kickstand was not engaged for forward facing use. The parents indicated that the kickstand was not down at the time of the crash. The shoulder harnesses were routed through the second set of rear-facing harness slots, versus the top set of forward-facing slots. The length of the harness straps between the slots and the buckle measured 39.4 cm (15.5”) and the adjustment tab on the front of the CSS was extended 9.5 cm (3.3”). The harness retainer clip was present on the harness straps 19.1 cm (7.5”) above the buckle, and the parents indicated it was located at the shoulder level of the 3-year-old child. Based on the slight rearward deflection of the locking tab on the retainer clip, it appeared that the harness was historically threaded correctly through the retainer clip.

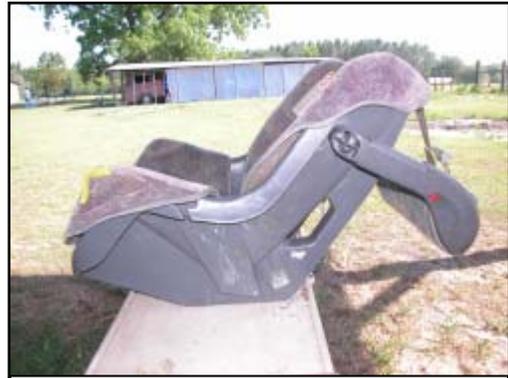
The CSS sustained minor damage as a result of the crash (**Figure 13**). Scuff marks and abrasions were present on the left side aspect of the plastic shell, and the left arm of the tray shield was partially separated at the seams. White scuff marks from contact with the intruding left side panel of the Lumina were present on the outboard left front aspect of the CSS on the overlapping fabric. The transfers began 2.5 cm (1.0”) from the front corner and measured 3.8 cm (1.5”) in length and 2.5 cm (1.0”) in height. Due to the lateral nature of the crash, loading to the harness straps and harness slots was minimal. Faint abrasions were present on the rear left aspects of both harness slots. Body fluid (blood) was present on the left aspect of the CSS fabric at the seat bight, on the center aspect of the CSS seat back between the top harness slots, and on the inboard aspect of the left side panel. There were no stress marks noted in the plastic shell at the time of the CSS inspection.

Figure 13. Left side view of the CSS
