# INDIANA UNIVERSITY

## **ON-SITE CERTIFIED ADVANCED 208- COMPLIANT VEHICLE INVESTIGATION**

CASE NUMBER - IN-04-023

VEHICLE - 2004 GMC Yukon

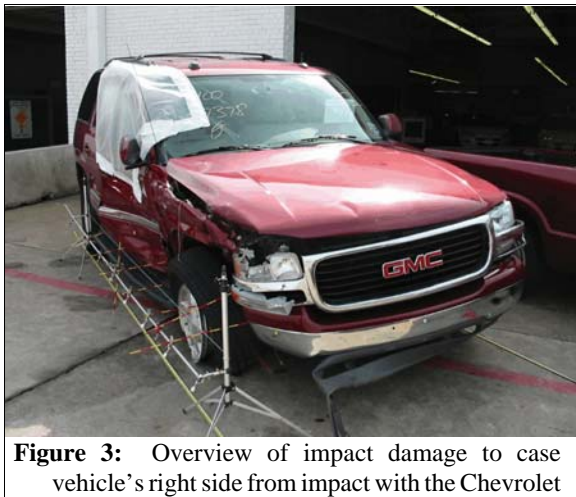
**Figure 3:** Overview of impact damage to case vehicle's right side from impact with the Chevrolet

**Exterior Damage:** The case vehicle sustained direct damage to its right front bumper corner, right fender, right front wheel and right front door due to the impact with the Chevrolet. The direct damage began at the right corner of the front bumper and extended 171 centimeters (67.3 inches) along the case vehicle’s right fender and right front door. Direct damage also involved the right headlamp/turn lamp assembly and the hood. Crush measurements were taken at the lower door level. Maximum crush was measured as 47 centimeters (18.5 inches) occurring 20 centimeters forward of at C<sub>5</sub> (**Figure 5**). The table below shows the case vehicle’s right side crush profile.

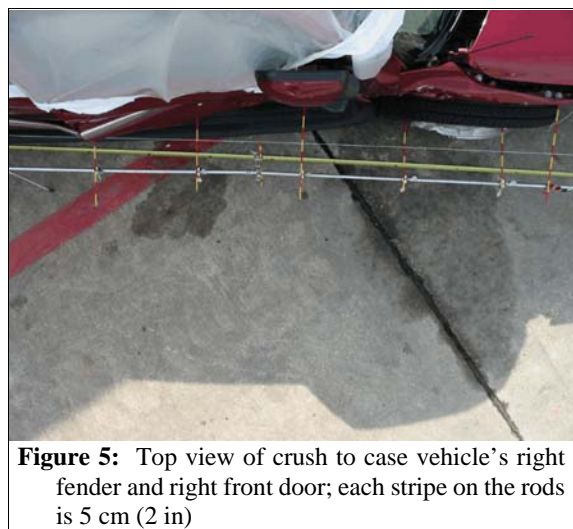
**Figure 5:** Top view of crush to case vehicle’s right fender and right front door; each stripe on the rods is 5 cm (2 in)

Units	Event	Direct Damage		Field L	C <sub>1</sub>	C <sub>2</sub>	C <sub>3</sub>	C <sub>4</sub>	C <sub>5</sub>	C <sub>6</sub>	Direct	Field L
		Width CDC	Max Crush								±D	±D
cm	1	171	47	217	0	8	26	12	13	13	88	110
in		67.3	18.5	85.4	0.0	3.2	10.2	4.7	5.1	5.1	34.6	43.3

The case vehicle’s right side wheelbase was reduced 18 centimeters (seven inches) and the left side wheelbase extended two centimeters (0.8 inch). Induced damage involved the hood, front bumper, grille and right front and rear doors. No obvious induced damage or remote buckling was noted to the remainder of the vehicle.

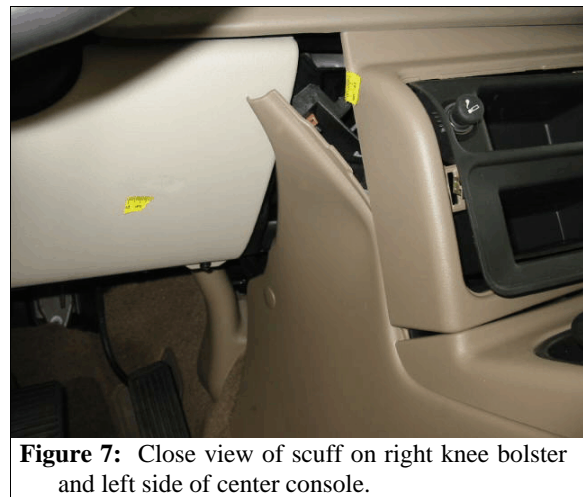
**Interior Damage:** Inspection of the case vehicle’s interior (**Figure 6**) revealed an occupant contact scuff on the driver’s right knee bolster and left side of the center console (**Figures 7**). The two occupant contact marks indicate the driver’s right knee impacted and scuffed the right knee bolster and the left side of the center console. The damage to the center console visible in **Figure 7** was due to the intrusion of the right front door, which has displaced the instrument panel to the left. No occupant contact marks were found on the driver’s air bag; however, three small possible blood spots were found on the top left and upper right edge of the air bag. No other occupant contact evidence was found.

**Figure 7:** Close view of scuff on right knee bolster and left side of center console.

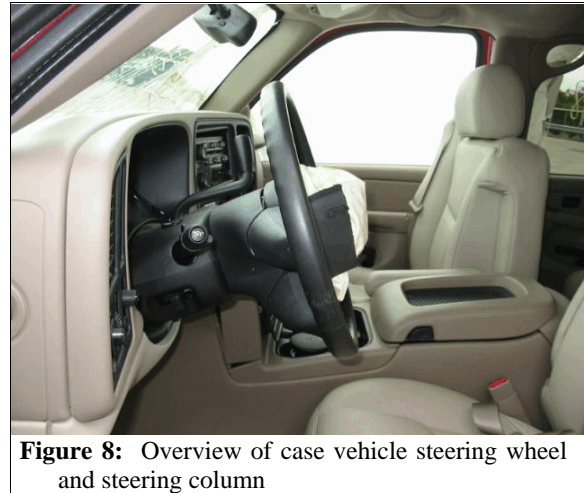
centimeters (11 inches) and the right front door panel intruded laterally 25 centimeters (9.8 inches). In addition, the left side panel of the center console intruded laterally 4 centimeters (1.6 inches), and the glove box door opened during the crash. Finally, there was no evidence of compression of the energy absorbing steering column, and no deformation of the steering wheel rim was observed (**Figure 8**).

**Figure 8:** Overview of case vehicle steering wheel and steering column

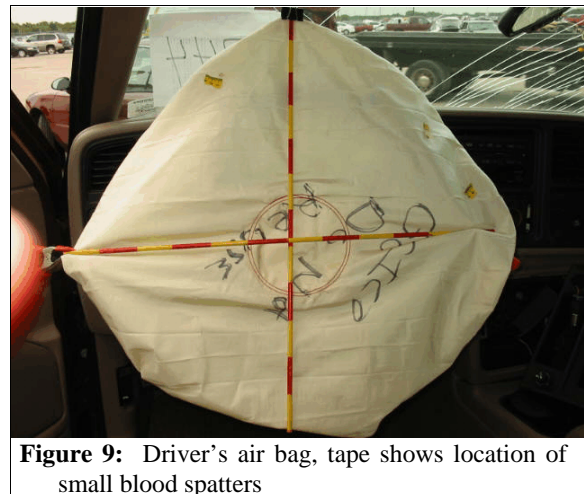
The case vehicle's driver air bag was located in the steering wheel hub. An inspection of the air bag module cover flaps and the air bag fabric revealed that the cover flaps opened at the designated tear points. There was no evidence of damage during the deployment to the air bag module cover flaps or the air bag fabric. Three small blood spots were found on the top left and upper right edge of the air bag; however, no clear occupant contact marks were observed on the air bag. The deployed driver's air bag (**Figure 9**) was round with a diameter of approximately 65

**Figure 9:** Driver's air bag, tape shows location of small blood spatters

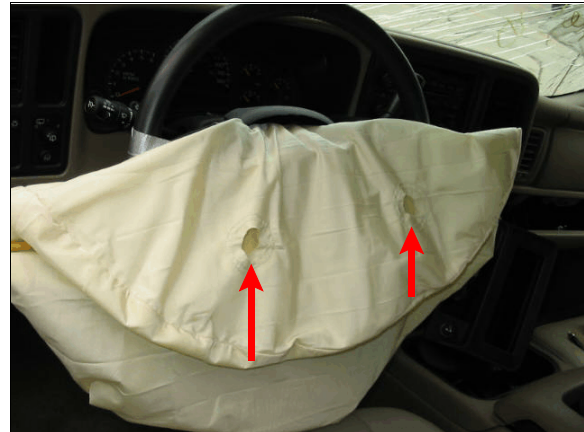
centimeters (25.6 inches). The air bag was designed with two tethers, each approximately 12 centimeters (4.7 inches) in width and had two vent ports (**Figure 10**), each approximately 3 centimeters (1.2 inches) in diameter, located at the 10 and 2 o'clock positions. The air bag module cover flaps (**Figure 11**) were constructed of pliable vinyl and the tear seams were in an “I” configuration across the top, bottom and vertically down the middle. Each module flap was 7.5 centimeters (3.0 inches) in width at the top, 5.0 centimeters (2.0 inches) in width at the bottom and 13 centimeters (5.1 inches) in height at the vertical tear seam.

**Figure 10:** Location of case vehicle’s driver air bag vent ports (arrows)

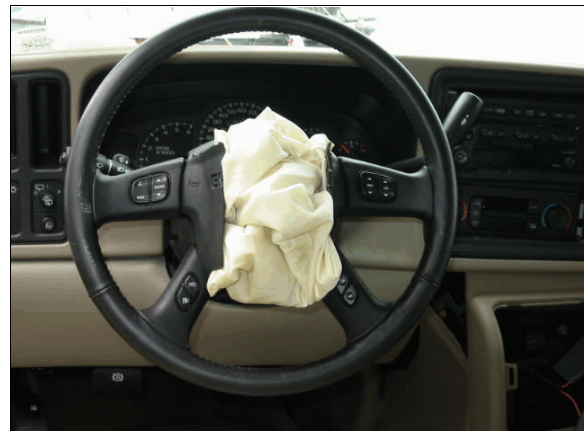
**Figure 11:** Case vehicle’s steering wheel and driver air bag module flaps

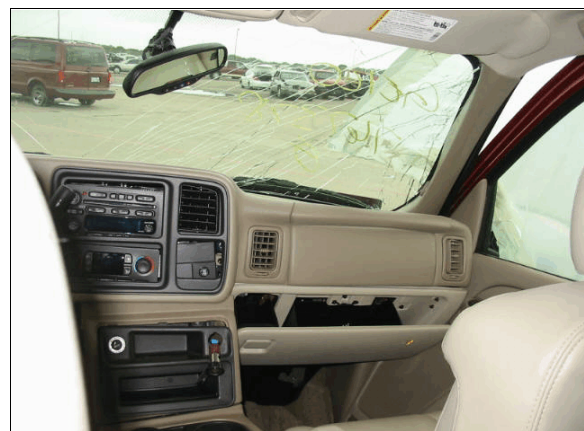
The front right passenger front air bag was located in the middle of the instrument panel (**Figure 12**). The deployment of the front right passenger air bag was properly suppressed by the case vehicle’s advanced occupant restraint system because no front right passenger was seated in the case vehicle.

**Figure 12:** Case vehicle’s front right air bag module door located above glove box door

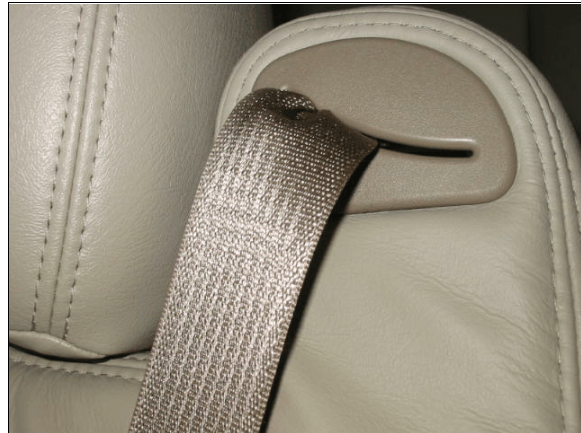
The evidence indicates the case vehicle's driver was using her manual, three-point, lap-and-shoulder safety belt system. The seat belt was observed to be stretched and the shoulder belt was jammed in the belt guide (**Figure 13**). The length of the belt in its jammed configuration (**Figure 14**) was consistent with it being used by the driver in the crash. In addition, the police report indicated the driver was using her lap and shoulder belt, and the EDR data indicates the driver's seat belt was buckled.

**Figure 13:** Case vehicle driver's shoulder belt jammed in the shoulder belt guide

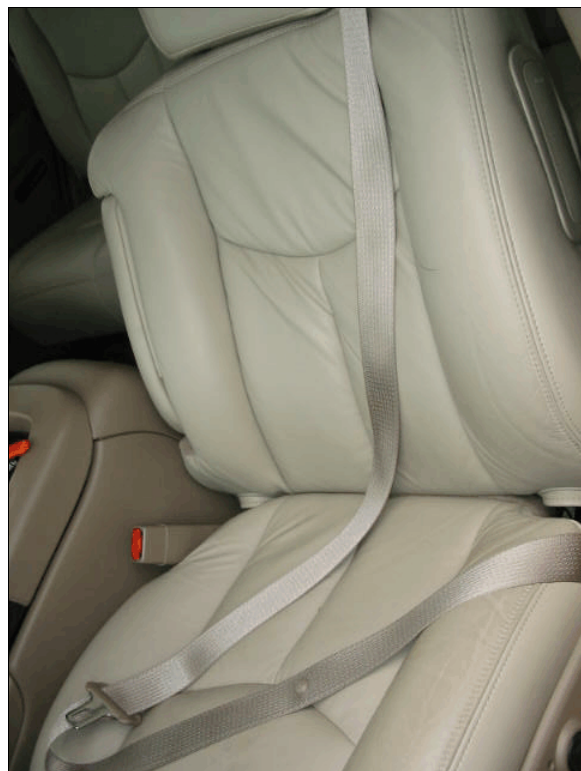
**Figure 14:** Overview of case vehicle driver's lap and shoulder belt in its jammed condition

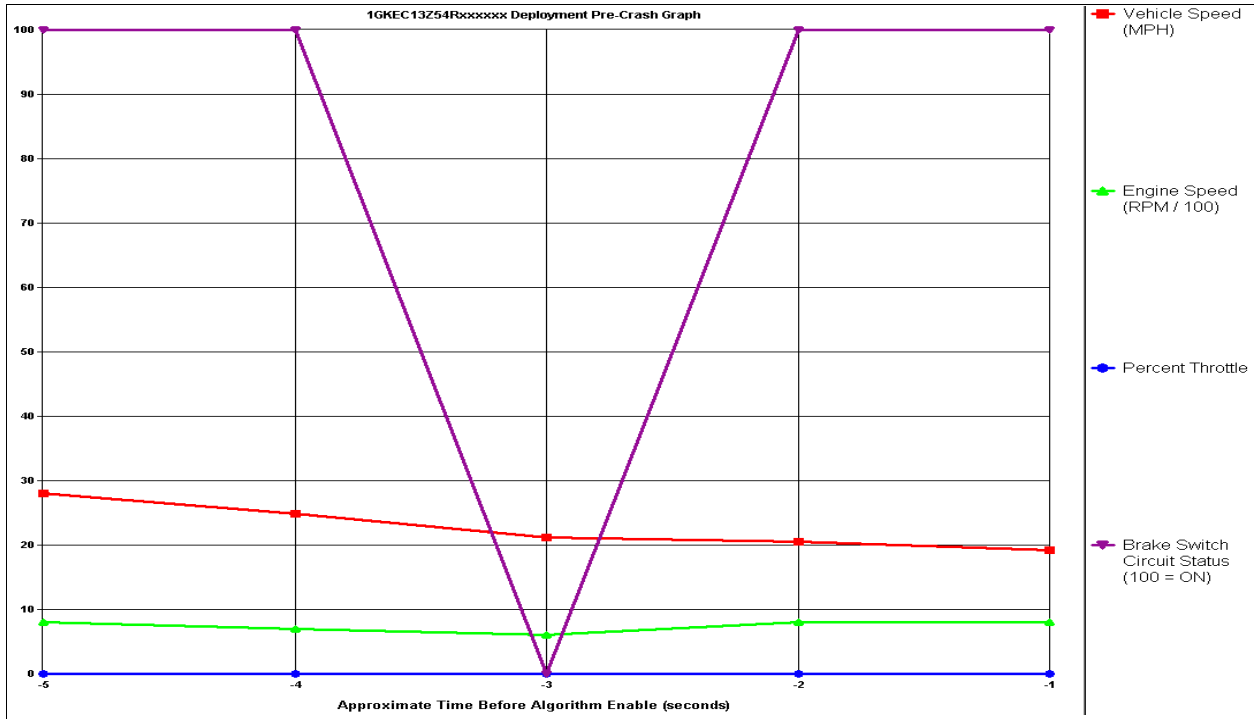
Figure 16: Case vehicle's Deployment Pre-crash Graph

The pre-crash data graph indicates the driver was not applying the throttle from five seconds to one second prior to the crash (i.e., AE). In addition, the brake switch circuit status was recorded as on at five and four seconds prior to the crash, off at three seconds and on again at two seconds and one second prior to the crash. The case vehicle slowed from 45 km.p.h. (28 m.p.h.) to 31 km.p.h. (19 m.p.h.) during this time. The pre-crash data is consistent with the driver slowing to negotiate the turn and indicates the driver was not stopped at the traffic signal prior to executing her left turn.
