**CALSPAN ON-SITE CERTIFIED ADVANCED 208-COMPLIANT VEHICLE
CRASH INVESTIGATION**

SCI CASE NO. – CA04-025

SUBJECT VEHICLE – 2004 HONDA ACCORD EX

CRASH DATE – APRIL 2004

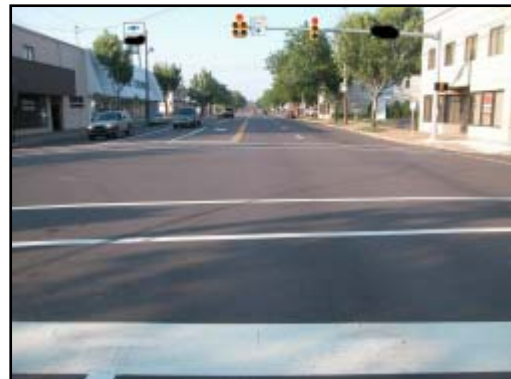
The front of the Honda impacted the front left aspect of the Dodge within the intersection (**Figure 4**). The resulting directions of force were within the 1 o'clock sector for the Honda and 10 o'clock sector for the Dodge. The damage algorithm of the WINSMASH program was used to calculate a delta V for this impact. The total delta V for the Honda was 16.0 km/h (9.9 mph). The longitudinal and lateral components were -13.9 (-8.6 mph) and -8.0 (-5.0 mph), respectively. The total delta V for the Dodge was 12.0 km/h (7.5 mph). The longitudinal and lateral components were -6.0 km/h (-3.7) and 10.4 km/h (6.5 mph), respectively. The Honda's EDR recorded delta V was 23.8 km/h (14.8 mph). The EDR recorded delta V was a more accurate representation of the crash severity. The WINSMASH model underestimated the crash severity due to the use of the default stiffness category for the Dodge. The Honda impacted a locally stiff area of the Dodge (axle) which reduced the calculated value by the model.

Figure 4. Northbound view of area of impact.

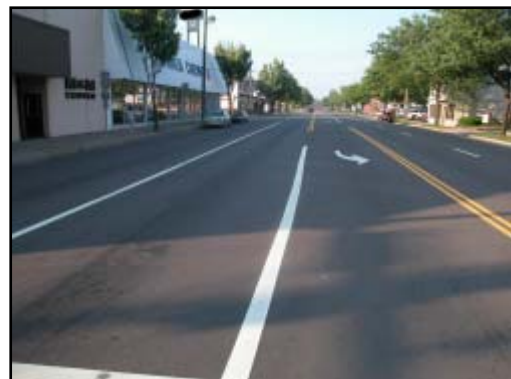
Figure 5. Area of impact between the Honda and the Ford.

The damage algorithm of the WINSMASH program was to calculate a delta V for this impact. The total delta V for the Honda was 7.0 km/h (4.3 mph). The longitudinal and lateral components were 0.0 and -7.0 km/h (-4.3 mph), respectively. The total delta V for the Dodge was 5.0 km/h (3.1 mph) and the longitudinal and lateral components were 0.0 and 5.0 km/h (3.1 mph), respectively. The Honda began a northwest trajectory subsequent to the side slap and entered the southbound lanes where the 1998 Ford F-150 was stopped. The frontal aspect of the Honda impacted the left rear of the stopped Ford (**Figure 5**).

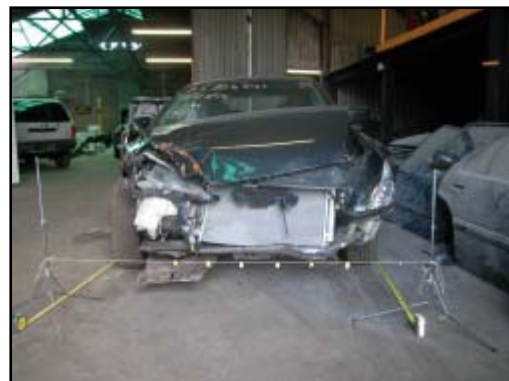
The initial impact with the Dodge resulted in moderate frontal damage to the Honda. The direct and induced damage involved the bumper fascia and bumper beam, frame rails, upper and lower radiator supports, fenders, and hood. The bumper beam was separated from the vehicle; therefore two crush profiles were documented at the levels of the upper and lower radiator supports (**Figure 6**). The direct damage measured 48.0 cm (18.9") and began at the front right end of the lower radiator support and extended left. The maximum crush measured 12.0 cm (4.7") and was located 16.0 cm (6.3")

Figure 6. Lower radiator crush profile.

right of the centerline. The crush profile was measured using a combined direct and induced damage width of 80.0 cm (31.5"). The crush was documented using six equidistant points along the lower radiator support and were as follows: C1 = 3.0 cm (1.2"), C2 = 0, C3 = 2.0 cm (0.8"), C4 = 5.0 cm (2.0"), C5 = 9.0 cm (3.5"), C6 = 12.0 cm (4.7").

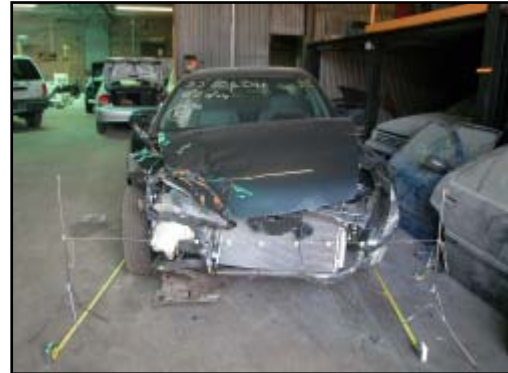
Six crush measurements were documented at the upper radiator support (**Figure 7**), and were as follows: C1 = 12.0 cm (4.7"), C2 = 13.0 cm (5.2"), C3 = 17.0 cm (6.7"), C4 = 23.0 cm (9.1"), C5 = 27.0 cm (10.6"), C6 = 30.0 cm (11.8"). The Collision Deformation Classification (CDC) for this impact was 01-FREW-2.

Figure 7. Upper radiator crush profile.

The average of the upper and lower radiator support crush measurements were used for WINSMASH to calculate a delta V. The crush measurements were as follows: C1 = 3.0 cm (1.2"), C2 = 7.0 cm (2.8"), C3 = 10.0 cm (4.0"), C4 = 14.0 cm (5.5"), C5 = 18.0 cm (7.1"), C6 = 21.0 cm (8.3").

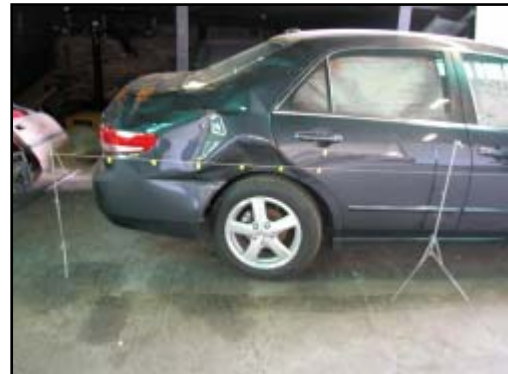
The right rear aspect of the Honda sustained moderate damage as a result of the secondary impact with the Dodge (**Figure 8**). The damaged components included the rear axle, right rear quarter panel, C-pillar, bumper cover, right rear taillight, trunk, and the backlight. The direct damage measured 90.0 cm (35.4") and began 265.0 cm (104.3") rear of the right front axle. The residual damage was documented along the mid-door level using a combined direct and induced damage width of 110.0 cm (43.3"). Six crush measurements were documented and were as follows: C1 = 0, C2 = 1.0 cm (0.4"), C3 = 3.0 cm (1.2"), C4 = 7.0 cm (2.8"), C5 = 4.0 cm (1.6"), C6 = 0. The CDC for this impact was 03-RZAW-2.

Figure 8. Crush profile for secondary impact.

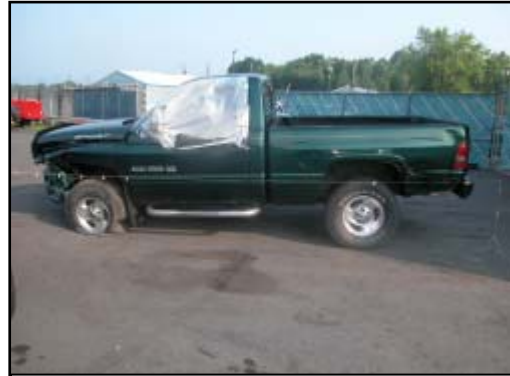
The 1999 Dodge Ram sustained moderate damage as a result of the initial impact with the Honda (**Figure 9**). The direct damage began 264.0 cm (103.9”) forward of the left rear axle and measured 96.0 cm (37.8”) to the front left corner. The maximum crush measured 40.5 cm (15.9) and was located 408.0 cm (160.6”) forward of the left rear axle. A crush profile was documented at the mid-door level using a combined direct and induced damage width of 131.0 cm (51.6”). Six crush measurements were used to document the residual crush, which were as follows: C1 = 0, C2 = 0.5 cm (0.2”), C3 = 5.5 cm (2.2”), C4 = 12.5 cm (4.9”), C5 = 14.5 cm (5.7”), C6 = 40.5 cm (15.9”). The CDC for this impact was 10-LFEW-2.

Figure 9. Overall view of the 1999 Dodge Ram and crush profile for initial impact.

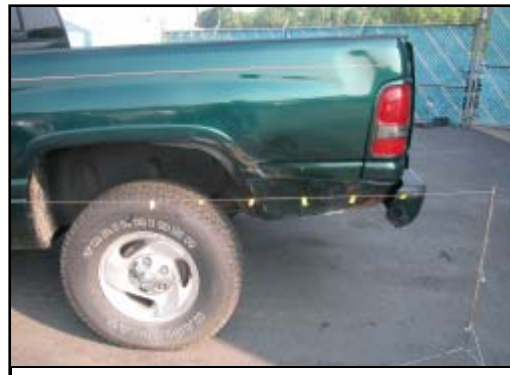
The secondary impact resulted in minor damage to the left rear aspect of the bed (**Figure 10**). The direct damage measured 104.0 cm (40.9”) and began 7.0 cm (2.8”) rear of the left rear axle. The maximum crush for this impact was 7.0 cm (2.8”) and was located 45.0 cm (17.7”) rear of the left rear axle. Six crush measurements were used to document the crush and were as follows: C1 = 6.0 cm (2.4”), C2 = 6.0 cm (2.4”), C3 = 7.0 cm (2.8”), C4 = 7.5 cm (3.0”), C5 = 0, C6 = 0. The CDC for this impact was 09-LBEW-1.

Figure 10. Left crush profile for secondary impact.

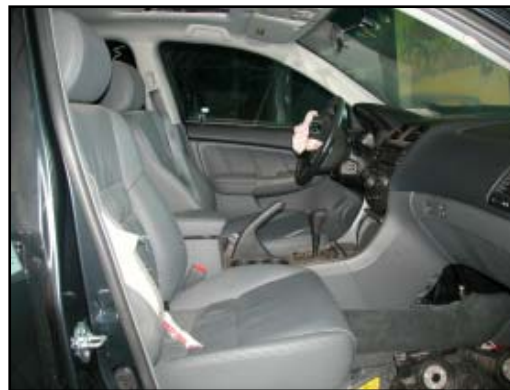
There were no occupant contact points or intrusion of the passenger compartment. The interior sustained minor damage from the deployment of the multiple air bags. No interior damage resulted from the driver's frontal air bag deployment. The outboard panel of the right seatback was torn at the designated tear points during the right side impact air bag deployment. The resulting damage required the replacement of the front right seatback. The headliner of the Honda was deformed at the

Figure 11. Overall view of the interior first row.

right roof side rail from the deployment of the right curtain air bag, which warranted the replacement of the headliner. **Figure 11** is an overall view of the interior first row.

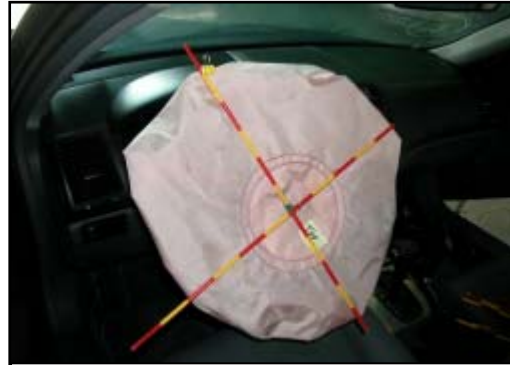
Figure 12. Deployed driver's frontal air bag.

The driver's air bag was located in the center of the steering wheel hub (**Figure 12**). Two H-configuration cover flaps concealed the air bag. The top cover flap measured 12.0 cm (4.7") in width and 9.5 cm (3.7") in height. The lower cover flap measured 12.0 cm (4.7") in width and 6.5 cm (2.6") in height. The air bag module also contained two pliable, symmetrical, I-configuration vinyl flaps behind the exterior module cover flaps. The air bag membrane measured 61.0 cm (24.0") in diameter in its deflated state and was configured with a 16.0 cm (6.3") diameter center circular stitching for the tethers. Four tethers were attached to the circular stitching and two vent ports at the 11 and 1 o'clock positions on the rear panel vented the air bag. No occupant contacts were present on the air bag membrane, however; dirt transfers were noted on the membrane from post-crash handling. The driver bag was identified by the following nomenclature printed on the rear panel at the 12 o'clock position of the air bag:

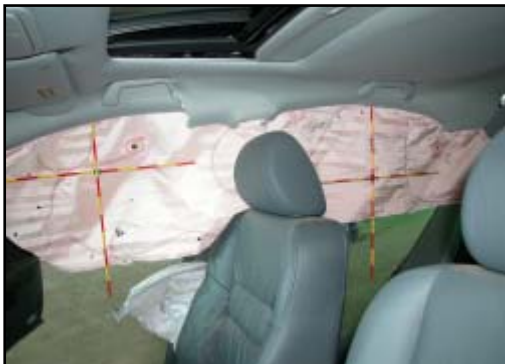
The 2004 Honda Accord was equipped Inflatable Curtain (IC) air bags for the outboard seating positions. In the subject vehicle the right side IC deployed during the initial impact with the Dodge. The IC deployed downward from the right roof side rail and extended from the right A-pillar to the right C-pillar. The IC measured 180.0 cm (70.9”) in width and 46.0 cm (18.1”) in height (**Figure 13**). A fabric liner housed the non-deployed IC, and the IC deployed through a tear seam in the bottom aspect of the headliner. The IC consisted of the two chambers for the front and rear outboard seating positions (**Figure 14**). The front right chamber measured 100.0 cm (39.4”) in width and 42.0 cm (16.5”) in height. The rear right chamber measured 38.0 cm (15.0”) in width and 32.0 cm (12.6”) in height. The IC inflator canister was concealed within the C-pillar area and utilized compressed helium to deploy the IC. No occupant contact points were present on the air bag; however, dirt transfers were noted to the right front chamber from post-crash handling. The following nomenclature was noted on the IC rear of the front chamber:

Figure 13. Overall view of deployed right side IC.

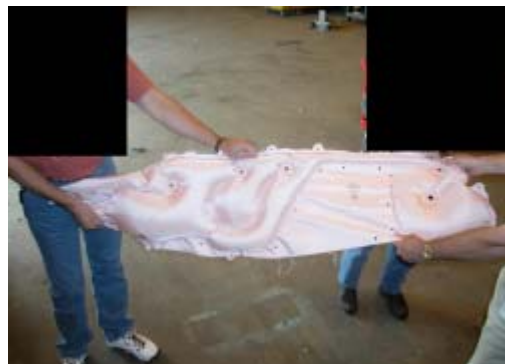
Figure 14. Deployed IC with front and rear chambers inflated.

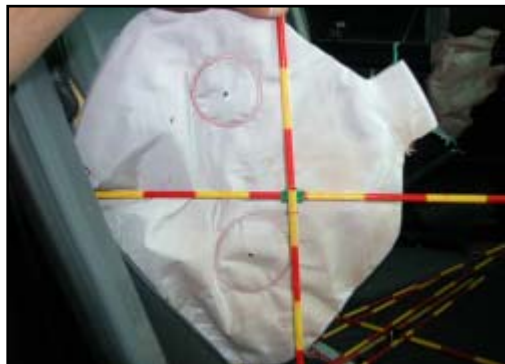
The 2004 Honda Accord was equipped with seatback-mounted side impact air bags for the front seat positions. The right side impact air bag deployed during the initial impact with the Dodge. The air bag membrane was of a semi-circular shape and measured 36.0 cm (14.2”) in height and 24.0 cm (9.4”) in width from the

Figure 15. Deployed right seatback mounted side impact air bag.

seatback to maximum forward excursion (**Figure 15**). The air bag membrane continued an additional 6.0 cm (2.4”) into the seatback module. A small non-inflatable tab that measured 5.0 cm (2.0”) in length and 7.0 cm (2.8”) in height was attached to the forward aspect of the air bag. The air bag contained two circular stitch patterns that created tethers between the front and rear panels. The upper stitching measured 6.0 cm (2.4”) in diameter and was located 5.0 cm (2.0”) rear of the forward seam and 5.0 cm (2.0”) cm below the top seam. The center of the stitching contained a 0.7 cm (0.3”) diameter hole. The lower stitch measured 7.5 cm (2.9”) in diameter and was located 10.0 cm (3.9”) above the lower seam and 10.5 cm (4.1”) inboard of the forward seam. The lower stitch also contained 0.7 cm (0.3”) diameter hole in the center. No occupant contact points were present on the air bag; however, dirt transfers were noted from post-crash handling. The air bag membrane contained a bar code and the following identifier:
