ON-SITE POTENTIAL SAFETY-RELATED DEFECT INVESTIGATION

CASE NUMBER - IN-04-025

LOCATION - Missouri

VEHICLE - 2004 SATURN VUE

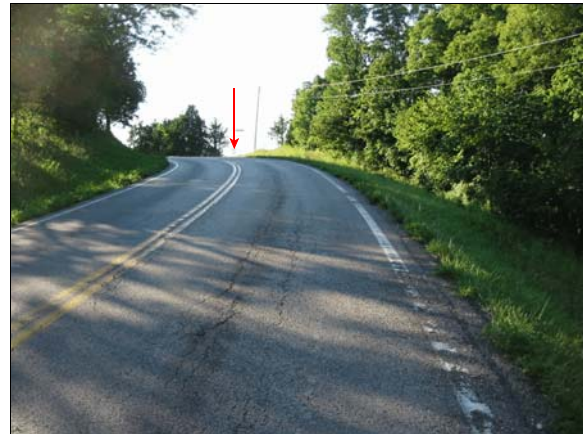
Figure 1: Approach of case vehicle northwest bound approaching intersecting roadway, arrow shows intersection

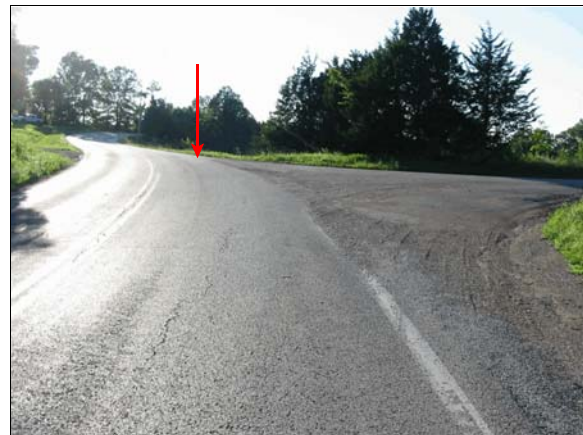
Figure 2: Intersecting roadway with loose gravel, arrow shows area of first right rear yaw mark

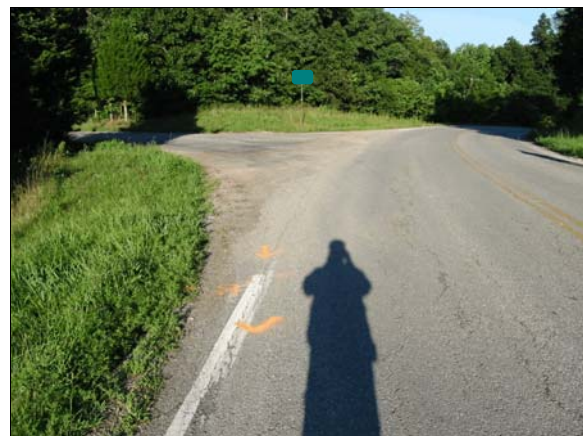
Figure 3: View east back to case vehicles approach, orange paint shows first right rear yaw mark

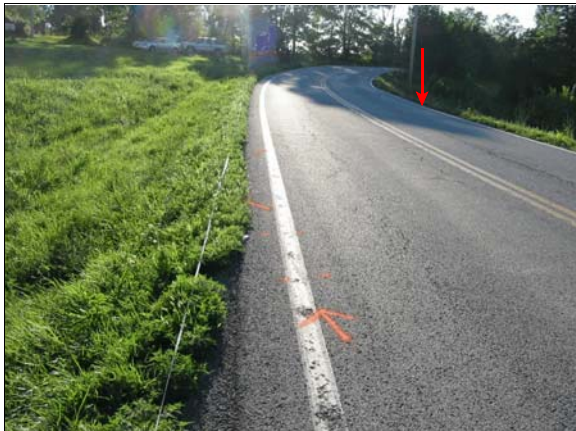
Figure 4: View west to left rear yaw mark on south edge line of roadway (orange arrow), red arrow shows area of second right rear yaw mark

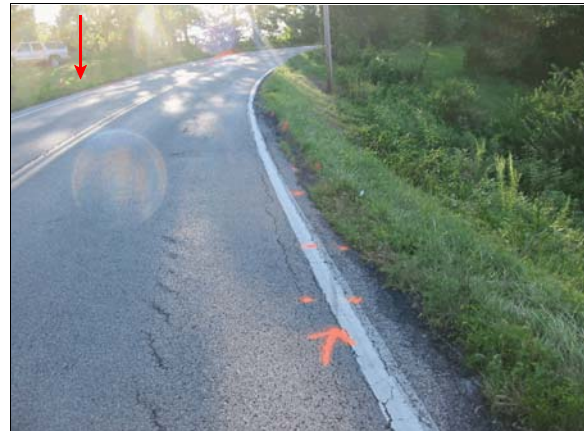
Figure 5: View west to second right rear yaw mark on north edge line of roadway and in grass, red arrow shows location of crash

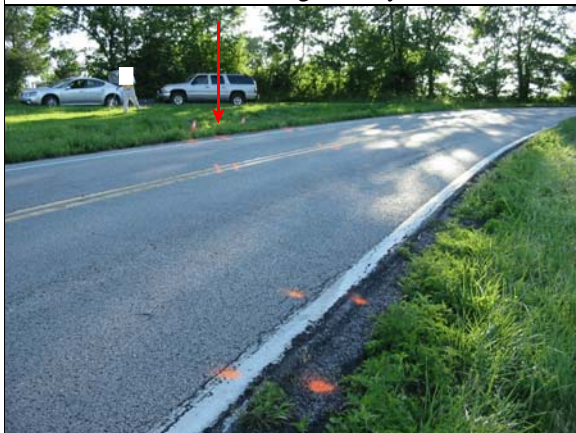
Figure 6: View southwest to case vehicle’s yaw path leading to the area of rollover, indicated by arrow

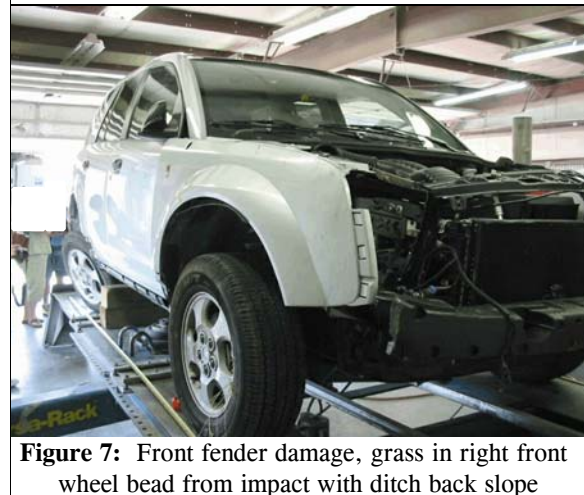
Figure 7: Front fender damage, grass in right front wheel bead from impact with ditch back slope

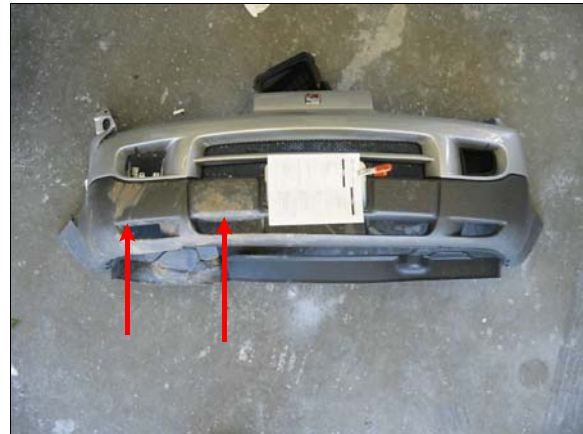
Figure 8: Case vehicle’s front bumper cover showing dirt transfer and ground contact damage to right half of the bumper cover

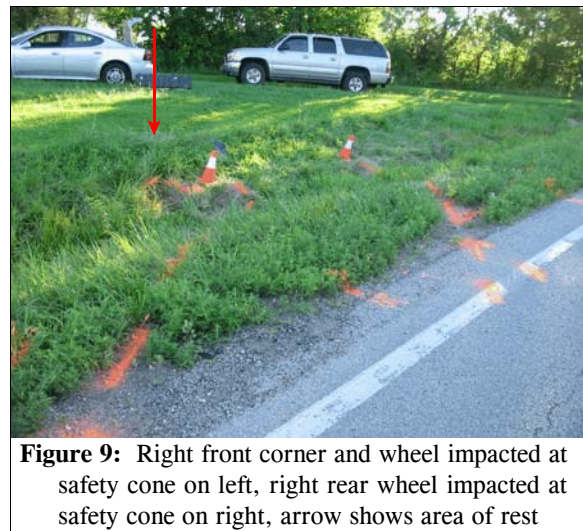
Post-Crash: The case vehicle came to rest on its right side on the south side of the roadway facing northeast (**Figure 9**). The passengers were able to exit the vehicle under their own power.

Figure 9: Right front corner and wheel impacted at safety cone on left, right rear wheel impacted at safety cone on right, arrow shows area of rest

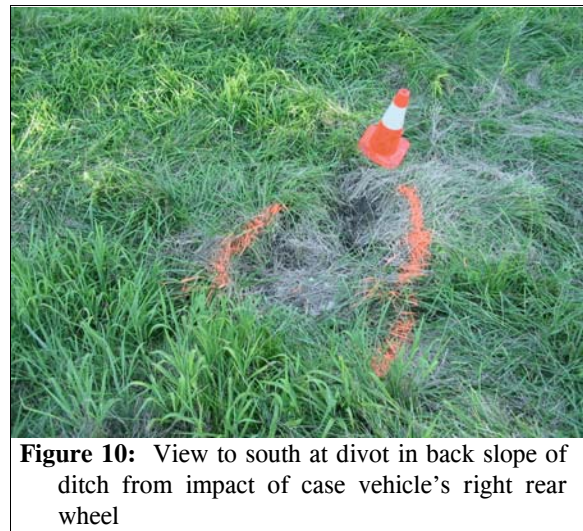
Figure 10: View to south at divot in back slope of ditch from impact of case vehicle’s right rear wheel

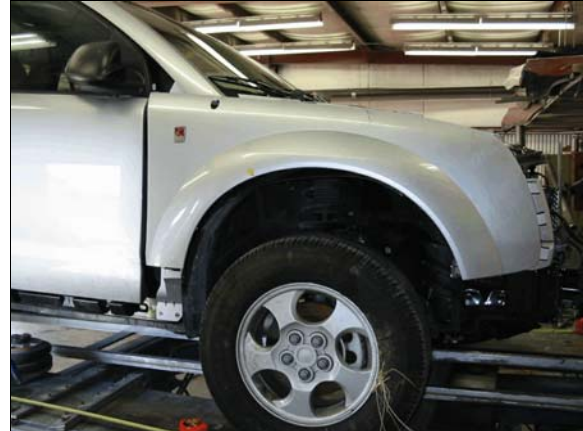
Exterior Damage: The case vehicle's initial contact with the back slope of the ditch involved the right front wheel, right portion of the front bumper and right fender. The bumper cover, right headlamp/turn lamp assembly, right edge of the hood and right fender were directly damaged. The direct damage involved about half the width of the front bumper. There was no residual crush to the front bumper; however, the right fender frame and radiator frame were displaced. The direct damage to the right side began at the right bumper corner and hood and extended approximately 70 centimeters (27.6 inches) rearward on the edge of the hood and 81 centimeters (31.9 inches) rearward on the front fender, beginning at the front edge of the fender (**Figure 11**). The center portion of the vehicle's right side did not show any signs of direct damage (**Figure 12**), although the right side mirror was turned in against the window. There was direct ground contact to the right rear wheel, and the wheel was bent it in at the bottom and displaced forward. The right quarter panel was also directly damaged. Grass and dirt were lodged in the seam between the back bumper cover and lower quarter panel (**Figure 13**). The case vehicle's left side wheelbase was unaltered, but the right side

Figure 11: Direct damage scratches began at front of right front fender, grass in right front wheel bead

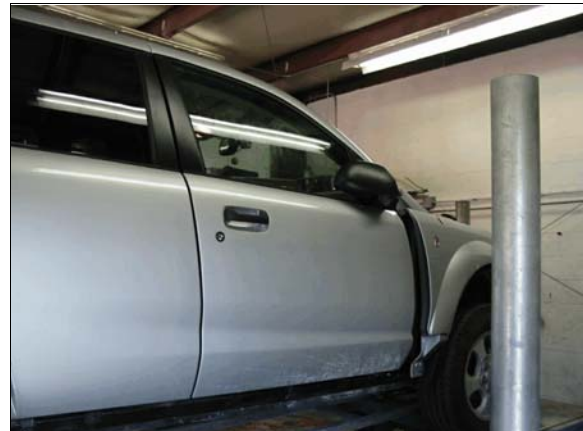
Figure 12: Case vehicle's right front and right rear doors were undamaged

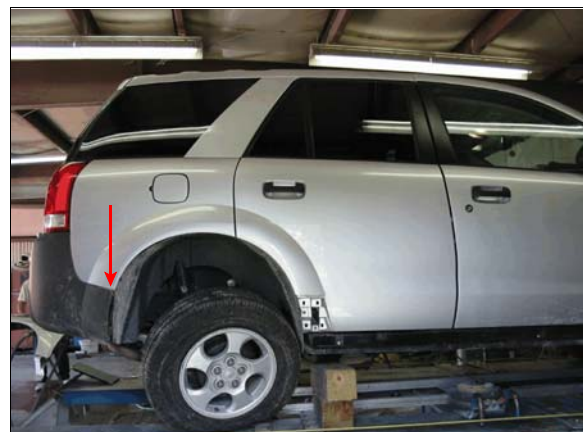
Figure 13: Overview of case vehicle's right side doors, right rear wheel and quarter panel, arrow shows grass/dirt jammed in quarter panel seam

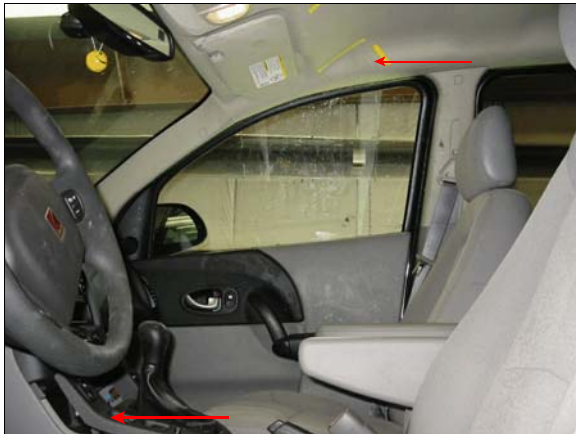
Vehicle Interior: Inspection of the case vehicle's interior revealed occupant contacts on the center console trim, front right roof, glove box door and right front door and window (**Figure 14** and **Figure 15** below). Some of these contacts could have occurred as the occupants were exiting the vehicle. There was an obvious shoe print on the right roof side rail that apparently occurred as the occupants were climbing out of the vehicle. There were no intrusions of the passenger compartment and no evidence of compression to the energy absorbing steering column or deformation of the steering wheel rim was observed (**Figure 16** below).

Figure 15: Overview of contacts, yellow tape shows marks on roof, arrows show shoe print on roof and displaced floor console trim

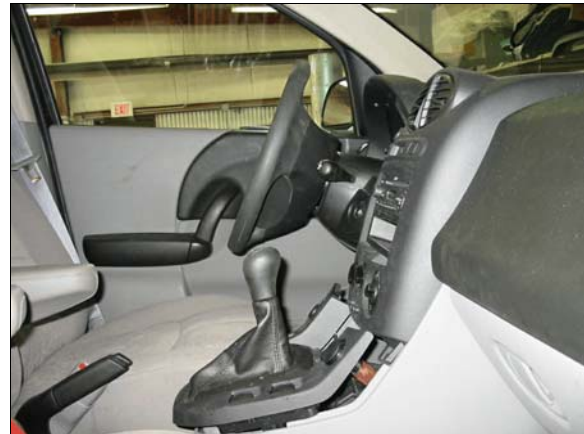
Figure 16: Overview of the case vehicle's steering wheel and steering column

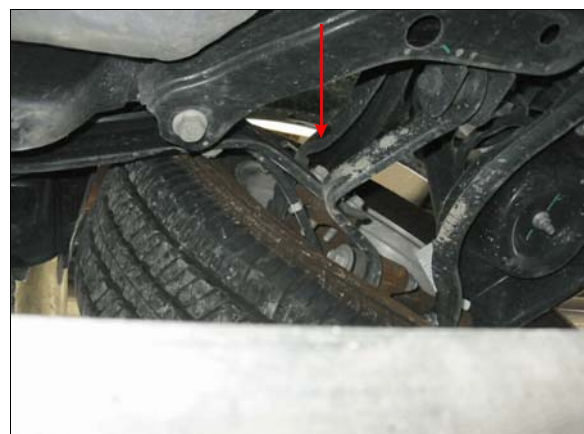
wheelbase was shortened 10 centimeters (3.9 inches). Induced damage involved the hood, front bumper cover, and suspension components of the right rear wheel. The right side panels of the vehicle were constructed of plastic, which was most likely the reason there was no induced damage to these components.

Figure 17: Damage to right rear suspension, toe link bent in V-shape, right rear tire against bent trailing arm, arrow shows upper control arm

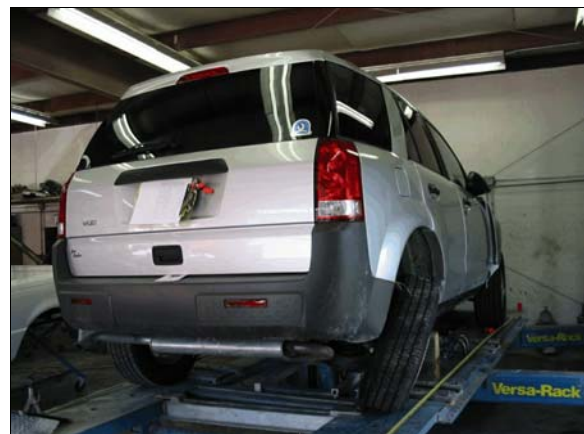
The case vehicle's owner stated in the Auto Safety Hotline, Vehicle Owner's Questionnaire that when the case vehicle went into the ditch, the right rear wheel collapsed and the vehicle overturned. This contractor's inspection of the case vehicle revealed that the right rear toe link and trailing arm were badly bent (**Figure 17**), and the right rear tire was against the trailing arm and front of the wheel house. The upper control arm appeared to be deformed as well. The right rear wheel was observed to be bent in at the bottom about 20 degrees (**Figure 18**) and angled to

Figure 18: Overview of back and right side of case vehicle showing condition of right rear wheel

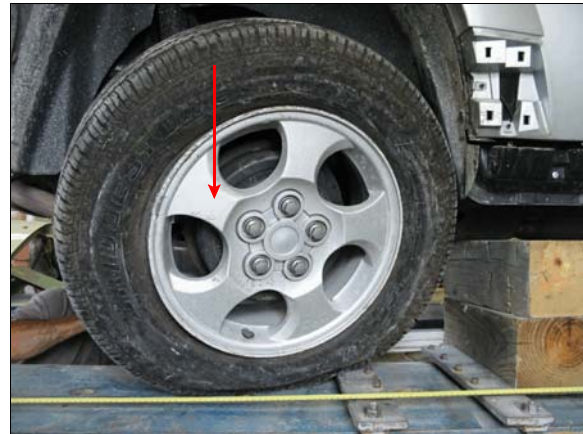
the left due to the toe control link and trailing arm damage. There also were scratches and dirt residue found on the wheel rim and lug nuts (Figure 19). In addition, the scene inspection revealed a ground divot in the back slope of the ditch (Figure 10 above) that corresponded to an impact by the right rear wheel during the rollover. Based on the evidence, this contractor concludes that this was an impact- induced, passenger side leading rollover that occurred as the case vehicle departed the south side of the roadway and entered a ditch in a severe counterclockwise yaw. The right rear wheel did not collapse causing the rollover. The rollover was initiated when the right front corner and right front wheel impacted the back slope of the ditch. The right rear wheel and suspension damage was caused as the back of the case vehicle swung around during the rollover and the right rear wheel impacted the back slope of the ditch.

Figure 19: Right rear wheel, dirt on lug nuts and rim, arrow shows scratches on rim

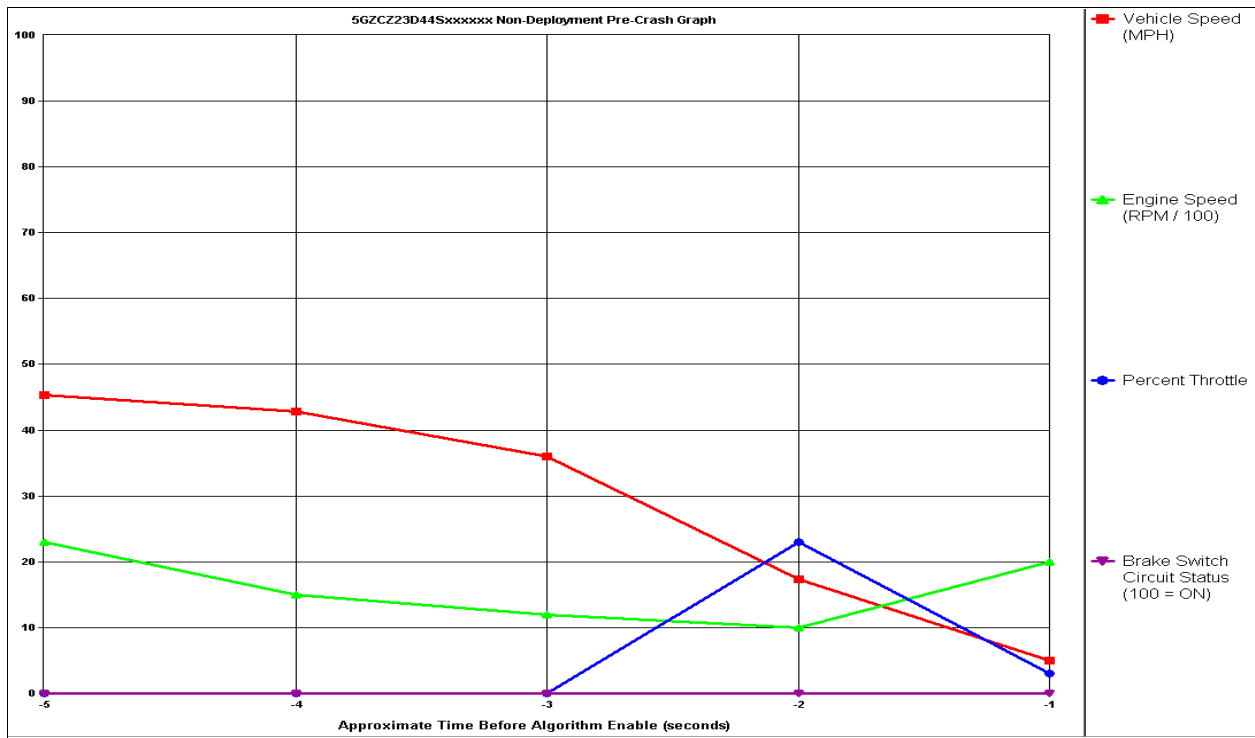
The download of the case vehicle’s EDR was done during the vehicle inspection via connection to the case vehicle’s diagnostic link connector. The EDR recorded a non-deployment event. The EDR reports (Figures 21 - 23) are presented at the end of this report. It is this contractor’s opinion that the crash sensing algorithm was activated when the case vehicle’s right front corner impacted the back slope of the ditch. The system status report indicates the case vehicle sustained a longitudinal deceleration just severe enough to wake up the crash sensing algorithm as indicated by the maximum recorded velocity change of -0.02 km.p.h. (-0.01 m.p.h). The system status report also recorded the SIR warning lamp as off and the driver’s seat belt switch circuit as unbuckled. The pre-crash data shows the brake switch circuit was off for the five, one-second sample periods prior to algorithm enable (AE). It also recorded the case vehicle traveling 72 km.p.h. (45 m.p.h.) at 0% throttle five seconds prior to algorithm enable. The speed then begins to decrease and the percent throttle

Figure 22: Case vehicle's Non-Deployment Pre-Crash Graph

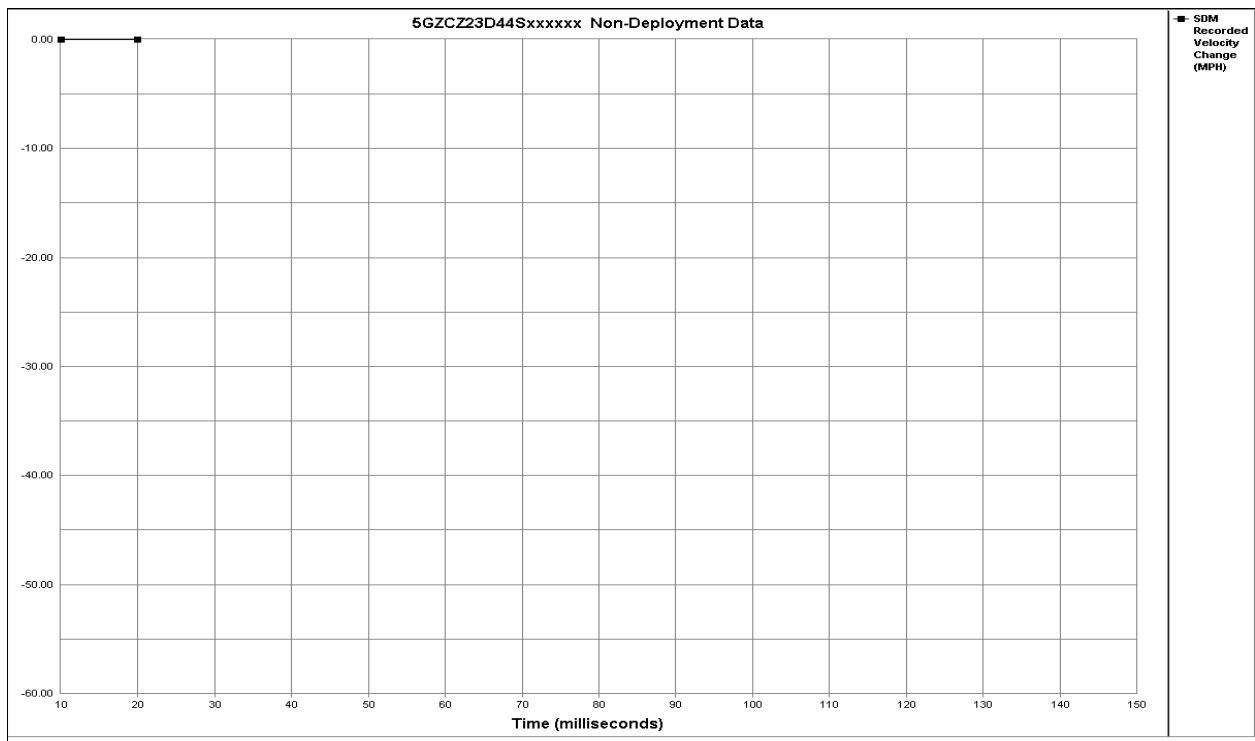
Figure 23: Case vehicle's Non-Deployment SDM Recorded Velocity Change graph

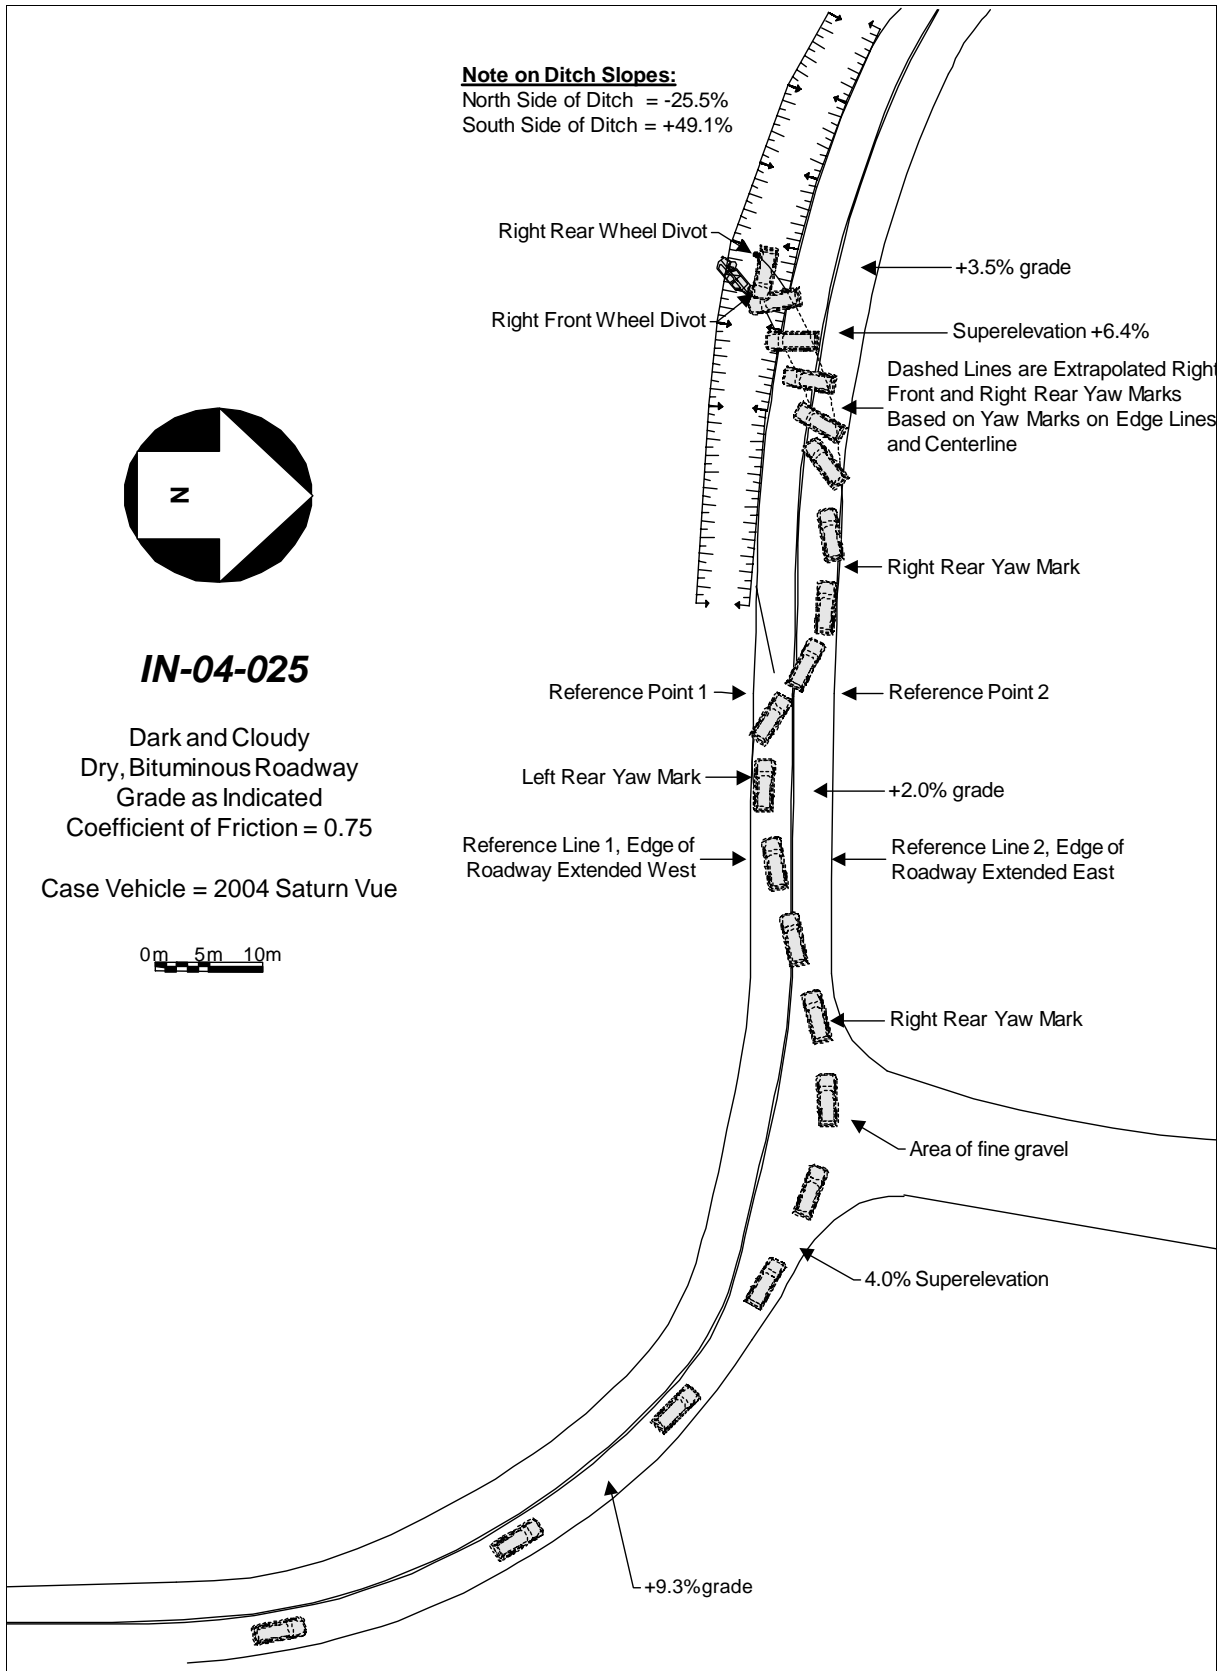
A critical speed analysis was performed on the case vehicle's reconstructed final yaw path that led to the south road edge departure and rollover. The speed at the onset of the final yaw based on this analysis was approximately 65 km.p.h (40 m.p.h). The reconstructed speed was consistent with the EDR recorded pre-crash speed of 69 km.p.h. (43 m.p.h) recorded at four seconds prior to AE (i.e., impact with the back slope of the ditch), which, based on the reconstruction, occurred near the beginning of the final yaw. The critical speed equation and data used in the calculation are presented in **Figure 24** at the end of this report.

Figure 24: Critical speed analysis based on reconstructed yaw path of case vehicle's center of mass (Note: track distance was not required since curve radius was based on path of case vehicle's center of mass, percent grade is average of superelevation and roadway grade)
