**CALSPAN ON-SITE CERTIFIED ADVANCED 208-COMPLIANT
VEHICLE CRASH INVESTIGATION**

CASE NO: CA04-026

VEHICLE: 2004 TOYOTA CAMRY

CRASH DATE: MARCH 2004

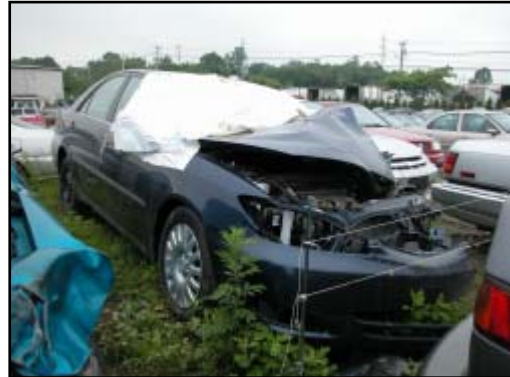
Figure 1. 2004 Toyota Camry.

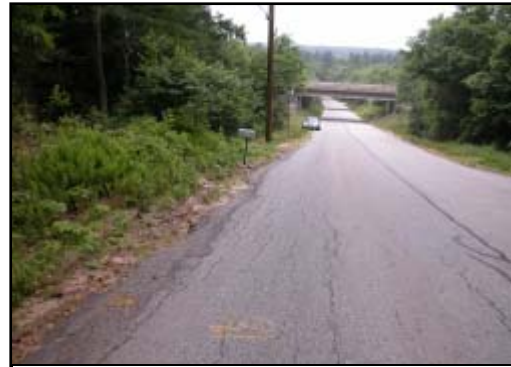
This run-off-road crash occurred during the nighttime hours of March 2004. At the time of the crash, the weather was clear with no adverse conditions. The crash occurred off the left road side of a two-lane east/west roadway (**Figure 2**). The roadway curved to the

Figure 2. Westbound view of crash site.

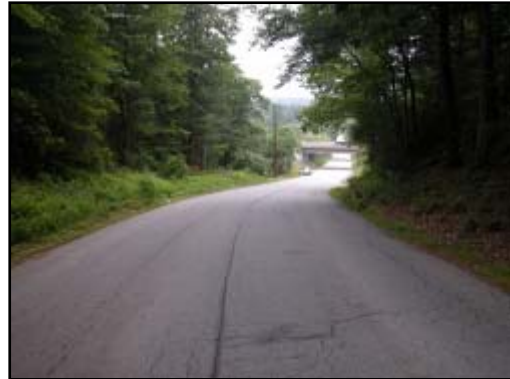
The restrained 43-year-old male driver of the 2004 Toyota Camry was operating the vehicle westbound on the two-lane roadway negotiating the right curve with a negative grade (**Figure 3**). As the driver continued westbound, he allowed the vehicle to drift left across the eastbound travel lane as he exited the curve. The Camry departed the south (left) road edge in a presumed tracking mode. Due to the duration between the crash date and the SCI investigation, there was no physical evidence to support the vehicle's trajectory.

Figure 3. Toyota's westbound approach.

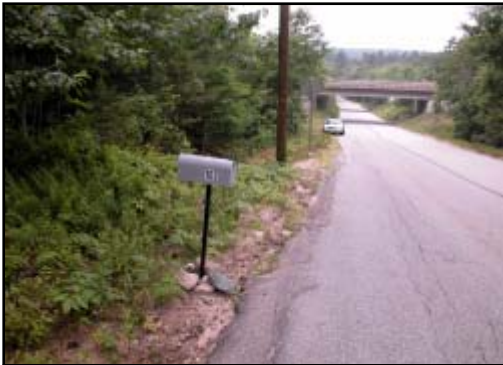
The Toyota impacted a mailbox post with the front left corner area (**Figure 4**). The mailbox separated from the post and subsequently impacted the lower left A-pillar as the Camry continued forward. Minor damage resulted to the pillar. The Toyota continued approximately 9 meters (30 feet) forward and impacted and fractured a wooden utility pole (**Figure 5**) with the front left corner area, masking the initial impact damage from the mailbox. This event resulted in a 12 o'clock impact force. Although the corner impact was outside the scope of the WINSMASH program, the Barrier Equivalent algorithm was used to calculate an approximate delta V due to the pole yielding at impact. Two crush profiles were documented for this impact, one at bumper beam level and the second at the upper radiator support. The average of the two profiles was used to calculate a total delta V of 19 km/h (11.2 mph) with a longitudinal component of -19 km/h (11.8 mph) and lateral component of 0 km/h (0 mph). The pocketing of the pole into the fender and the tire/wheel and suspension could not be accounted for in this reconstruction, therefore the output is conservative. The vehicle's onboard EDR recorded a longitudinal velocity change of 62 km/h (38.5 mph) at 150 ms of Algorithm Enable (AE). As a result of the frontal impact, the driver's frontal air bag deployed at an EDR reported High (Stage 2) level. The driver's safety belt retractor pretensioner fired. The seatback-mounted side air bags and the IC's did not deploy.

Figure 4. Area of struck mailbox.

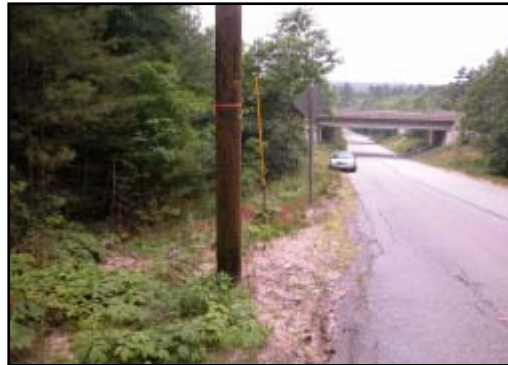
Figure 5. Area of struck utility pole. (Utility pole was replaced.)

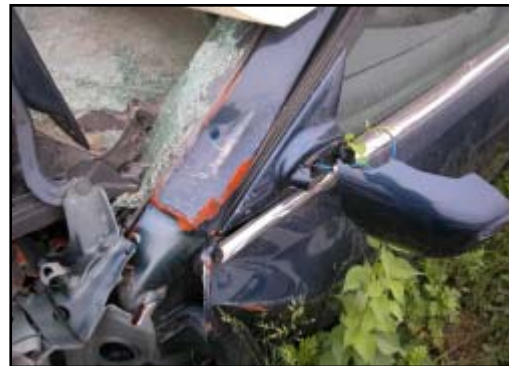
The Toyota impacted the mailbox post and the utility pole with the front left corner area. The initial impact with the mailbox was masked by the subsequent pole engagement. The Collision Deformation Classification (CDC) for this impact was estimated at 12-FLEN-1. The mailbox impacted the lower aspect of the left A-pillar and corner of the windshield as the vehicle continued forward. The damage consisted of deformation with laterally oriented abrasions to the upper left A-pillar. The mailbox also fractured the lower left corner of the windshield and the left side view mirror (**Figure 6**). The CDC for this impact was 12-FLGE-6.

Figure 6. Damage from the mailbox impact.

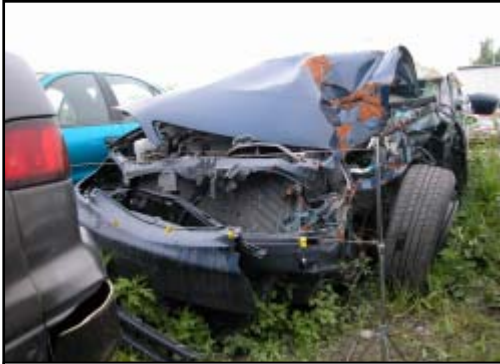
The Toyota sustained moderate severity damage as a result of the impact with the utility pole (**Figure 7**). The damage involved the bumper fascia, bumper support, hood, left front fender, left front tire/wheel and suspension, and the upper radiator support. The engagement with the pole crushed the left corner of the bumper beam to a maximum depth of 19 cm (7.5") and the left corner of the upper radiator support 43 cm (16.9"). The direct damage contact began 43 cm (17") left of the centerline and extended 27 cm (10.8") to the left bumper corner. Two crush profiles were used to document the residual crush. Six equidistant crush measurements were used to document the crush using a combined direct and induced damage length of 121 cm (47.5"). The crush profile documented at the bumper level was as follows: C1 = 19 cm (7.5"), C2 = 9 cm (3.5"), C3 = 8 cm (3.1"), C4 = 6 cm (2.4"), C5 = 6 cm (2.4"), C6 = 2 cm (0.8").

The crush profile documented at the upper radiator support was as follows: C1 = 43 cm (16.9"), C2 = 4 cm (1.6"), C3 = 1 cm (0.4"), C4 = 0 cm, C5 = 0 cm, C6 = 0 cm. The Collision Deformation Classification (CDC) for this impact was 12-FLEE-3.

Figure 7. Front left corner damage from the utility pole impact.

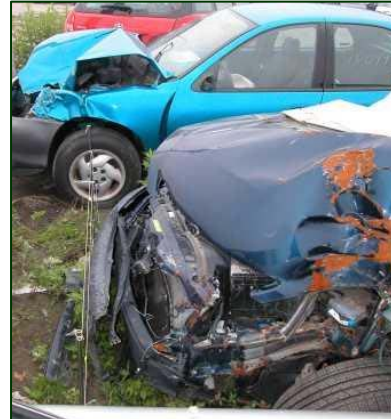
The average of these two profiles was used for the damage algorithm of the WINSMASH program to calculate a delta V. The average crush measurements for this input were as follows: C1 = 31 cm (12.2”), C2 = 9 cm (3.5”), C3 = 8 cm (3.1”), C4 = 6 cm (2.4”), C5 = 6 cm (2.4”), C6 = 1 cm (0.4”). **Figure 8** is a lateral view of the two profiles.

Figure 8. Lateral view depicting the extent of frontal crush.

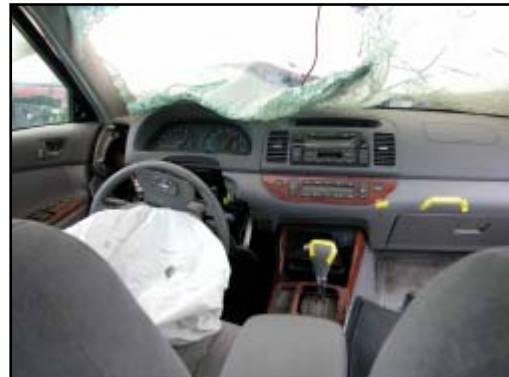
The interior of the 2004 Toyota Camry sustained moderate severity damage as a result of occupant contacts. There was no intrusion of the passenger compartment. At impact with the utility pole, the driver's frontal air bag deployed. The unrestrained driver initiated a forward trajectory and contacted the knee bolster, which deformed the plastic knee bolster panel. The driver's torso loaded through the deployed air bag and engaged the steering wheel rim, deforming the lower right quadrant of the steering wheel 3 cm (1") forward. His loading force was transmitted into the steering column which fully compressed, disengaging the column from the instrument panel substructure.

Figure 9. Overall view of the driver's trajectory and contact points.

This column was not equipped with typical shear capsule brackets, therefore no measurements were obtained. Also noted were hair and glass fragments in a 6 cm (2.5") diameter area at the forward edge of the sunroof cover from rebound contact from the driver's head. A tissue/fabric transfer was noted to the rear aspect of the transmission lever from contact with the driver's right hand. An oily scuffmark was located 27-35 cm (10.5-13.8") right of center and 19-22 cm (7.5-8.5") below the top apex of the instrument panel from contact with the driver's head. Body fluid was located on the center instrument panel 14-15 cm (5.5-6.5") right of center and 22-24 cm (8.5-9.5") below the top IP from possible contact with driver's right hand post-crash. **Figure 9** is an overall view of the driver's contact points.

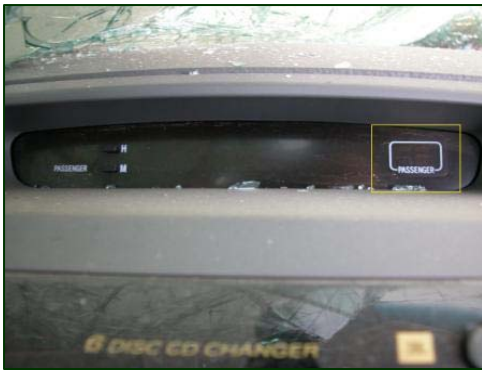
Figure 10. Passenger air bag indicator light for CAC safety system.

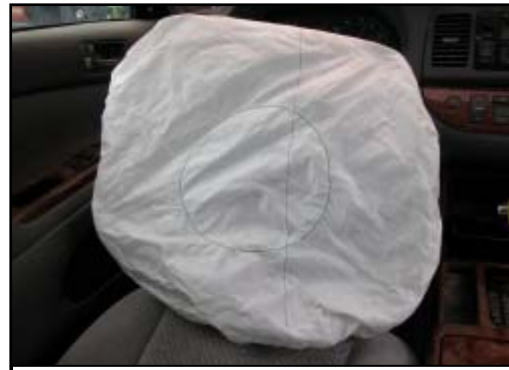
Figure 11. Deployed driver's frontal air bag.

The driver's frontal air bag deployed during the impact sequence with the utility pole. The driver's air bag was located in the center of the steering wheel hub (**Figure 11**) and was concealed by two H-configuration module cover flaps. The top flap measured 12 cm (4.6") in width at the top hinge point and 17 cm (6.5") in width at the horizontal tear seam. The upper flap was 10 cm (4") in height. The lower cover flap measured 14 cm (5.4") in width and 8 cm (3") in height. The air bag membrane measured 59 cm (23") in diameter in its deflated state. No occupant contact evidence was present on the air bag. The air bag was vented by two 3 cm (1") diameter ports that were centered 8 cm (3.3") forward of the peripheral seam at the top aspect of the air bag. The bag was tethered by two 12 cm (4.8") wide band tethers that were sewn to the face of the air bag at the 3 and 9 o'clock positions. A 22 cm (8.8") diameter tether stitch pattern was located on the center face of the air bag.

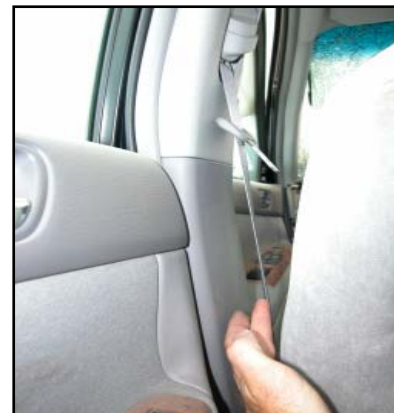
The 2004 Toyota Camry was equipped with manual 3-point lap and shoulder safety belts for the five designated seated positions. The driver safety belt system was configured with a sliding latch plate, Emergency Locking Retractor (ELR), height adjustable D-ring, and a retractor pretensioner with force limiters. The adjustable D-ring was in the full-down position at the time of the SCI inspection. The driver did not use the safety belt in the crash, which was evidenced by the occupant contact points to the frontal components and the fired status of the retractor pretensioner. The pretensioner spooled the continuous loop webbing taut against the B-pillar (**Figure 12**).

Figure 12. Stowed and taut position of the driver's safety belt webbing due to the fired
