ON-SITE CERTIFIED ADVANCED 208- COMPLIANT VEHICLE INVESTIGATION

CASE NUMBER - IN-04-027

VEHICLE - 2004 CHEVROLET AVALANCHE

CRASH DATE - June 2004

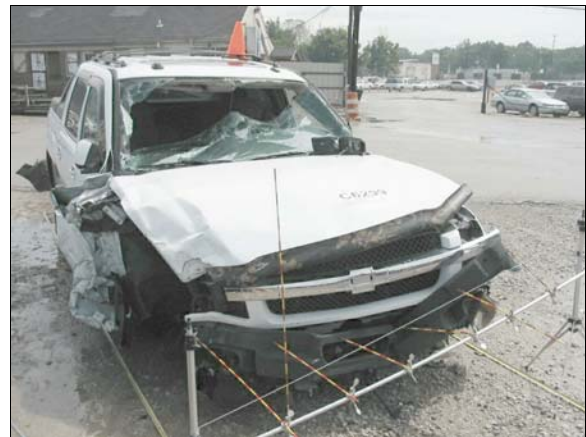
Figure 2: Damage to front right corner of case vehicle from impact to back of Silverado's towed trailing unit, each stripe on rods is 5 cm (2 in)

Crash: The front right corner of the case vehicle (**Figure 2**) impacted the back left corner of Chevrolet Silverado's towed trailing unit. The impact caused an angled gouge in the roadway (**Figure 3**) and caused the case vehicle to rotate clockwise and tip up on its left side wheels. The rim of the left front wheel (**Figure 4**) gouged into the pavement (**Figure 5** below) and the case vehicle rolled over onto its left side (**Figures 6 and 7** below). The absence of any direct contact

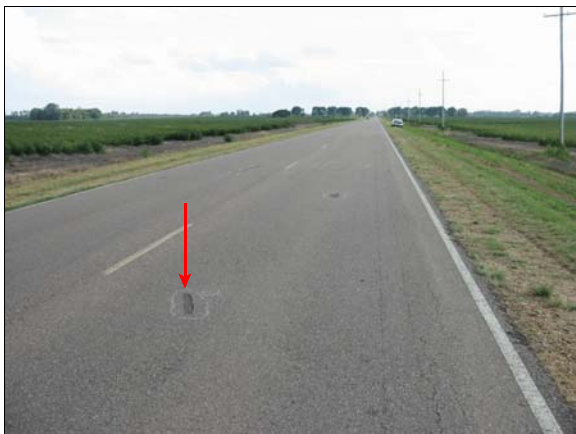
Figure 3: Angled gouge indicated by arrow shows area of impact in southwest travel lane

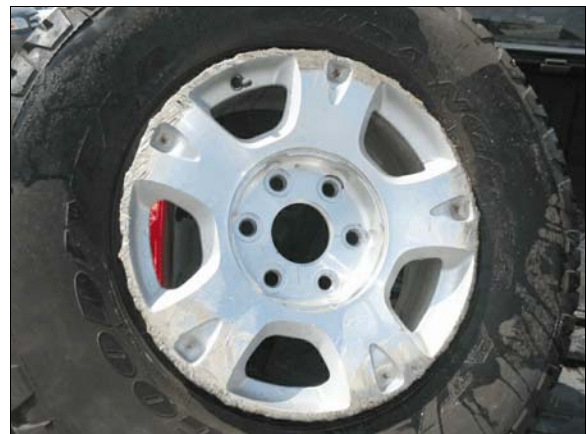
Figure 4: Pavement grinding on rim of case vehicle's left front wheel

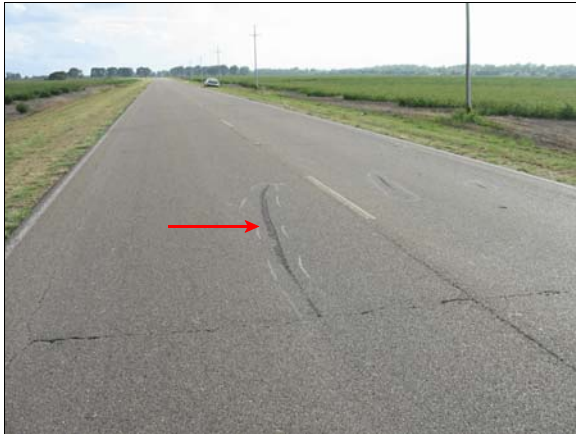
Figure 5: Arrow shows pavement gouge from rim of case vehicle's left front wheel

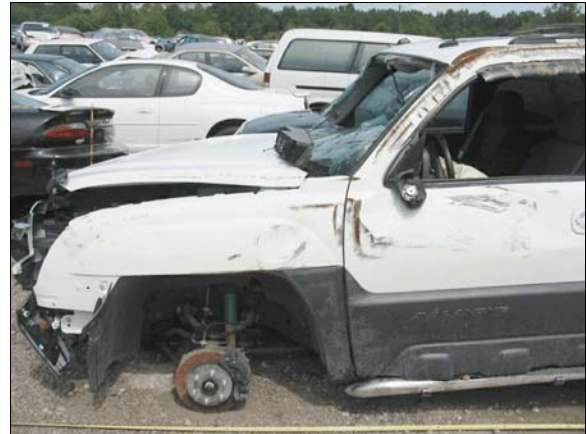
damage to the right side and top indicates the case vehicle rolled over only one quarter turn onto its left side. Following the impact, the towed trailing units separated from the case vehicle and the Silverado. The location where the separations occurred is not known.

Figure 6: Rollover damage to case vehicle's left fender and left front door

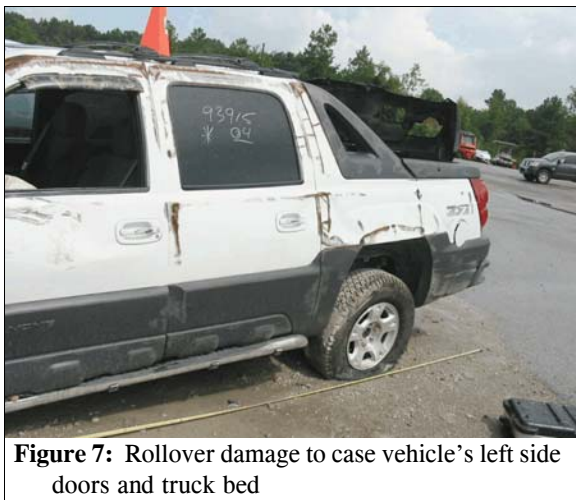
Figure 7: Rollover damage to case vehicle's left side doors and truck bed

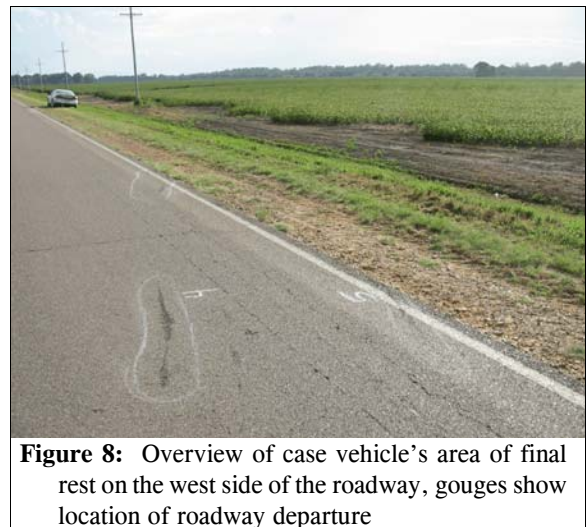
Figure 8: Overview of case vehicle's area of final rest on the west side of the roadway, gouges show location of roadway departure

Post-Crash: Following the rollover, the case vehicle rotated clockwise, slid on its left side on the roadway approximately 40 meters (131 feet) and departed the west side of the roadway. The direction of abrasions in the plastic components on the case vehicle's left side show that the vehicle slid backwards during the rotation. This indicates the case vehicle rotated clockwise about 270 degrees prior to departing the roadway. The case vehicle then traveled approximately 10 meters (33 feet) off the roadway and, based on the police crash diagram and interview data, came to rest on its wheels facing southeast (**Figure 8**). It appears that as the case vehicle departed the roadway

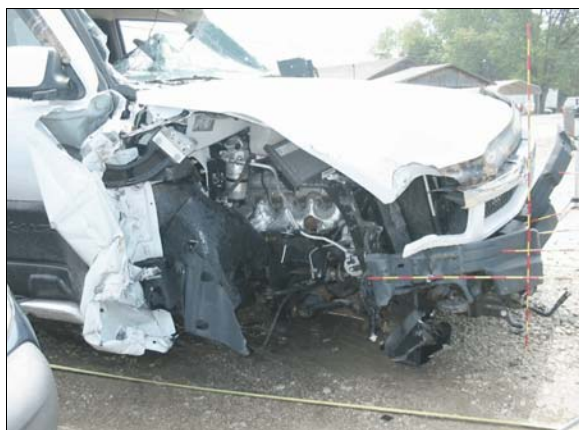
Exterior Damage: The case vehicle's initial contact with the back of the Chevrolet Silverado's towed trailing unit involved the right corner of the front bumper, right headlamp/turn lamp assembly, hood, grille and the right fender (**Figure 9** below). The impact crushed the fender rearward, pulled it outward and broke the right front wheel off its axle. The direct contact extended rearward to the A-pillar. The left portion of the front bumper was pulled forward a significant amount and there was an induced buckle in the center of the bumper. Due to the lack

Figure 9: Damage to case vehicle from impact with Chevrolet Silverado’s towed training unit; crush measurements taken to bumper backing bar

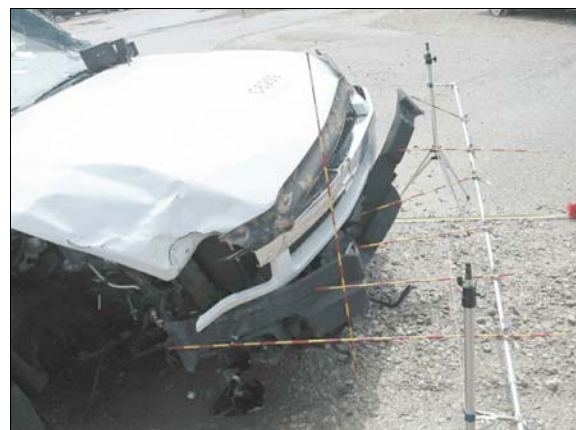
Figure 10: Crush to front of case vehicle from impact with back of Chevrolet Silverado’s towed trailing unit, each stripe on rods is 5.0 centimeters (2.0 inches)

The crash related direct damage began at the front right bumper corner and extended 28 centimeters (11 inches) along the front bumper. Residual maximum crush was measured as 61 centimeters (24 inches) at C₆ (**Figure 10**). The table below shows the case vehicle’s crush profile

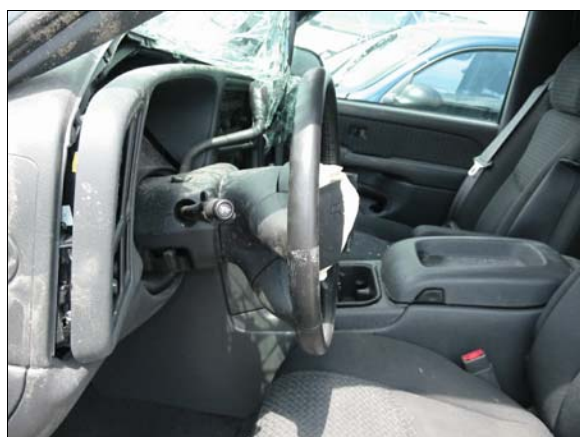
Vehicle Interior: Inspection of the case vehicle’s interior revealed no evidence of occupant contact to any interior surfaces or components. There was no evidence of compression of the energy absorbing steering column or deformation of the steering wheel (**Figure 11**). In addition, there was no indication of damage to the adjustable pedals (**Figure 12**). Several occupant compartment intrusions were observed and documented. The most severe intrusions occurred to the right toe pan, which intruded longitudinally 16 centimeters (6.3 inches) into the front right occupant space and the right front door, which intruded laterally 8.0 centimeters (3.1 inches) into the front right occupant space. Other minor intrusions involved the left front door and the left “A”-pillar cover.

Figure 11: Case vehicle’s steering column and steering wheel showing lack of deformation

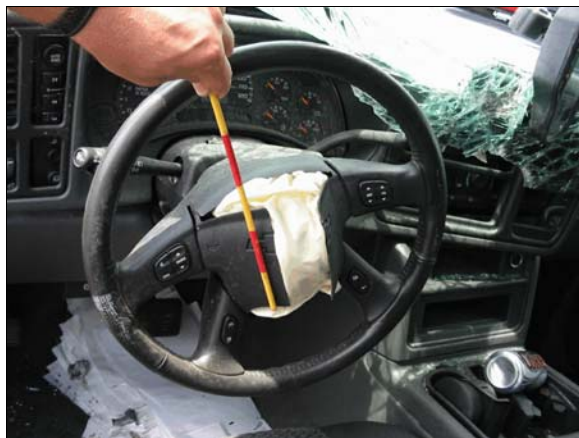
The case vehicle's driver air bag was located in the steering wheel hub. An inspection of the air bag module cover flaps and the air bag fabric revealed that the cover flaps opened at the designated tear points (**Figure 13**). There was no evidence of damage during the deployment to the air bag or the cover flaps. The air bag module cover consisted of symmetrical "I" configuration cover flaps. The two cover flaps were each constructed of pliable vinyl, and each flap was approximately 7 centimeters (2.8 inches) in width at the top and approximately 6.0 centimeters (2.4 inches) in width at the bottom. The vertical tear seam between the two cover flaps was 12 centimeters (4.7 inches) in height. The deployed driver's air bag (**Figure 14**) was round with a diameter of approximately 63 centimeters (24.8 inches) and was designed with two tethers, each approximately 11 centimeters (4.3 inches) in width. The driver's air bag had two vent ports, each approximately 3 centimeters (1.2 inches) in diameter, located at the 10 and 2 o'clock positions (**Figure 15** below). An inspection of the driver's air bag fabric revealed no evidence of occupant contact. The distance between the mid-center of the driver's seat back, as positioned at the time of the inspection (i.e., approximately at the rear track position), and the front surface of the air bag's fabric at full excursion was 34 centimeters (13.4 inches).

Figure 13: Case vehicle's driver air bag cover flaps

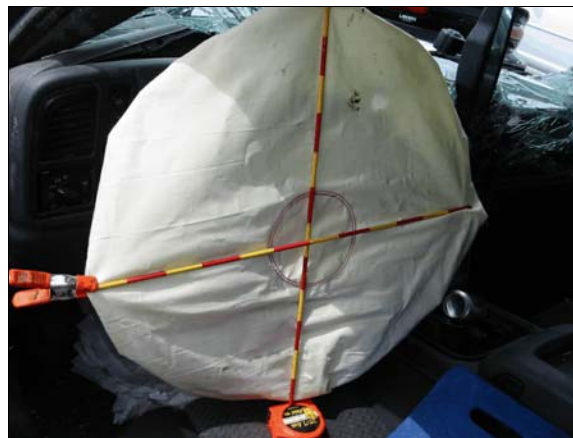
Figure 14: case vehicle's driver air bag, each stripe on rods is 5.0 centimeters (2.0 inches)

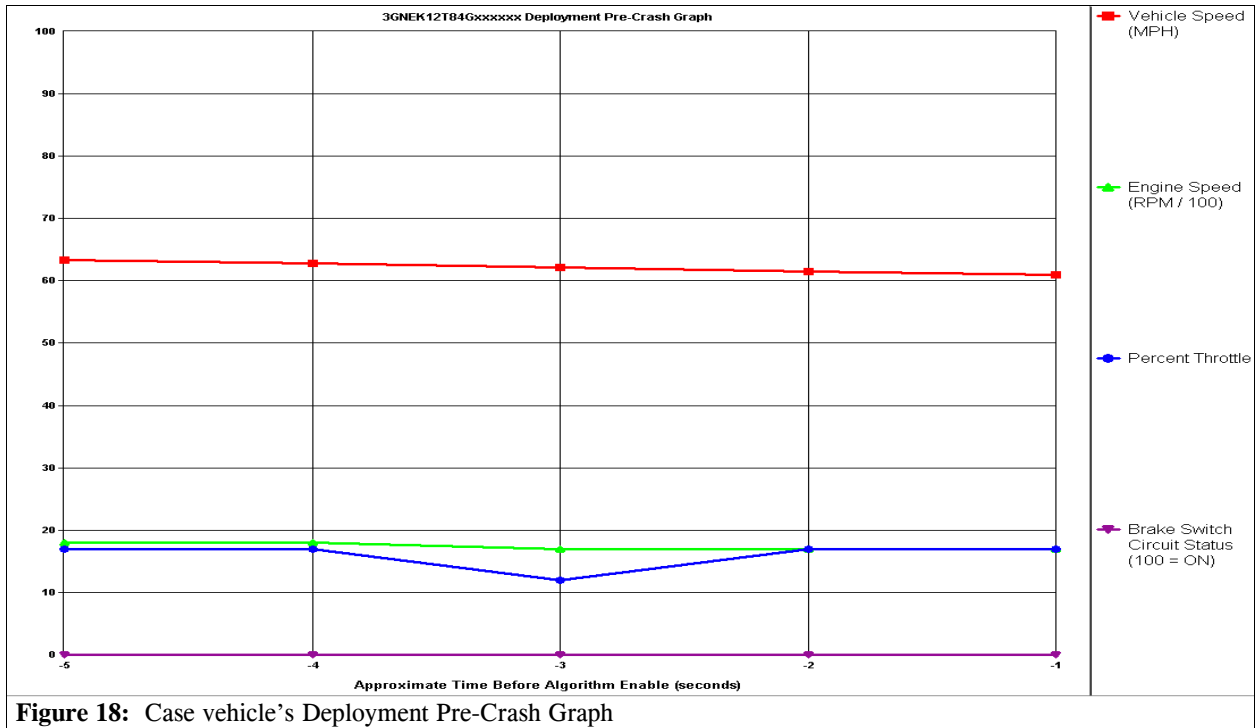
Figure 18: Case vehicle's Deployment Pre-Crash Graph

The system status report shows that the first stage deployment criteria for the driver's air bag was met 32.5 milliseconds after AE, and the second stage deployment criteria was not met. In addition, the system status report indicates that the deployment of the front right passenger air bag was suppressed. The deployment pre-crash data also indicates the case vehicle's driver did not apply the brakes prior to the crash and was traveling 101 km.p.h. (63 mph) five seconds prior to the crash, and had slowed slightly to 98 km.p.h. (61 mph) one second prior to the crash.

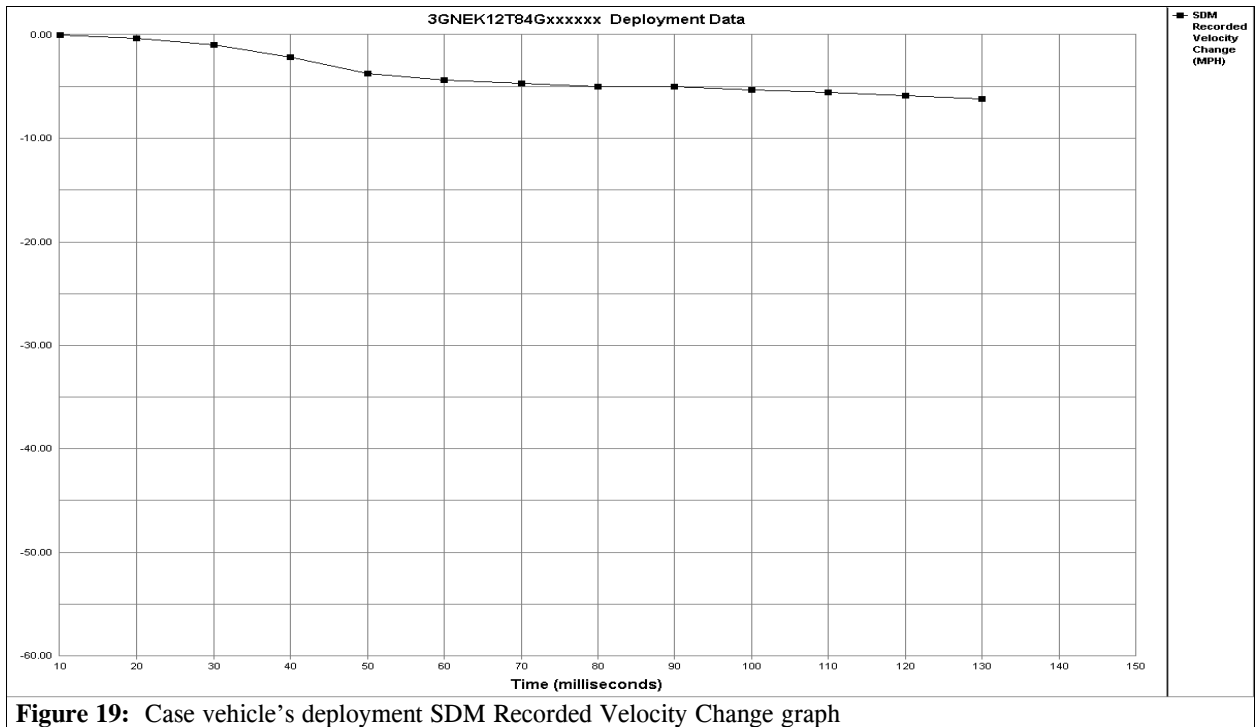
Figure 19: Case vehicle's deployment SDM Recorded Velocity Change graph

The download of the case vehicle's EDR was done during the vehicle inspection via direct connection to the SDM. The EDR reports for the downloaded data are presented at the end of this report (**Figures 17-22**). The EDR recorded a first stage deployment event and a non-deployment event. In addition, the data indicated there were multiple events associated with the non-deployment record, and one or more of the events were not recorded. The system status reports for the deployment and non-deployment events show that both events occurred during this crash because they were both recorded on the same ignition cycle. Therefore, the non-deployment event and the non-recorded events associated with it are most likely related to the rollover. The system status reports also show that the SIR warning lamp was recorded as off, and the driver's seat belt switch circuit was recorded as unbuckled. In addition, the maximum SDM recorded longitudinal velocity change was recorded as -15.45 km.p.h. (-9.60 m.p.h.) for the deployment event occurring 230 milliseconds after algorithm enable (AE) and -0.69 km.p.h. (-0.43 m.p.h.) for the non-deployment event occurring 97.5 milliseconds after AE.
