ON-SITE CERTIFIED ADVANCED 208- COMPLIANT VEHICLE INVESTIGATION

CASE NUMBER - IN-04-029
LOCATION - TEXAS
VEHICLE - 2004 GMC YUKON
CRASH DATE - June 2004

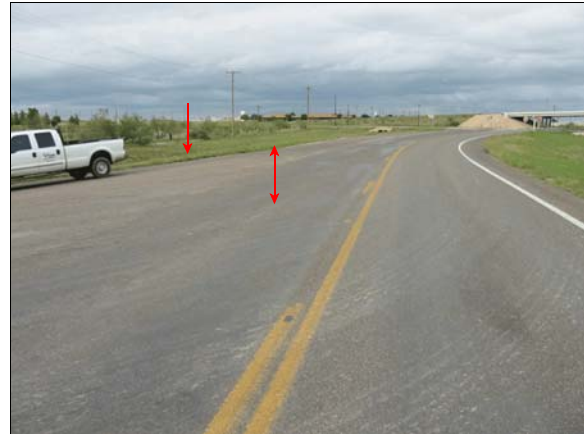
Figure 3: View northeast to area of impact, double head arrow shows area of impact and final rest of case vehicle, single head arrow shows area of final rest of Chevrolet in ditch

Post-Crash: As a result of the impact, the case vehicle rotated clockwise, traveled a short distance and came to final rest facing southwest with the back left portion of the case vehicle partially over the centerline of the roadway (**Figure 3**). The impact caused the Chevrolet to rotate clockwise approximately 225 degrees, depart the north side of the roadway, travel down the front slope of a shallow ditch and come to final rest at the bottom of the ditch facing northwest (**Figure 5**).

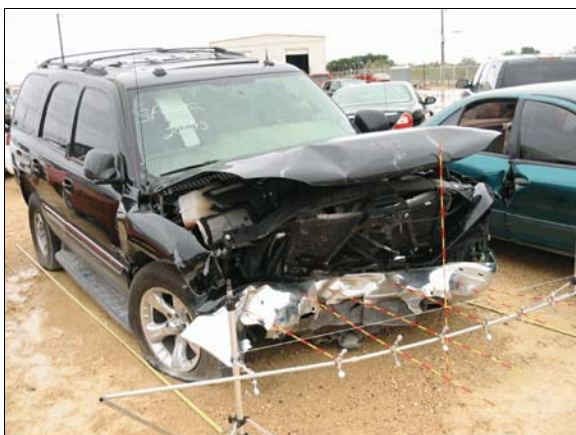
Crash: The front of the Chevrolet impacted the front of the case vehicle (**Figure 4** below) causing both stages of the case vehicle's driver air bag to

Figure 4: Overview of damage to front of case vehicle from impact with the Chevrolet, each stripe on rods is 5 cm (2 in)

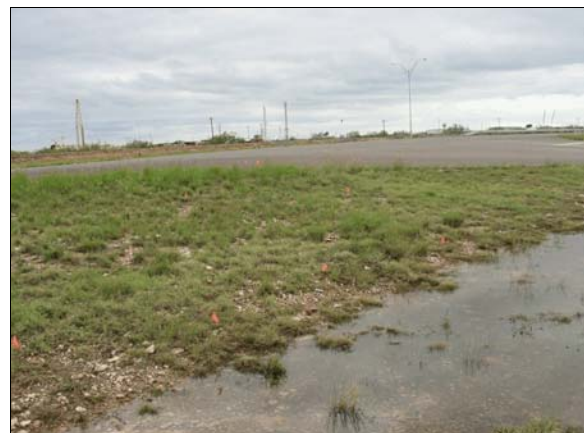
Figure 5: View back to area of impact from final rest location of Chevrolet, orange flags shows furrows from Chevrolet's tires

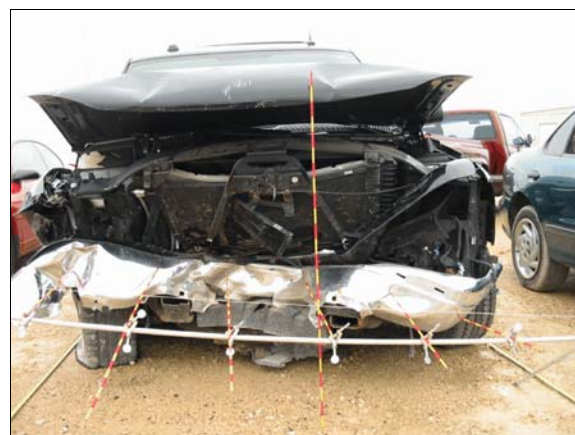
Exterior Damage: The case vehicle sustained direct damage to its front bumper, grille, right headlamp/turn lamp assembly, hood and right fender (**Figure 6**) due to the impact with the Chevrolet. The direct damage began at the right corner of the front bumper and extended 102 centimeters (40.2 inches) along the case vehicle’s front bumper. Crush measurements were taken at the bumper level (**Figure 7** below). Maximum crush was measured as 64 centimeters (25.2 inches) occurring at C₄. The table below shows the case vehicle’s crush profile.

Figure 6: Direct damage to front of case vehicle from impact with Chevrolet

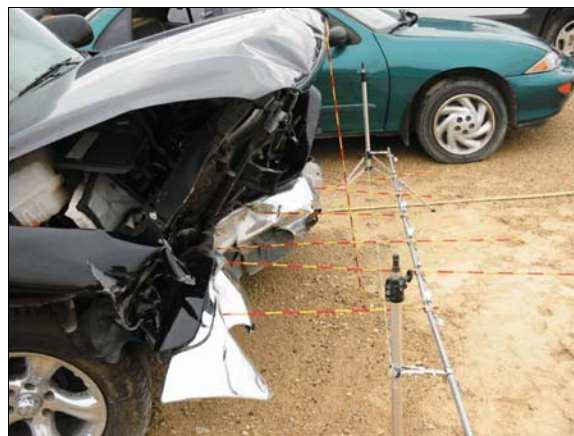
Units	Event	Direct Damage		Field L	C ₁	C ₂	C ₃	C ₄	C ₅	C ₆	Direct	Field L
		Width CDC	Max Crush								±D	±D
cm	1	102	64	148	10	21	45	64	55	32	27	0
in		40.2	25.2	58.3	3.9	8.3	17.7	25.2	21.7	12.6	10.6	0.0

The case vehicle’s right side wheelbase was reduced 17 centimeters (6.7 inches) and the left side wheelbase was reduced 5 centimeters (2 inches). Induced damage involved the left portion of the front bumper, left headlamp/turn lamp assembly, hood, right fender, right front door, right “A”-pillar and right roof side rail, and the windshield.

Figure 7: Crush to front of case vehicle, each stripe on rods is 5.0 centimeters (2.0 inches)

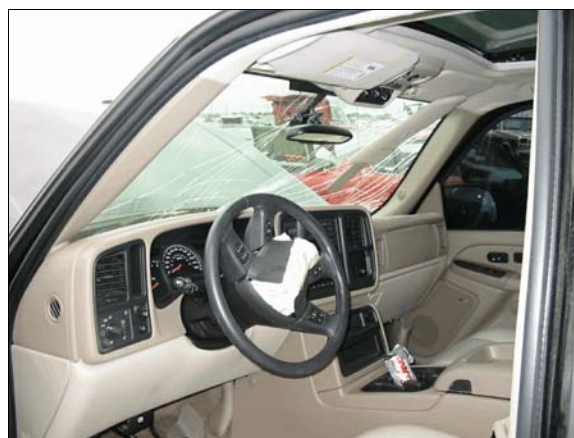
Vehicle Interior: Inspection of the case vehicle’s interior revealed no evidence of occupant contact to any components or surfaces (**Figure 8**). There was no evidence of compression of the energy absorbing steering column or deformation of the steering wheel rim (**Figure 9** below), and the power adjustable pedals were not displaced or deformed (**Figure 10** below). The front right toe pan was observed to be intruded longitudinally 25 centimeters (9.8 inches).

Figure 8: Overview of case vehicle’s steering wheel and instrument panel

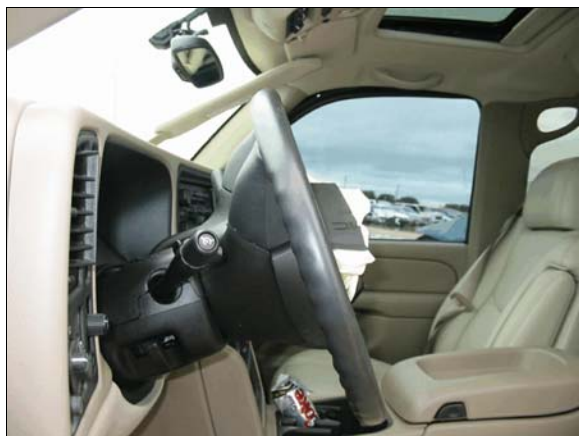
Figure 9: Case vehicle's steering wheel and steering column showing lack of deformation

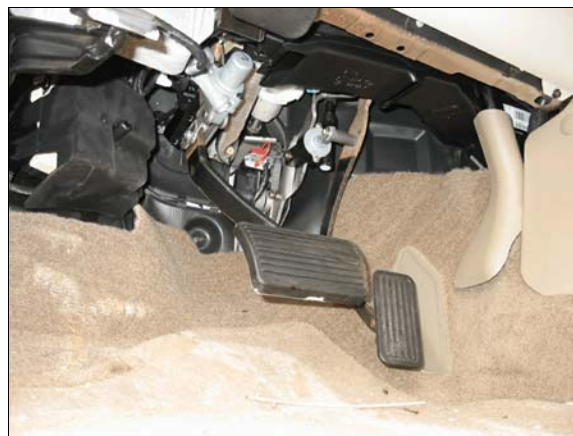
Figure 10: Case vehicle's power adjustable brake and accelerator pedals

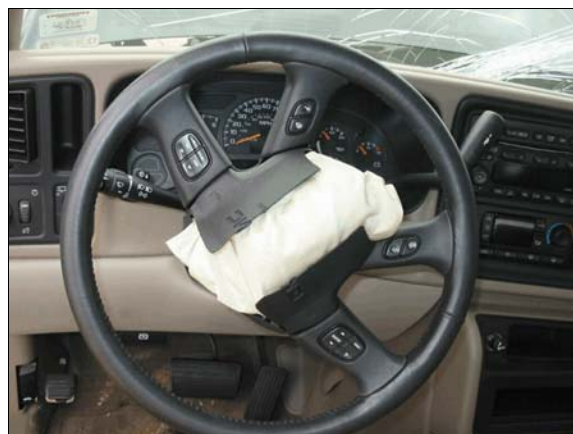
The case vehicle's driver air bag was located in the steering wheel hub. The module cover consisted of symmetrical "I" configuration cover flaps made of pliable vinyl. Each flap was 7 centimeters (2.8 inches) in width at the top seam, 5 centimeters (2 inches) in width at the bottom seam and 12 centimeters (4.7 inches) in height along the center seam. The distance between the mid-center of the driver's seat back, as positioned at the time of the vehicle inspection and the front surface of the air bag's fabric at full excursion was 41 centimeters (16.1 inches). An inspection of the air bag module cover flaps and the air bag fabric revealed that the cover flaps opened at the designated tear points (**Figure 11**). There was no

Figure 11: Case vehicle's steering wheel and air bag module cover flaps, steering wheel is rotated counterclockwise approximately 120 degrees

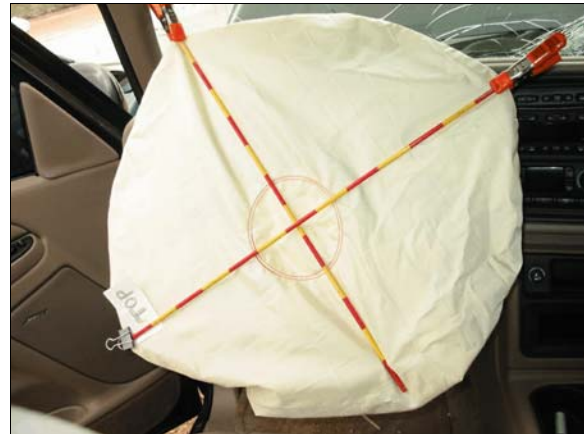
evidence of damage during the deployment to the air bag module cover flaps or the air bag fabric, and no evidence of occupant contact to the air bag was observed. The deployed driver's air bag (**Figure 12**) was round with a diameter of approximately 63 centimeters (24.8 inches). The air bag was designed with two tethers, each approximately 13 centimeters (5.1 inches) in width and had two vent ports (**Figure 13**), each approximately 3 centimeters (1.2 inches) in diameter, located at the 10 and 2 o'clock positions.

Figure 12: Case vehicle's driver air bag

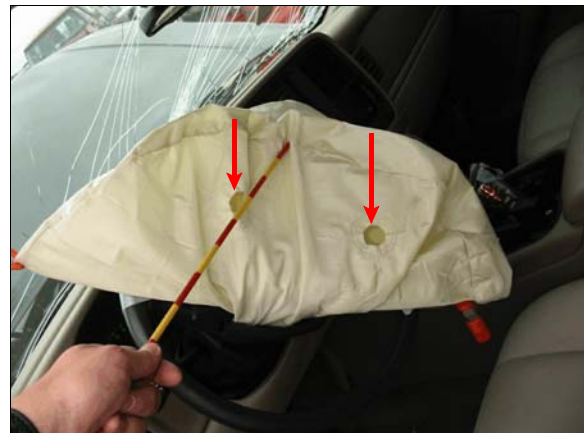
Figure 13: Case vehicle's driver air bag vent ports at top of air bag

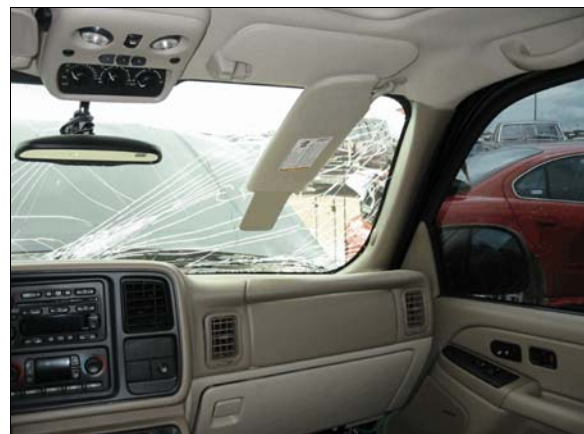
The front right passenger air bag was located in the middle of the instrument panel (**Figure 14** below) above the glove box door. The deployment of the front right passenger air bag was properly suppressed by the case vehicle's occupant detection and air bag suppression system because there was no front right passenger in the case vehicle at the time of the crash.

Figure 14: Overview of case vehicle's front right instrument panel, front right air bag located above glove box door

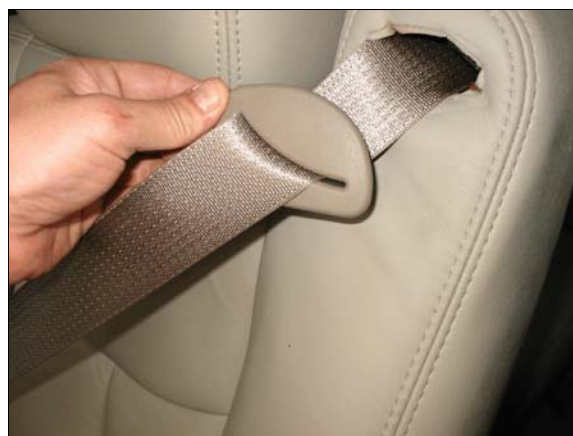
The evidence indicates the case vehicle's driver was restrained by her manual, three-point, lap-and-shoulder safety belt system. The safety belt showed no obvious signs of loading, but the shoulder belt guide was pulled out of the seat (**Figure 15**). Driver safety belt usage was also supported by the EDR data, which indicated the driver's safety belt was buckled. In addition, the police report indicated the driver was using her lap-and-shoulder belt in the crash.

Figure 15: Case vehicle driver's shoulder belt guide pulled out of the seat
