TRANSPORTATION RESEARCH CENTER

ON-SITE CERTIFIED ADVANCED 208- COMPLIANT VEHICLE INVESTIGATION

CASE NUMBER - IN-04-030
LOCATION - MISSOURI
VEHICLE - 2004 CHEVROLET SILVERADO Z-71
CRASH DATE - September 2004

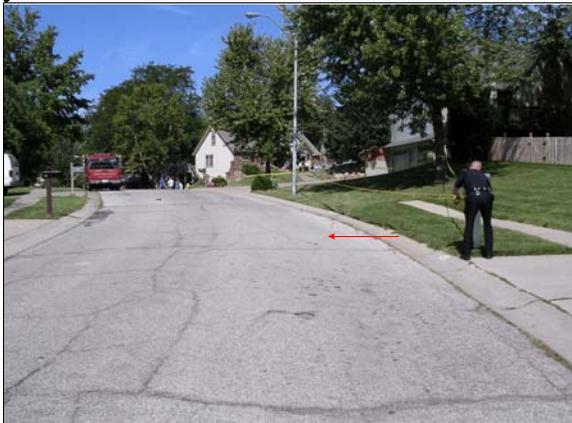
Figure 2: On-scene photo showing area of roadway departure and case vehicle's yaw mark, indicated by arrow (case photo # 111)

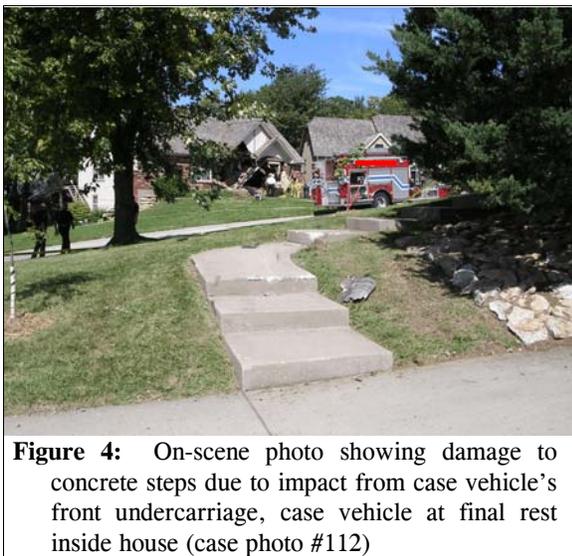
Figure 4: On-scene photo showing damage to concrete steps due to impact from case vehicle's front undercarriage, case vehicle at final rest inside house (case photo #112)

It is this contractor's opinion that the undercarriage impact with the concrete steps just prior to the vehicle becoming airborne caused the case vehicle's driver air bag to deploy. The downloaded EDR data indicated that only the first stage of the dual-stage air bag activated. The case vehicle was equipped with an automatic air bag suppression system and an air bag suppression switch for the front right passenger air bag. The suppression switch was set to the "auto" position. This air bag properly did not deploy during the crash sequence because there was no front right passenger in the vehicle.

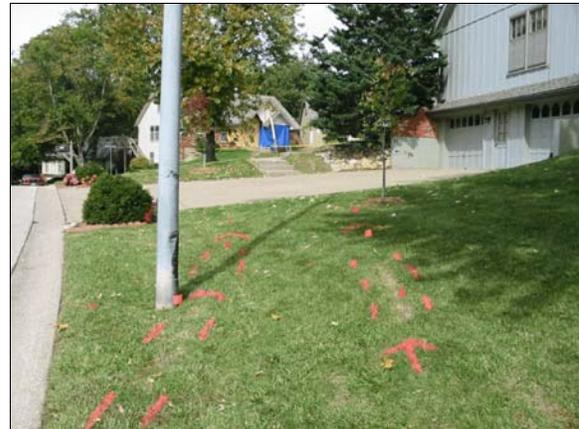
Figure 3: Case vehicle's tire marks in grass, damage to luminaire pole due to impact by case vehicle's left fender and left front tire (case photo #06)

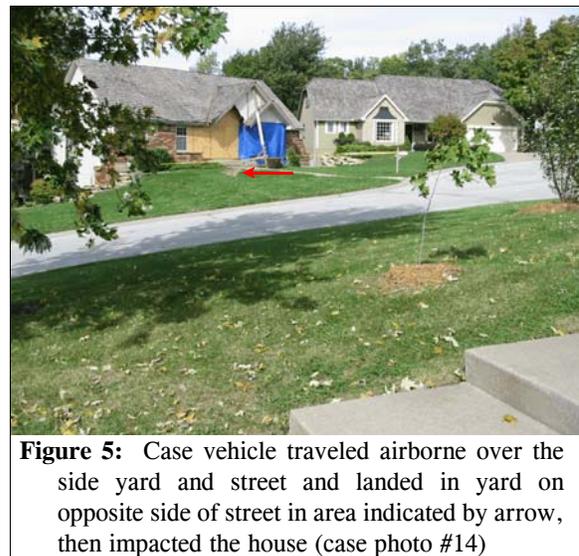
Figure 5: Case vehicle traveled airborne over the side yard and street and landed in yard on opposite side of street in area indicated by arrow, then impacted the house (case photo #14)

perpendicular to the original roadway (**Figure 5**). Total airborne distance was measured at approximately 30 meters (98 feet). The left side of the case vehicle (**Figure 6** below) then impacted the ground as the vehicle touched down in the front yard of a house on the west side of the street (**Figure 7** below). The case vehicle ramped off the ground, continued to rotate

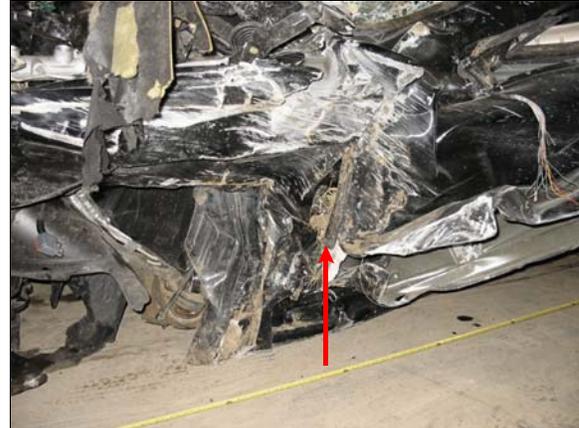
Figure 6: Dirt and grass jammed in left fender, left front door seam (arrow) and left front door (case photo #38)

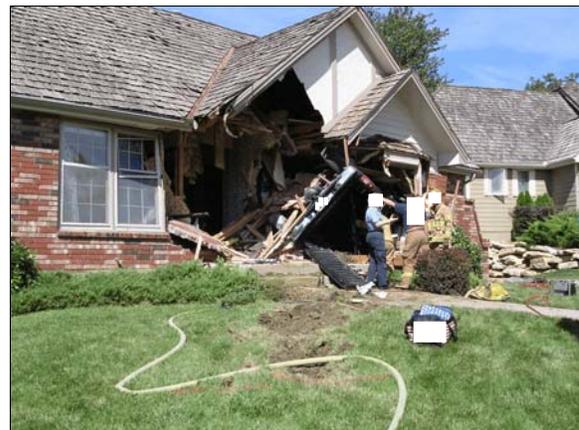
counterclockwise about its longitudinal axis, and the front of the vehicle impacted the house resulting in nearly the entire case vehicle penetrating into the house (**Figure 7**). During the course of the airborne and house impact sequence, the case vehicle rolled over counterclockwise a total of three quarter turns.

Figure 7: On-scene photo showing divot in ground from impact by case vehicle's left side and final rest of case vehicle in house (case photo #113)

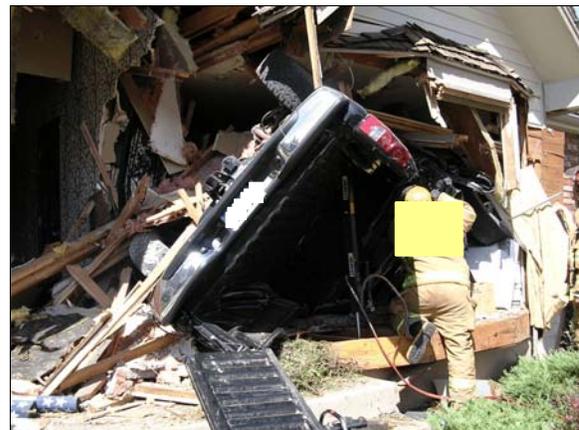
Post-Crash: The case vehicle came to rest in the living room of the house partially on its roof and right side facing northwest (**Figure 8**). The driver sustained fatal injuries in the crash and was extricated from the case vehicle by rescue personnel.

Figure 8: Close view of case vehicle at final rest inside of house (case photo #114)

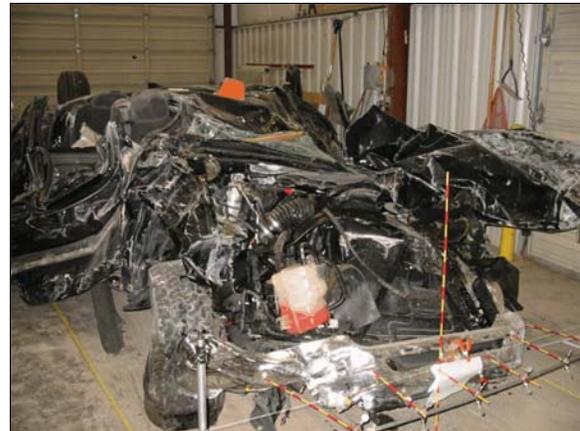
Figure 9: Overview of damage to case vehicle from front right corner (case photo #32)

ground. The subsequent impact with the house directly damaged the entirety of the vehicle (Figures 9 and 10 above) with the exception of the back end. Crush measurements were taken at the bumper and above bumper levels (Figure 11 above) on the front of the case vehicle. The direct damage began at the front right bumper corner and extended 155 centimeters (61 inches) across the front bumper. Residual maximum crush was measured as 27 centimeters (10.6 inches) at C₆. Above the bumper the residual maximum crush was measured as 37 centimeters (14.6 inches) at C₆. The average residual maximum crush at C₆ was 32 centimeters (12.6 inches). The case vehicle's entire front plane including both A-pillars, windshield and windshield header were directly damaged and crushed rearward. There was also direct damage to the full length of both sides of the vehicle with considerable leftward displacement of the right side of the truck bed. Lastly, the entire roof was directly damaged and crushed downward and to the left. The table below shows the case vehicle's front crush profile after averaging the bumper and above bumper crush values.

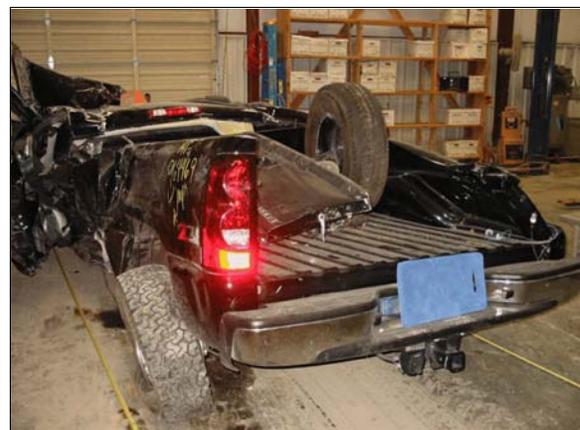
Figure 10: Overview of damage to case vehicle from back left corner (case photo #47)

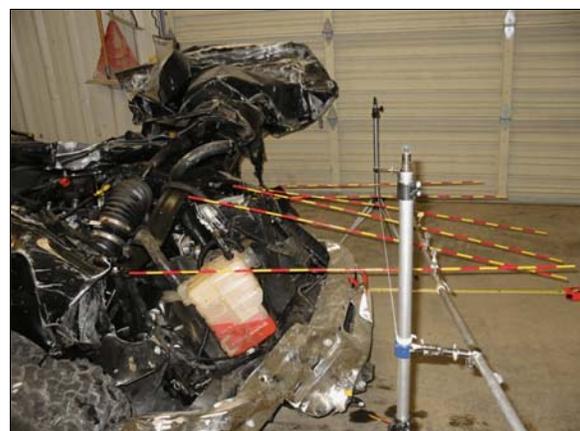
Figure 11: Right side view of crush [each stripe on rods is 5 cm (2 in)]to front of case vehicle (case photo #29)

The case vehicle's wheelbase was reduced 15 centimeters (5.9 inches) on the left side while the right side wheelbase was shortened 6 centimeters (2.4 inches). Induced damage involved the back bumper.

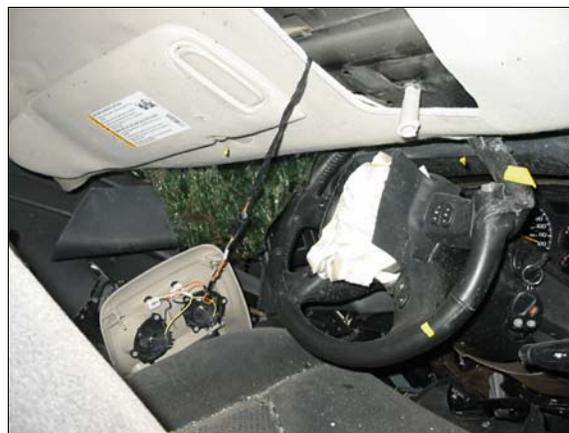
inches) of longitudinal intrusion of the steering assembly. The steering wheel was also broken due to impact by the intruding windshield header (**Figure 12**) and the steering column was compressed due to contact by the driver.

Figure 12: Damage to steering wheel due to intrusion of windshield header (case photo #78)

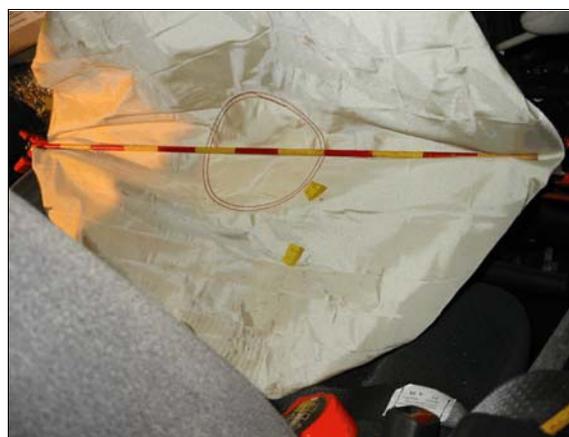
Figure 13: Case vehicle's driver air bag, yellow tape shows location of two small cuts in air bag (case photo #83)

the cover flaps. The deployed driver's air bag (**Figure 13** above) was round with a diameter of approximately 63 centimeters (24.8 inches). The driver's air bag was designed with two tethers, each approximately 12 centimeters (4.7 inches) in width, and had two vent ports (**Figure 14**), approximately 3 centimeters (1.2 inches) in diameter, located at the 11 and 1 o'clock positions. The air bag module cover flaps consisted of two symmetrical flaps constructed of pliable vinyl. The tear seams were located across the top and bottom and vertically down the center of the flaps. Each flap was approximately 7.5 centimeters (3 inches) wide at the top, 5.5 centimeters (2.2 inches) wide at the bottom and 11.5 centimeters (4.5 inches) high along the center tear seam. An inspection of the driver's air bag fabric revealed two small blood stains and two small cuts through the air bag fabric on the front of the air bag (**Figures 13** above and **15**). The cuts in the air bag fabric were probably due to glass fragments. In addition, there was an area of scuffing at the bottom of the air bag that appeared to be possible occupant contact.

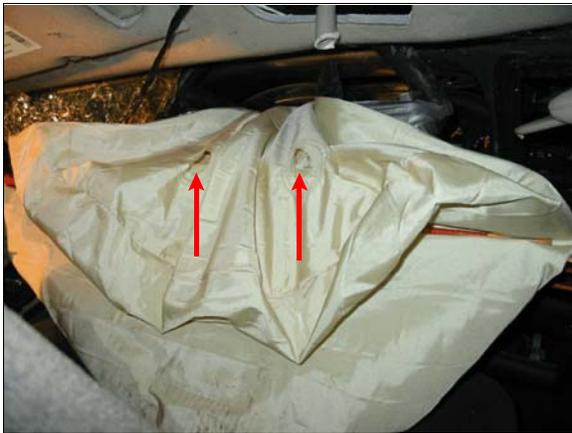
Figure 14: Back of top portion of driver's air bag, arrows show vent ports (case photo #88)

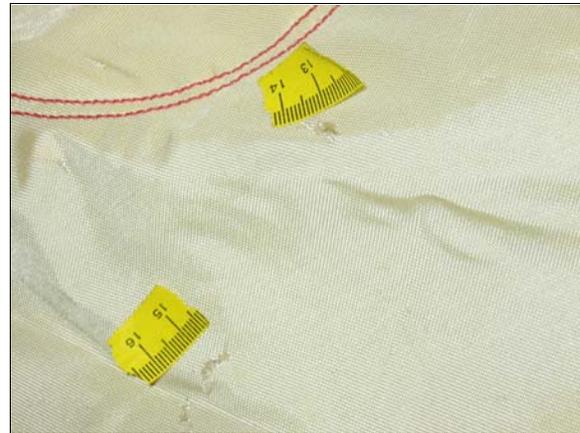
Figure 15: Close view of two small cuts in driver's air bag (case photo #84)

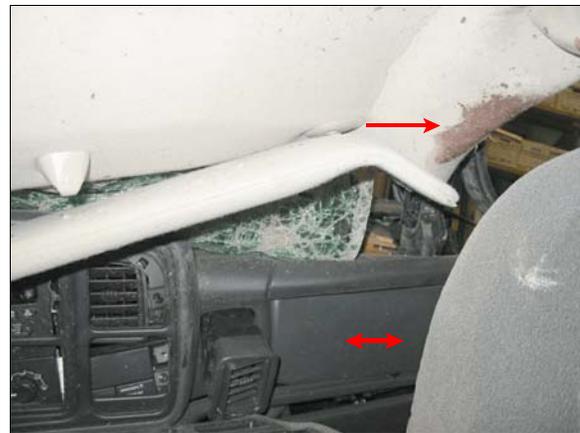
The front right passenger's air bag was located in the middle of the instrument panel (**Figure 16**). This air bag properly did not deploy because there was no passenger seated in the front right seat. The air bag suppression switch was set on "Auto".

Figure 16: Passenger air bag located in middle of right instrument panel (double head arrow), arrow shows driver's head contact on right roof side rail (case photo #91)

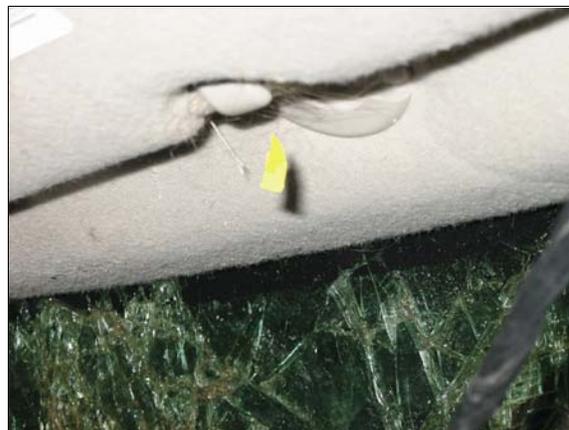
Figure 17: Close view of Figure 12 above showing hair in hinge of driver's sunvisor (case photo #80)

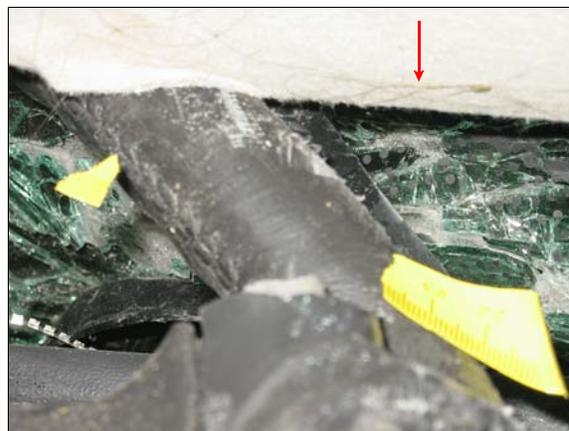
Figure 18: Close view of Figure 12 above showing hair deposit on center portion of windshield header, indicated by arrow (case photo #81)

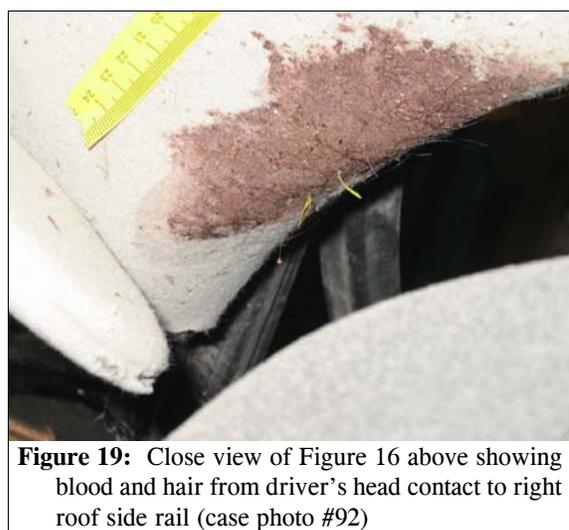
Figure 19: Close view of Figure 16 above showing blood and hair from driver's head contact to right roof side rail (case photo #92)

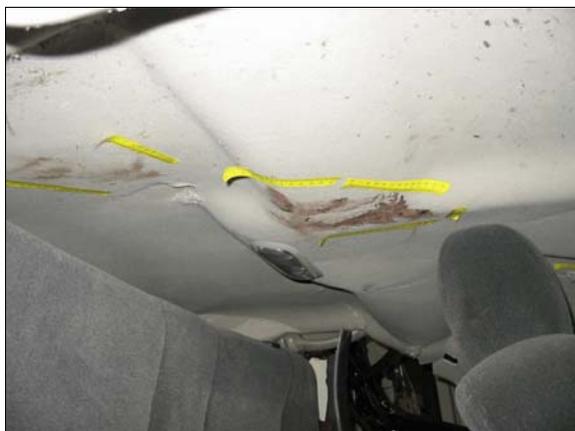
Figure 20: Blood on roof over back seat, photo taken from right side of case vehicle (case photo #95)
