**CALSPAN ON-SITE CERTIFIED ADVANCED 208-COMPLIANT
VEHICLE CRASH INVESTIGATION**

CASE NO: CA04-031

VEHICLE: 2004 TOYOTA CAMRY

CRASH DATE: MAY 2004

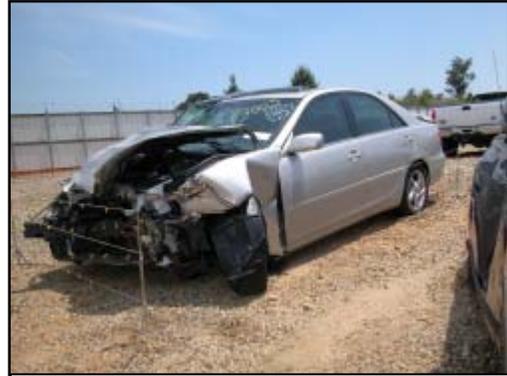
Figure 1. Subject 2004 Toyota Camry.

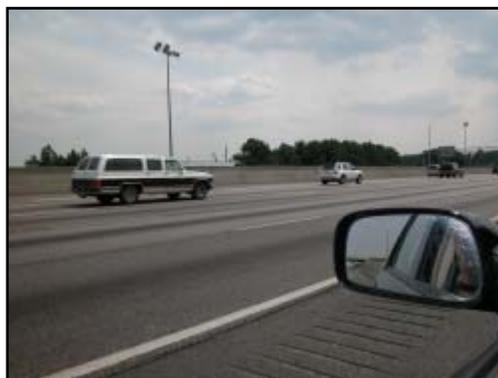
The Toyota traveled into the Volvo's travel lane where the front of the Toyota underrode the trailer portion of the Volvo (**Figure 2**). The left side of the trailer struck the top surface of the Toyota's hood. The resulting direction of force for the Toyota was non-horizontal. Consequently, the damage was out of the scope of the WINSMASH program, therefore a delta V was not calculated for this impact.

Figure 2. North approach for all the vehicles and area of impact.

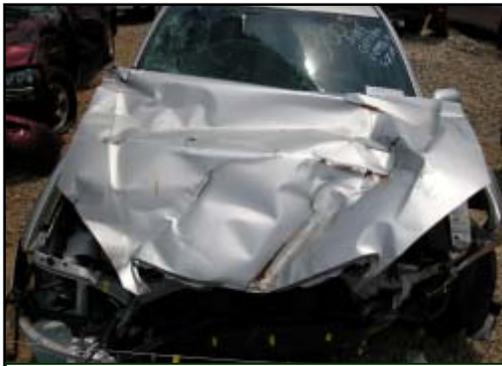
The Toyota sustained minor severity damage to the hood as a result of the initial impact with the Volvo's trailer (**Figure 3**). The damage consisted of a vertically deformed hood with diagonally oriented creases. The damage length was 98 cm (38.5") and 148 cm (58.3") in width. A crush profile was not documented for this non-horizontal impact. The Collision Deformation Classification (CDC) for this impact was 00-TFDW-6.

Figure 3. Damage to the top surface of the hood.

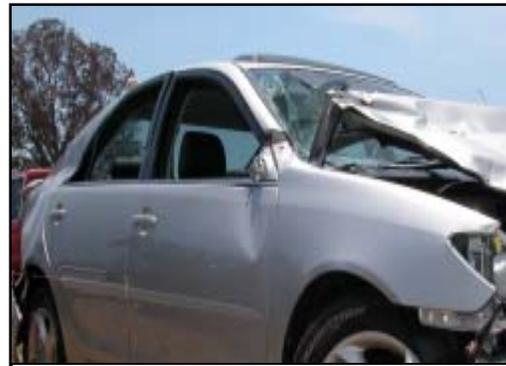
Figure 3. Right side damage from the impact with the lower edge of the

The Toyota sustained minor severity right side damage as a result of the secondary impact with the Volvo's trailer (**Figure 4**). The damage consisted of lateral deformation to the right upper A-, B-, and C-pillars and disintegrated right side glazing. The damage to the right A-pillar began 10 cm (4.0") above the beltline and extended upward 18 cm (7.0"). The maximum crush measured 2 cm (0.9") at the A-pillar. The B-pillar sustained minor lateral deformation. The direct damage on the C-pillar measured 67 cm (26.5") and the maximum crush was 3 cm (1.3"). The CDC for this impact was 03-RDGW-2.

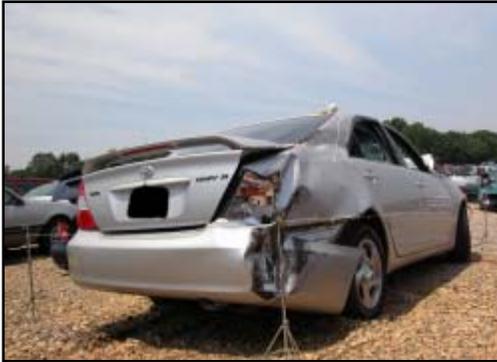
The third impact event resulted in moderate severity damage to the rear right aspect as a result of the impact with the left side tires of the Volvo's trailer (**Figure 5**). The trailer tires impacted the bumper fascia corner and continued onto the quarter panel. The direct damage began 67 cm (26.4") right of the rear centerline and extended to the right rear corner of the bumper fascia. The deformation area was outboard of the bumper beam, which yielded no residual crush to the bumper beam. The damage extended 116 cm (45.5") forward onto the quarter panel terminating 20 cm (8") forward of the right rear axle. The CDC for this impact was 06-BRES-4.

Figure 5. Rear damage from the impact with the trailer wheels.

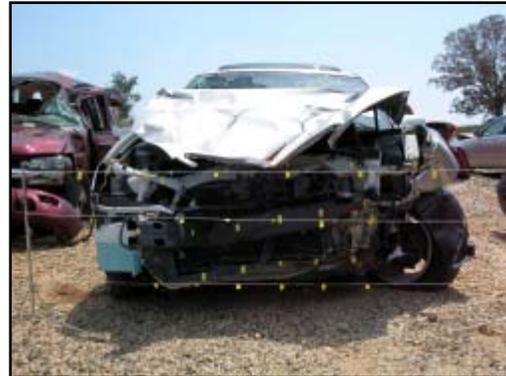
Figure 6. Frontal damage from the extended height Jersey barrier. View of the three crush profiles documented for this impact.

The Toyota sustained moderate severity frontal damage as a result of the impact with the extended height Jersey median barrier (**Figure 6**). The damage consisted of longitudinal deformation to the front structural components. Three crush profiles were utilized to document the damage. These involved a profile at the lower radiator support, bumper support, and upper radiator support levels. The direct damage began 41 cm (16") left of the centerline and extended 57 cm (22.5") to the outboard corner of the frontal sheet metal. Six crush measurements were documented using a combined direct and induced damage width of 86.4 cm (34.0") at the lower radiator support and were as follows: C1 = 41 cm (16.2"), C2 = 31 cm (12.2"), C3 = 24 cm (9.8"), C4 = 20 cm (7.9"), C5 = 14 cm (5.4"), C6 = 7 cm (2.8").

The crush at the bumper beam was documented using a combined direct and induced damage width of 96.0 cm (37.8"). Six crush measurements were utilized to obtain a crush profile of the residual damage, and were as follows: C1 = 40 (15.7"), C2 = 37 cm (14.6"), C3 = 40 cm (15.7"), C4 = 41 cm (16.1"), C5 = 34 cm (13.4"), C6 = 3 cm (1.2").

The crush at the upper radiator support was measured using a combined direct and induced damage width of 146 cm (57.3"). Six crush measurements were documented as follows: C1 = 13 cm (5.2"), C2 = 22 cm (8.7"), C3 = 31 cm (12.2"), C4 = 22 cm (8.7"), C5 = 20 cm (7.9"), C6 = 0 cm. The CDC for this impact was 01-FDEW-2.

Although three crush profiles were documented, the bumper beam crush profile yielded the greatest depth of crush; therefore it was used to calculate the delta V for this barrier impact.

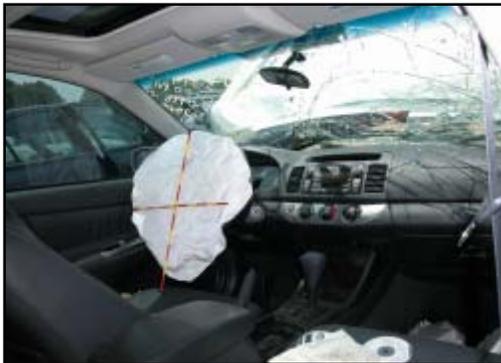
The interior of the 2004 Toyota Camry sustained no damage as a result of occupant contact points or exterior deformation. The vehicle sustained minor interior damage due to passenger compartment intrusion. The right A-pillar intruded laterally 3 cm (1") from the impact with the Volvo's trailer. **Figure 7** is an overall of the driver's area.

Figure 7. Overall view of the driver's area.

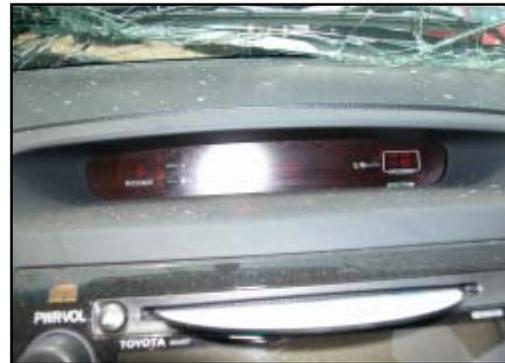
Figure 8. Front right air bag indicator light and safety belt minder light.

also consisted of a passenger air bag indicator light (**Figure 8**), which notifies the occupants of the on/off status of the front right air bag. An air bag control module monitors the system and measures and predicts crash severity, and then deploys the appropriate safety systems based on seat track position, belt status, and front right occupant presence. The air bag control module had Event Data Recording (EDR) capabilities. The air bag control module was removed from the Toyota by the SCI investigator and forward to NHTSA for download by Toyota. The output is summarized in the section that follows.

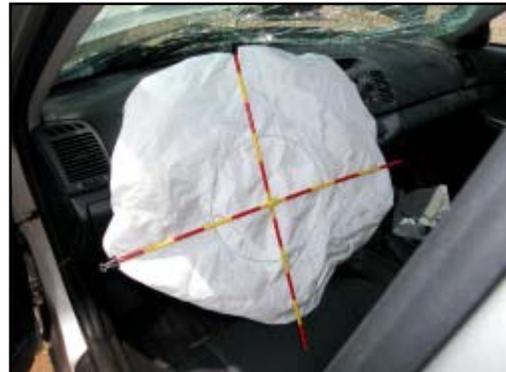
The driver's frontal air bag deployed at impact with the extended height Jersey median barrier. The driver's air bag was located in the center of the steering wheel hub (**Figure 9**). The air bag module consisted of a triangular cover flap configuration with a horizontal tear seam. The top cover flap measured 15 cm (5.9") in width and 8 cm (3") in height. The two lower flaps were symmetrical and measured 8 cm (3") at the horizontal tear seam, 6 cm (2.3") at the vertical tear seam, and 9 cm (3.3") at the outboard hinges. The air bag membrane was 64 cm (25.3") in diameter in its deflated state. No occupant contact points were noted on the air bag.

Figure 9. Deployed driver's frontal air bag.

The air bag contained two wide band tethers that were 11 cm (4.5") in width. The tethers were sewn to a 22 cm (8.8") diameter tether stitching on the face of the air bag. The air bag was vented by two 3 cm (1") diameter vent ports that were located 7 cm (2.6") forward of the peripheral seam at the 11 and 1 o'clock positions. The driver's bag was identified by the following nomenclature that was stamped on the top surface of the air bag membrane:

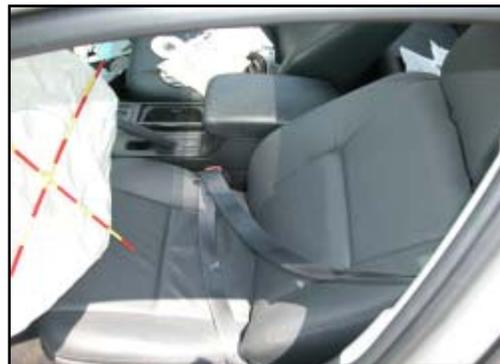
Figure 10. Driver's safety belt restricted in used position due to the fired pretensioner.

her safety belt in the crash, which was evidenced by the lack of occupant contact points and the fired status of the retractor pretensioner (**Figure 10**). The driver's safety belt was found in the used position with 159 cm (62.5") of webbing locked and extended from the D-ring by the fired pretensioner. No crash related evidence such as loading was present on the safety belt webbing or hardware components.

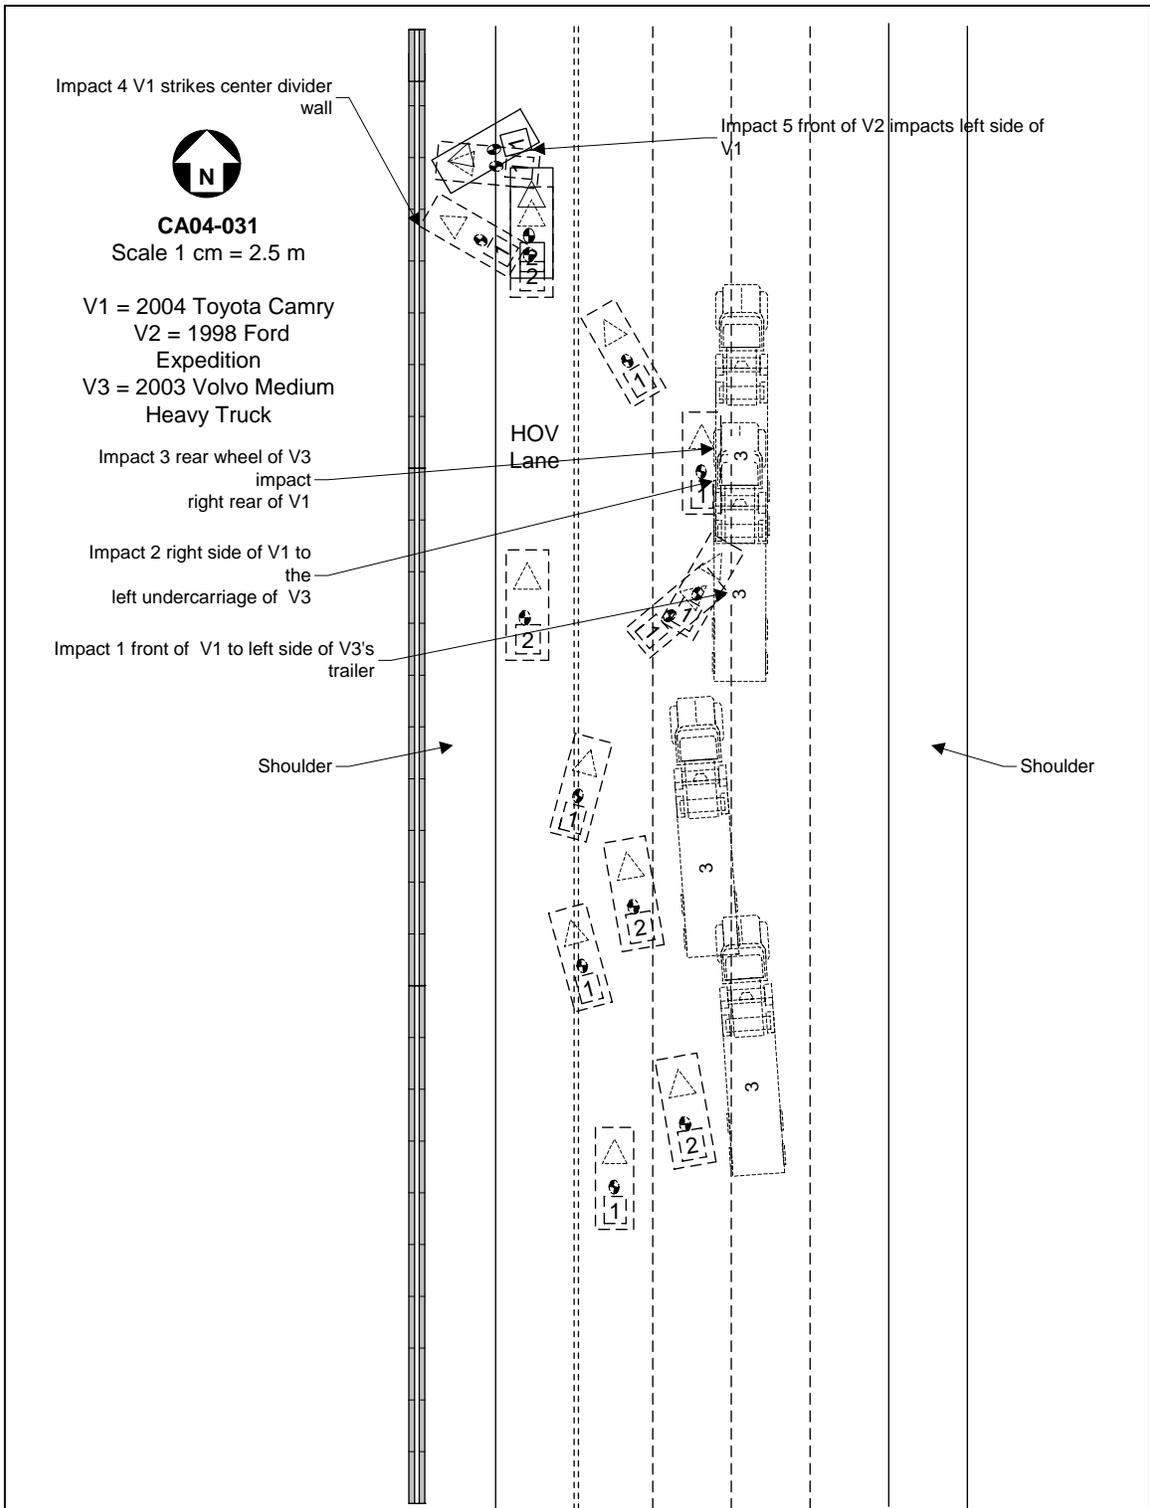
Figure 11. Scene Schematic

were configured with four through traffic lanes and a High Occupancy Vehicle (HOV) lane. The interstate was delineated by an extended height Jersey median barrier. The roadway was surfaced with asphalt and was bordered by asphalt shoulders. The posted speed limit for the northbound traffic was 105 km/h (65 mph). The scene schematic is included as **(Figure 11)** of this report.
