**GENERAL DYNAMICS ON-SITE CERTIFIED ADVANCED-208 COMPLIANT
VEHICLE CRASH INVESTIGATION**

SCI CASE NO. – CA04-033

SUBJECT VEHICLE – 2004 GMC YUKON

CRASH DATE – JUNE 2004

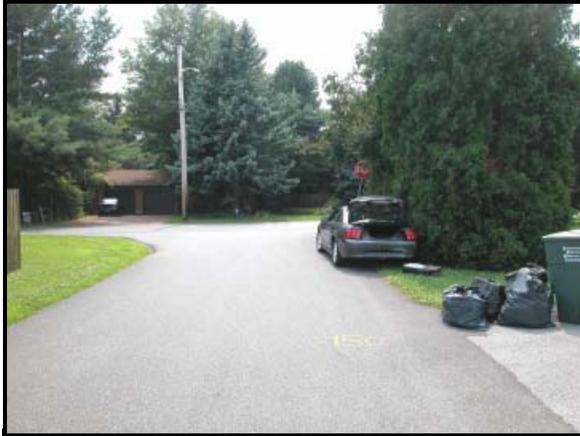
Figure 2: Southbound trajectory view 46 m (150 ft) from impact.

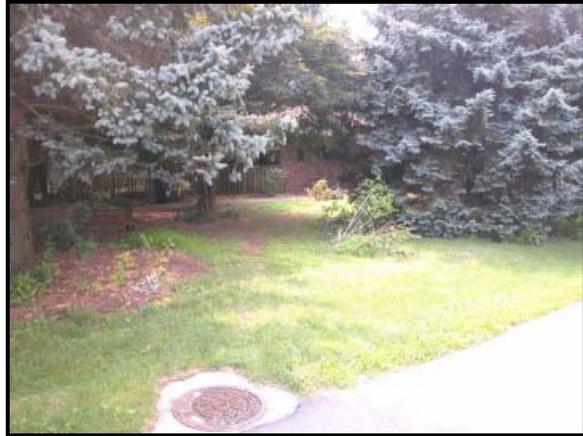
Figure 3: GMC trajectory view through the yard to impact.

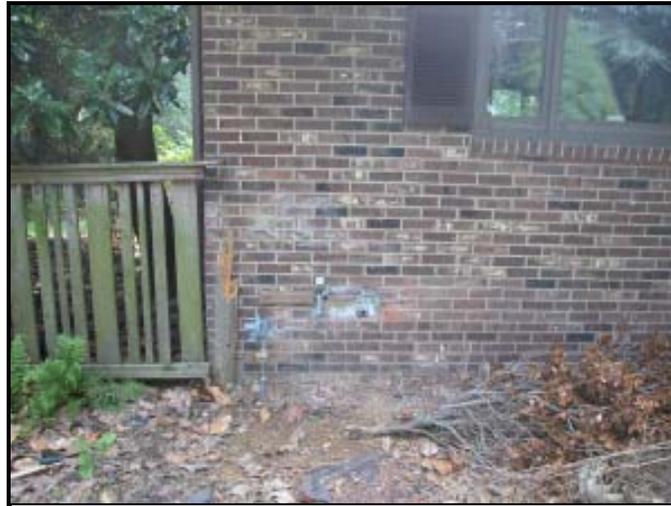
The GMC continued forward in a tracking mode and left and center aspects of the Yukon's frontal plane impacted the northeast corner of the house, **Figure 4**. The force of the impact cracked the brick and mortar structure over a 1.5 m x 1.8 m (5 ft x 6 ft) area on the north and east faces of the building. The vehicle's direct contact to the north face of the house measured 144 cm x 122 cm (45 in x 48 in), width by height. A gas main located at the corner of the house was severed by the interaction with the front of the vehicle. The EDR recorded maximum delta V for

Figure 4: View of the point of impact

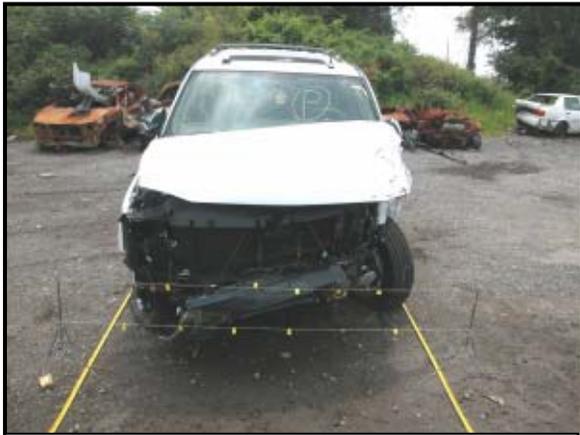
Figures 5 and 6 are a front view and a left lateral view of the 2004 GMC Yukon. The GMC Yukon sustained moderate damage to the frontal plane during the crash sequence. Examination of the frontal profile identified two regions of direct contact damage that related to this multi-event crash. At impact, the bumper fascia had fractured and separated from the vehicle. The separated fascia exposed the fiberglass bumper reinforcement. The reinforcement bar was fractured on both ends, outboard the respective frame rails. The impact to the house (Event 2) resulted in a combined direct and induced damage pattern that extended across the entire 168 cm (66.0 in) front end width. The induced damage from this impact overlapped the damage from the

The direct damage to the right aspect of the front plane was related to the impact with the 13 cm (5 in) diameter tree, Event 1. The location of the direct damage was identified by localized pocketing and buckling of the hood face. The pocketing measured 25 cm (10 in) in diameter and began 39 cm (15.5 in) right of center. The maximum crush of the deformed area measured 2.0 cm (0.8 in). The Collision Deformation Classification (CDC) for this event was 12-FREN-1. The EDR reported longitudinal delta V for this impact was -1.66 km/h (-1.03 mph).

The direct damage related to Event 2 began 35.6 cm (14.0 in) left of center and extended 48.3 cm (19.0 in) to the left corner. Due to the angular orientation of the vehicle relative to the house at impact, this direct contact wrapped around the left corner and extended 74.9 cm (29.5 in) onto the left side. The residual crush profile measured along the bumper reinforcement beam was as follows: C1 = 57 cm (22.4 in), C2 = 30 cm (11.8 in), C3 = 20 cm (7.9 in), C4 = 10 cm (3.9 in), C5 = 0, C6 = 0. The maximum crush was located at the left corner of the reinforcement beam. The CDC of the impact was 12-FLEW-3. The left front fender was crushed and shifted rearward 11 cm (4.5 in). There was a 24 cm (9.5 in) reduction of the left wheelbase. The lower left aspect of the windshield was fractured by the exterior impact force. The side window glazings remained intact and all the doors remained operational. The EDR reported longitudinal delta V for the impact was -36.24 km/h (-22.52 mph). The delta V calculated by the Damage Algorithm of the WINSMASH model was 23.6 km/h (14.7 mph). The longitudinal and lateral components were -23.6 km/h (-14.7 mph) and 0, respectively. The WINSMASH calculation underestimated the severity of the crash.

Figure 5: Front view of the GMC.

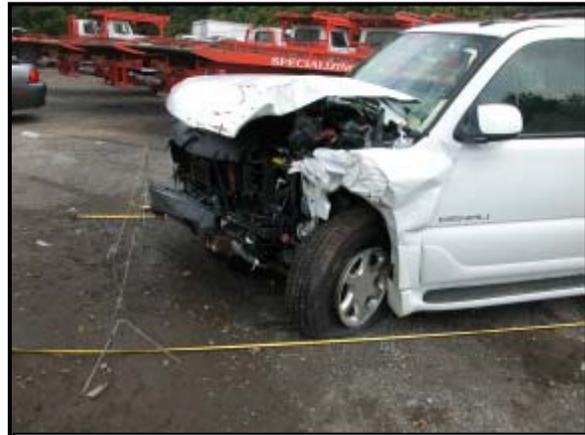
Figure 6: Left lateral view of the deformation.

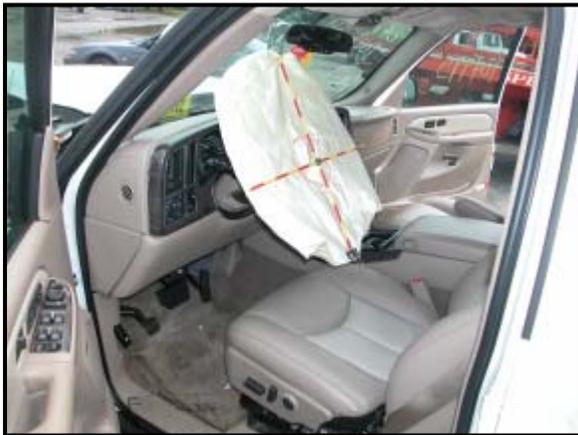
Figures 7 and 8 are views of the left front interior. The intrusion of the central aspect of the toe pan extended to the back side of the brake pedal and measured 9.4 cm (3.7 in). The intrusion of the left corner of the instrument panel measured 2.0 cm (0.8 in). There was no intrusion into the center or front right occupant space.

Figure 7: View of the front left interior.

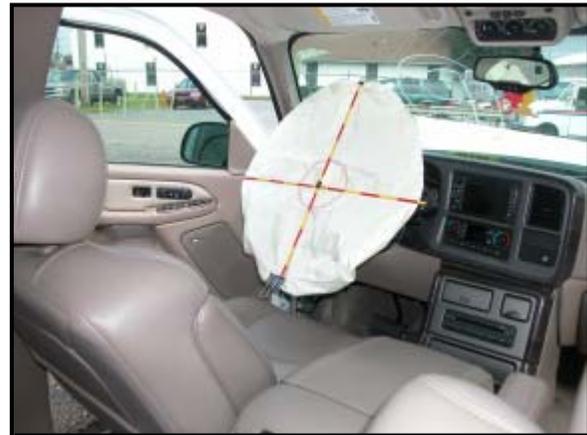
Figure 8: Driver interior view.

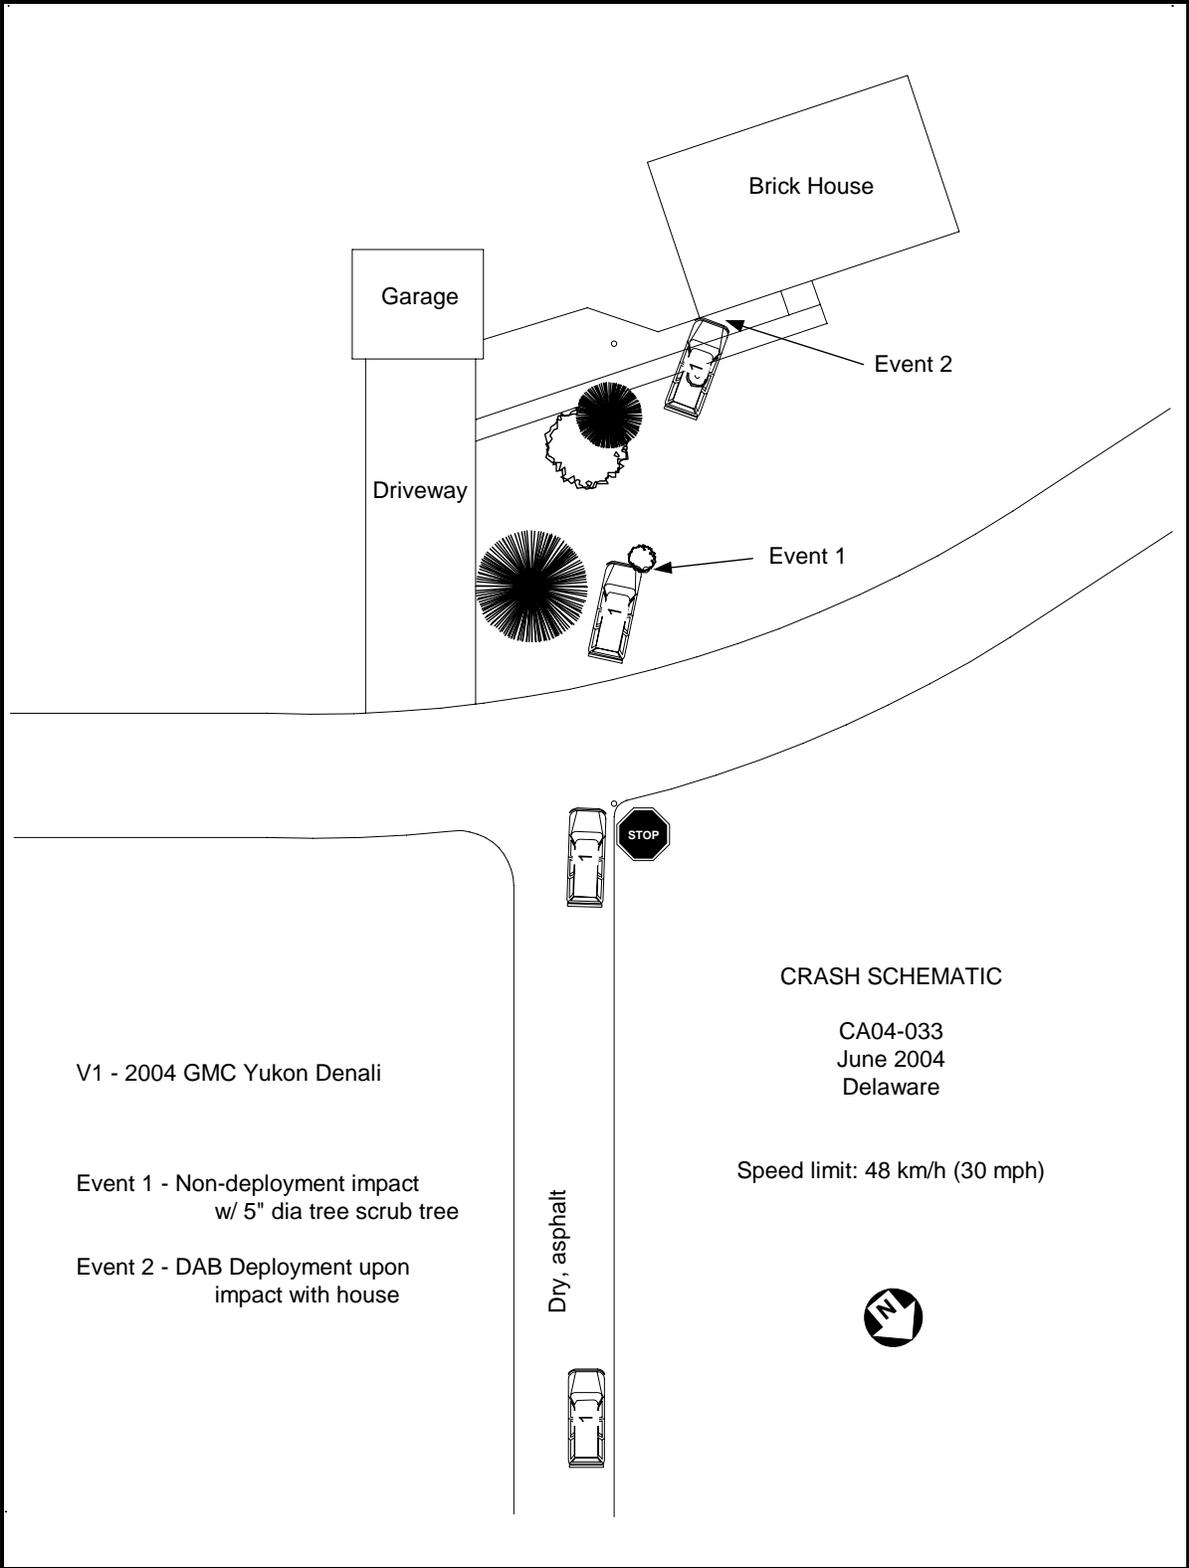
Figure 9: Crash Schematic.

the impact was -36.24 km/h (-22.52 mph). The GMC rotated counterclockwise approximately 25 degrees and came to rest in close proximity to the corner of the house. **Figure 9** is a schematic of the crash.
