TRANSPORTATION RESEARCH CENTER

ON-SITE CERTIFIED ADVANCED 208- COMPLIANT VEHICLE INVESTIGATION

CASE NUMBER - IN-04-034
LOCATION - Texas
VEHICLE - 2004 MAZDA 3
CRASH DATE - September 2004

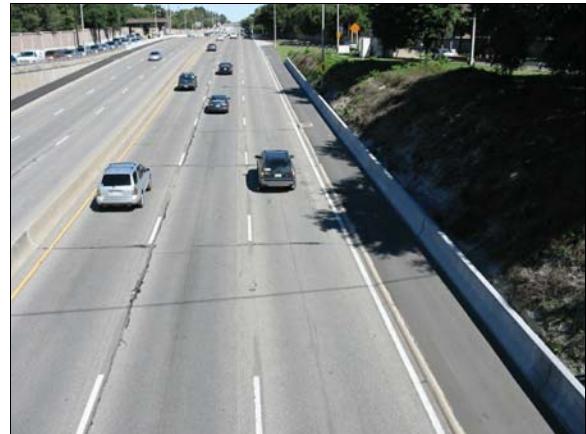
Pre-Crash: The case vehicle was traveling north in the center lane, and the driver was intending to continue northbound (**Figure 1**). A non-contact vehicle was northbound in the inside lane and changed lanes to the right and crossed in front of the case vehicle. The case vehicle's driver braked and steered right to avoid the non-contact vehicle, and the case vehicle traveled to the right across the outside lane. The driver steered left and the case vehicle entered the outside shoulder heading toward the concrete longitudinal barrier. The initial impact of the crash sequence occurred on the outside shoulder of the roadway.

Figure 1: Overview of trafficway and approach of case vehicle northbound in middle lane (case photo #01)

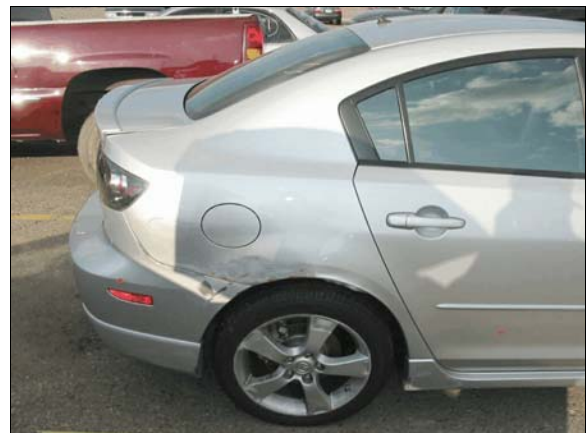
Crash: As the case vehicle's driver steered to the left, the case vehicle's right rear wheel and quarter panel (**Figure 2**) sideswiped the concrete longitudinal barrier (**Figure 3**). As the case vehicle separated from the barrier, it began to rotate counterclockwise and continued to rotate counterclockwise approximately 95 degrees as it traveled to the left across all three northbound travel lanes. The front of the case vehicle (**Figure 4** below) then impacted the concrete median barrier (**Figure 5** below) causing the case vehicle's driver air bag to deploy. The case vehicle's front right air bag did not deploy because there was no front right occupant in the case vehicle. The occupant weight sensor in the front right seat properly determined the absence of an

Figure 2: Damage to right quarter panel and right rear wheel due to sideswiping the concrete longitudinal barrier (case photo #15)

Exterior Damage: The case vehicle's initial impact with the concrete longitudinal barrier involved the right quarter panel and right rear wheel (**Figure 2** above). A few scratches were also observed on the back portion of the right rear door. Direct damage began 198 centimeters (78 inches) rear of the right front axle and extended 124 centimeters (48.8) inches along the right rear door, sill, quarter panel, right rear wheel and right side of the rear bumper cover. The maximum crush to

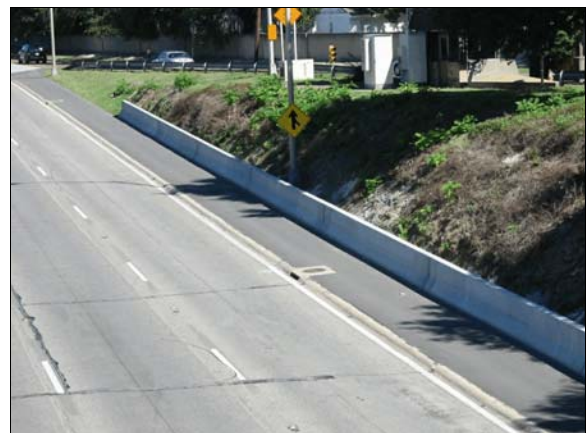
Figure 3: View to northeast to area of case vehicle's sideswipe impact with the concrete longitudinal barrier (case photo #02)

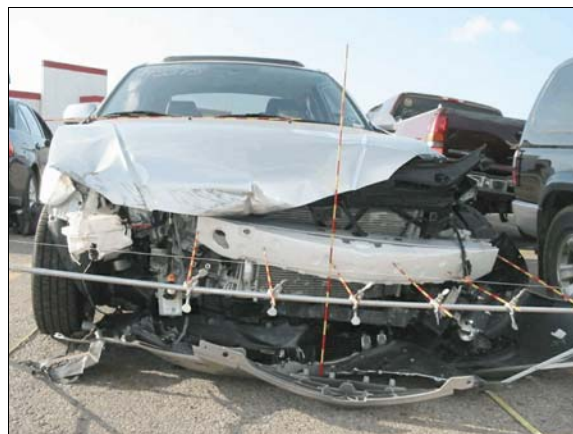
Figure 4: Damage to front of case vehicle [each stripe on rods is 5 cm (2 in)] from impact with the median barrier (case photo #08)

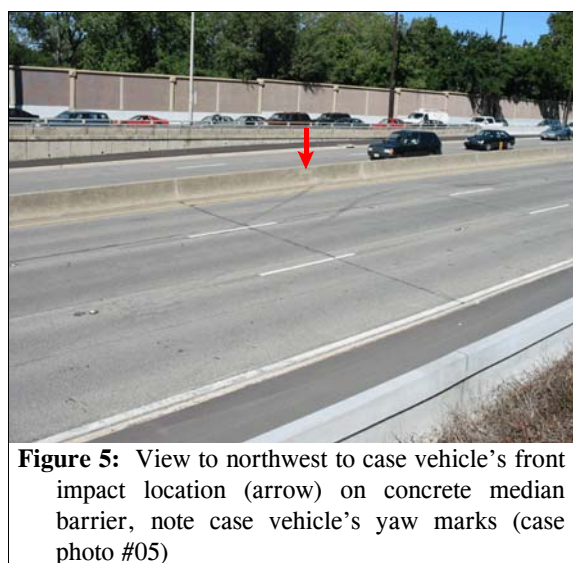
Figure 5: View to northwest to case vehicle's front impact location (arrow) on concrete median barrier, note case vehicle's yaw marks (case photo #05)

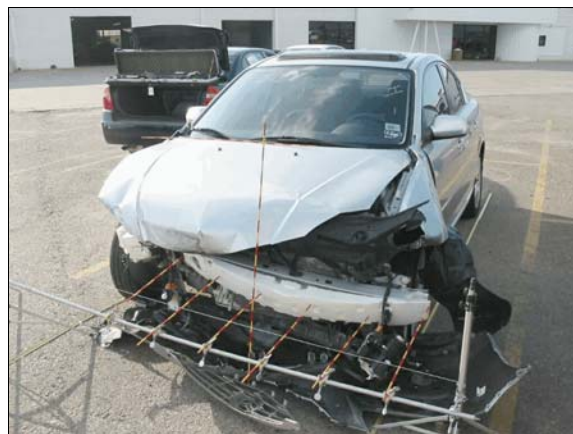
the right quarter panel was about 1.0 centimeter (0.4 inch) occurring at C₂, and the right rear wheel was bent inward at the bottom. The case vehicle's impact with the concrete median barrier involved the front bumper, right fender, right headlamp/turn lamp assembly, grille and hood. (Figure 6). Direct damage began at the right corner of the front bumper and extended 118 centimeters (46.5 inches) across the front of the case vehicle. Crush measurements were taken at the bumper and maximum crush was measured as 31 centimeters (12.2 inches) occurring at C₂ and C₃ (Figure 7). The table below shows the case vehicle's crush profile.

Figure 6: Overview of damage to front of case vehicle from impact with the concrete median barrier (case photo #10)

The right side wheelbase was extended 1.0 centimeter (0.4 inch). The left side wheelbase was unchanged. Induced damage involved the front bumper, grille, hood, right fender and left fender.

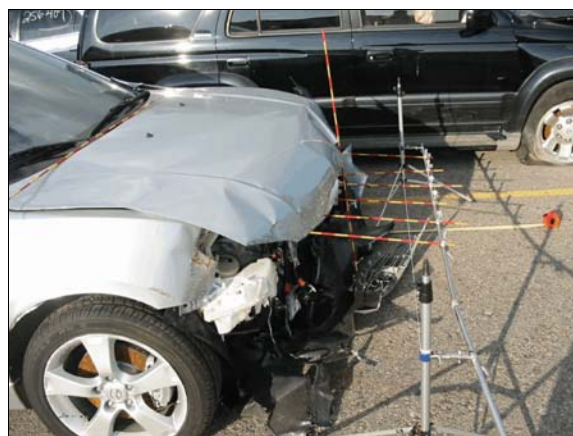
Figure 7: Right side view of crush to front of case vehicle (case photo #16)

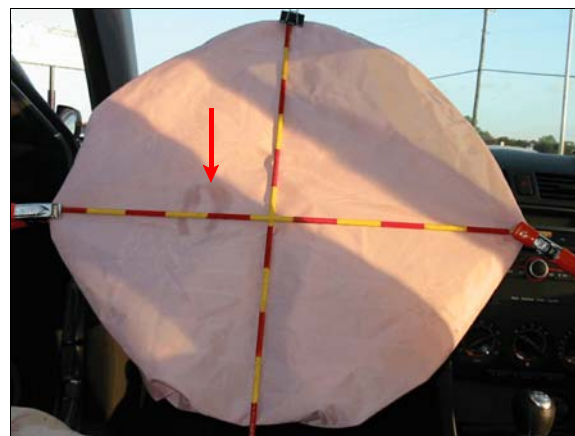
Vehicle Interior: Inspection of the case vehicle’s interior revealed a possible occupant contact on the left center portion of the air bag (**Figure 8**). The contact appeared to be a stain in the air bag material. It did not appear to be a transfer of lip stick or make-up. No other evidence of occupant contact was noted on the case vehicle’s interior. In addition, there was a heavy abrasion noted on the driver’s shoulder belt, and her buckle-mounted pretensioner had activated. No occupant compartment intrusions were observed, and there was no compression of the energy absorbing steering column or deformation of the steering wheel rim (**Figure 9**).

Figure 8: Case vehicle’s driver air bag, arrow shows stain in the air bag material (case photo #25)

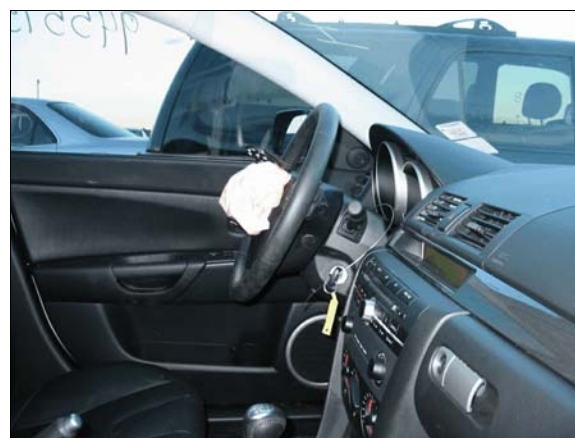
Figure 9: Overview of steering wheel and steering column showing lack of deformation (case photo #38)

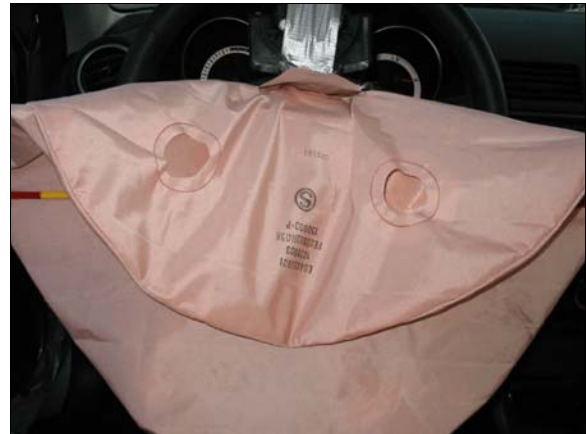
Figure 10: Case vehicle's driver air bag vent ports (case photo # 27)

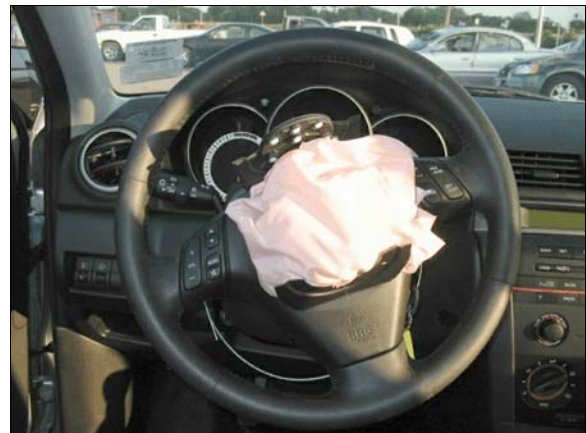
The case vehicle's driver air bag was located in the steering wheel hub. An inspection of the air bag module cover flaps and the air bag fabric revealed that the cover flaps opened at the designated tear points. There was no evidence of damage during the deployment to the air bag module cover flaps or the air bag. The deployed driver's air bag (**Figure 8** above) was round with a diameter of approximately 58 centimeters (22.8 inches). The air bag was designed without tethers and had two vent ports (**Figure 10**), each approximately 4 centimeters (1.6 inches) in diameter, located at the 11 and 1 o'clock positions. There were two air bag module cover flaps (**Figure 11**). The top portion of the top flap was rectangular in shape with a semi-circular center portion that mated with the semi-circular center portion of the bottom flap. The top flap was 11 centimeters (4.3 inches) in width at the top, and the bottom flap was 8.5 centimeters (3.3 inches) in width at the bottom. The distance between the mid-center of the driver's seat back and the front surface of the air bag's fabric at full excursion was 20 centimeters (7.9 inches).

Figure 11: Overview of air bag module flaps (case photo # 22)

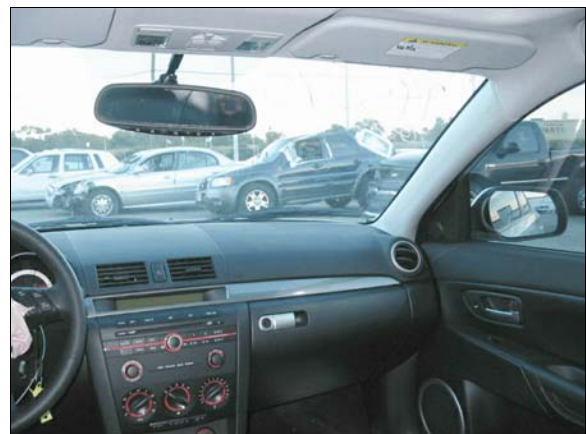
The front right passenger air bag was located in the middle of the instrument panel (**Figure 12**). The deployment of the front right air bag was properly suppressed by the case vehicle's advanced occupant protection system because there was no front right occupant in the case vehicle at the time of the crash.

Figure 12: Front right air bag located in top of instrument panel above glove box door (case photo #35)

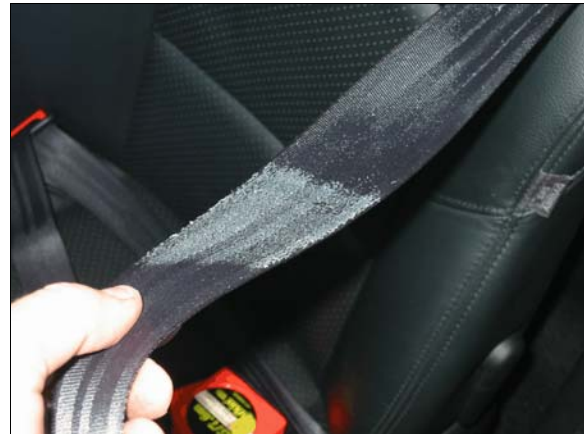
The evidence observed during the vehicle inspection indicates the case vehicle's driver was using her active, three-point, lap-and-shoulder safety belt system. Inspection of the safety belt assembly revealed a heavy abrasion on the shoulder belt (**Figure 13** above) due to loading on the D-ring during the crash. In addition, the buckle-mounted pretensioner had activated during the crash. The safety belt buckle stalk was observed to be compressed (**Figure 14**), and the pretensioner piston was flush with the end of the cylinder, a movement of approximately 8 centimeters (3.1 inches).

Figure 13: Load mark on driver's shoulder belt (case photo #30)

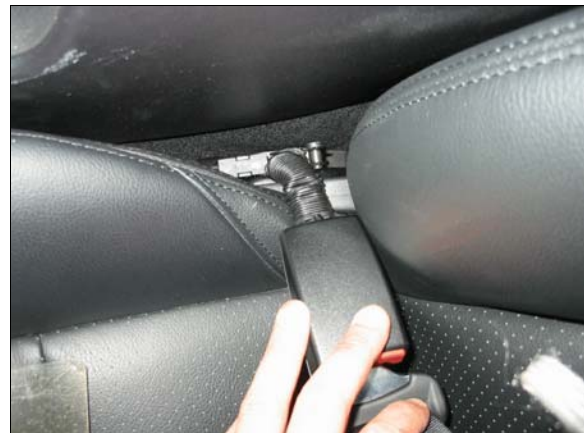
Figure 14: Compression of driver's seat belt buckle stalk due to activation of the seat belt pretensioner (case photo # 31)
