**CALSPAN ON-SITE CERTIFIED ADVANCED 208-COMPLIANT VEHICLE
CRASH INVESTIGATION**

CASE NO: CA04-034

VEHICLE: 2004 LEXUS ES 330

CRASH DATE: JUNE 2004

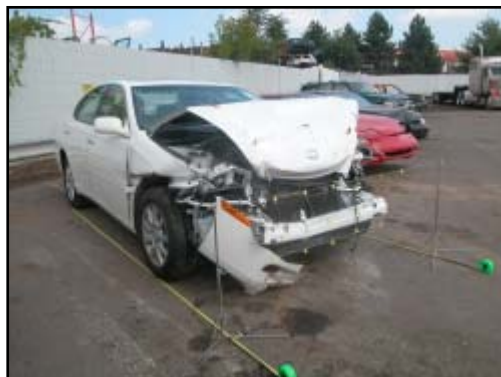
Figure 1. Damaged 2004 Lexus ES 330

The Lexus ES 330 (**Figure 1**) was occupied by a 42-year-old male driver. The driver was operating the vehicle under the influence of alcohol and at a high rate of speed on a four-lane divided highway. The driver attempted a lane change maneuver from the inboard lane and struck the rear aspect of a 1989 Mazda 929 traveling in the outboard lane. The impact was sufficient to deploy the frontal air bag system in the Lexus. Since the front right seat was unoccupied, the front right passenger's air bag did not deploy. The Lexus was deflected onto the outboard shoulder and struck a three-strand cable guardrail. The Lexus continued in a forward direction against the guardrail to final rest. The driver of the Lexus did not sustain injury and did not receive medical treatment.

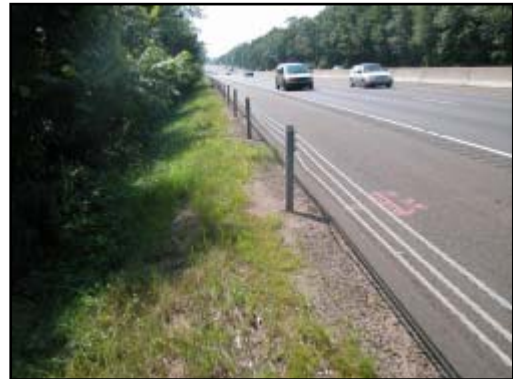
Figure 2. Close-up of three-strand cable guardrail (northbound roadside)

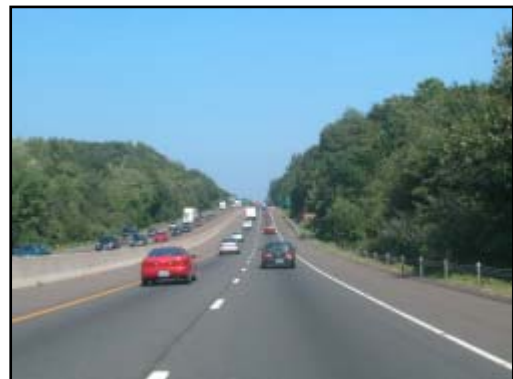
Police reported that the driver of the 2004 Lexus ES 330 was operating the vehicle under the influence of alcohol. His pre-crash speed was not known. He was operating the Lexus on the inboard northbound lane of the divided highway (**Figure 3**). The 1989 Mazda 929 was traveling in the same direction on the outboard northbound lane ahead of the Lexus. The driver of the Lexus initiated a lane change maneuver to the outboard lane but did not detect the Mazda in the travel lane.

Figure 3. Northbound approach for both vehicles

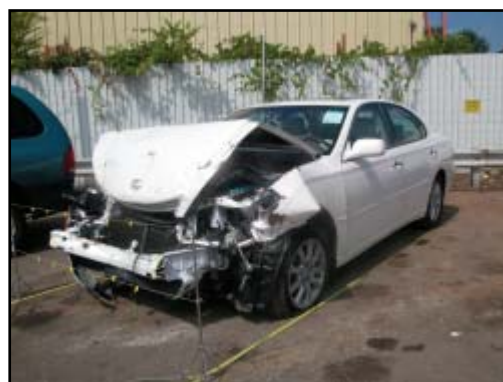
The 2004 Lexus ES 330 sustained moderate frontal damage (**Figure 4**) as a result of the initial impact with the Mazda 929. The leading edge of the hood sustained abrasions and deformation as a result of direct contact with the Mazda. The direct contact damage on the hood began 48.3 cm (19.0") right of the centerline and extended 121.9 cm (48.0") laterally to the front left corner. The direct contact on the hood extended 38.1 cm (15.0") longitudinally from the leading edge. The bumper fascia was fractured and separated at the time of the vehicle inspection. The front bumper beam was crushed rearward and the maximum crush on the beam was located 4.4 cm (1.8") right of center and measured 30.8 cm (12.1"). The leading 27.9 cm (11.0") of the left frame rail was deflected inward 8.9 cm (3.5"). The combined direct and induced damage involved the entire frontal width of the Lexus and measured 121.9 cm (48.0") across the damaged front bumper beam. The hood was bucked upward and rearward and the upper radiator support was deformed as a result of engagement with the hood. Both front fenders sustained induced buckling. There was no reduction of the wheelbase and no induced damage from the initial impact rear of the A-pillars. Six crush measurements were documented across the front bumper beam and were as follows: C1 = 3.8 cm (1.5"), C2 = 13.3 cm (5.3"), C3 = 25.1 cm (9.9"), C4 = 27.6 cm (10.9"), C5 = 14.6 cm (5.8"), C6 = 0.0 cm. The Collision Deformation Classification (CDC) for the initial impact with the Mazda 929 was 12-FDEW-2.

Figure 4. Frontal damage to the 2004 Lexus ES 330

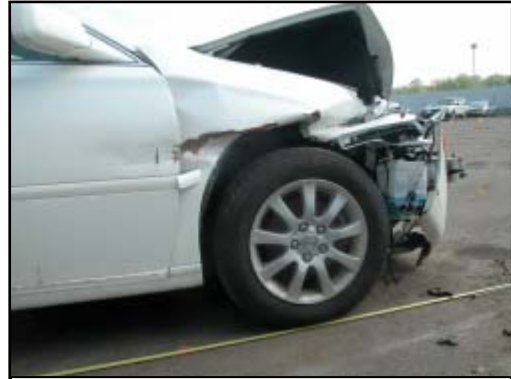
The Lexus sustained minor right side damage as a result of the guardrail impact. The direct damage began at the right front corner above the bumper and extended along the entire right side plane. Pocketing in the right front fender above the right front wheel was present from the initial engagement of the cables (**Figure 5**). The pocketing of the fender measured 3.8 cm (1.5”) in height and 9.5 cm (3.8”) in depth at the leading aspect, and diminished to surface abrasions at the rear aspect. The pocketing began at the leading edge of the right front fender and extended 85.1 cm (33.5”) to the leading edge of the right front door. There was no structural deformation present aft of the right front fender. Abrasions from the cable guardrail were present on the mid-door level of the right front door, right rear door, and the right rear quarter panel. A scuff mark was also present on the right sill below the right front door, which began at the leading edge of the sill and measured 83.8 cm (33.0”) in length. The CDC for the guardrail impact was 12-FRES-9.

Figure 5. Right front fender damage from guardrail

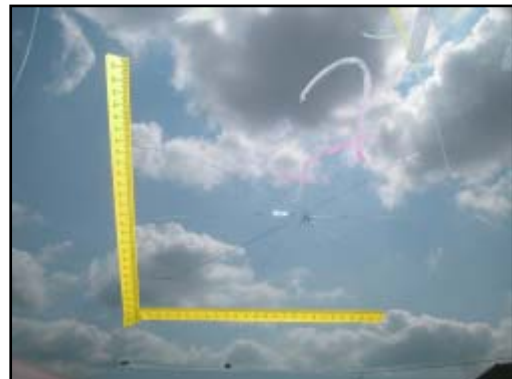
The Lexus ES 330 sustained minor interior damage as a result of the crash. There was no intrusion of the passenger compartment. The windshield sustained a small focused fracture that was located 15.2 cm (6.0”) left of the centerline and 33.7 cm (13.3”) below the windshield header. The fracture (**Figure 6**) may have resulted from a fling of the driver’s right hand into the windshield as a result of the driver’s air bag deployment. There was no damage to the side glazing, backlight, or sunroof.

Figure 6. Close-up of windshield fracture

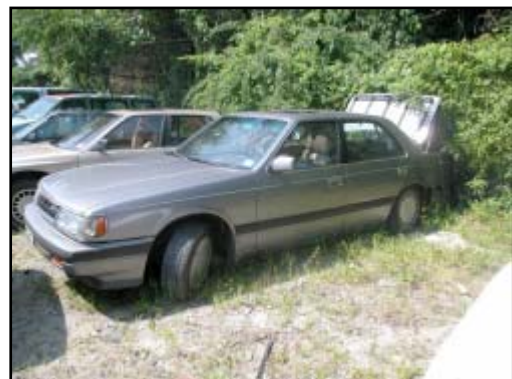
The 1989 Mazda 929 sustained moderate rear damage as a result of the impact with the Lexus ES 330 (**Figure 7**). The rear bumper fascia was partially separated and sustained abrasions and white paint transfers from direct contact with the Lexus. The direct contact damage began 64.8 cm (25.5”) left of the centerline and extended 139.7 cm (55.0”) to the rear right corner of the rear bumper. The bumper beam sustained longitudinal crush, and the maximum crush was located 6.4 cm (2.5”) left of center and measured 18.0 cm (7.1”). The direct contact from the Lexus extended upward along the lower edge of the trunk.

Figure 7. View of damaged 1989 Mazda 929

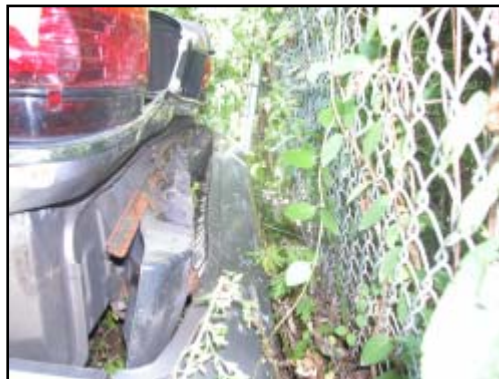
The combined direct and induced damage involved the entire width of the rear bumper (**Figure 8**) and measured 152.4 cm (60.0"). Both rear quarter panels sustained induced buckling, more severe on the right side. Due to limited access to the rear plane as a result of the vehicle location, the reference line was established laterally across the trunk 60 cm (23.6") rear of the undamaged rear axle, and the crush measurements documented accordingly across the rear bumper beam as follows: C1 = 7.8 cm (3.1"), C2 = 11.6 cm (4.6"), C3 = 14.2 cm (5.6"), C4 = 16.7 cm (6.6"), C5 = 14.8 cm (5.8"), C6 = 12.9 cm (5.1"). The CDC for the impact with the Lexus was 06-BDEW-2.

Figure 8. Lateral view from left along damaged rear bumper beam

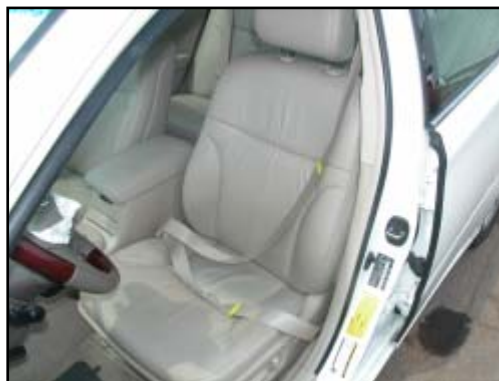
The 2004 Lexus ES 330 was configured with manual 3-point lap and shoulder belts for all five seating positions. The driver's safety belt was configured with a sliding latch plate, Emergency Locking Retractor (ELR), and an adjustable D-ring that was located in the full-up position at the time of the vehicle inspection. At the time of the vehicle inspection, the driver's safety belt was restricted in the used position as a result of the retractor pretensioner actuation (**Figure 9**). The total exposed webbing measured 191.8 cm (75.5") between the lower anchor and the D-ring. The driver's plastic-covered latch plate exhibited moderate abrasions as a result of the driver's loading to the safety belt. The driver's D-ring sustained abrasions from the loading to the safety belt, as well. Minor deformation was present on the webbing from driver loading. The deformation began 47.0 cm (18.5") above the lower anchor and extended 95.3 cm (37.5") up the webbing.

Figure 9. View of driver's safety belt

The driver's D-ring sustained abrasions from the loading to the safety belt, as well. Minor deformation was present on the webbing from driver loading. The deformation began 47.0 cm (18.5") above the lower anchor and extended 95.3 cm (37.5") up the webbing.

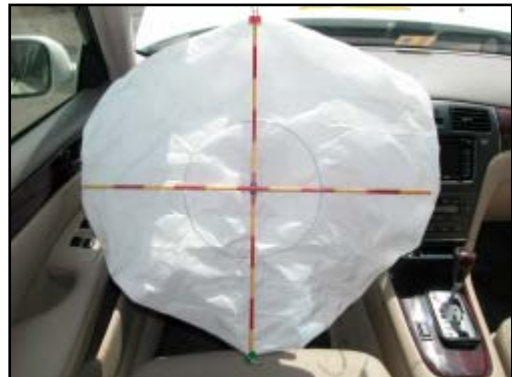
The driver's air bag deployed from the center of the steering wheel that was configured with a triangular cover flap configuration with a horizontal tear seam that measured 14.9 cm (5.9") in width. The top cover flap measured 7.6 cm (3.0") in height and the contoured symmetrical bottom flaps measured 5.1 cm (2.0") in height. The air bag (**Figure 10**) measured 66.0 cm (26.0") in diameter. The air bag was vented by two circular ports that measured 2.5 cm (1.0") in diameter. The vent ports were located 7.6 cm (3.0") from the circumferential seam at the 1 and 11 o'clock positions on the top rear aspect of the air bag. The air bag was tethered by two internal straps that measured 12.7 cm (5.0") in width and were located at the 3 and 9 o'clock positions of the air bag. There was no occupant contact evidence present on the air bag or module cover flaps.

Figure 10. Deployed driver's air bag

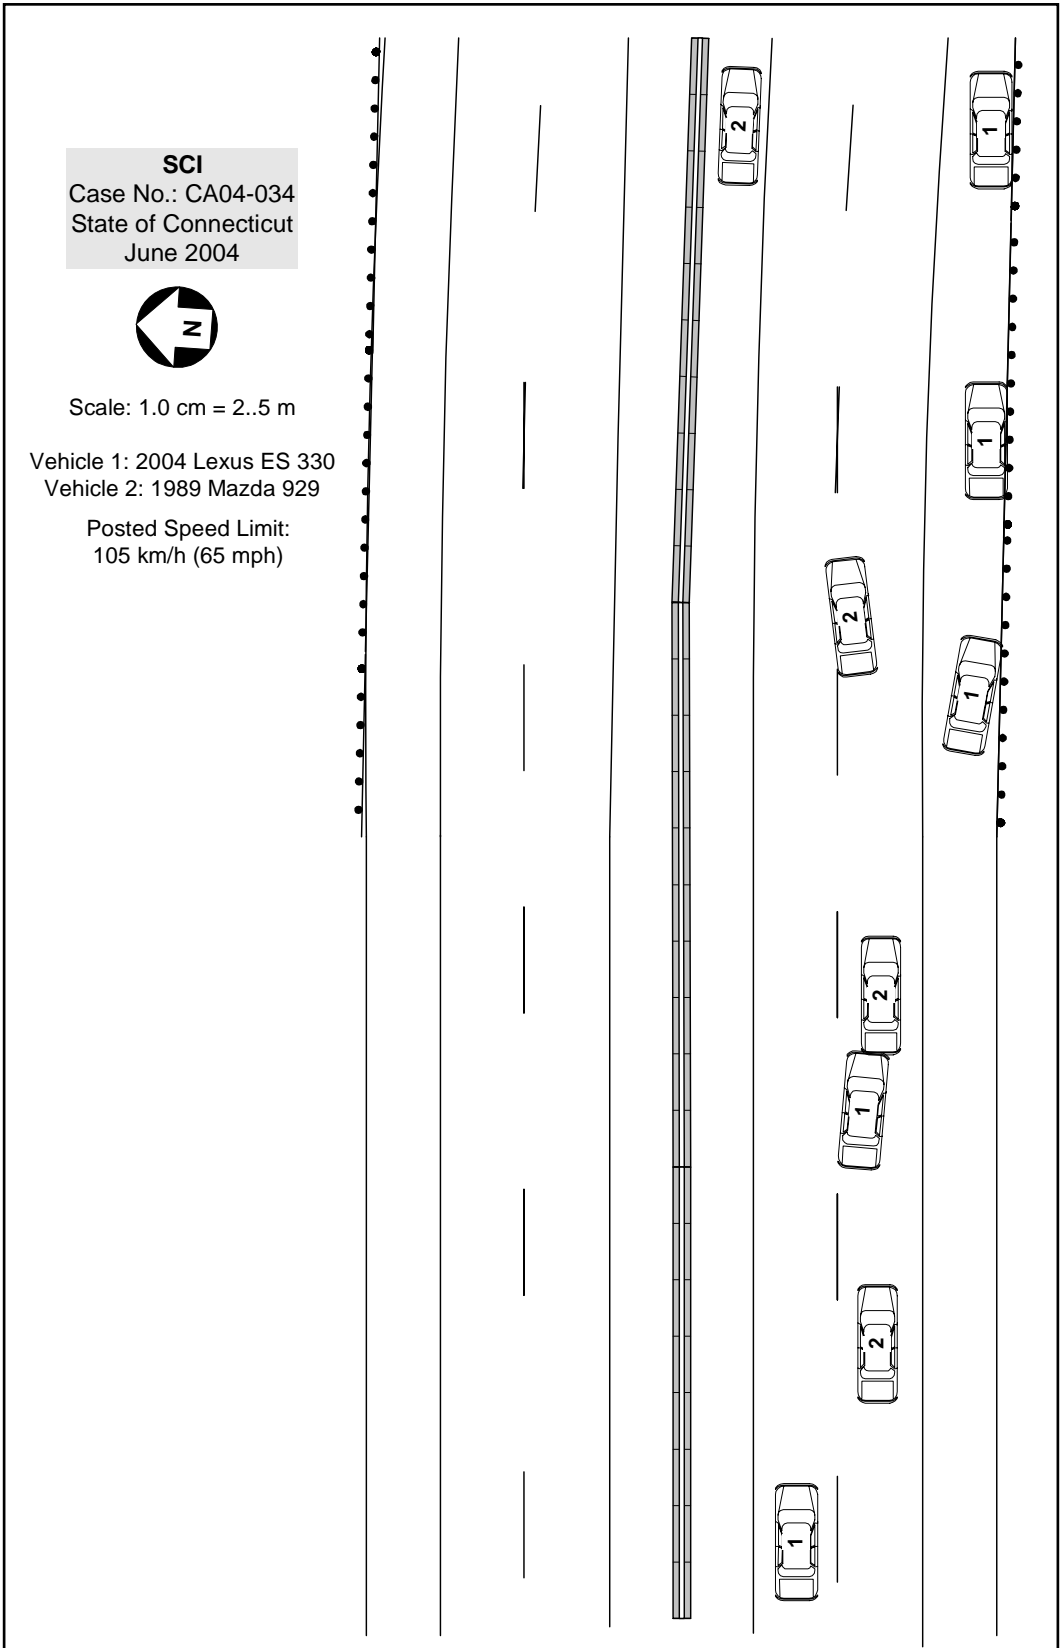
This two-vehicle crash occurred during the nighttime hours of June 2004 in the state of Connecticut. At the time of the crash, the weather was clear and the asphalt roadway surface was dry. The crash occurred on the northbound lanes of a four-lane divided highway. The north/south travel lanes were separated by an extended-height Jersey median barrier that was approximately 178 cm (70”) in height. Both southbound travel lanes measured 3.7 m (12.0’) in width and were bordered by asphalt shoulders and Continuous Shoulder Rumble Strips (CSRS). A three-strand cable guardrail was present on the outboard roadside supported by weak-post I-beams spaced on 3.8 m (12.5’) centers (**Figure 2**). The northbound travel lanes exhibited a slight right curve and a slight positive northbound grade at the crash site. The posted speed limit was 105 km/h (65 mph). Due to heavy traffic flow, the scene was not thoroughly documented. A scene schematic with estimated distances is included as **Figure 11** of this narrative report.

Figure 11. Approximated scene schematic
