INDIANA UNIVERSITY

TRANSPORTATION RESEARCH CENTER

ON-SITE CERTIFIED ADVANCED 208- COMPLIANT VEHICLE INVESTIGATION

CASE NUMBER - IN-04-035
LOCATION - Texas
VEHICLE - 2004 BMW 530i
CRASH DATE - September 2004

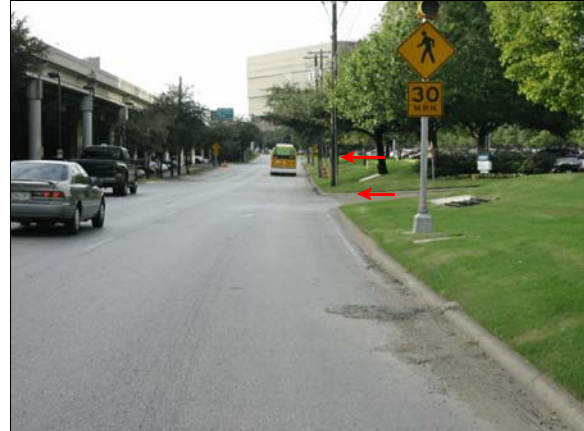
Pre-Crash: The case vehicle was traveling northwest in the outside lane (**Figure 1**), and the driver was intending to continue traveling northwest. The case vehicle's driver was leaning to her right looking for her cellular telephone and the case vehicle departed the right (i.e. north) side of the roadway and entered the mouth of a driveway to a parking lot. The driver stated that she did not take any avoidance actions. The crash occurred on the north side of the roadway.

Figure 1: Approach of case vehicle northwestbound in outside lane, arrows show impacted curb and utility pole (case photo #01)

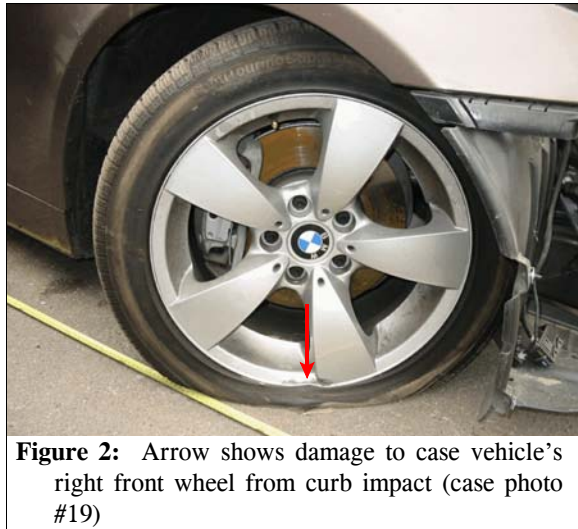
Figure 2: Arrow shows damage to case vehicle's right front wheel from curb impact (case photo #19)

Crash: As the case vehicle traveled to its right while the driver was looking for her cellular telephone, the right front and right rear wheels (**Figures 2 and 3**) impacted a curb on the northwest side of the driveway. The case vehicle traveled over the curb and the front (**Figure 4**) immediately impacted a 15 centimeters (6.0 inches) diameter steel conduit pipe attached to a utility pole (**Figure 5** below) causing the case vehicle's driver and front right air bags to deploy

Exterior Damage: The case vehicle’s impact with the curb involved the right front and right rear wheels. The right front wheel sustained a small dent in the rim (**Figure 2** above). The right rear wheel sustained a dented rim, and the inner tire carcass was damaged causing an air bubble in the outer tire sidewall (**Figure 3** above). It is not known if the left front wheel was damaged. It had been removed from the case vehicle and was not available for inspection. The case vehicle’s impact with the utility pole/steel conduit pipe involved the front bumper, grille and hood. The direct damage on the hood began 10 centimeters (4.0 inches) left of the centerline of the vehicle and extended 25 centimeters (9.8 inches) along the hood and approximated the shape of the steel conduit pipe (**Figure 6**). Crush measurements were not taken because most of the damaged front components had been removed. The left side wheelbase was shortened 15 centimeters (5.9 inches)

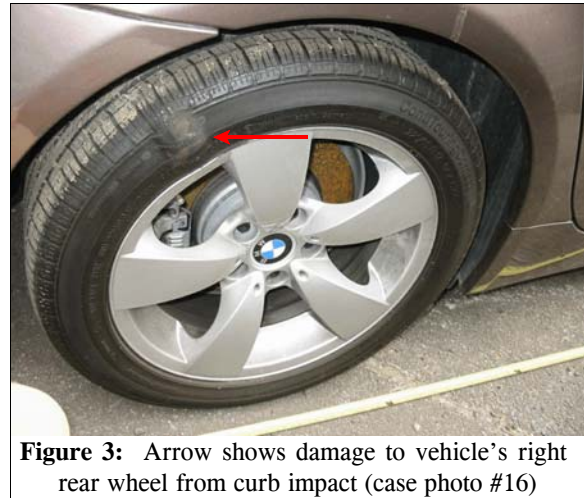
Figure 3: Arrow shows damage to vehicle's right rear wheel from curb impact (case photo #16)

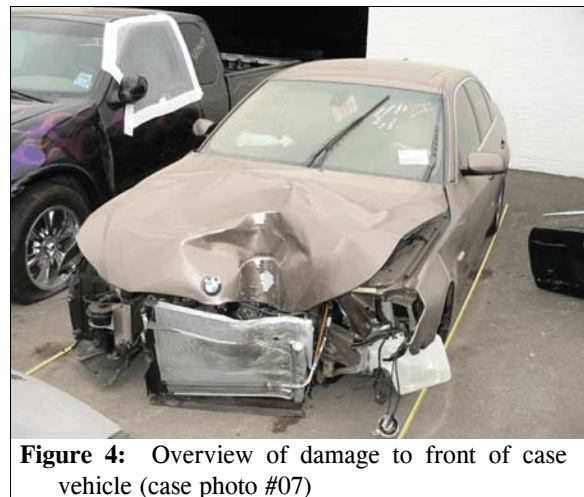
Figure 4: Overview of damage to front of case vehicle (case photo #07)

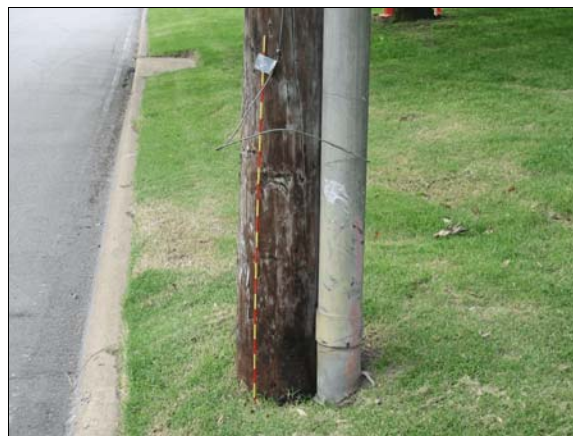
Figure 5: The utility pole [each stripe on rod is 5 cm (2 in)], case vehicle impacted steel conduit pipe (case photo #04)

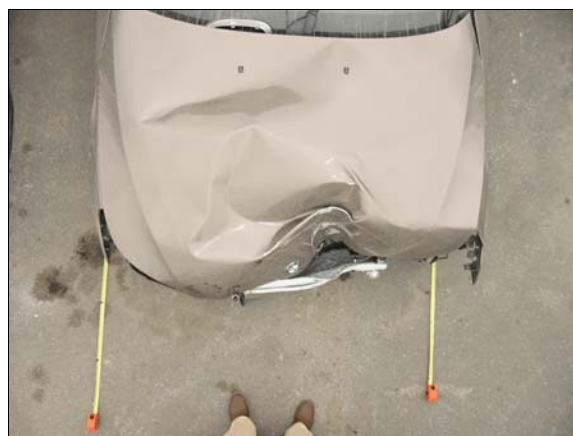
Figure 6: Top view of damage to case vehicle’s front end (case photo #21)

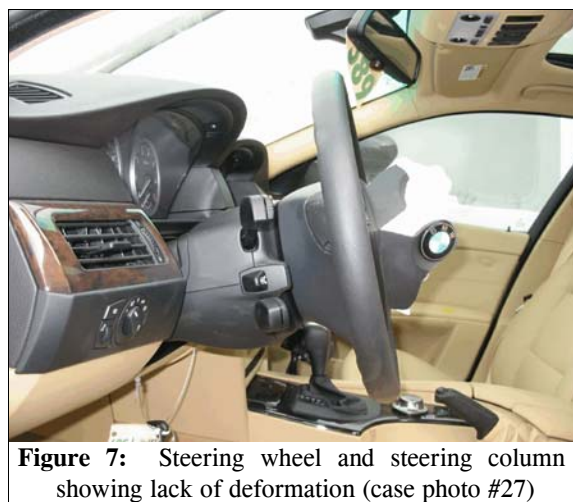
Vehicle Interior: Inspection of the case vehicle’s interior revealed several possible makeup smudges on the deployed driver’s air bag and several drops of blood on the deployed front right air bag and right front door. No other evidence of occupant contact to any interior surfaces or components was observed. In addition, there were no intrusions to the passenger compartment, and no compression of the energy absorbing steering column or deformation of the steering wheel rim was observed (**Figure 7**).

Figure 7: Steering wheel and steering column showing lack of deformation (case photo #27)

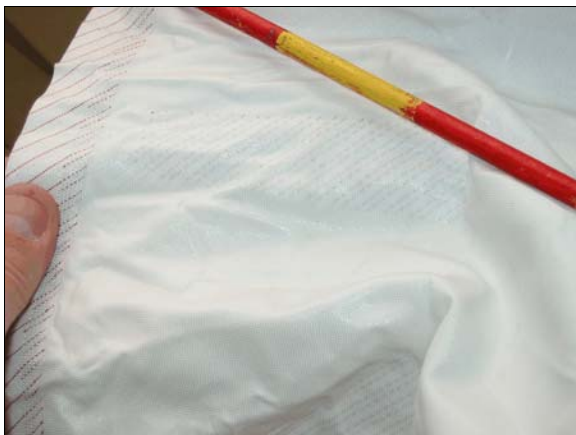
The case vehicle's driver air bag was located in the steering wheel hub. An inspection of the air bag module cover flaps and the air bag fabric revealed that the cover flaps opened at the designated tear points. There was no evidence of damage during the deployment to the air bag module cover flaps or the air bag. The air bag was designed with the front and back bonded together at the outer edge at the 12 o'clock, 3 o'clock, 6 o'clock and 9 o'clock positions. Each area contained three strips on bonding, each 9.0 centimeters (3.5 inches) in length and about 2.0 centimeters (0.8 inch) in width (**Figure 8**). These areas appeared to be designed to separate during deployment, and may be related to the dual stage deployment design of the air bag, or possibly related to controlling the shape of the air bag during deployment. There was no separation of the bonding at the 9 o'clock position, and only two of the three bonding strips separated at the 6 o'clock position. There was total separation of the bonding strips at the 12 o'clock and 3 o'clock positions.

Figure 8: Close view of the bonding strips on the driver's air bag (case photo #31b)

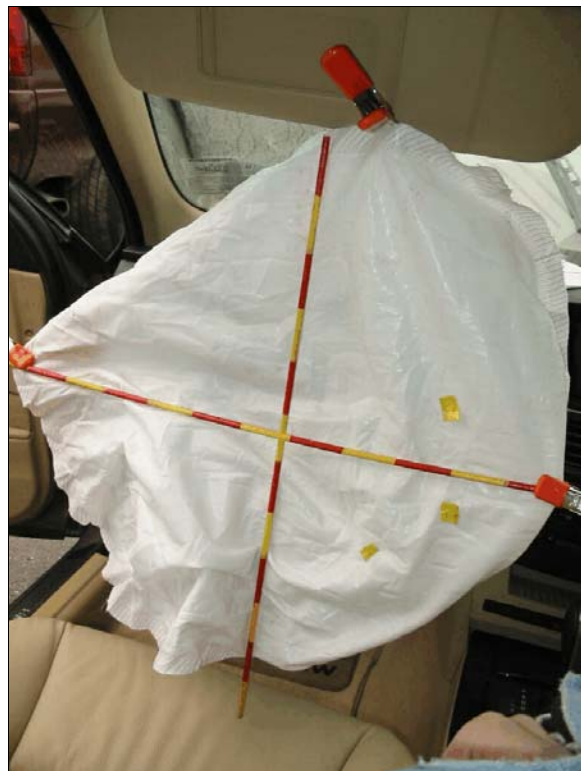
Figure 9: Driver's air bag, yellow tape shows area of probable makeup smears (case photo #28)

The deployed driver's air bag (**Figure 9** above) was round with a diameter of about 58 centimeters (22.3 inches). The air bag was

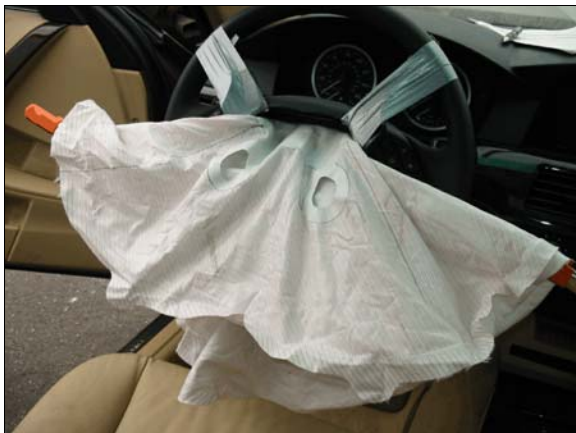
Figure 10: Driver's air bag vent ports (case photo #39)

designed without tether straps and had two vent ports (**Figure 10** above), each approximately 3 centimeters (1.2 inches) in diameter, located at the 10 and 2 o'clock positions. The air bag module was designed with four irregularly shaped cover flaps (**Figure 11**) made of thick pliable vinyl. The lower flaps were longer than the top flaps, and the circular BMW emblem formed the center portion of the left lower flap. The distance between the mid-center of the driver's seat back, as positioned at the time of the vehicle inspection, and the front surface of the air bag's fabric at full excursion was 12 centimeters (4.7 inches). Inspection of the air bag material revealed trace evidence of several probable makeup smears on the right central portion of the air bag indicating the driver's face probably contacted her deployed air bag.

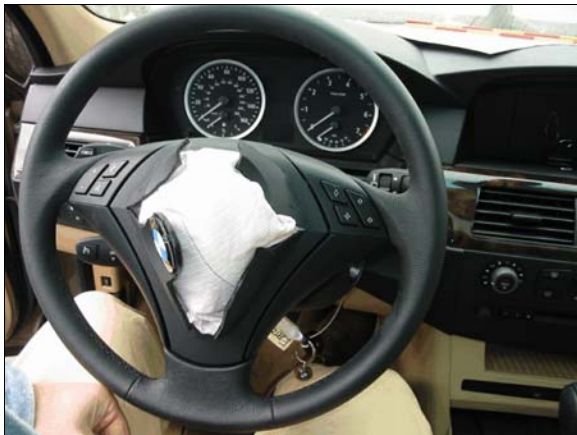
Figure 11: Driver's air bag module cover flaps (case photo #26)

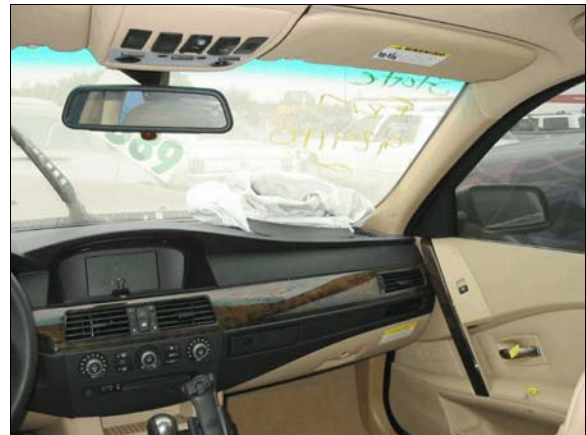
Figure 12: Overview of location of front right passenger air bag in top of right instrument panel (case photo #48)

The front right passenger air bag was located in the top of the instrument panel (**Figure 12**). The deployed front right air bag (**Figure 13**) was about 43 centimeters (16.9 inches) in width and 64 centimeters in height (25.1 inches). The distance between the mid-center of the front right passenger's seat back, as positioned at the time of

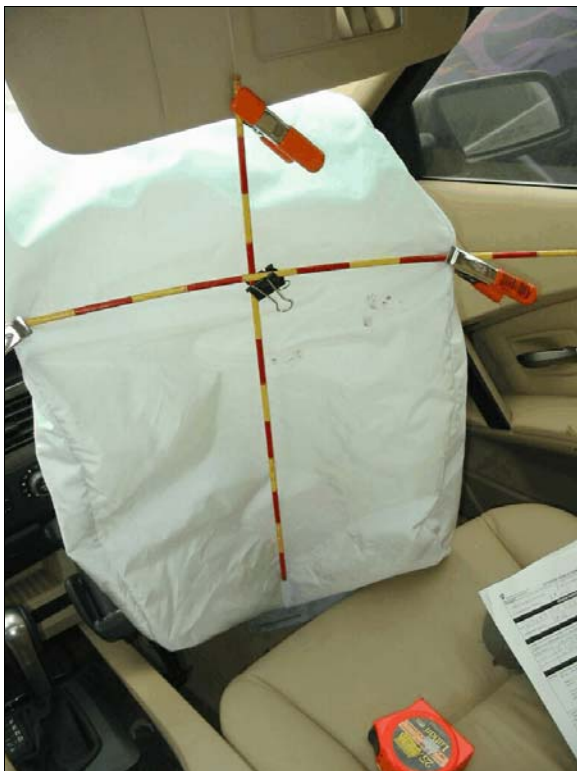
Figure 13: Front right passenger air bag, blood smears in right lower quadrant (case photo #32)

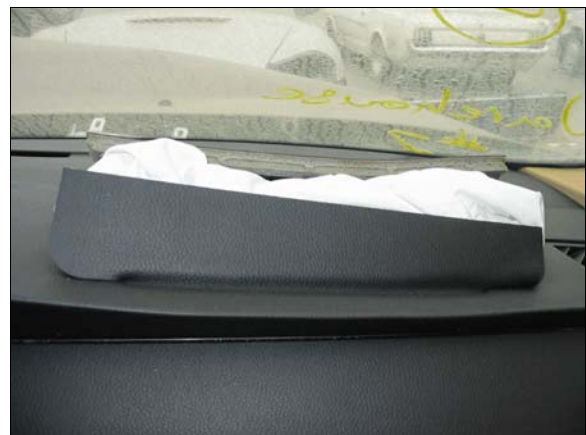
Figure 14: Front right air bag module cover flaps (case photo #37)

the vehicle inspection, and the front surface of the air bag's fabric at full excursion was 12 centimeters (4.7 inches). The air bag was designed without tether straps and had two vent ports, each 3.5 centimeters in diameter, located at approximately the 9 o'clock and 3 o'clock positions. The air bag module was designed with two cover flaps (**Figure 14** above). The top flap was 27.5 centimeters (10.8 inches) in width and 7.0 centimeters (2.8 inches) in height. The bottom flap was 27.5 centimeters (10.8 inches) in width and 5.5 centimeters (2.2 inches) in height on the left and 3.5 centimeters (1.4 inches) in height on the right. It was slightly bent during deployment. Both flaps were constructed of vinyl with a soft foam backing. Inspection of the air bag material revealed no evidence of occupant contact marks on the air bag. However, several blood smears were present on the lower right quadrant of the air bag. They were most likely blood drops from the front right passenger's right hand laceration due to contact with the right front door grab-handle.

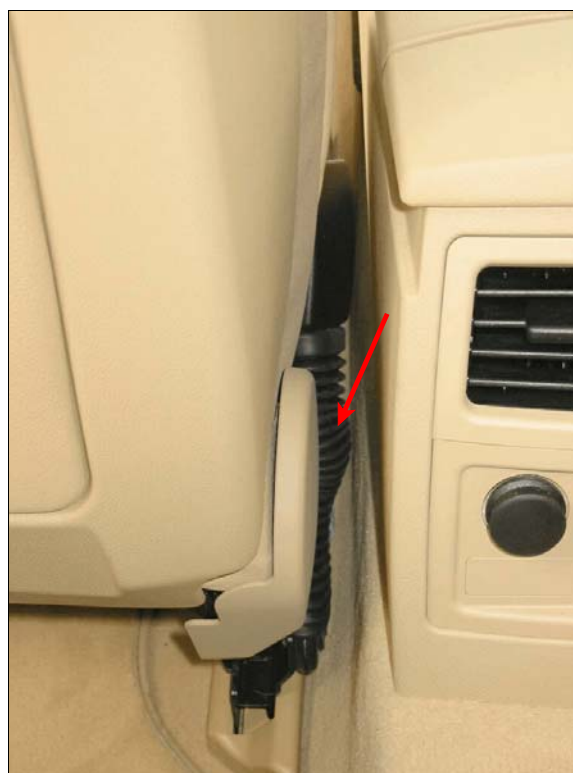
The case vehicle's driver was restrained by her three-point, lap and shoulder safety belt. The driver stated she was using the safety belt, and the evidence indicated that the belt was in use at the time of the crash. The driver's buckle-mounted pretensioner had activated in the crash compressing the seat belt buckle stalk cover (**Figure 15**); however, no load marks were observed on the driver's shoulder belt or D-ring. The measurement from the pretensioner piston to the end of the piston cylinder was 2.5 centimeters (1.0 inch). The driver's statement that she was leaned to the right looking for her cellular telephone indicates she was out of position, and may have been at least partially out of the shoulder belt at the time of impact.

Figure 15: Arrow shows compression of driver's seat belt buckle stalk cover

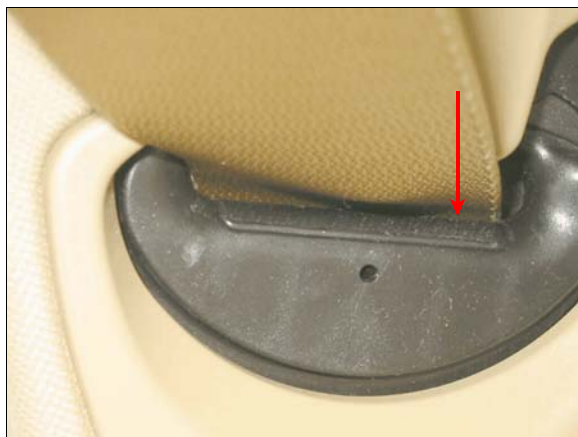
The front right passenger was using her three-point, lap and shoulder safety belt. The inspection of her seat belt assembly revealed load marks on the D-ring (**Figure 16**) and shoulder belt (**Figure 17**). In addition, the buckle-mounted pretensioner had activated and compressed the front right seat belt buckle stalk cover (**Figure 18** below). The measurement from the pretensioner piston to the end of the piston cylinder was 1.0 centimeter (0.4 inch).

Figure 16: Abrasions (arrow) from the shoulder belt on the front right D-ring (case photo #45)

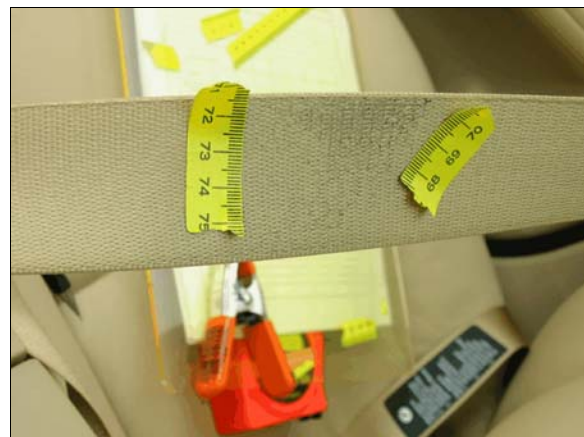
Figure 17: Plastic transfer from D-ring on front right shoulder belt (case photo #42)

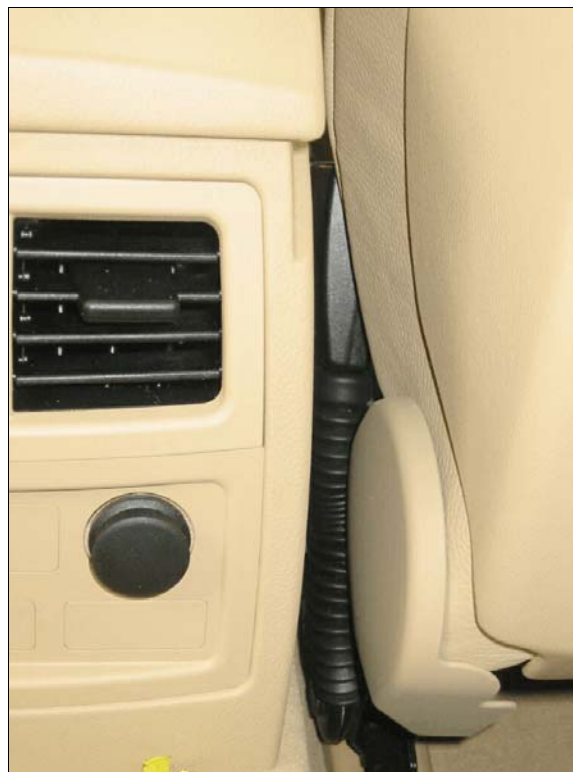
Figure 18: Compression of front right seat belt buckle stalk cover (case photo #48a)

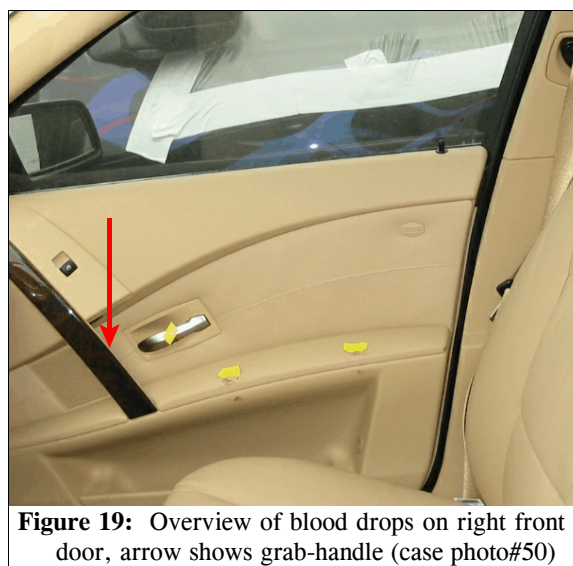
Figure 19: Overview of blood drops on right front door, arrow shows grab-handle (case photo#50)
