TRANSPORTATION RESEARCH CENTER

REMOTE CHILD SAFETY SEAT INVESTIGATION

CASE NUMBER - IN-04-039
LOCATION - Texas
VEHICLE - 1999 Toyota Camry
CRASH DATE - November 2004

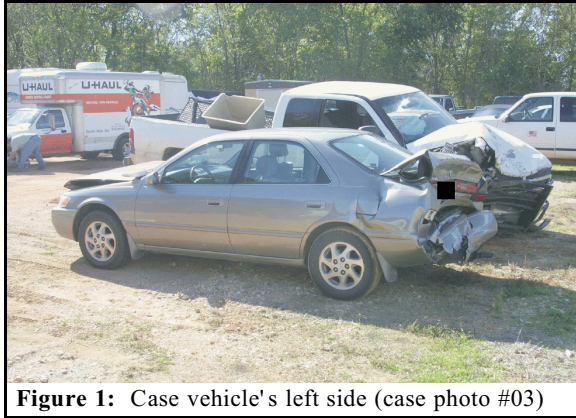
The case vehicle sustained direct contact damage across its entire back from the first impact (**Figures 1 and 2**). The bumper cover was torn and the steel bumper was crushed forward. The trunk lid was originally shaped such that it extended downward to form a vertical panel on the back plane and this was crushed inward, with the horizontal portion of the trunk lid folded nearly

double and bent upward. The trailing edge of both quarter panels was crushed forward, more so on the left, with the left tail light/turn signal assembly shattered and the right assembly displaced but intact. The left quarter panel was bent outward and sustained induced damaged that extended forward to the C-pillar, including the fuel port cover. There was no glazing damage and none of the tires were deflated or restricted.

Figure 1: Case vehicle's left side (case photo #03)

The CDC for the case vehicle's first impact was estimated from the available photographs as **06-BDEW-3 (180 degrees)**. The WinSMASH reconstruction program, missing vehicle algorithm based on the case vehicle's photo-estimated CDC, was used on the case vehicle's first impact. The total, longitudinal and lateral delta-Vs are, respectively: 35.0 km.p.h. [21.7 m.p.h.], + 35.0 km.p.h. [+ 21.7 m.p.h.], and 0 km.p.h. [0 m.p.h.]. This is a borderline reconstruction, but the results appear reasonable. The first (most severe) impact was of moderate severity (24-40 km.p.h. [15-25 m.p.h.]) for the case vehicle.

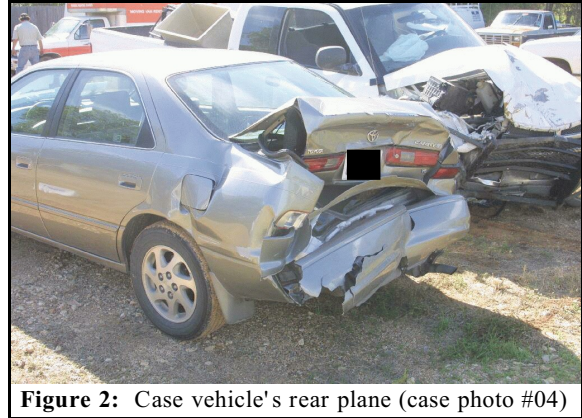
Figure 2: Case vehicle's rear plane (case photo #04)

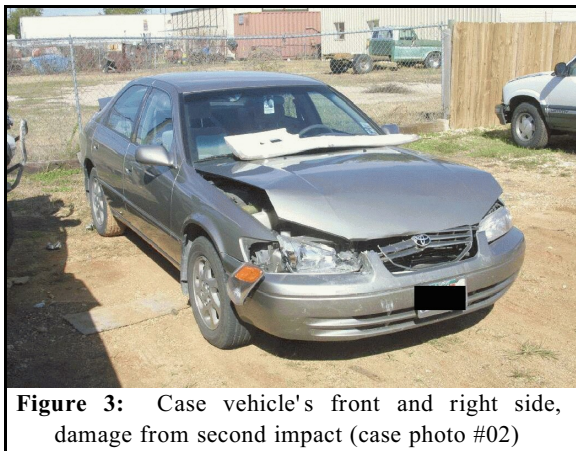
Figure 3: Case vehicle's front and right side, damage from second impact (case photo #02)

The case vehicle also sustained frontal damage from the second impact (**Figures 3 and 4**). Direct contact extended from slightly left of center to the front right bumper corner. There was abrading on the bumper cover and the plastic skin was slightly displaced, and the leading edge of the hood was folded down slightly. The grille was damaged and the right headlamp lens was shattered but neither was broken away. The right front turn signal assembly was intact, but was

knocked loose and was dangling by its wires. The hood was folded upward and was slightly displaced.

The CDC for the case vehicle's second impact was estimated from the available photographs as **12-FZEW-1 (0 degrees)**. The WinSMASH reconstruction program, missing vehicle algorithm based on the case vehicle's photo-estimated CDC, was used on the case vehicle's second impact. The total, longitudinal and lateral delta-Vs are, respectively: 21.0 km.p.h. [13.0 m.p.h.], -21.0 km.p.h. [-13.0 m.p.h.], and 0 km.p.h. [0 m.p.h.]. This is a borderline reconstruction, but the results appear reasonable. The second impact was of low severity (14-23 km.p.h. [9-14 m.p.h.]) for the case vehicle.

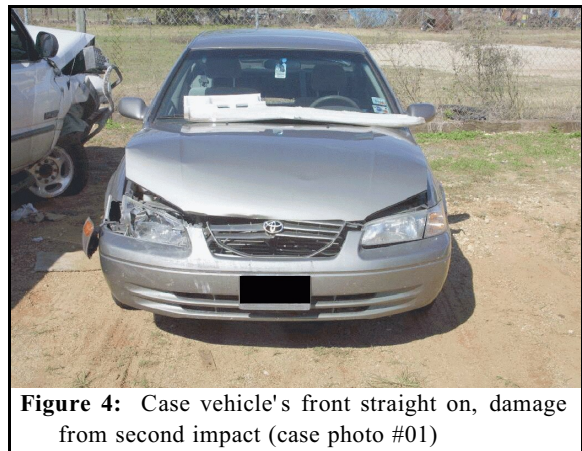
Figure 4: Case vehicle's front straight on, damage from second impact (case photo #01)

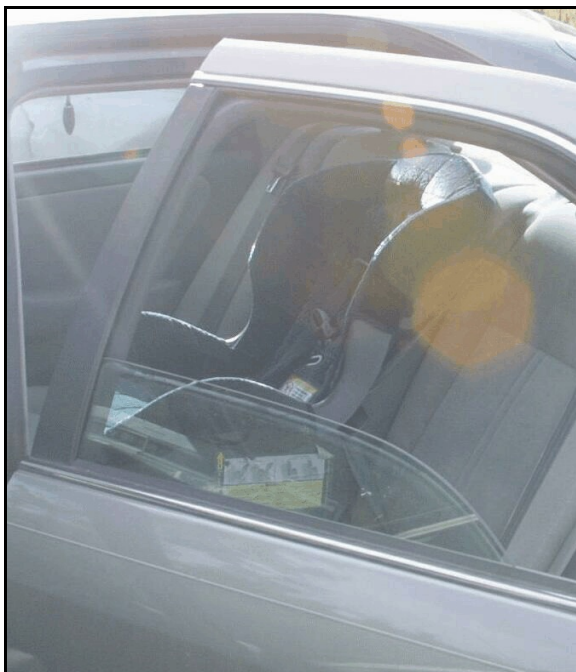
The back row center occupant was seated in an Evenflo Titan 5 convertible child safety seat (CSS), model #3672098P1, manufacture date September 25, 2002 (**Figures 5 and 6**). The CSS was configured in the forward-facing, upright mode, and was secured by the vehicle's available, manual, three-point, lap-and-shoulder safety belt system, with the webbing routed through the studs on the back of the CSS. The interviewee (driver; child's mother) stated that the switchable retractor was in automatic locking mode with the belt pulled tight such that the CSS could not move either forward-rearward or side-to-side. The interviewee further stated that the entire family had been to a child restraint checkpoint and the technicians confirmed that the CSS was correctly installed. The CSS was manufactured after the date when the Lower Anchors and Tethers for Children (LATCH) system components are expected to be present, but the interviewee stated that there was no tether strap. The case vehicle did not have LATCH system features.

Figure 5: Child safety seat, viewed through back left window (case photo #06)

The CSS had a five-point harness with a retainer clip. The interviewee did not know where the retainer clip was situated with respect to the child's body. The harness straps were routed through the top slots. The seat portion of the CSS assembly was a one-piece rigid plastic shell, lined with padded upholstery. The child was seated in an upright posture and the interviewee stated that the harness straps held the child snugly. During the crash, the CSS stayed in position and the child was restrained by the harness. The interviewee stated there was no evidence that the CSS had been damaged in the crash.

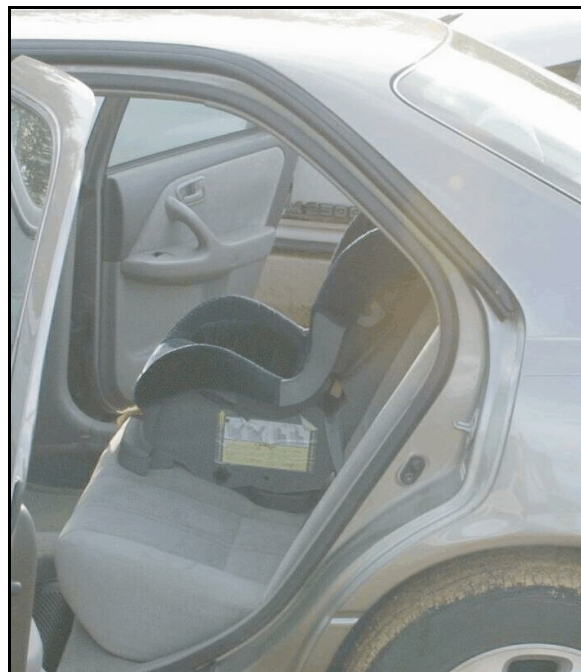
Figure 6: Child safety seat, viewed through back left door opening (case photo #05)

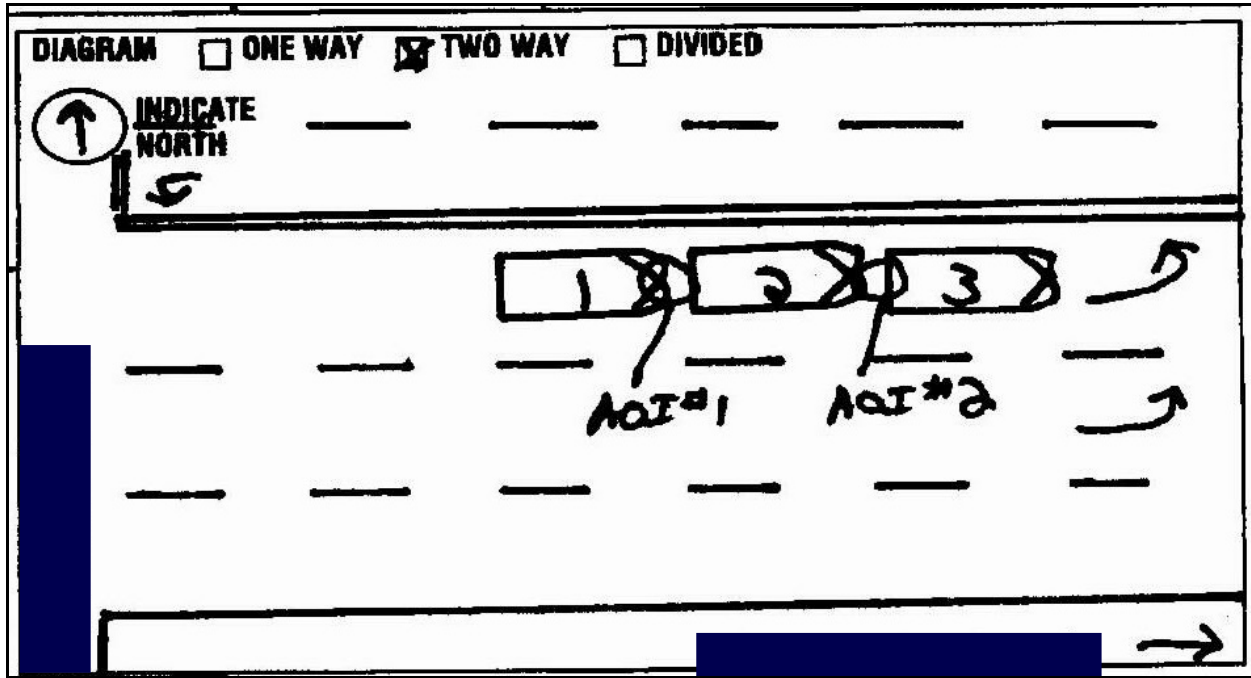
Copied from police crash report.

Vehicle #2 in this diagram is the case vehicle (1999 Toyota Camry)

Vehicle #1 is the first other vehicle (2001 Ford F150)

Vehicle #3 is the second other vehicle (2001 Chrysler Sebring)
