## ON-SITE CERTIFIED ADVANCED 208- COMPLIANT VEHICLE INVESTIGATION

CASE NUMBER - IN-04-040

VEHICLE - 2004 GMC K1500 SIERRA, EXTENDED CAB

CRASH DATE - October 2004

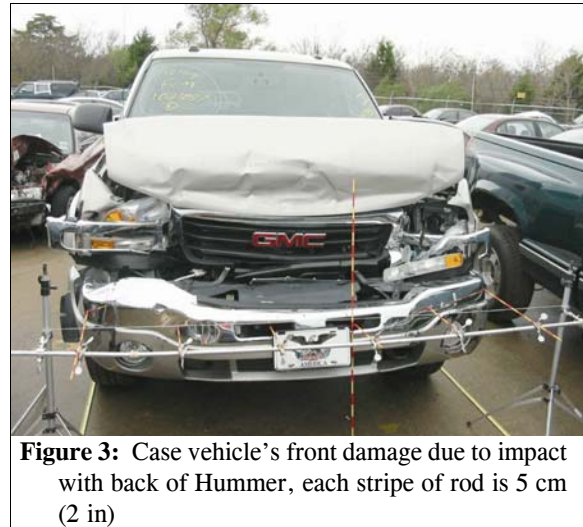
**Crash:** The front of the case vehicle (**Figure 3** below) impacted and underrode the back of the Hummer causing the case vehicle driver's air bag to deploy. The downloaded EDR data indicated only the first stage of the dual-stage air bag activated. The case vehicle was equipped with a front right passenger air bag suppression switch that was set to the "Auto" position. This air bag properly did not deploy during the crash sequence because there was no passenger seated in the front right seat.

**Figure 3:** Case vehicle's front damage due to impact with back of Hummer, each stripe of rod is 5 cm (2 in)

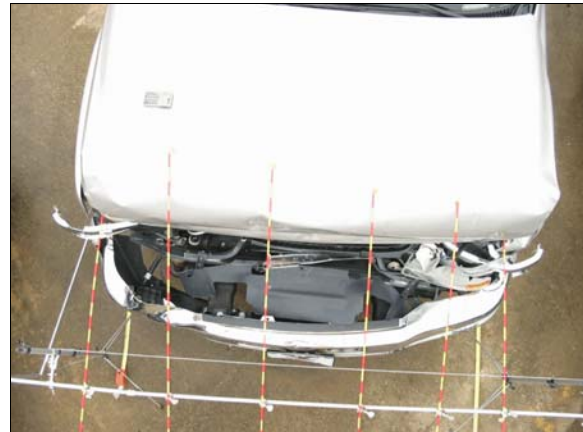
**Exterior Damage:** The case vehicle’s contact with the Hummer involved the full width of the frontal plane. The case vehicle’s grille, radiator, hood, both headlamp/turn lamp assemblies, and the front of both fenders were directly damaged and crushed rearward (**Figure 4**). There was no residual crush at the bumper level because the front bumper underrode the back of the Hummer, and the bumper was displaced slightly forward from it’s normal position, probably due to snagging as the two vehicle’s separated. The residual maximum crush above the bumper (measured at the radiator support) was measured as 29 centimeters (11.4 inches) occurring at both C<sub>5</sub> and C<sub>6</sub> (**Figure 4**). The table below shows the case vehicle’s crush profile after averaging the bumper and above bumper crush values.

**Figure 4:** Crush measured at radiator support via projection of ends of measurement rods

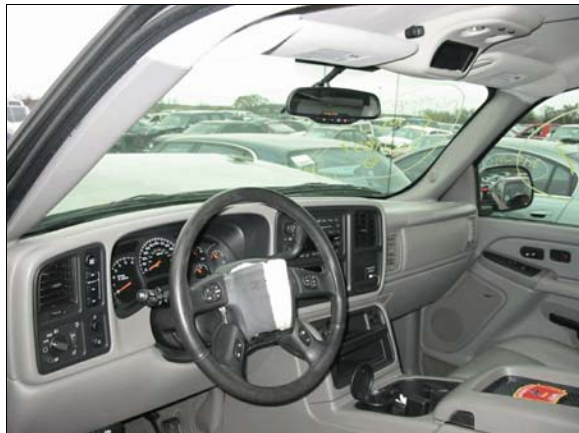
**Vehicle Interior:** Inspection of the case vehicle's interior (**Figure 5**) revealed a probable driver contact scuff on the air bag and a load mark on the driver's shoulder belt. There was no intrusion of the occupant compartment. In addition, there was no evidence of compression of the energy absorbing steering column or deformation of the steering wheel rim (**Figure 6** below).

**Figure 5:** Overview of steering wheel, windshield and instrument panel

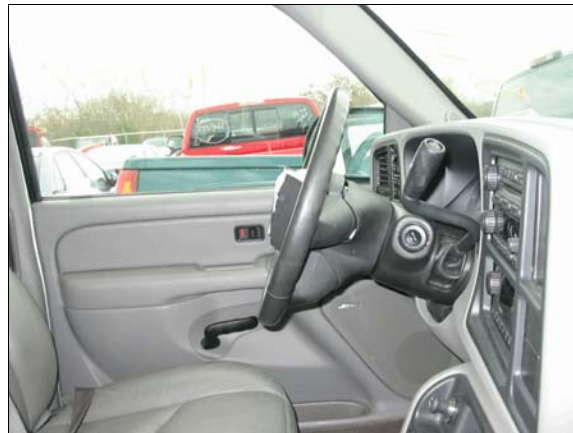
**Figure 6:** Steering wheel and steering column were not deformed

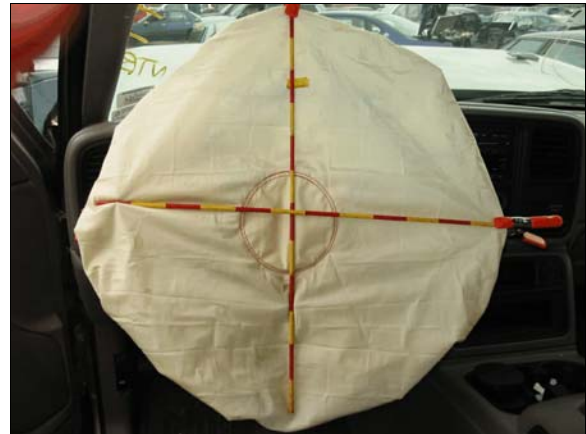
The case vehicle's driver air bag was located in the steering wheel hub. An inspection of the air bag module cover flaps and the air bag fabric revealed that the cover flaps opened at the designated tear points. There was no evidence of damage during the deployment to the air bag or the cover flaps. The air bag module cover consisted of "I" configuration cover flaps made of pliable vinyl. Each flap was approximately 7.3 centimeters (2.9 inches) in width at the top, 5 centimeters (2 inches) in width at the bottom and 11.5 centimeters (4.5 inches) in height at the center tear seam. The driver's air bag was designed with two tethers, each approximately 10 centimeters (3.9 inches) in width. The deployed driver's air bag (**Figure 7** below) was round with

a diameter of approximately 65 centimeters (25.6 inches) and had two vent ports (Figure 8), approximately 3 centimeters (1.2 inches) in diameter, located at the 11 and 1 o'clock positions. The distance between the mid-center of the driver's seat back, as positioned at the time of the vehicle inspection, and the front surface of the air bag at full excursions was 45 centimeters. An inspection of the driver's air bag fabric revealed a probable occupant contact scuff at 12 o'clock approximately 21 centimeters (8.3 inches) above the center of the air bag.

**Figure 7:** Case vehicle's driver air bag, yellow tape shows probable occupant scuff

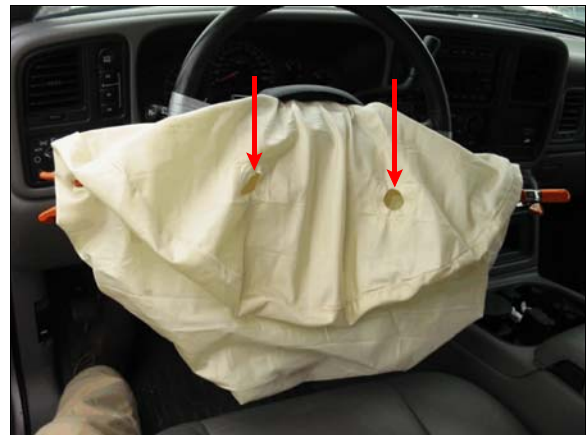
**Figure 8:** Back of driver's air bag, arrows show air bag vent ports

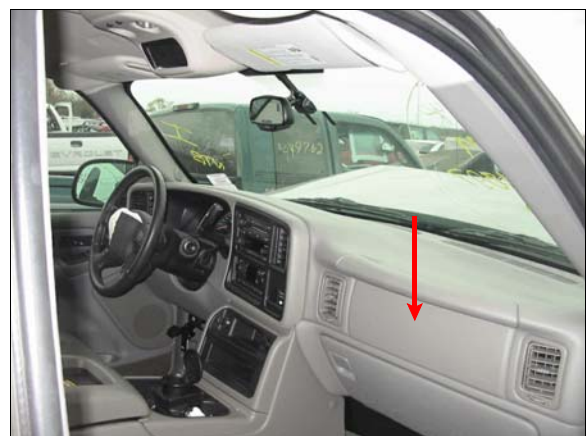
The front right passenger's air bag was located in the middle of the instrument panel (Figure 9). This air bag properly did not deploy because there was no passenger seated in the front right seat. The case vehicle's advanced occupant restraint system properly determined the absence of a front right passenger and suppressed the deployment of the front right air bag. The air bag was also equipped with a suppression switch, which was set to the "Auto" position.

**Figure 9:** Arrow shows location of front right air bag

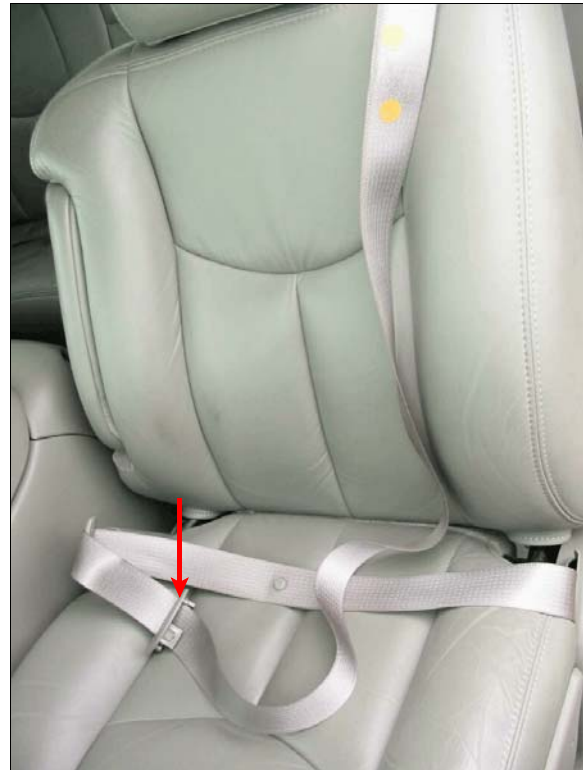
**Figure 10:** Overview of driver's seat and safety belt, orange dots show location of load mark on driver's shoulder belt, arrow shows displaced shoulder belt guide

of loading (**Figures 10 and 11** above). The plastic shoulder belt guide to the integral housing was displaced from the seat back and there was a light load mark on the shoulder belt.

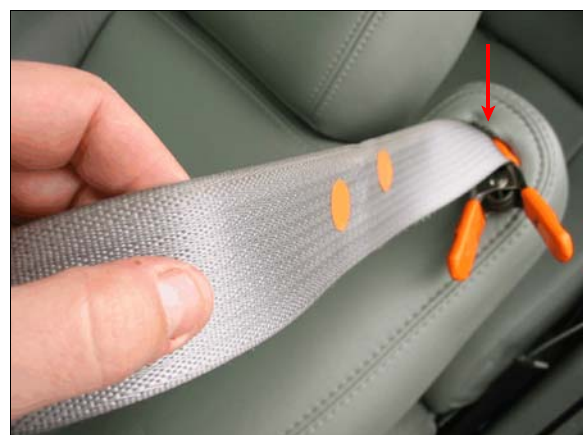
**Figure 11:** Close view of load mark on driver's shoulder belt, arrow shows installed location of displaced shoulder belt guide

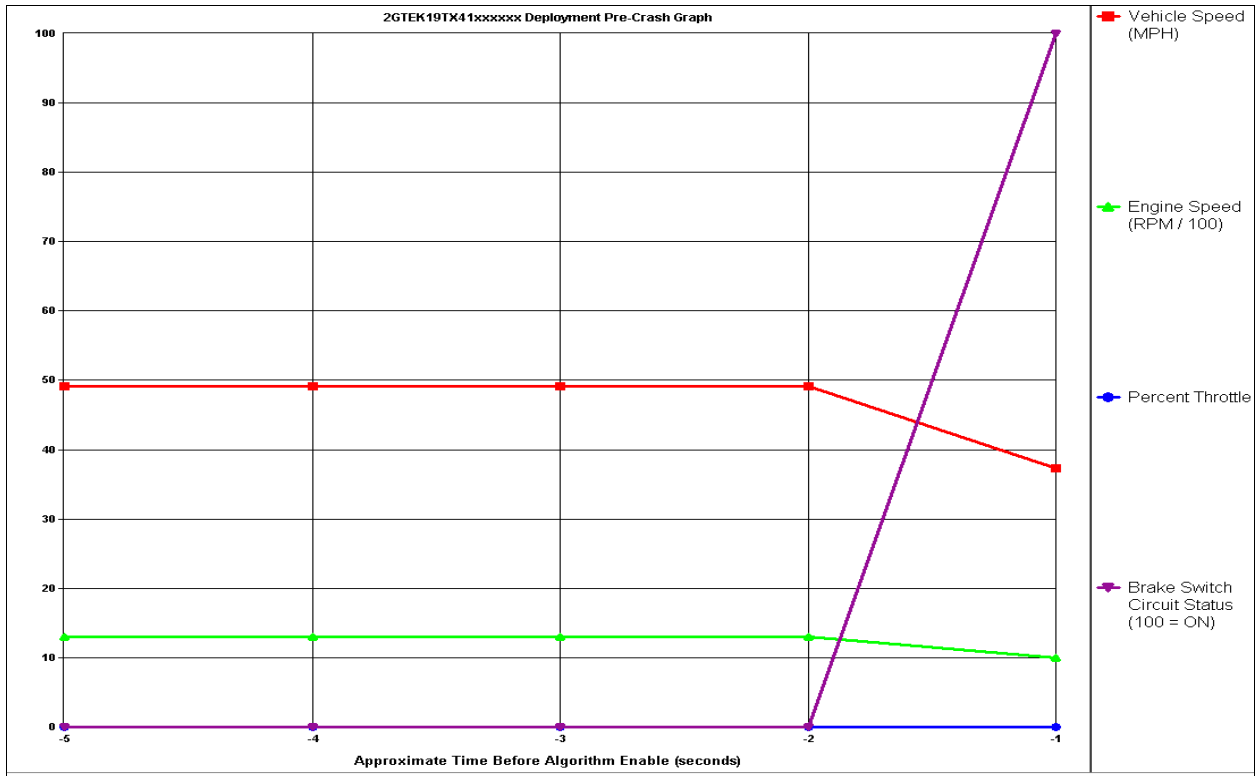
Figure 13: Case vehicle's Deployment Pre-Crash Graph

The pre-crash data indicate that the case vehicle was traveling 79 km.p.h. (49 mph) at 0% throttle five seconds prior to AE. The throttle remained at 0% for the remaining four sample periods. At one second prior to AE the case vehicle's brake switch is recorded as on and the speed is recorded as 60 km.p.h. (37 m.p.h) indicating the driver applied the brakes just prior to the impact.

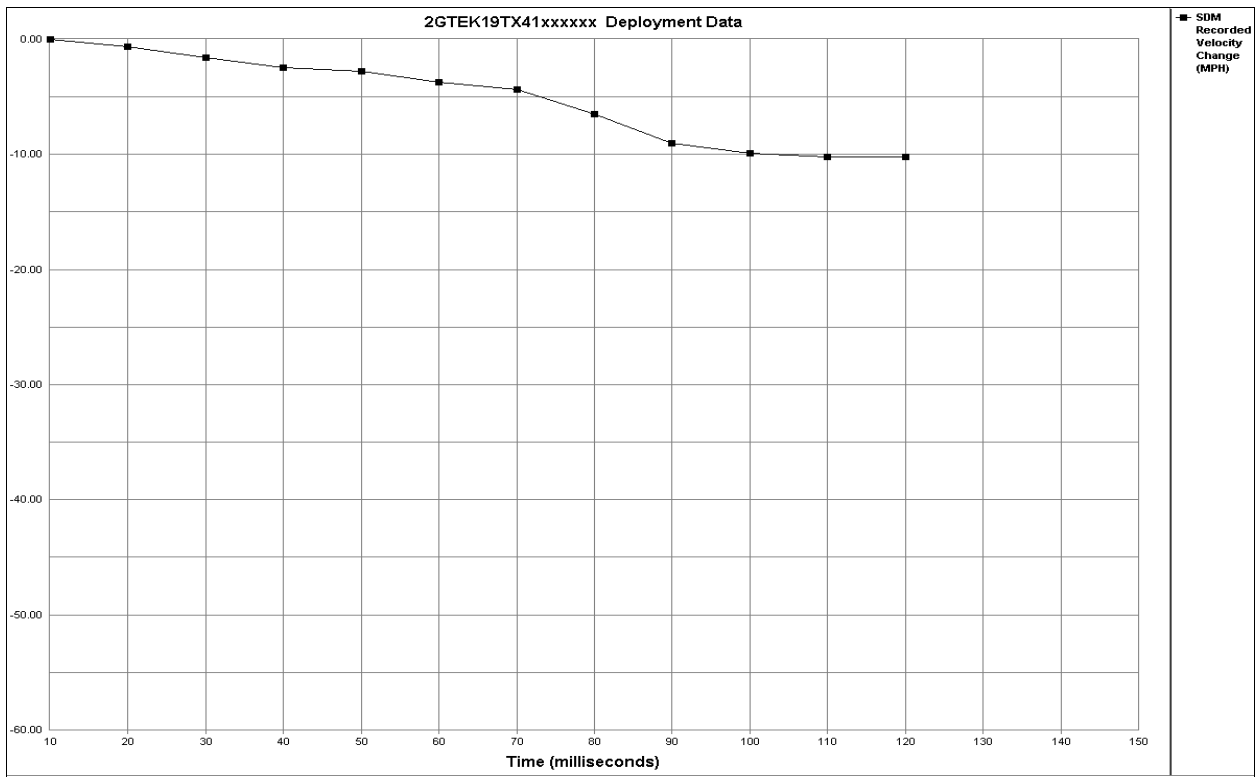
Figure 14: Case vehicle's deployment SDM Recorded Velocity Change graph

The EDR system status reports show that the SIR warning lamp was recorded as off, and the driver's seat belt switch circuit was recorded as buckled. In addition, the maximum SDM recorded velocity change was recorded as -16.94 km.p.h. (-10.53 m.p.h.) for the deployment event occurring 115 milliseconds after algorithm enable (AE), and -1.94 km.p.h. (-3.12 m.p.h.) for the non-deployment event occurring 60 milliseconds after AE. The system status report for the deployment event shows that the first stage deployment criteria for the driver's air bag was met 27.5 milliseconds after AE, and the second stage deployment criteria for the driver's air bag was not met.
