## ON-SITE CERTIFIED ADVANCED 208- COMPLIANT VEHICLE INVESTIGATION

CASE NUMBER - IN-04-041  
LOCATION - TEXAS  
VEHICLE - 2005 Ford F-150  
CRASH DATE - October 2004

September 29, 2005  
Revised August 31, 2007

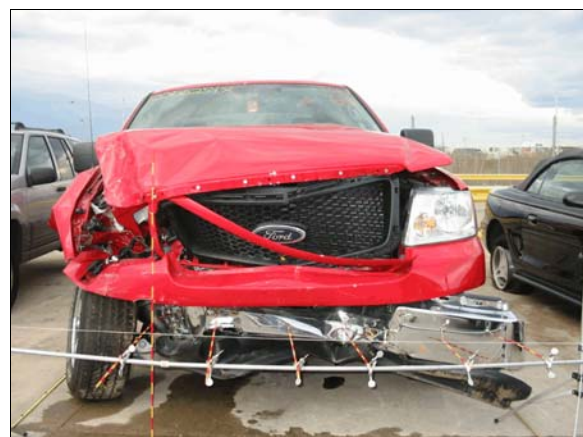
**Figure 4:** Frontal damage to case vehicle

**Crash:** The front right of the case vehicle (**Figure 4** above) impacted the left front of the Oldsmobile, causing the case vehicle's driver air bag to deploy. Due to the impact, the case vehicle rotated counterclockwise, the Oldsmobile rotated clockwise, and the left rear corner of the Oldsmobile impacted the case vehicle's right rear door (**Figure 5**). The case vehicle continued through the intersection, departed the southeast corner of the intersection, and the front right corner impacted a steel traffic signal pole (**Figure 6**) located about 1.3 meters (4.3 feet) off the roadway.

The impact with the metal traffic signal pole produced overlapping damage to the sheet metal at the front right corner of the case vehicle (**Figure 4** above), and the right front tire impacted the base of the pole. However, due to the leftward movement of the front bumper from the initial impact with the Oldsmobile and the aged appearance of the dent in the base of the metal traffic signal pole (**Figure 6** above), it appeared that the overlapping damage from the pole impact did not involve the case vehicle's front bumper. Therefore, since the front bumper crush was not contaminated by the subsequent impact with the traffic signal pole, the WinSMASH reconstruction program, missing vehicle algorithm was used to reconstruct the case vehicle's Delta V for the front impact with the Oldsmobile. The Total, Longitudinal, and Lateral Delta Vs are, respectively: 19 km.p.h. (11.8 m.p.h.), -17.9 km.p.h. (-11.1 m.p.h.), and -6.5 km.p.h. (-4.0 m.p.h.). The WinSMASH reconstruction program, missing vehicle algorithm, was also used for the case vehicle's right rear door impact with the Oldsmobile. The Total, Longitudinal, and Lateral Delta Vs for this impact are, respectively: 2.0 km.p.h. (1.2 m.p.h.), 0.0 km.p.h. (0.0 m.p.h.), and -2.0 km.p.h. (-1.2 m.p.h.). The collision fit the reconstruction module and the results appeared reasonable for the front impact, but appeared low for the right rear door impact. The case vehicle was towed due to damage.

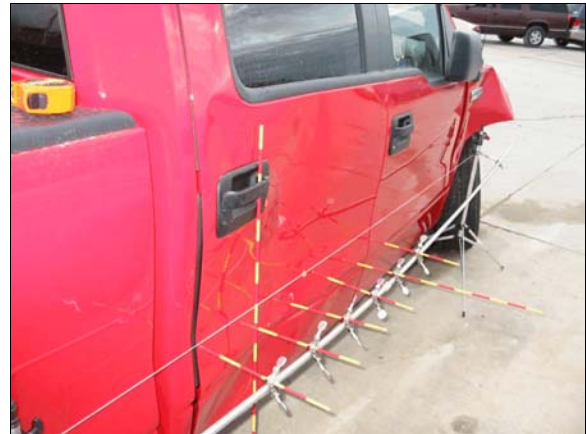
**Figure 5:** Side-slap damage to case vehicle's right rear door.

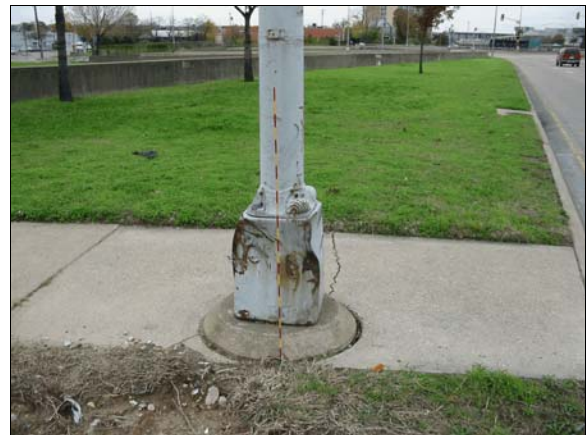
**Figure 6:** Traffic signal pole impacted by case vehicle, dent in base of pole is old damage

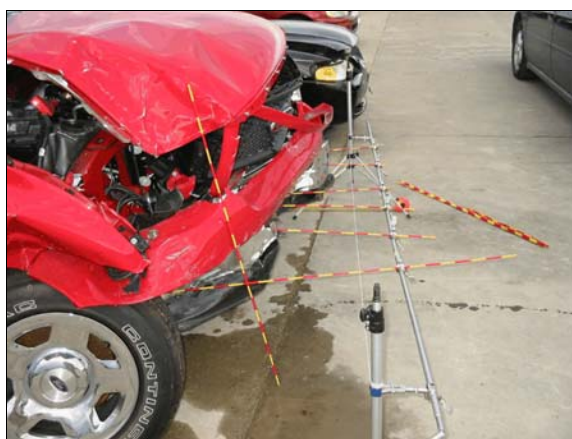
**Exterior Damage:** The case vehicle's initial contact with the Oldsmobile involved the front plane of the vehicle. Direct damage began at the right front bumper corner and extended 126 centimeters (49.6 inches), along the front bumper. Residual maximum crush was measured as 27 centimeters (10.6 inches) occurring at C<sub>6</sub> (**Figure 8**). The case vehicle's front bumper, bumper fascia, grille, radiator, right fender, right turn signal and headlamp assemblies and hood were directly damaged and crushed rearward (**Figure 9**). The case vehicle's side-slap with the Oldsmobile involved the right rear door. Direct damage began 113 centimeters (44.5 inches) forward of the right rear axle and extended forward 26 centimeters (10.2 inches) along the mid-door. Residual maximum crush was measured as 4 centimeters (1.6 inches) occurring at C<sub>4</sub>. The traffic signal pole impact involved the right fender, hood and right front tire. The table below shows the crush measurements for the front impact and the right side impact.

**Figure 8:** Crush to case vehicle's front bumper due to impact with the Oldsmobile, each stripe on rods in 5 cm (2 in)

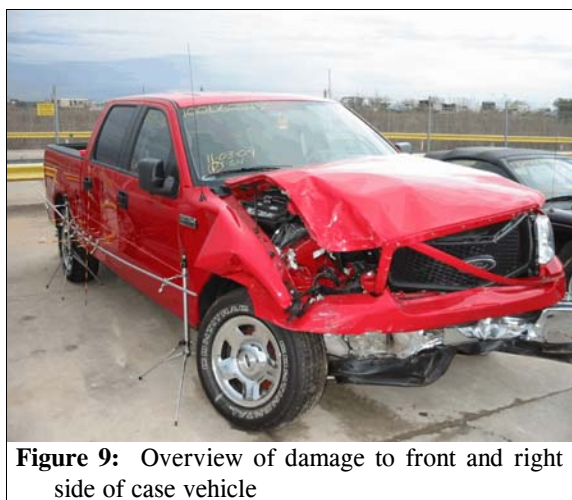
**Figure 9:** Overview of damage to front and right side of case vehicle

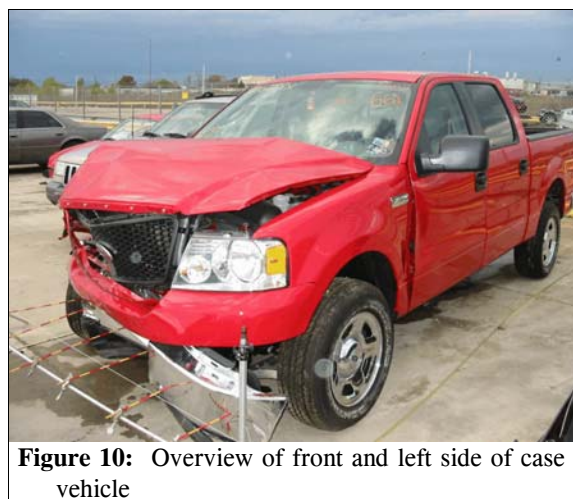
The wheelbase on the case vehicle’s left side was shortened 1 centimeter (0.4 inches) while the right side wheel base was extended 10 centimeters (4 inches). There was induced damage to the hood and left fender (**Figure 10**), but no other obvious induced damage or remote buckling from the front impact was noted. Induced damage from the side-slap impact was limited to the right rear door.

**Figure 10:** Overview of front and left side of case vehicle

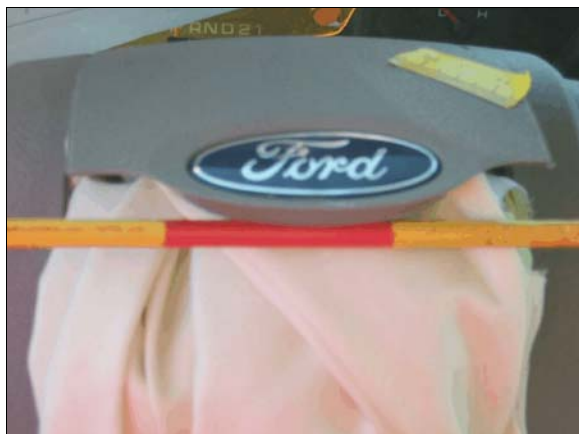
**Interior Damage:** Inspection of the case vehicle’s interior revealed a diagonal scuff approximately 4 centimeters (1.6 inches) long on the top, right side of the driver’s air bag flap. The driver stated

that she sustained an abrasion and a bruise to the underside of her right forearm. The air bag flap was most likely the source of these injuries (**Figure 11**). There also appeared to be some scuffs on the lower steering wheel rim. In addition, there was no intrusion of the occupant compartment or damage to the steering wheel, and there appeared to be no compression of the energy absorbing steering column (**Figure 12**).

**Figure 11:** Tape shows scuff on upper air bag module cover flap

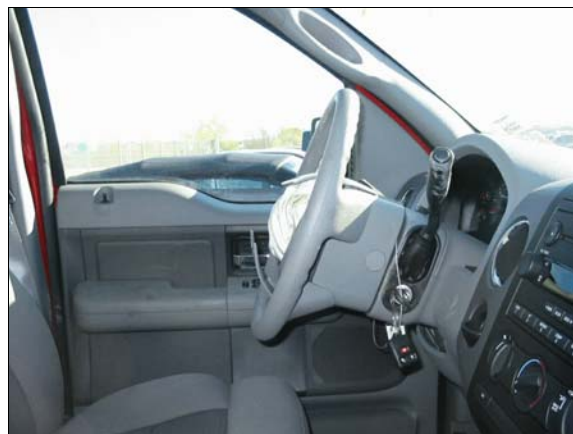
**Figure 12:** Case vehicle's steering column and steering wheel showing lack of damage

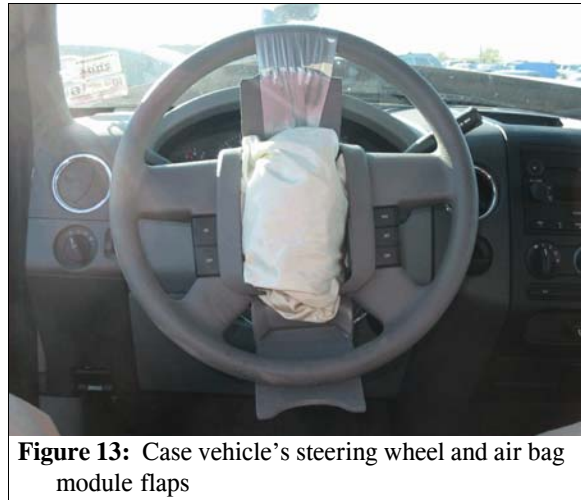
The case vehicle's driver air bag was located in the steering wheel hub. An inspection of the air bag module's cover flaps and the air bag's fabric revealed that the cover flaps opened at the designated tear points (**Figure 13**), and there was no evidence of damage during the deployment to the air bag or the cover flaps. The module cover consisted of symmetrical "H" configuration cover flaps constructed of thick vinyl. There was a rounded contour in the center of each cover flap at the tear seam to accommodate the Ford emblem. The top module cover flap was 11 centimeters wide (4.3 inches) and 8 centimeters (3.1 inches) high. The bottom module flap was 11 centimeters (4.3 inches) wide and 11.5 centimeters (4.5 inches) high. The deployed driver's air bag (**Figure 14** below) was round with a diameter of approximately 59 centimeters (23 inches), and was designed with two tethers, each approximately 14 centimeters (5.5 inches) in width. The driver's air bag had two vent ports (**Figure 15**), each approximately 2.5 centimeters (1 inch) in diameter, located at the 11 and 1 o'clock positions. The distance between the mid-center of the driver's seat back, as positioned at the time of the vehicle inspection, and the front surface of the air bag at full excursion was 29 centimeters (11.4 inches). An inspection of the driver's air bag fabric revealed no evidence of occupant contact. The front right passenger's air bag was located in the middle of the right instrument panel. This air bag did not deploy because there was no occupant seated in the front right seat.

**Figure 13:** Case vehicle's steering wheel and air bag module flaps
