ON-SITE REDESIGNED AIR BAG INVESTIGATION

CASE NUMBER - IN-04-042

VEHICLE - 2004 MAZDA 6

CRASH DATE - October 2004

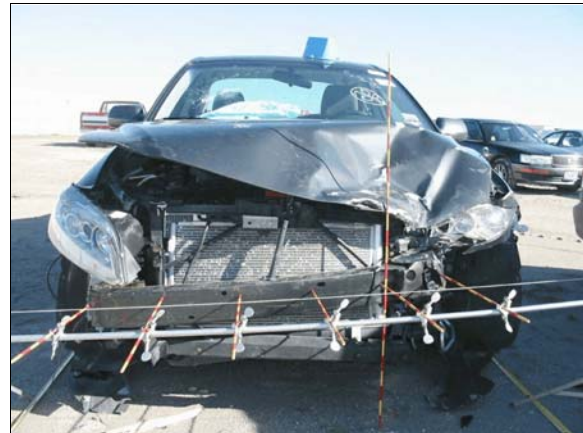
Figure 3: Damage to front of case vehicle due to impact with Ford and Toyota

Exterior Damage: The case vehicle’s initial contact with the Ford involved the front plane as did the second impact with the Toyota. The front bumper, bumper fascia, grille, hood, left fender, and both headlamp/ turn lamp assemblies were directly damaged and crushed rearward. The bumper fascia was removed from the case vehicle and was not present at the inspection, so the specific length of the direct damage for each impact could not be determined. One set of measurements was taken to determine the totality of the crush to the front end. Based on the direct damage above the bumper level, it appeared that the two impacts directly damaged approximately the full width of the case vehicle’s front bumper, which was 166 centimeters (65.4 inches). The crush measurements were taken along the metal bumper bar, and the residual maximum crush (Figure 7) was measured as 18 centimeters (7.1 inches) occurring at C₂. The table below shows the case vehicle’s crush profile.

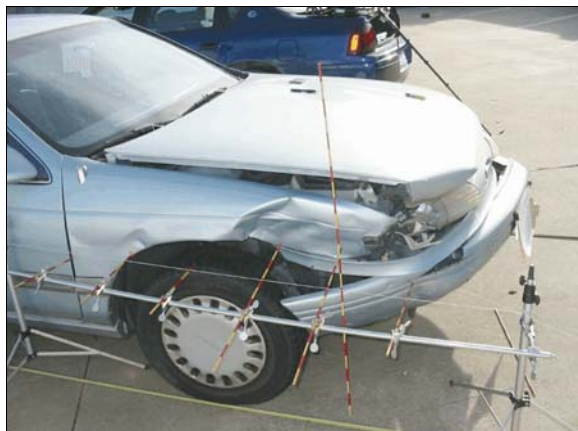
Figure 4: Damage to right fender of Ford Taurus due to impact with case vehicle, each stripe on rods is 5 cm (2 in)

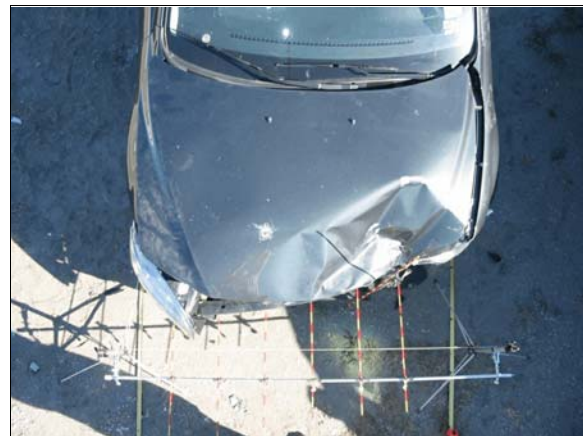
Figure 7: Overhead view of case vehicle’s front crush, each stripe on rods is 5 cm (2 in)

Damage Classification: Based on the vehicle inspection, the CDCs for the case vehicle were determined to be: **11-FYEW-1 (340 degrees)** for the initial impact with the Ford and **12-FRE?-1 (0 degrees)** for the impact with the Toyota. Due to the missing bumper fascia, the length of the direct damage from the impact with the Toyota could not be determined and character six of the CDC is unknown.

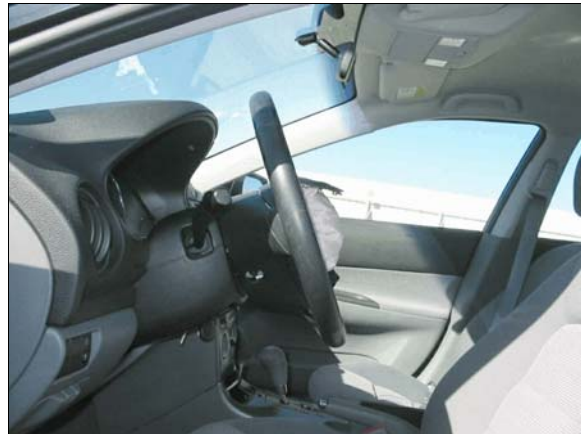
Vehicle Interior: Inspection of the case vehicle’s interior (**Figures 8 and 9**) revealed no evidence of occupant contact. There were also no occupant compartment intrusions, no compression of the energy absorbing steering column and no deformation of the steering wheel (**Figure 10** below).

Figure 10: Case vehicle's steering column and steering wheel showing lack deformation

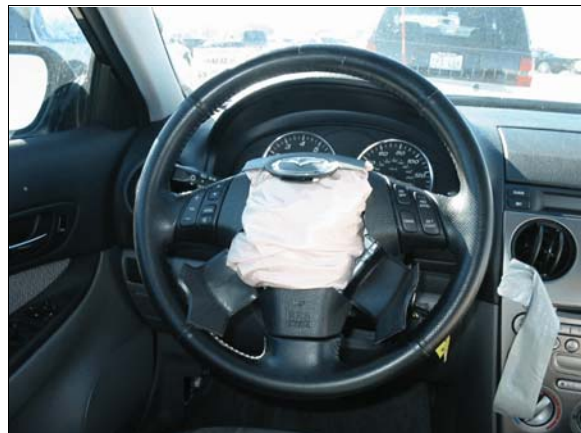
The case vehicle's driver air bag was located in the steering wheel hub. An inspection of the air bag module's cover flaps and the air bag's fabric revealed that the cover flaps opened at the designated tear points (**Figure 11**). There was no evidence of damage during the deployment to the air bag or the cover flaps. The module cover consisted of three flaps made of pliable vinyl. The top flap was 17 centimeters in width and had a rounded contour in the center of the flap to accommodate the Mazda emblem. The height of the top flap, measured at the center of the flap, was 7 centimeters (2.8 inches). Each of the two bottom flaps were irregularly shaped. Each flap was constructed with a concave contour in the center that mated to the top flap's Mazda emblem. The outer edge of each flap was 6 centimeters (2.4 inches) in length. The top of each flap was approximately 5.5 centimeters (2.2 inches) in length, the bottom was approximately 4.5 centimeters (1.8 inches) in length, and the distance across each concave contour was approximately 4 centimeters (1.6 inches). The deployed driver's air bag (**Figure 12** below) was round with a diameter of approximately 57 centimeters (22.4 inches), and was designed without any tethers. The driver's air bag had two vent ports (**Figure 13** below), each approximately 3 centimeters (1.2 inches) in diameter, located at the 11 and 1 o'clock positions. An inspection of the driver's air bag fabric revealed no evidence of occupant

Figure 11: Case vehicle's steering wheel and air bag module flaps

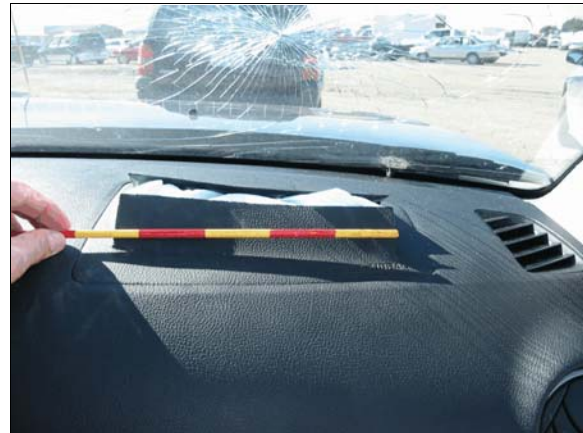
(2.4 inches) in diameter, located at the 9:30 and 2:30 o'clock positions. The distance between the face of the instrument panel and the first module flap was approximately 19 centimeters (7.5 inches). The distance between the mid-center of the front right passenger's seat back, as positioned at the time of the inspection (i.e., the rear most track position), and the front surface of the passenger air bag at full excursion was 44 centimeters (17.3 inches). An inspection of the front right passenger's air bag fabric revealed no evidence of occupant contact. The air bag contacted and cracked the windshield during deployment (**Figure 14**).

Figure 14: Front right passenger air bag module flaps and cracked windshield from air bag deployment

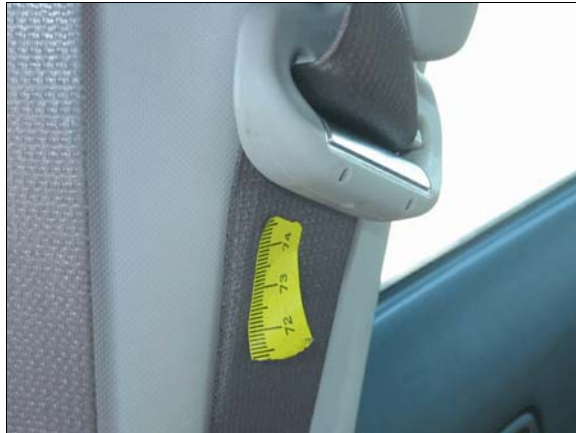
front right passenger's safety belt webbing, "D"-ring, and latch plate revealed load marks on the shoulder belt webbing (**Figure 16**). In addition, the front right passenger's safety belt was found spooled out of the retractor, and the retractor was jammed indicating the pretensioner had actuated (**Figure 17**).

Figure 16: Load abrasion on front right passenger's shoulder belt, indicated by yellow tape

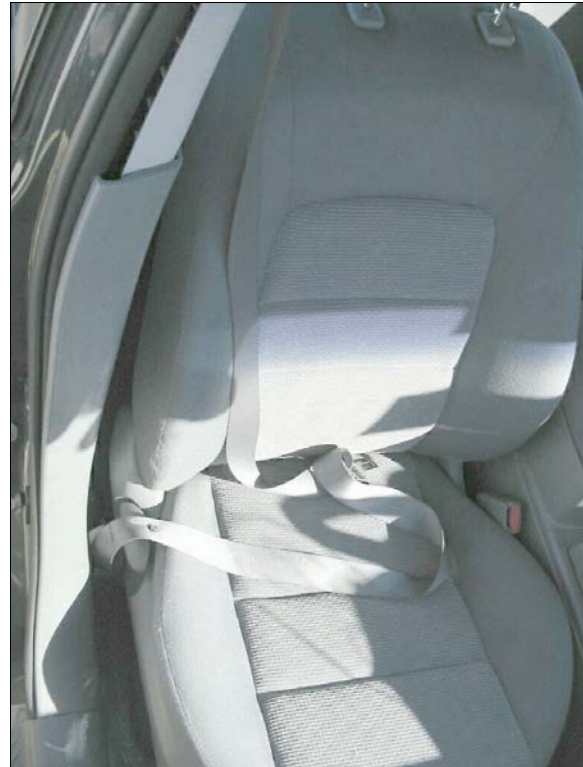
Figure 17: Front right passenger's safety belt, it would not spool out or retract

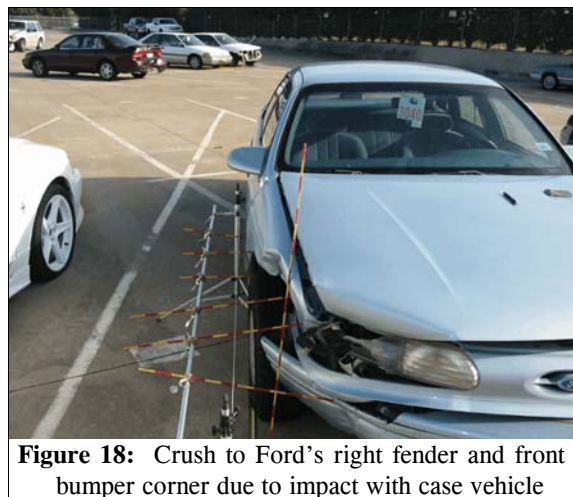
Figure 18: Crush to Ford’s right fender and front bumper corner due to impact with case vehicle

Exterior Damage: The Ford’s impact with the Mazda involved the right fender and right corner of the hood and front bumper. The right corner of the Ford’s front bumper and hood were directly damaged and crushed inward and rearward. The right fender was directly damaged and crushed inward. The direct damage began 244 centimeters (96 inches) forward of the right rear axle and extended 92 centimeters (36.2 inches) along the right fender and front bumper corner. The maximum crush to the Ford (**Figure 18**) was measured as 18 centimeters (7.1 inches) occurring at C₆. The Ford was towed due to damage. The table below shows the Ford’s crush profile.

Damage Classification: Based on the vehicle inspection, the CDC for the Ford was determined to be: **02-RFEW-3 (50 degrees)**.
