CALSPAN ON-SITE ROLLOVER CRASH INVESTIGATION

CALSPAN CASE NO.: CA04-049

VEHICLE: 2002 CADILLAC ESCALADE

CRASH DATE: OCTOBER 2004

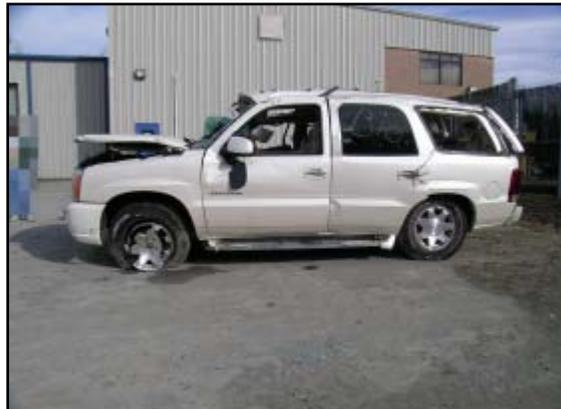
Figure 1. 2002 Cadillac Escalade subject vehicle.

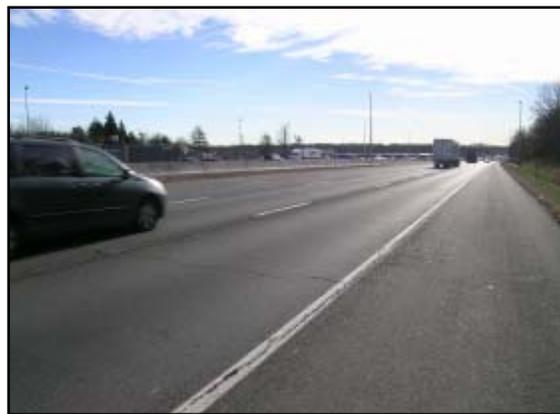
The 16-year-old female driver of the Cadillac was operating the vehicle southbound in the center lane (**Figure 2**) at a police reported speed of 105 km/h (65 mph). The vehicle was also occupied by six teenage females that were seated in the front right, second row, and third row (2/3/2). The driver attempted to change lanes from the center to the left lane. As the vehicle entered the left travel lane, the driver applied a sudden right steering input that resulted in a loss of directional control. The left side tires rolled under the alloy wheels exposing the rims to the asphalt road surface.

Figure 2. Southbound travel direction of the Cadillac.

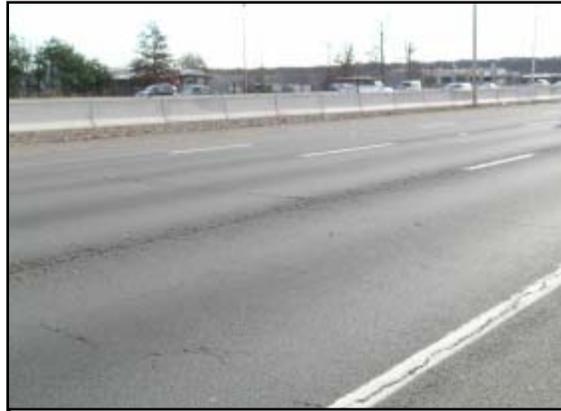
The left side alloy rims contacted the asphalt road surface resulting in a tripped left side leading rollover. The vehicle rolled four-quarter turns and came to rest on the center travel lane facing in a westerly direction (**Figure 3**). The total distance from the rollover initiation to final rest was approximately 13 meters (40 feet). Due to the passage of time and the heavily traveled interstate roadway, there was no physical evidence remaining at the crash site

Figure 3. Area of rollover and final rest.

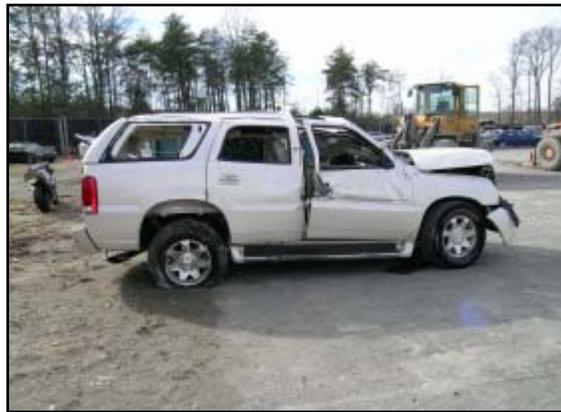
The Cadillac sustained moderate severity damage to all four planes as a result of the four quarter-turn rollover event. The area of greatest crush was located along the right roof side rail. The direct contact damage measured 244 cm (96") and extended from the right A-pillar to the right D-pillar. The maximum crush measured 13 cm (5.1") and was located at center of the right front door on the roof side rail. A crush profile was documented along the full length of the roof side rail (**Figure 4**). The six crush measurements were as follows: C1 = 5 cm (2"), C2 = 4 cm (1.6"), C3 = 7 cm (2.8"), C4 = 9 cm (3.5"), C5 = 10 cm (3.9"), C6 = 12 cm (4.7"). The Collision Deformation Classification for this event was 00-TDDO-3.

Figure 4. Overall view of the crush to the roof side rail.

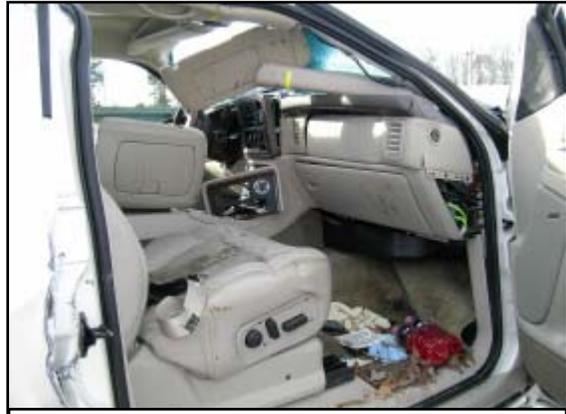
The interior of the Cadillac sustained severe damage as result of intrusion and occupant contact points. The driver’s area consisted of a contact point at the left A-pillar which was evidenced by body fluid and tissue. The right front passenger contact points consisted of hair, body fluid, and tissue that was located on the right A-pillar. Body fluid was noted on the top aspect of the right B-pillar and throughout the right front passenger space. Additionally, hair, tissue, and body fluid

Figure 5. Overall view of the front right area.

was found on the out side of the right front door. **Figure 5** is an overall view of the front right area.

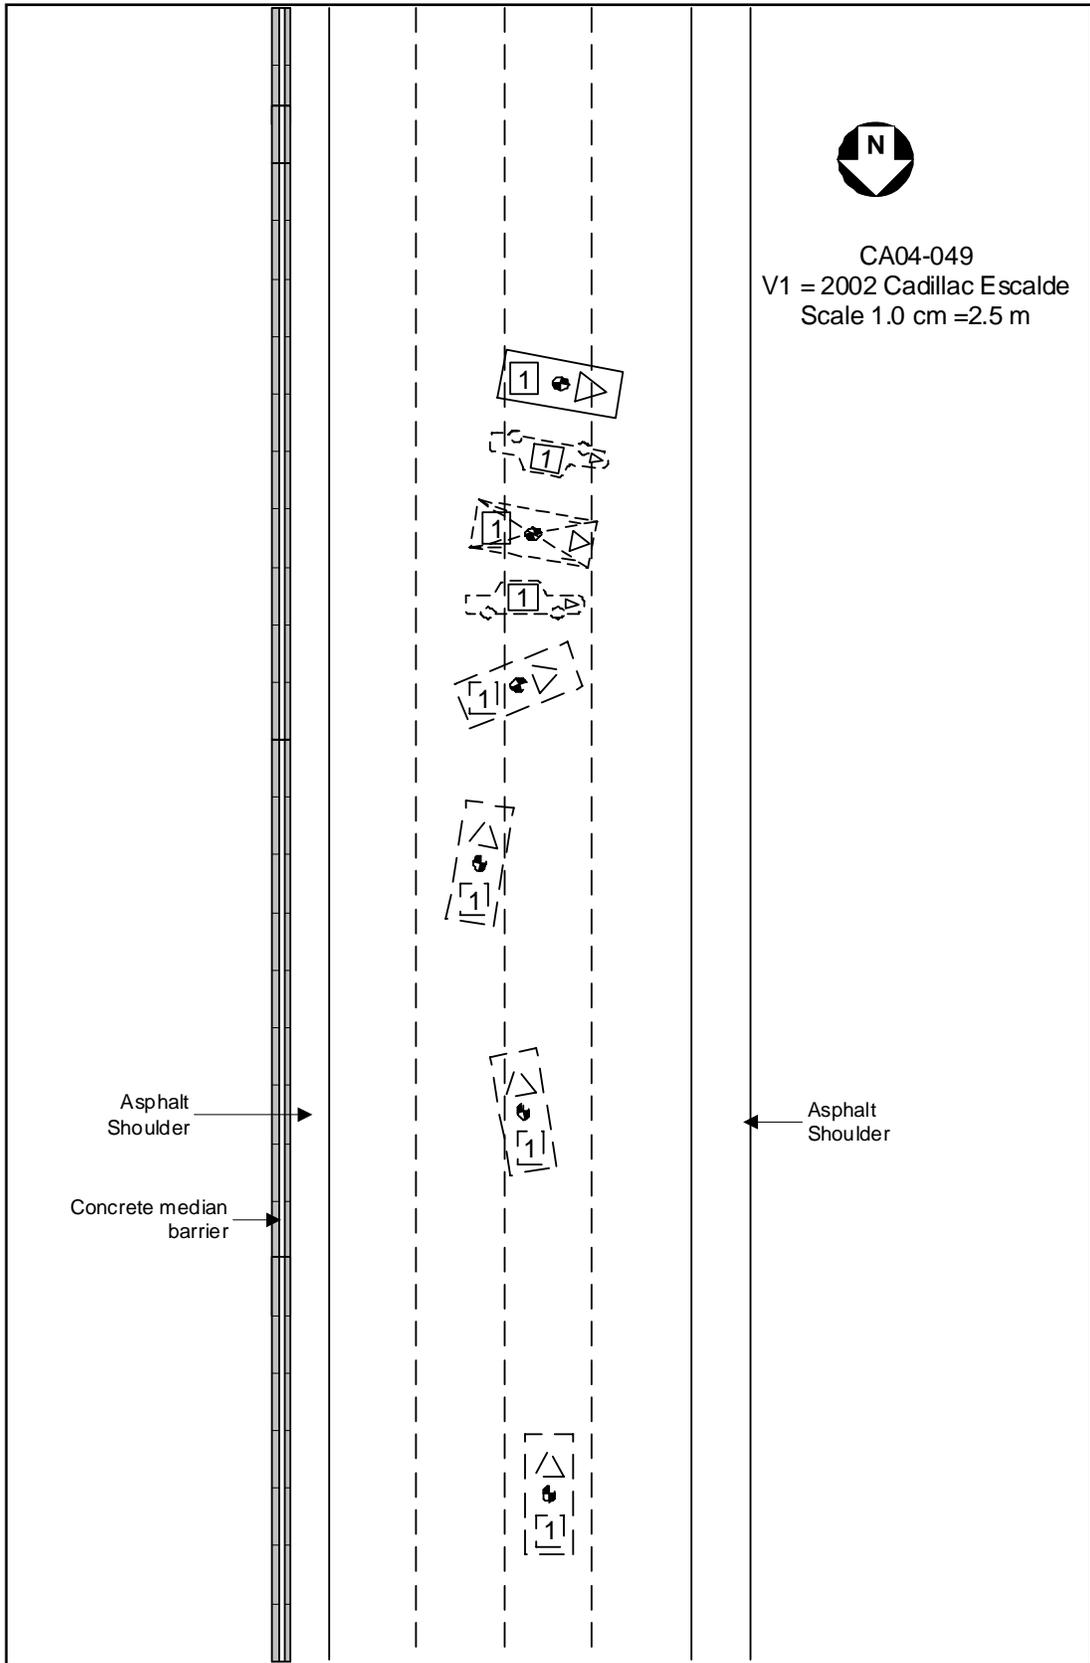
Figure 6: Scene Schematic

The crash occurred on the southbound lanes of a north/south interstate during daylight hours. The three southbound travel lanes were constructed of asphalt and were delineated by broken white lane lines. The travel lanes were bordered by asphalt shoulders on the east and west roadsides. A concrete median barrier wall divided the roadway. The posted speed limit was 89 km/h (55 mph). Due to the passage of time between the crash date and the investigation date, there was no remaining physical evidence at the crash site to support the vehicle's trajectory. The scene schematic is included as **Figure 6** of this report.
