ON-SITE ADULT AIR BAG RELATED SERIOUS INJURY INVESTIGATION

CALSPAN CASE NO: CA04-050

VEHICLE – 1996 CHEVROLET CAVALIER

CRASH DATE – NOVEMBER, 2004

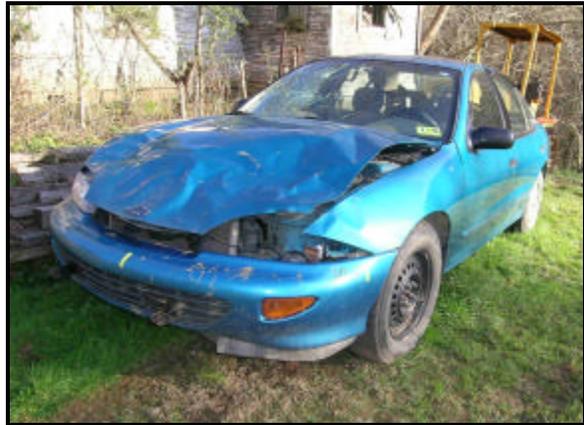
This investigation focused on the crash severity and injury mechanisms that resulted in a spinal cord injury at C5 of the 62 year old female driver in a 1996 Chevrolet Cavalier, **Figure 1**. The Cavalier was equipped with frontal air bags for the driver and front right passenger that deployed as a result of an impact with a deer. Although the driver initially denied injury at the crash site, the symptoms of her injury surfaced during her examination by the responding emergency medical technicians (EMT's). She was transported to a local hospital with an elevated blood pressure. In the emergency room, she reportedly complained of a burning sensation in her bilateral upper extremities and had some weakness. She also complained of neck pain. She was transferred to a regional trauma center and diagnosed with C5 spinal stenosis with spinal cord compression and central cord syndrome. A C4-C6 cervical fusion surgery was performed two days post-crash. The driver was hospitalized ten days and released with a prognosis of full recovery.

Figure 1: Front left view of the Cavalier.

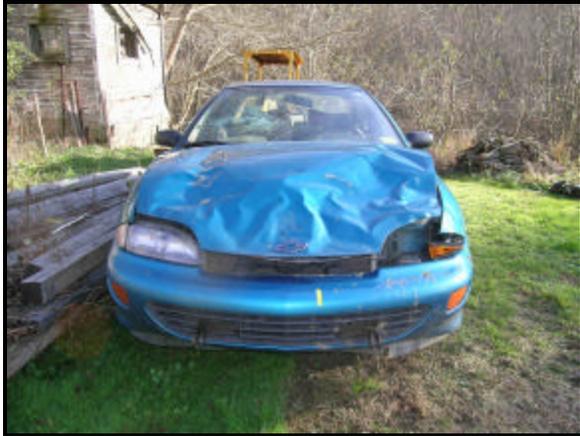
Figures 2 and 3 are the front and overhead views of the Chevrolet, respectively. The exterior damage to the Chevrolet as a result of the impact with the deer consisted of minor contact evidence to the left and central aspects of the front bumper and a wide region of deformation and buckling of the hood. The front fascia revealed evidence of the contact that began 13.2 cm (5.2 in) left of center and extended 55.4 cm (21.8 in) to the left corner of the front bumper. This contact pattern wrapped around the left corner and extended 33.0 cm (13.0 in) along the forward aspect of the left side plane. There was no measurable residual crush at the elevation of the long the front bumper reinforcement. The Collision Deformation Classification (CDC) was 12-FDEW-1

The surface of the hood was deformed and had buckled. The area of the deformation measured 71 cm x 135 cm (28 in x 53 in), length by width. The hood was displaced rearward and rightward. The left rear corner of the hood impacted the lower left aspect of the windshield resulting in a minor fracture. The left headlamp assembly fractured and separated. The left front fender shifted rearward 1.3 cm (0.5 in). All the doors remained closed during the impact and were operational post-crash. There was no damage to the side windows glazing. The wheelbase dimensions were unchanged.

Figure 3: Front view of the Chevrolet.

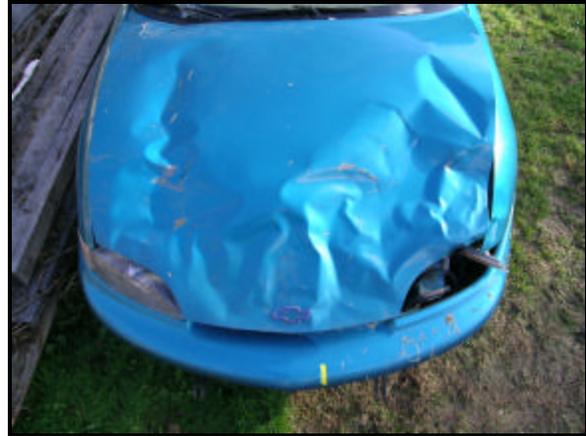
Figure 2: Overhead view.

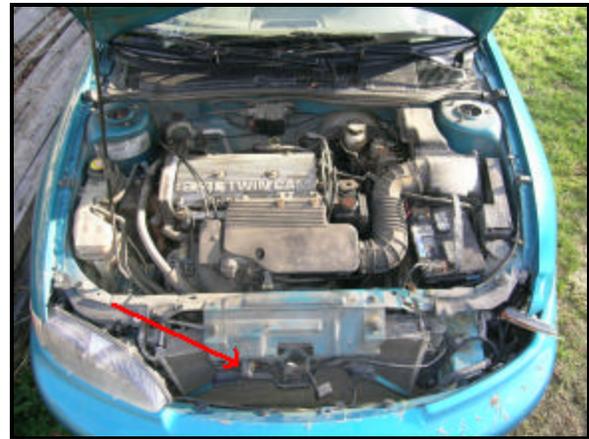
Examination of the engine compartment revealed that the vehicle did not sustain any mechanical damage. The engine was operational. **Figure 4** is an overhead view of the engine compartment. It was noted that the left aspect of the upper radiator support sustained minor rearward displacement that measured 1.9 cm (0.75 in). A formed sheet metal section was attached to the center aspect of the upper radiator support. The sheet metal section contained the hood latch receiver. A forward sensor for the air bag system was mounted to the metal section, as well. The location of the sensor is denoted by the arrow in Figure 4. During the impact, the metal section was displaced rearward into the radiator core, as the hood deformed downward and buckled. The location of the sensor adjacent to the area of the impact and the subsequent localized impact induced deceleration was the cause of the air bag deployment. Refer to the Air Bag Section of this report for further explanation.

Figure 4: Engine compartment view.

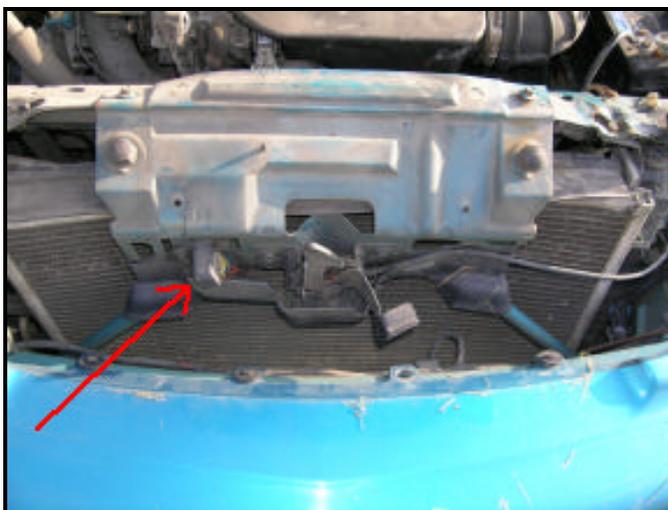
The 1996 Chevrolet Cavalier was equipped with an air bag system that consisted of driver and front right passenger modules. The system was monitored and controlled by the SDM located under the front right seat. A forward sensor located 15 cm (6 in) right of the center line and immediately forward of the radiator core assisted the SDM in the crash detection. **Figure 5** is a close-up view of the forward sensor location. Due to the deformation and buckling of the hood as a result of the crash, the sensor was directly contacted and displaced. The location of the sensor

Figure 5: Forward air bag sensor location.

and its direct involvement in the area of deformation resulted in a deceleration profile sufficient to cause the deployment of the air bags in this (otherwise) low severity impact.

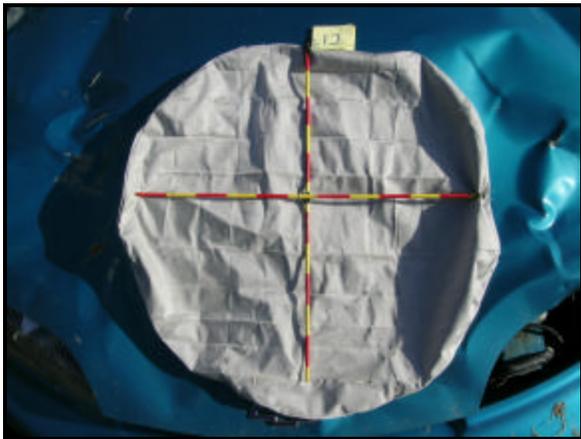
steering wheel. The I-configuration cover flaps were symmetrical and measured 10 cm x 10 cm (4 in x 4 in). **Figures 6 and 7** are views of the front and back of deployed driver air bag, respectively. The driver air bag measured 66 cm (26 in) in diameter in its deflated state. The bag was not tethered and was vented by two 2.5 cm (1.0 in) diameter ports in the 3/9 o'clock sector. Examination of the face of the bag was unremarkable for occupant contact evidence. Minor black vinyl deployment scuffs were identified in the 12 and 6 o'clock sectors.

Figure 6: Face of the driver air bag.

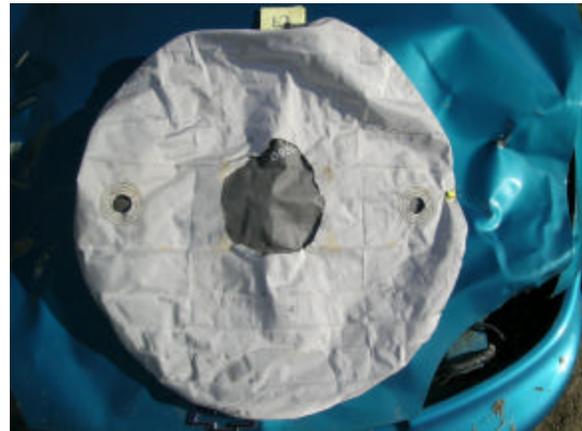
Figure 7: Back side of the driver air bag.

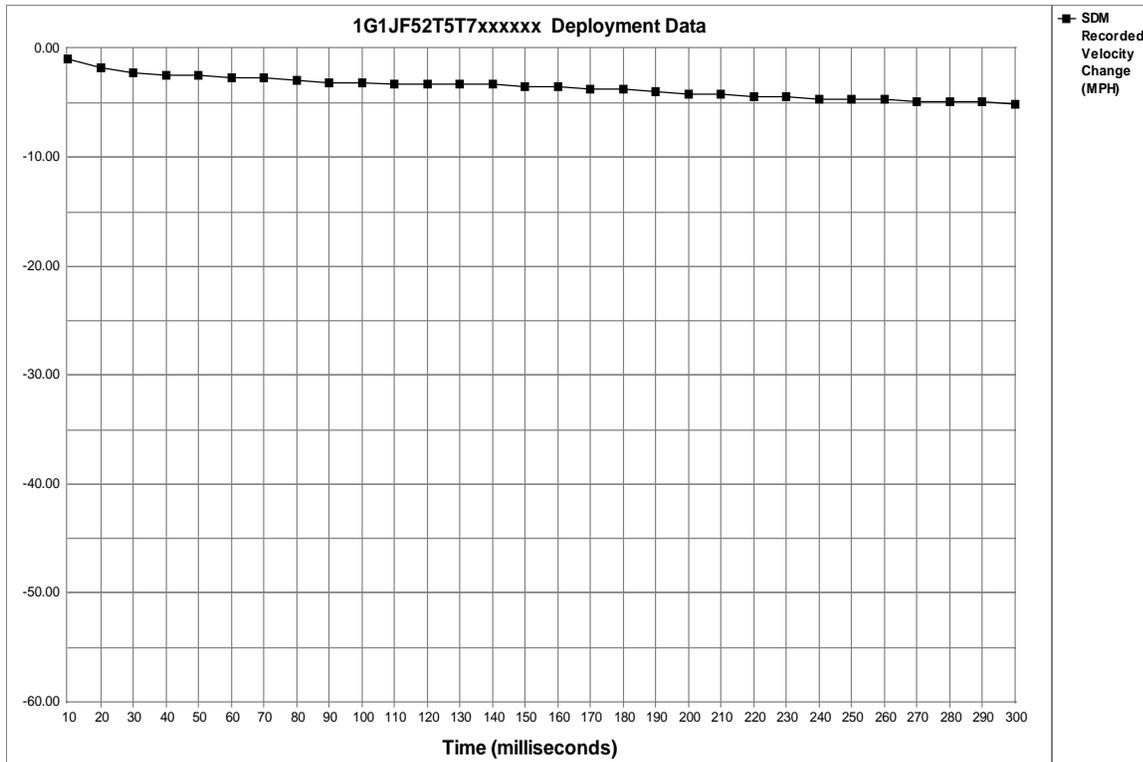
SIR Warning Lamp Status	OFF
Driver's Belt Switch Circuit Status	BUCKLED
Ignition Cycles At Deployment	20798
Ignition Cycles At Investigation	20818
Time From Algorithm Enable To Deployment Command (msec)	20
Time Between Non-Deployment And Deployment Events (sec)	N/A

Time (milliseconds)	10	20	30	40	50	60	70	80	90	100	110	120	130	140	150
Recorded Velocity Change (MPH)	-0.88	-1.76	-2.19	-2.41	-2.41	-2.63	-2.63	-2.85	-3.07	-3.07	-3.29	-3.29	-3.29	-3.29	-3.51
Time (milliseconds)	160	170	180	190	200	210	220	230	240	250	260	270	280	290	300
Recorded Velocity Change (MPH)	-3.51	-3.73	-3.73	-3.95	-4.17	-4.17	-4.39	-4.39	-4.61	-4.61	-4.61	-4.83	-4.83	-4.83	-5.05

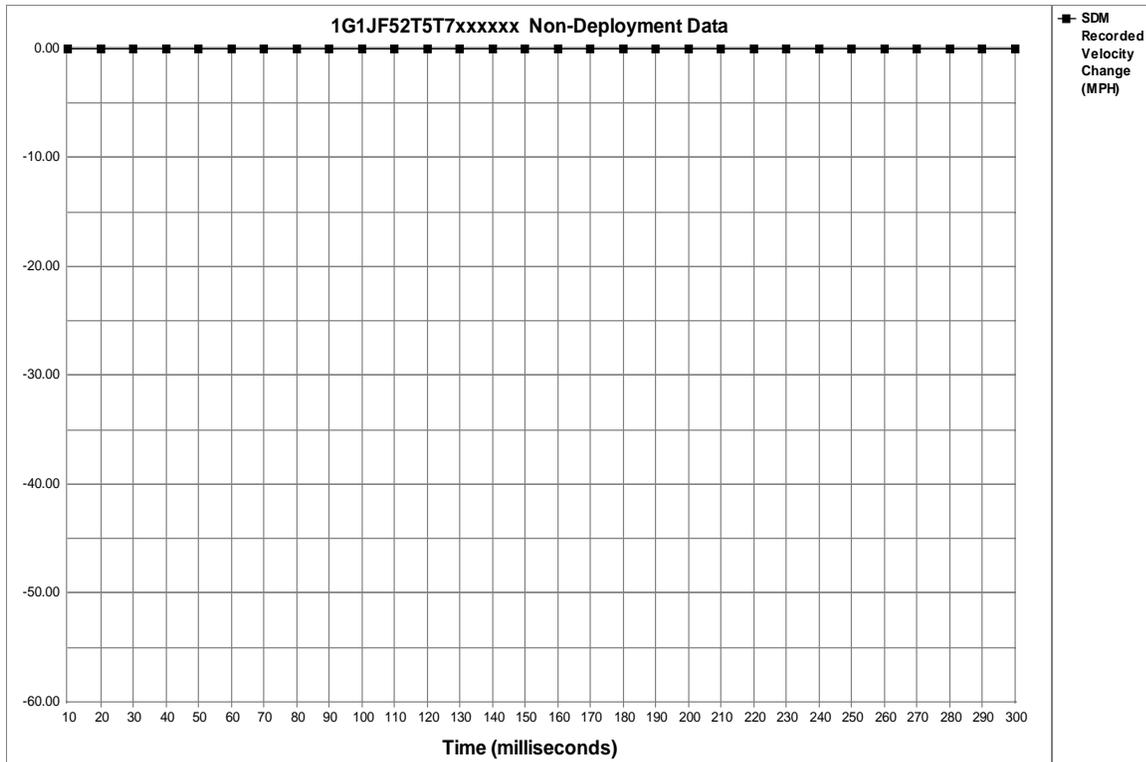
SIR Warning Lamp Status	OFF
Driver's Belt Switch Circuit Status	UNBUCKLED
Ignition Cycles At Non-Deployment	20598
Ignition Cycles At Investigation	20818
Algorithm Enable to Maximum SDM Recorded Velocity Change (msec)	1.25
Maximum SDM Recorded Velocity Change (MPH)	-0.22
A Deployment was Commanded Prior to this Event	No

Time (milliseconds)	10	20	30	40	50	60	70	80	90	100	110	120	130	140	150
Recorded Velocity Change (MPH)	0.00	0.00	0.00	0.00	0.00	0.00	0.00	0.00	0.00	0.00	0.00	0.00	0.00	0.00	0.00
Time (milliseconds)	160	170	180	190	200	210	220	230	240	250	260	270	280	290	300
Recorded Velocity Change (MPH)	0.00	0.00	0.00	0.00	0.00	0.00	0.00	0.00	0.00	0.00	0.00	0.00	0.00	0.00	0.00
