**CALSPAN ON-SITE ADULT AIR BAG RELATED FATALITY CRASH  
INVESTIGATION**

**CASE NO: CA04-053**

**VEHICLE: 1993 CHEVROLET CORSICA**

**CRASH DATE: JULY 2004**

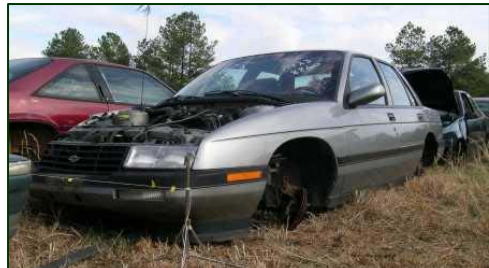
The subject vehicle in this crash was a 1993 Chevrolet Corsica, four-door sedan. The vehicle was manufactured on 3/93 and was identified by Vehicle Identification Number (VIN) 1G1LT5340PY (production number deleted). Although the crash occurred in July 2004, the vehicle was located at a used auto parts facility in January 2005. At the time of the SCI inspection, the Corsica was partially disassembled with the engine, transmission, radiator, air conditioning condenser, taillight assemblies, and all four tires and wheels removed and separated from the vehicle (**Figure 3**). The exterior crush profile and the interior of the vehicle remained intact and unaltered from the crash. Non-crash related vehicle damage was noted to the right side of the Corsica. This damage is further documented in the **Vehicle Damage – Exterior** section of this report.

**Figure 3. Dismantled state of the Corsica at the time of the SCI inspection.**

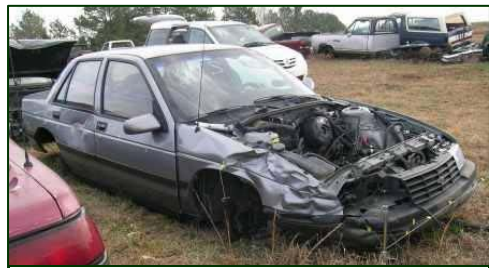
The exterior of the Corsica sustained moderate severity frontal and right side damage as a result of the corner engagement (**Figure 4**) with the Dodge Caravan. The maximum crush was measured at 10 cm (4”) located at the right corner of the bumper beam. The direct contact damage began 48 cm (18.75”) right of center and extended 19 cm (7.4”) to the right bumper corner. The impact deformed the full width of the bumper beam resulting in a combined direct and induced damage length of 129 cm (50.75”). A crush profile was documented at the level of the bumper beam (**Figure 5**) and the six equidistant measurements were as follows: C1 = 2 cm (0.75”), C2 = 2 cm (0.75”), C3 = 2 cm (0.75”), C4 = 3 cm (1.25”), C5 = 5 cm (1.9”), C6 = 10 cm (4”).

**Figure 4. Front right view of the corner impact damage to the Corsica.**

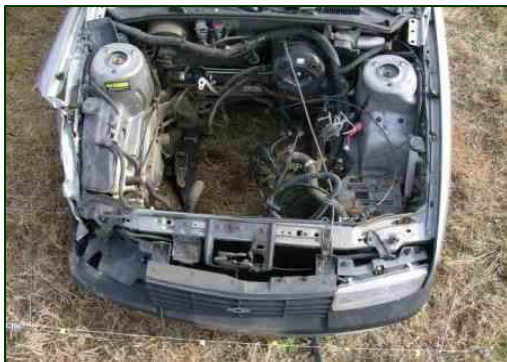
**Figure 5. Overhead view documenting the depth of frontal crush.**

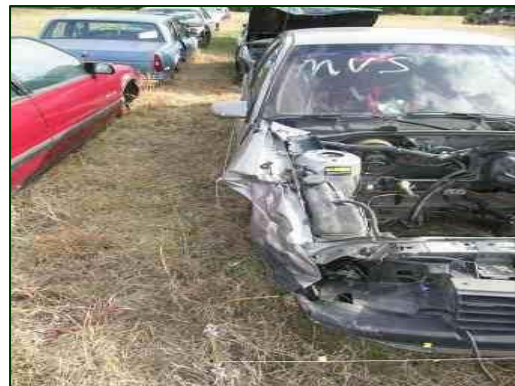
**Figure 6. Front and right side damage to the Corsica.**

The corner impact damaged extended onto the right front fender of the Corsica, terminating 58 cm (23”) aft of the leading edge (**Figure 6**). The engagement also involved the right front tire as the lower right control arm was deformed rearward, resulting in a right wheelbase reduction of 1 cm (0.3”). Remote buckling was noted to

the roof immediately forward of the right B-pillar. All four doors remained closed and operational post-crash. The windshield was cracked adjacent to the right A-pillar due to body stress. The Collision Deformation Classification (CDC) for this impact was 12-FREE-3.

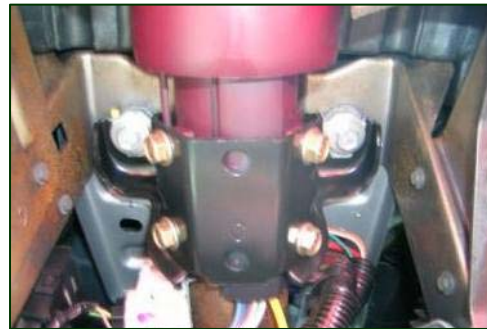
There was no damage or intrusion to the passenger compartment associated with this crash event. There were no driver contact points within the vehicle or loading evidence to the deployed air bag, safety belt system, or steering column compression (**Figure 7**).

**Figure 7. Steering column shear brackets; no separation**

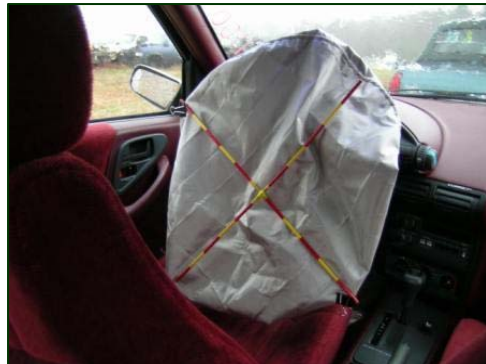
The driver's air bag module was mounted to the two-spoke steering wheel rim. The wide spokes were positioned at the 4 and 8 o'clock positions. The driver's air bag deployed as designed from the H-configuration module cover flaps. The horizontal tear seam of the flaps measured 19 cm (7.5") in width and the vertical dimensions of the upper and lower flaps were 6 cm (2.5") and 4 cm (1.75") respectively. There was no damage or contact evidence to the cover flaps.

**Figure 8. Deployed driver air bag.**

The air bag membrane measured 67 cm (26.5") in diameter in its deflated state. The air bag was not tethered and was vented by two 1 cm (0.375") diameter ports located at the 3 and 9 o'clock positions, centered 10 cm (3.75") forward of the internally sewn peripheral seam. There was no occupant contact evidence or damage to the deployed air bag (**Figure 8**). It should be noted that although the crash occurred six months prior to this SCI inspection, the interior of the Corsica was closed to the weather and kept intact in good condition.

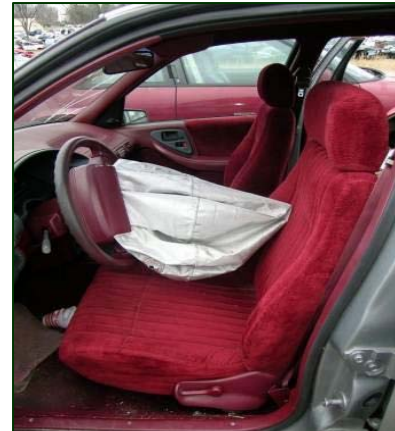
The maximum rearward excursion of the driver's air bag measured 55 cm (21.5"). In an attempt to replicate the crash scenario for this event, the seat track was repositioned to the mid point of the 19 cm (7.625") of total track travel and the seat back was left at the 17.5 degree recline angle. In this position, the horizontal distance between the mid point of the driver's air bag module and the seat back measured 50 cm (19.5"), at a height that was 43 cm (17.0") above the seat bight. The maximum excursion of the air bag engaged the seat back with the track adjusted to the mid position (**Figure 9**).

**Figure 9. Rearward excursion of the driver's air bag into mid track seat position.**

The continued expansion of the air bag resulted in contact to the driver's face. She sustained soft tissue injuries of the right face, nose and inner lip. The driver also sustained a right conjunctiva edema. The air bag impacted the driver's head with sufficient force to accelerate the head rearward resulting in an avulsion fracture of the odontoid along the posterior left lateral aspect. The driver also sustained bilateral subdural hematomas, a 1.5 cm right cortical contusion and scattered subarachnoid hemorrhage. **Figure 9** represents the rearward excursion of the air bag with respect to the presumed adjusted seat track position for the driver.
