CALSPAN ON-SITE CHILD SAFETY SEAT CRASH INVESTIGATION

CASE NO: CA04-055

VEHICLE: 2003 DODGE RAM 2500 PICKUP TRUCK

CRASH DATE: NOVEMBER 2004

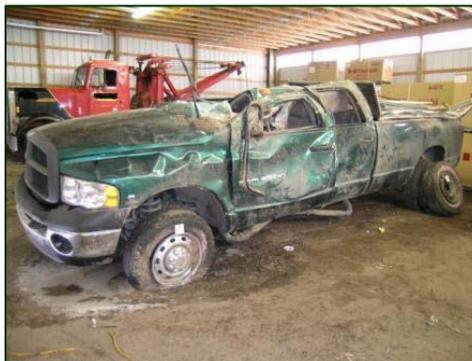
Figure 1. 2003 Dodge Ram pickup truck.

The Dodge Ram pickup truck sustained severe damage to the greenhouse area as a result of the rollover event. The vehicle rolled to its left and completed six quarter turns prior to coming to rest on its roof. The right roof side rail area impacted the ground during the second-to-third quarter-turns which displaced the right roof side rail and right upper pillars to the left. As the vehicle continued to roll, the left roof side rail engaged the ground between quarter-turns 5 and 6. This impact displaced the left roof side and upper left pillars to the vehicle's right. As a consequence of the side rail impacts, the left third area of the roof buckled downward to the level of the beltline. Maximum crush was 70 cm (27.75") located at the roof over the driver's position. This roof deformation resulted in extensive intrusion of the roof into all six occupant positions.

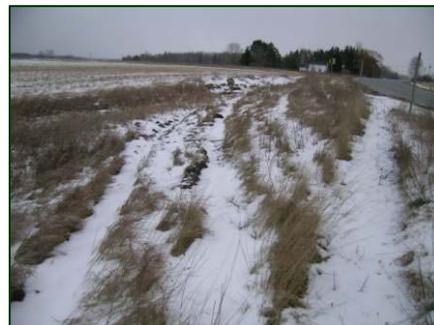
Figure 4. Tire furrows through the soft roadside.

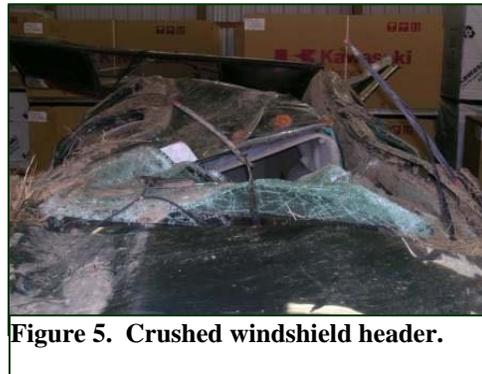
The crush of the roof and greenhouse area was documented at various structural locations to capture the magnitude of the crush and the resulting intrusion. The windshield header deformed to a W-shape (**Figure 5**) with a lateral damage width of 108 cm (42.5"). The maximum crush at this profile was 44 cm (17.5") located 18 cm (7") inboard of the left A-pillar. The crush at six equidistant points along this profile were as follows: C1 (left) = 30 cm (12"), C2 = 27 cm (10.5"), C3 = 27 cm (10.5"), C4 = 37 cm (14.5"), C5 = 41 cm (16"), C6 = 34 cm (13.5").

Figure 5. Crushed windshield header.

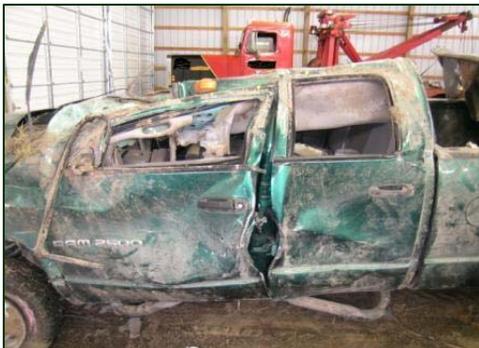
The vertical crush of the left roof side (**Figure 6**) rail was documented along a damage length of 131 cm (51.5") that extended from the C-pillar to the upper A-pillar. The crush values at this level were as follows: C1 (C-pillar) = 11 cm (4.5"), C2 = 17 cm (6.5"), C3 = 19 cm (7.5"), C4 = 24 cm (9.5"), C5 = 29 cm (11.5"), C6 = 29 cm (11.5").

Figure 6. Left side rail crush.

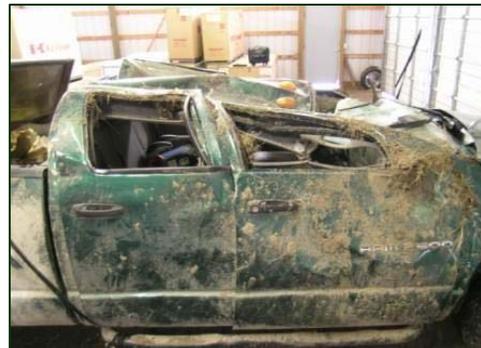
The right roof side rail crush (**Figure 7**) was documented using the same procedure as the left. The damaged length of this profile was 127 cm (50"). The vertical crush profile was: C1 = 27 cm (10.5"), C2 = 33 cm (13"), C3 = 38 cm (15"), C4 = 39 cm (15.5"), C5 = 43 cm (17"), C6 = 32 cm (12.5").

Figure 7. Right side rail crush.

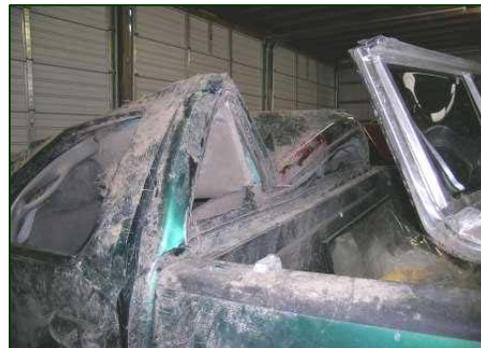
The backlight header buckled to a V-shape (**Figure 8**) and was reduced in lateral width. The lateral measurement between the C-pillars was 105 cm (41.5"). The crush profile was as follows: C1 = 4 cm (1.75"), C2 = 41 cm (16"), C3 = 38 cm (15"), C4 = 32 cm (12.5"), C5 = 26 cm (10.25"), C6 = 22 cm (8.5").

Figure 8. Backlight header crush.

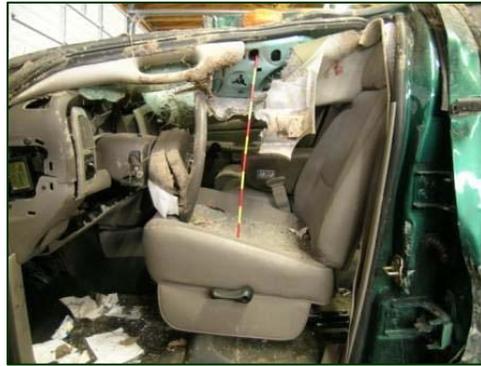
Figure 11. Intrusion of the driver's compartment.

As the vehicle initiated a lateral rollover to the left, the driver responded to the lateral forces and moved to his left. During the continued rollover event, the driver's head was impacted by the intruding roof (**Figure 11**). It was possible that his head was partially ejected through the left door window opening. He sustained massive trauma of the head and expired at the scene. Body fluid was present on the roof, side rail, and left upper A-pillar.

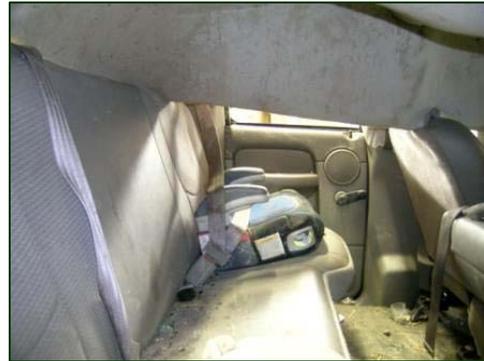
At the on-set of the rollover, the ELR retractor locked. The child passenger would have initiated a lateral trajectory to his left in response to the lateral forces exerted on the vehicle. There was no contact evidence to the left rear door panel. As the vehicle continued to rollover, the child loaded the manual belt system which held the child in position and prevented him from ejection. The booster seat elevated the child to provide a better fit of the manual belt system. The severe roof intrusion was located immediately above the child passenger's position (**Figure 13**). He did have sufficient occupant space left of his seated position. The vertical distance between the leading edge of the booster seat cushion and the intruding roof measure d 27 cm (10.5"). The aft edge of the booster seat cushion to the roof measured 38 cm (15.1").

Figure 13. Lateral view across the rear seat area and the roof intrusion.
