Combination Hybrid Vehicle Investigation/ Vehicle to Vehicle
Dynamic Science, Inc. / Case Number: 2005-082-083A
2004 Honda Civic
Washington
September, 2005

1. Report No. 2005-082-083A	2. Government Accession No.	3. Recipient Catalog No.	
4. Title and Subtitle Combination Hybrid Vehicle Investigation		5. Report Date March 24, 2006

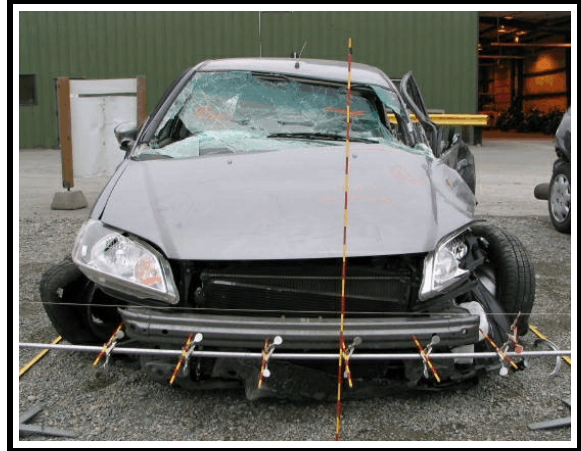
Figure 1. Front, 2004 Honda Civic Hybrid

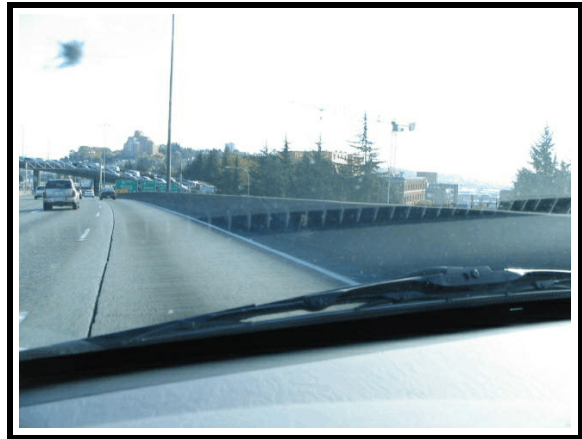
Figure 3. Path of vehicle over wall

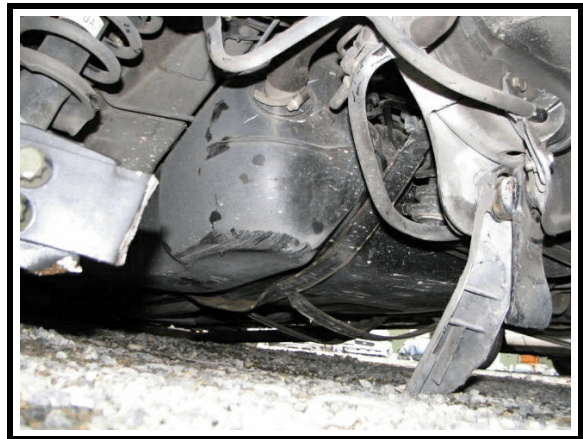
Figure 4. Gas tank contact

After this impact, the Honda climbed up and over the cement barrier. While doing so, a portion of the gas tank was abraded. This event was not initially recorded, but was added as Event #4. The CDC is partially unknown, and has thus been encoded as 00U9999.

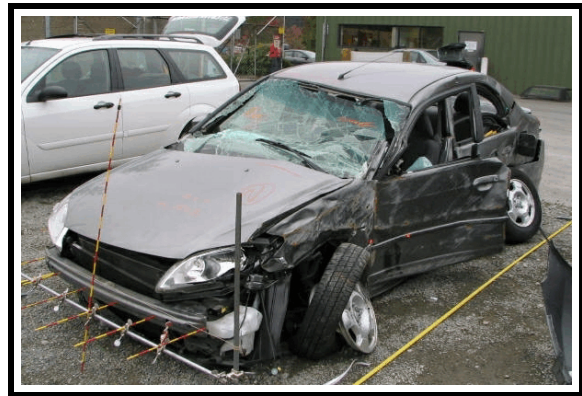
Figure 5. Left side damage, 2004 Honda Civic

Damage Description:	The vehicle sustained moderate damage to the entire left side. This occurred as the vehicle exchanged forces with the Pacifica (Event #2), then struck the ground as it climbed over the cement right barrier and fell 7.6 m (25.0 ft) to the ground below (Event #6).	
CDC:	Event #1-impact with cement barrier: 12FRE9U ³ Event #2-impact with Pacifica: 09L9999 Event #3-impact with same barrier: 12FREE9 Event #4-impact while atop barrier: 00U9999 ⁴ Event #5-roll/falls to roadway below: 00LDAO3	
Delta V:	Total	Unknown
	Longitudinal	Unknown
	Latitudinal	Unknown
	Energy	Unknown

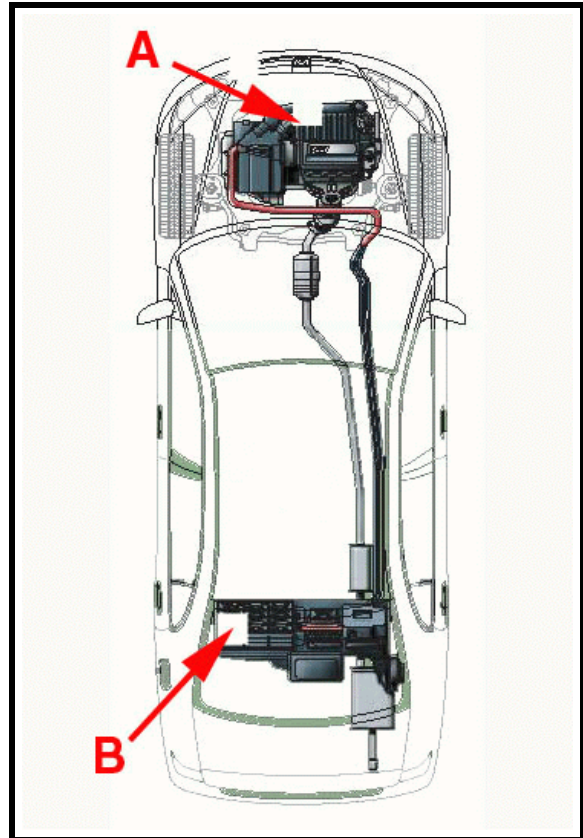
Figure 6. (A) Combination gasoline/electric powerplant, (B) Ni-MH battery pack

- There were no indications of electrolyte spillage from the propulsion battery.
- There was no movement of the battery module.
- The electrical isolation test was not conducted. There were no indications, however, of any arcing, fire, or component meltdown. See Attachment 2 for discussion of electrical isolation test.

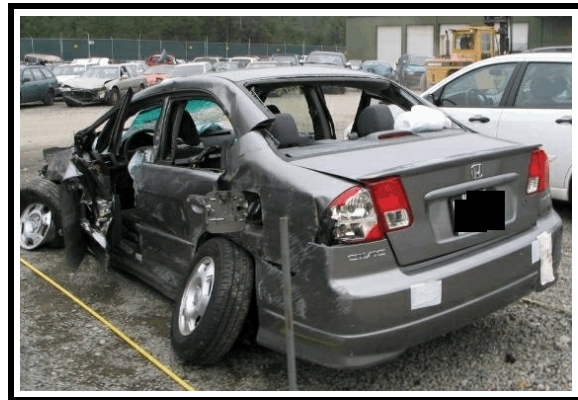
Figure 7. Left rear view, 2004 Honda Civic

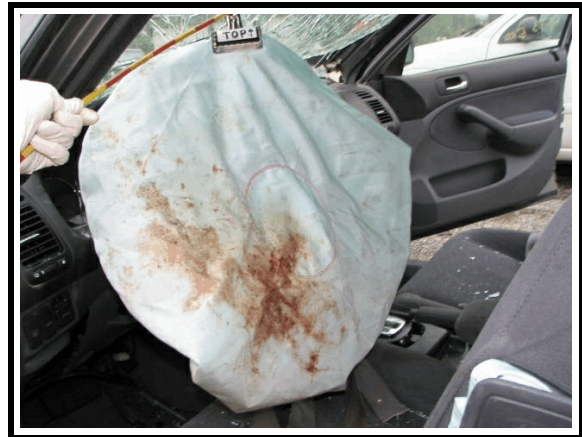
The driver's air bag deployed from the center of the steering wheel hub through H-configuration module cover flaps. The top flap measured 16.0 cm (6.3 in) in height by 8.0 cm (3.1 in) in width. The bottom flap measured 16.0 cm (6.3 in) in height by 8.0 cm (3.1 in) in width. The deployed driver's air bag measured 50.0 cm (19.7 in) in diameter in its deflated state. Two circular vent ports were located at the 11 and 1 o'clock aspects on the rear of the air bag. Blood was found in the left upper and lower quadrants.

Figure 8. Deployed driver's air bag

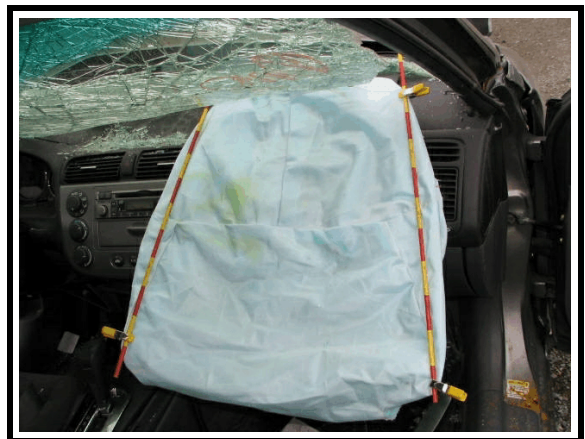
Figure 9. Deployed front right passenger's air bag

top mount module with an H-configuration cover flap. The top module cover flap measured 22.0 cm (8.7 in) in width and 4.0 cm (1.6 in) on the left and 6.0 cm (2.4 in) on the right. The bottom module cover flap measured 22.0 cm (8.7 in) in width and 6.0 cm (2.4 in) on the left and 4.0 cm (1.6 in) on the right. The deployed front right passenger's air bag measured 50.0 cm (19.7 in) in height and 50.0 cm (19.7 in) in width. Two circular vent ports were located at the 3 and 9 o'clock aspects of each side panel of the air bag. There was a burn mark located in the top left quadrant and blood found in the top right quadrant.
