**CALSPAN ON-SITE CHILD AIR BAG RELATED FATALITY
CRASH INVESTIGATION**

CASE NO: CA05-001

VEHICLE: 2000 CHEVROLET METRO LSi

CRASH DATE: NOVEMBER 2004

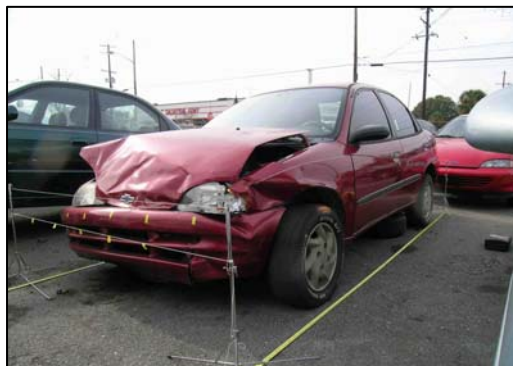
Figure 1 - Damaged 2000 Chevrolet Metro.

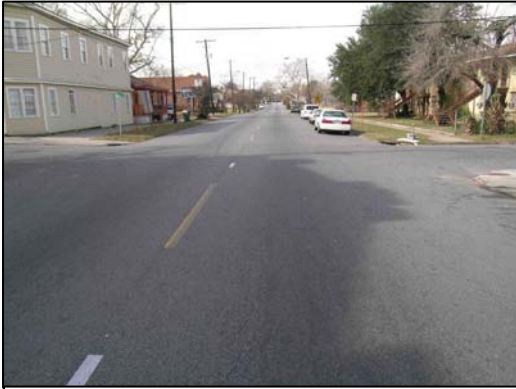
The adult female driver of the Chevrolet was operating the vehicle in a westbound direction (**Figure 2**) and was approaching the four-leg intersection. The 13-year old male was operating the Buick in the northbound direction (**Figure 3**) and approaching the same intersection controlled by a stop sign for north/south traffic. The driver of the Buick disregarded the unobstructed stop sign on the southeast corner of the intersection. Occupant contact patterns suggest that a pre-crash braking action was taken by the Chevrolet prior to impact; however, no physical evidence was found at the scene for corroboration.

Figure 2 - Westbound approach of the 2000 Chevrolet Metro.

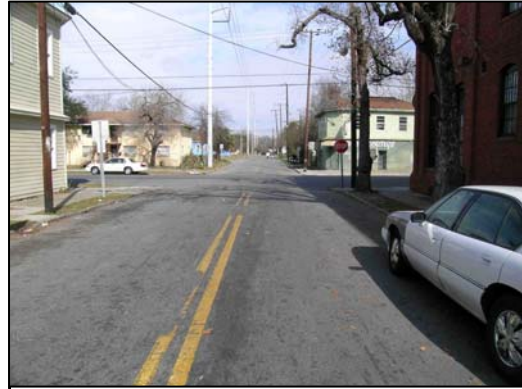
Figure 3 - Northbound approach of the 1996 Buick Century.

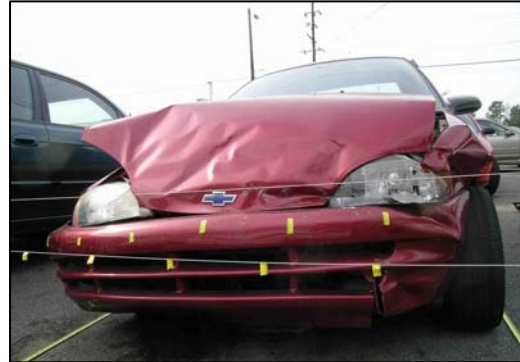
The 2000 Chevrolet Metro (**Figure 4**) sustained moderate damage as a result of the right angle crash with the 1996 Buick Century. The direct contact damage was distributed across the full width of the frontal plane and measured 124 cm (49"). The combined direct and induced damage also encompassed the full front end of the vehicle. The maximum crush was located at the left aspect of the bumper and was 17 cm (7") in depth. Six equidistant crush measurements were documented across the front bumper and were as follows: C1 = 17 cm (7"), C2 = 16 cm (6.3"), C3 = 17 cm (7"), C4 = 16 cm (6.3"), C5 = 15 cm (6"), C6 = 17 cm (7"). The Collision Deformation Classification (CDC) was 11-FDEW-1. The bumper shifted 14 cm (5.5") to the right during the impact; however, the structural components remained in place and end shift was not incremented.

Figure 4 - Damaged 2000 Chevrolet Metro.

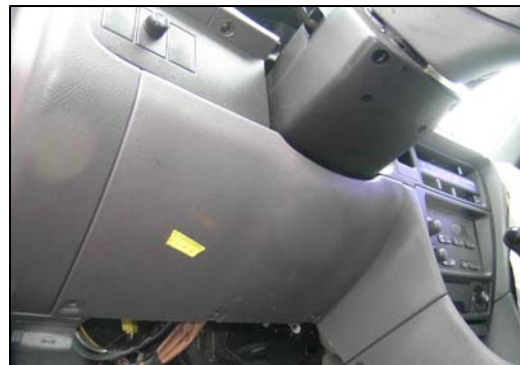
The 2000 Chevrolet Metro sustained moderate interior damage as a result of occupant loading of interior components and air bag contact. A scuff was present on the left knee bolster, located 35 – 36 cm (13.75 – 14.24") below the brow at the top aspect of the instrument panel and 43 – 48 cm (17 – 19") left of the vehicle's centerline. This contact had an associative orange fabric transfer present that was attributed to the driver's left knee (**Figure 5**). Blood spatter was present on the center console and transmission selector. Additional blood transfers were found on the front right seat cushion. The glove compartment cover was found in an open position and would not re-latch.

Figure 5 - Driver's knee contact location.

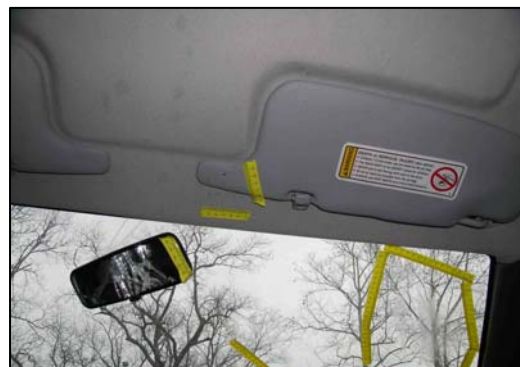
A distinct air bag abrasion was present at the top aspect of the center instrument panel. The rearview mirror also exhibited air bag associated contact evidence as its internal glass was cracked and its left side was displaced into the windshield where it fractured the same. In addition to the rearview mirror, the windshield was also contacted at multiple locations by both the expanding air bag and the 4-year old passenger during the crash sequence. A 2 cm (0.6") diagonally oriented scuff with a

Figure 6 - Windshield area occupant contact points.

distinguishable crosshatching transfer pattern from the air bag membrane was located slightly inboard of the right A-pillar. Additionally, four vertically oriented transfers extended from the top aspect of the windshield at the header to the midpoint of the glazing. Clear body fluid transfers were identified 12 – 21 cm (30 – 53”) slightly inboard of the right A-pillar and head and hair oil transfers were located 42 – 51 cm (16.5 – 20”) right of the glazing’s centerline and 10 – 25 cm (3.75 – 10”) below the header. Associative dark and coarse textured hairs were affixed to the windshield glazing along with 10 – 12 blood spatter marks on the header and left side of the sun visor. An overall view of the contact points on or near the windshield is exhibited in **Figure 6**.

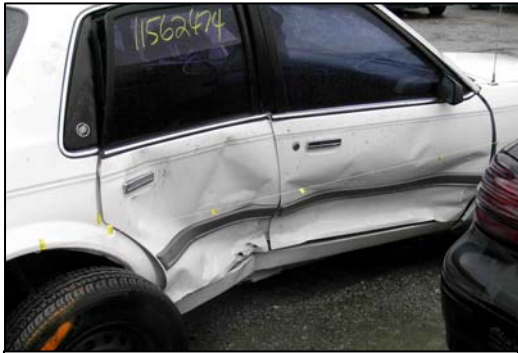
The 1996 Buick Century sustained moderate right side damage (**Figures 7 and 8**) as a result of the impact with the 2000 Chevrolet Metro. The direct contact damage began 50 cm (20”) aft of the right front axle along the leading edge of the front right door and extended 156 cm (61.5”) rearward. The combined direct and induced damage began 48 cm (19”) aft of the right front axle and extended rearward 190 cm (75”). The maximum crush was located 124 cm (49”) aft of the right front axle at the B-pillar and was 32 cm (12.5”) in depth. Both right side doors were jammed closed due to this impact. Six equidistant measurements were taken along the mid-door level of the vehicle and were as follows: C1 = 2 cm (0.75”), C2 = 17 cm (6.75”), C3 = 32 cm (12.5”), C4 = 29 cm (11.5”), C5 = 19 cm (7.5”), C6 = 5 cm (2”). The CDC for this impact was 02-RPEW-3.

Figure 7 - Right side damage to the 1996 Buick Century.

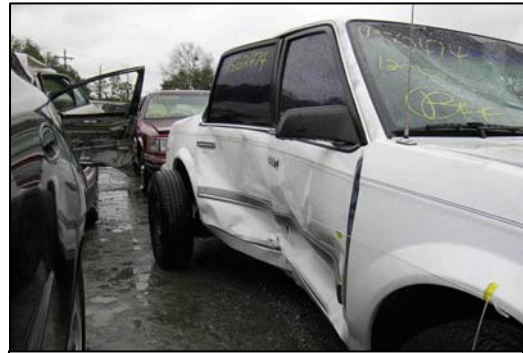
Figure 8 - Longitudinal view of the depth of crush on the right side of the 1996 Buick Century.

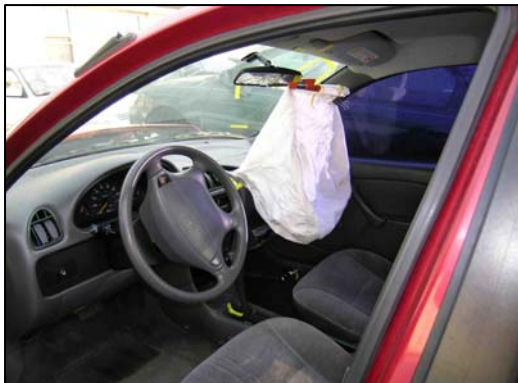
The 2000 Chevrolet Metro was equipped with redesigned air bags for the driver and front right passenger positions. The air bag deployment was asymmetrical with only the front right air bag deploying (**Figure 9**). The driver's air bag was housed in the steering wheel hub with horizontally oriented H-configuration cover flaps.

Figure 9 - Asymmetrical air bag deployment.

The Chevrolet's Event Data Recorder (EDR) was removed from the vehicle and downloaded by the SCI investigator. The EDR summary report is included as **Attachment A** at the end of this narrative report. The system recorded a Deployment event as a result of the frontal impact with the 1996 Buick Century. The SCI investigation concluded that the driver was not restrained by the manual safety belt system. This was supported by the EDR that recorded the driver's belt switch circuit status as unbuckled. The EDR commanded a deployment of the redesigned air bag system at 35 milliseconds from AE. The EDR module recorded the air bag warning lamp status and being in the 'ON' position during this single event crash, which indicates that a problem existed within the air bag system. The driver's air bag failed to deploy during the crash.

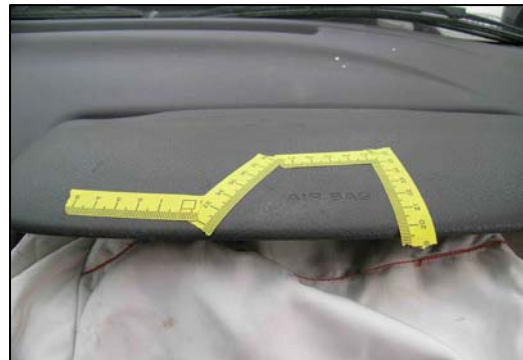
The front right passenger air bag was housed in the right instrument panel area with a single cover flap design hinged at the top aspect. The flap was 36 cm (14") in width and 16 cm (6.2") in height and rectangular in shape. A tissue transfer was identified on the leading edge of the cover flap (**Figure 10**). The transfer was 6 cm (2.4") in width and 4 cm (1.75") in height and began 37 cm (15") right of the vehicle's centerline, 5 cm inboard of the lower left corner of the cover flap. A lone hair was present on the cover flap slightly below the top aspect.

Figure 10 - Transfer evidence on the leading edge of cover flap.

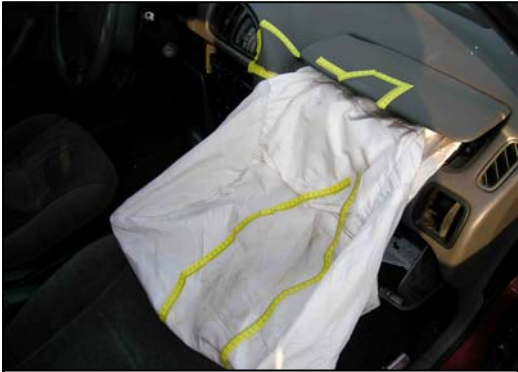
The air bag membrane measured 46 cm (18") in width and 50 cm (25") in height. A large tissue transfer was present on the air bag that began at the top horizontal seam approximately 8 cm (3") inboard of the right vertical seam and extended rearward 6 cm (2.25"). The transfer continued below the horizontal seam and the width of transfer increased to 22 cm (8.5") at its widest point. The vertically oriented transfer transitioned to a lateral orientation at 25 cm (10") below the horizontal seam on the face of the air bag and extended downward an additional 29 cm (11.5"). The air bag contained no tether straps or external vent ports. **Figures 11** and **12** are overall views of the transfer evidence on the front right air bag.

Figure 11 - Overall view of the transfer evidence on the front right air bag.

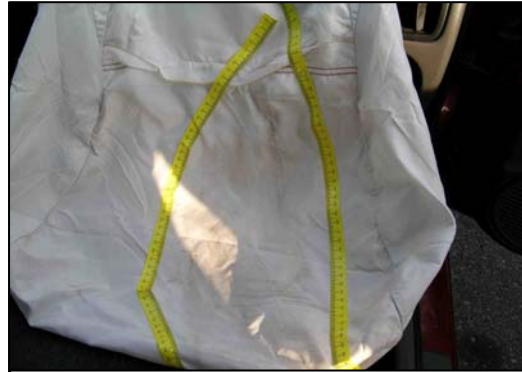
Figure 12 - Overall view of transfer evidence on the front right air bag.

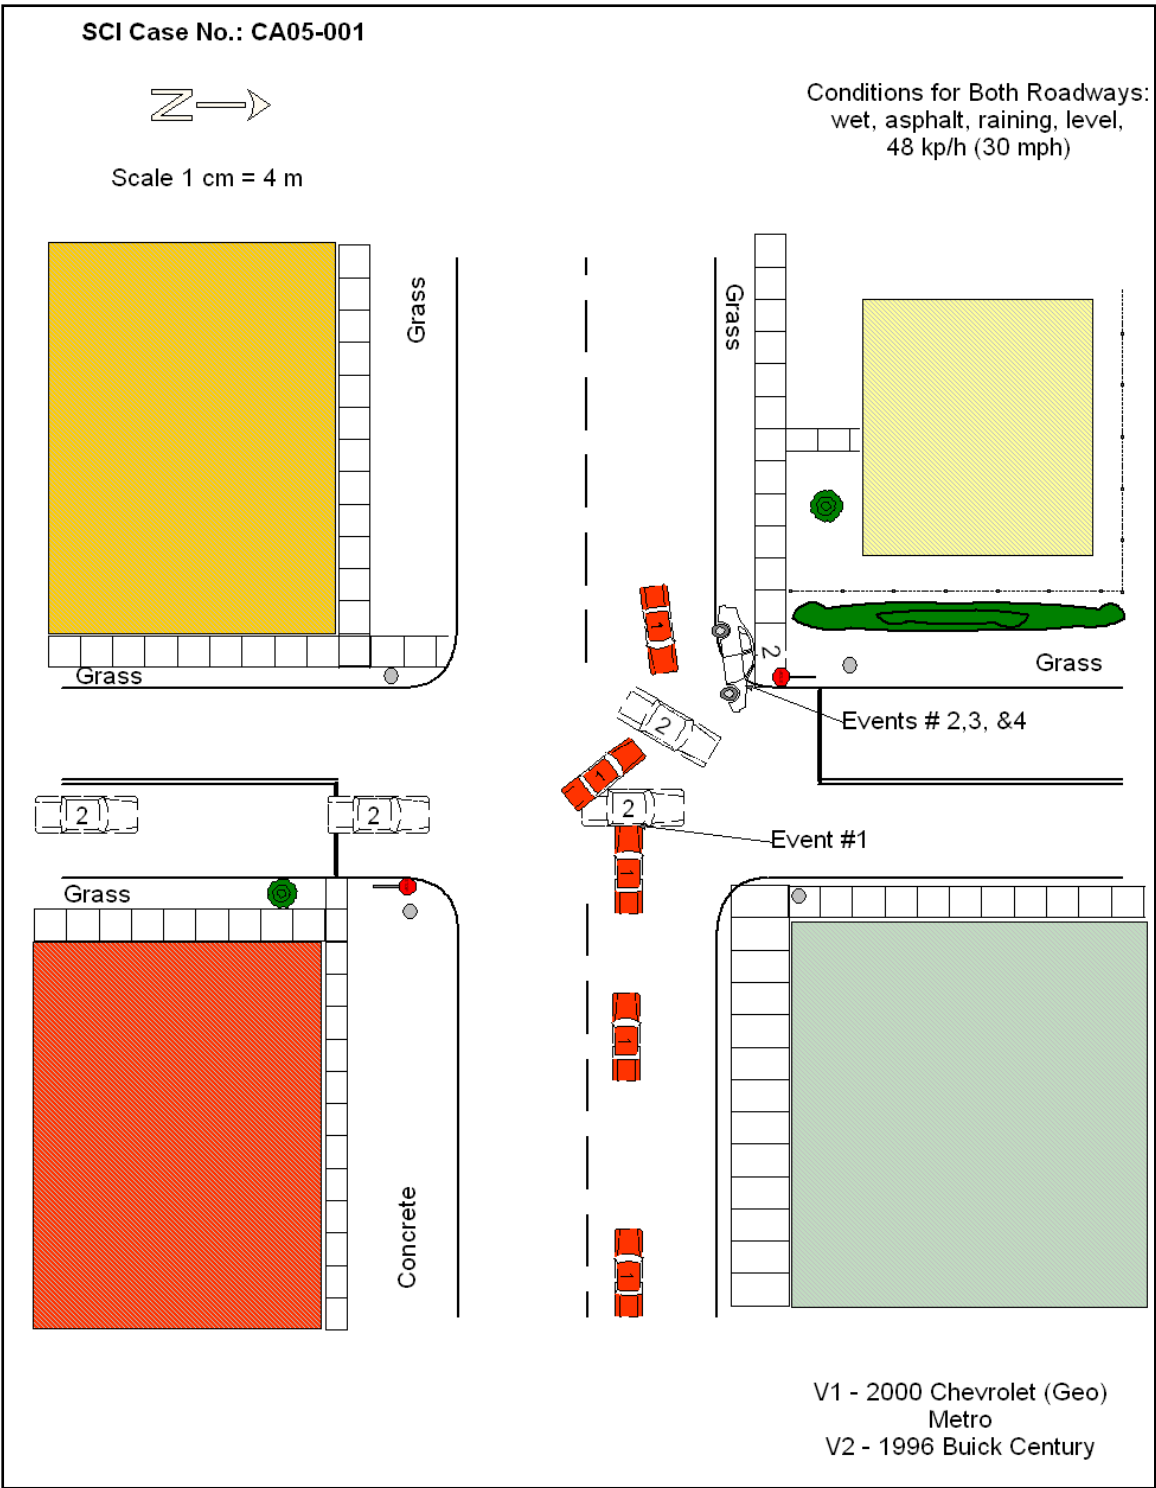
Figure 13 – SCI Scene Schematic.

This two-vehicle crash occurred in the state of Georgia in November 2004 at a four-leg intersection. It was raining at the time of the evening crash and the roadways were wet. The east/west roadway was configured with one lane in each direction that was separated by a broken yellow painted centerline. The north/south roadway had one lane in each direction that was delineated by double-yellow painted centerlines. Both roadways were straight and level and had posted speed limits of 48 km/h (30 mph). The crash occurred in an urban setting and the roadside environment consisted of multiple business and residential dwellings. Stop signs with no sight obstructions were located on the southeast and northwest corners controlling north/south traffic. The SCI scene schematic is included as **Figure 13** at the end of this narrative report.
