ON-SITE CHILD SAFETY SEAT INVESTIGATION

CASE NUMBER - IN-05-001

LOCATION - MINNESOTA

VEHICLE - 2003 KIA SEDONA

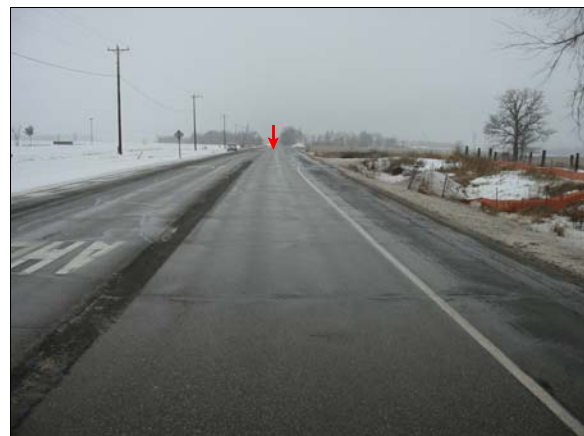
Crash Environment: The trafficway on which both vehicles were traveling (**Figure 1**) was a two-lane, undivided, county roadway, traversing in a north-south direction. The trafficway formed a "Tee" intersection with a three-lane divided driveway to a church/school complex located on the east side of the trafficway. In the area of the crash, the trafficway widened. There was one northbound lane north of the driveway, and two northbound and two southbound lanes south of the driveway. For southbound traffic (i.e., both vehicle's travel direction), the outside lane was a passing lane to accommodate through traffic when vehicles were waiting to turn left into the church/school complex. It was 3.3 meters (10.8 feet) in width. The inside southbound lane was 3.5 meters (11.5 feet) in width. For northbound traffic, south of the driveway, there was one through lane, 3.2 meters (10.5 feet) in width, and

Figure 1: Overview of the trafficway and approach of the school bus southbound to impact, arrow shows area of impact

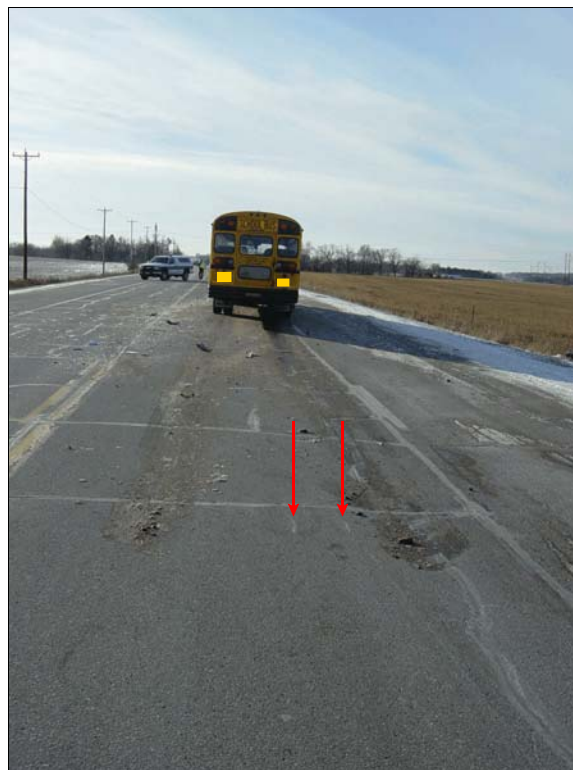
Pre-Crash: The case vehicle was stopped at the “Tee” intersection in the southbound through lane. The driver was intending to turn left into the church/school driveway. The driver stated to police that he was stopped with his left turn signal on. The case vehicle was stopped behind a vehicle that had initiated a left turn into the school/church driveway just prior to the crash. The school bus was traveling south in the southbound through lane at a reconstructed speed of 71 to 77 km.p.h. (44 to 48 m.p.h.). The bus driver was intending to proceed straight ahead. The case vehicle's driver made no avoidance maneuvers prior to the crash. The crash occurred in the southbound through lane of the roadway (**Figure 2**).

Figure 2: Police on-scene photo showing point of impact (arrows show gouges from case vehicle) and final rest position of school bus

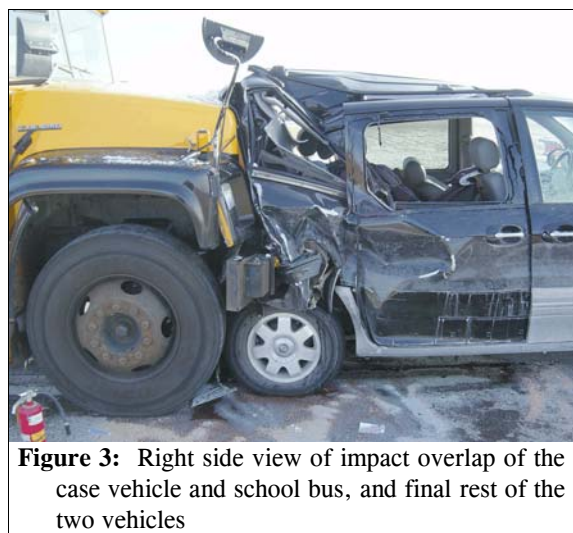
Crash: The front of the school bus impacted the back of the case vehicle. There was full overlap to the back of the case vehicle. The bus' front bumper overrode the case vehicle's back bumper. At impact, the centerline of the bus and case vehicle were approximately aligned (**Figure 3** and **Figure 4** below).

Figure 3: Right side view of impact overlap of the case vehicle and school bus, and final rest of the two vehicles

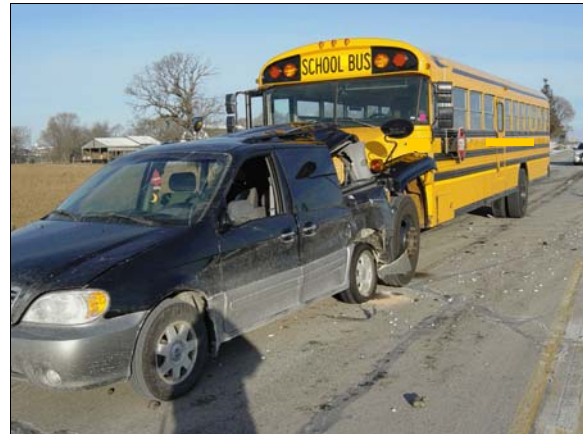
Post-Crash: As a result of the impact, the case vehicle was pushed forward approximately 29 meters (95 feet) to its final rest position. Neither vehicle rotated as a result of the impact. They angled slightly westward as they traveled to final rest. Both vehicles remained in contact and were facing slightly southwest at final rest (**Figure 4** below). The police on-scene photographs show

that the school bus driver locked his brakes post-impact, and the bus skidded to final rest. Skid marks are visible in the photographs from the front and rear wheels of the school bus (**Figure 2** above and **Figure 4**). In addition, the police photographs show no pre-impact skid marks from the school bus. At final rest, the right side wheels of both vehicles were just over the lane line dividing the through lane and passing lane.

Figure 4: Final rest position of case vehicle and school bus and view of school bus' left front and left rear skid marks

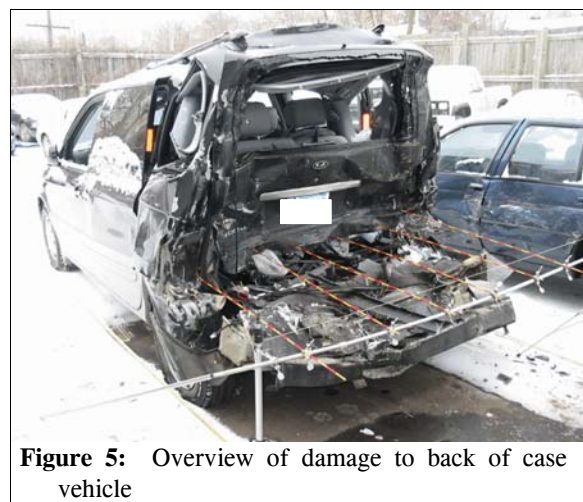
Exterior Damage: The impact to the back of case vehicle involved the entire rear plane (**Figure 5**). The case vehicle's rear bumper, bumper fascia, rear door, both turn signal/tail lamp assemblies, backlight, backlight header, and both right and left rear side panels were directly damaged and crushed forward. Direct damage began at the left rear bumper corner and extended 150 centimeters (59 inches) along the rear bumper. Residual maximum crush at the bumper was measured as 10 centimeters (3.9 inches) occurring at C₅. The front of the school bus overrode the case vehicle's back bumper resulting in severe crush above the back bumper. The residual maximum above-bumper crush (**Figure 6** below) was measured as 96 centimeters (37.8 inches) occurring at C₆. The table below shows the average of the case vehicle's bumper level crush and above bumper crush.

Figure 5: Overview of damage to back of case vehicle

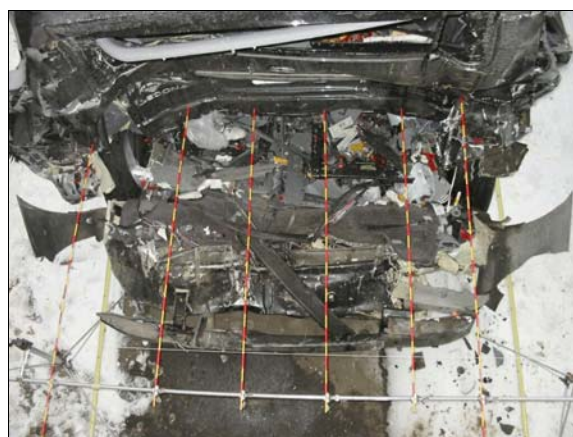
The wheelbase on the case vehicle’s left side was extended 2 centimeters (0.8 inches) while the right side wheelbase was unaltered from the crash. Induced damage involved the roof and both right and left quarter panels and rear doors. In addition, the rear-most glazing on the left side and both rear glazing panels on the right side were broken out, and all the side doors were jammed closed. No obvious induced damage or remote buckling was noted to the remainder of the case vehicle’s exterior.

Figure 6: Top view of crush to back of case vehicle, measurements above the bumper, each increment on rods is 5 cm (2 in)

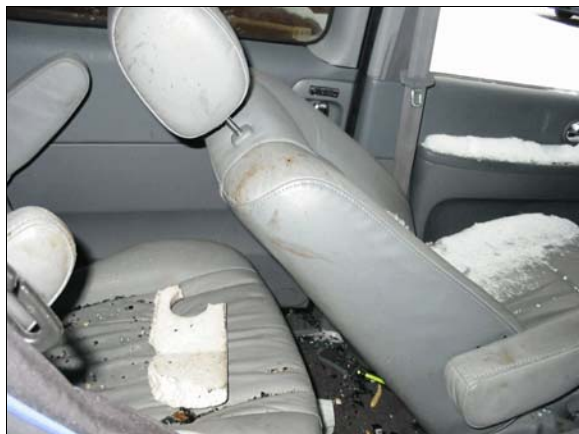
Vehicle Interior: Inspection of the case vehicle’s interior revealed blood stains on the driver’s head restraint, seat back, and arm rest, as well as the right arm rest of the seat directly behind the driver. The driver’s seat back was bent rearward (**Figure 7** below) to an angle of about 45 degrees due to the driver loading the seat back during the crash. In addition, the seat back of the seat directly behind the driver (i.e., where the child was seated in the child safety seat) was also

Figure 7: The case vehicle driver's seat back

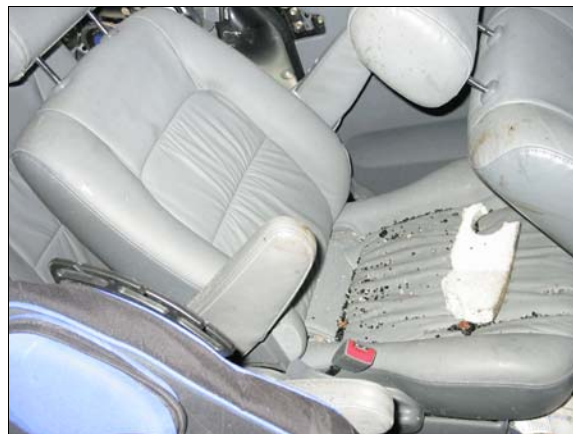
bent rearward at about the same angle (**Figure 8**). Despite the severity of the crash, there were no other occupant contacts found in the remainder of the case vehicle.

Figure 8: The second seat row, left seat

found angled rearward approximately 45 degrees during the vehicle inspection, the approximate same angle as the driver's seat back.

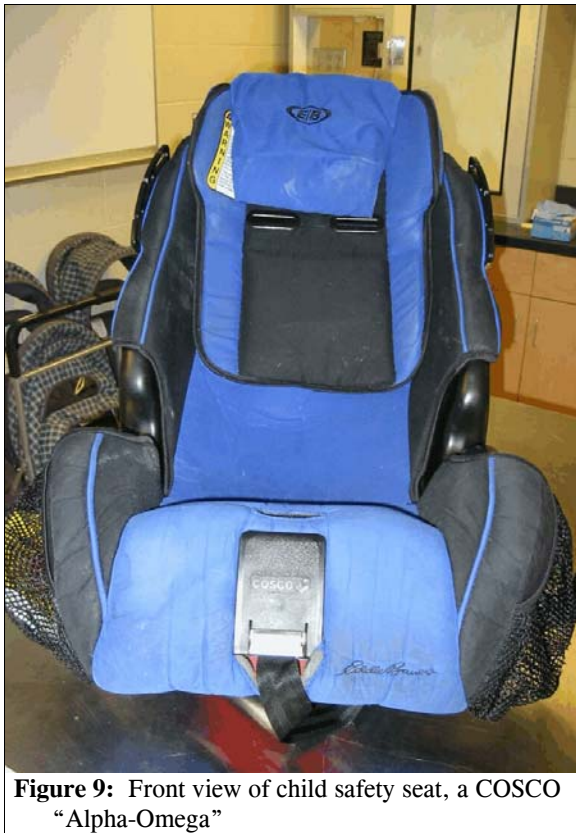
The second seat row, left passenger was a 3-year-old, male [White (non-Hispanic), unknown height and weight]. He was seated in a convertible child safety seat that was positioned in a forward-facing configuration as a belt-positioning booster seat. The child safety seat was a COSCO "Alpha-Omega" (**Figure 9** below) manufactured by Dorel Juvenile Group, Inc., of Columbus, Indiana on November 13, 2001 and identified by model number 02-537-EBN. The child seat was designed to be used as a rear facing infant seat, forward facing toddler seat with

Figure 9: Front view of child safety seat, a COSCO “Alpha-Omega”

Inspection of the child safety seat revealed no apparent damage or fractures to the shell. There were some worn and discolored areas on the head rest cushion and sides of the seat cover, but no load marks or occupant contact marks were found. There was a manufacturer’s warning label affixed to both sides of the seat stating “do not use as a belt positioning seat with lap belt only” In addition, labels were affixed to the seat illustrating

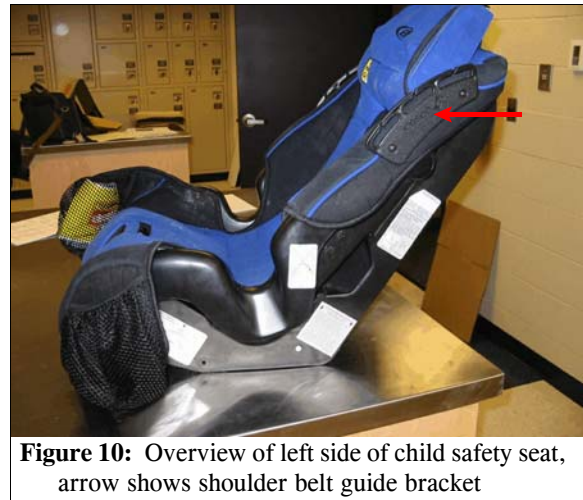
Figure 10: Overview of left side of child safety seat, arrow shows shoulder belt guide bracket

The second seat row, left passenger was restrained in the child safety seat by the case vehicle's lap-and-shoulder belt. The lap-and-shoulder belt was routed over the child, securing the child and the child safety seat. It is not known if the shoulder belt was routed through one of the three shoulder belt guides on the left side wing of the child safety seat. The lap-and-shoulder safety belt was reportedly cut in two places by police personnel to extricate the child from the vehicle. The safety belt was not available for inspection during this contractor's field investigation. Inspection of the safety belt buckle revealed no damage to the buckle. The shoulder belt anchor was found adjusted to its full-down position.
