Child safety seat fatality/ Vehicle to Vehicle  
Dynamic Science, Inc. / Case Number: DS05002  
1993 Eagle Vision  
Oregon  
January, 2005

1. Report No. DS05002	2. Government Accession No.		3. Recipient Catalog No.	
4. Title and Subtitle Child safety seat fatality			5. Report Date April 4, 2006

**Dynamic Science, Inc.**  
**Crash Investigation**  
**Case Number: DS05002**

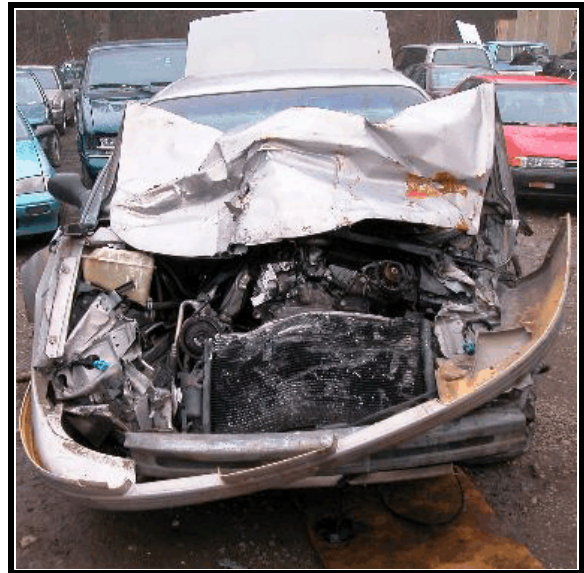
**Figure 1.** Frontal damage, 1993 Eagle Vision

**Damage Description:** The 1993 Eagle Vision sustained major front end damage as a result of the impacts with the Caravan and Bronco. The damage caused by the Caravan was likely minimal, but it could not be separated from the impact damage sustained from the Bronco. The resultant direct damage began at the left bumper corner and extended laterally 134.0 cm (52.7 in) across the entire front end. Four crush measurements were documented at the bumper and above bumper level and then averaged as follows: C1=45.0 cm (17.7 in), C2=46.0 cm (18.1 in), C3=53.5 cm (21.0 in), C4=58.0 cm (31.1 in).

The left front tire was separated from the rim and the rim was deformed. The final rim position was at approximately 90 degrees. The wheelbase on the left had been shortened by 19.0 cm (7.5 in). The wheelbase on the right had been shortened by 2.0 cm (0.8 in).

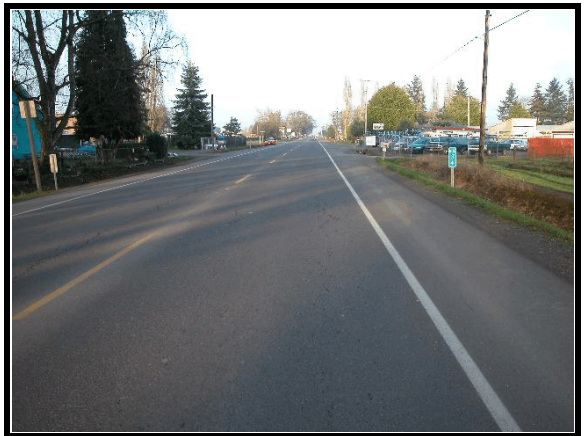
**Figure 2.** Approach to area of impact - north

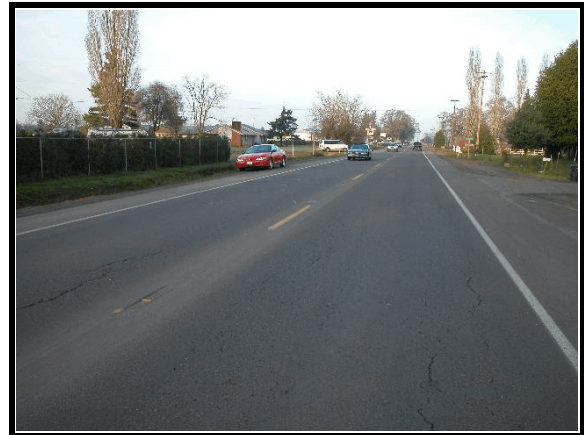
**Figure 3.** Area of impact - south

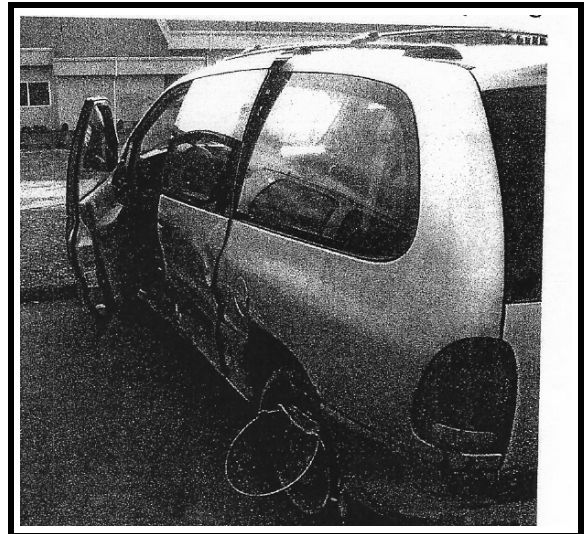
**Figure 4.** 1998 Dodge Caravan - police photo

Description:	1998 Dodge Caravan minivan	
VIN:	2B4GP439WRxxxxxx	
Odometer:	Unknown	
Engine:	3.0 liter, 6 cylinder	
Reported Defects:	None noted	
Cargo:	Unknown	
Damage Description:	Moderate left side damage	
CDC:	12LDE99 - per police photo	
Delta V:	Total	Unknown
	Longitudinal	Unknown
	Latitudinal	Unknown
	Energy	Unknown

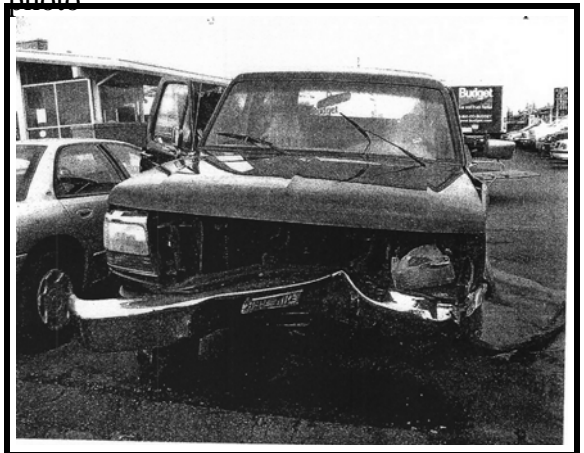
**Figure 5.** 1995 Ford Bronco - police photo

Description:	1995 Ford Bronco 4x4 sport utility vehicle	
VIN:	1FMEU15N8SLxxxxxx	
Odometer:	Unknown	
Engine:	5.0 liter, V8	
Reported Defects:	None noted	
Cargo:	Unknown	
Damage Description:	Moderate front end damage. Towed from the scene.	
CDC:	12FYEW1 - per police photo	
Delta V:	Total	26.0 km/h (16.2 mph)
	Longitudinal	-26.0 km/h (-16.2 mph)
	Latitudinal	0.0 km/h (0.0 mph)
	Energy	44,347 joules (32,709 ft lbs)

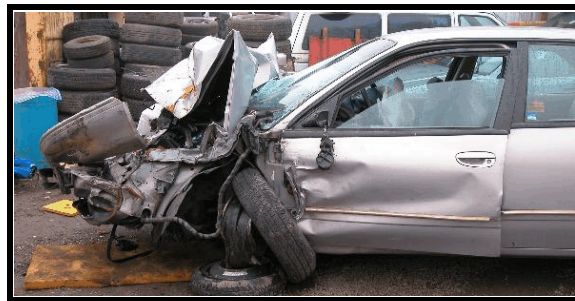
**Figure 6.** Left side, case vehicle

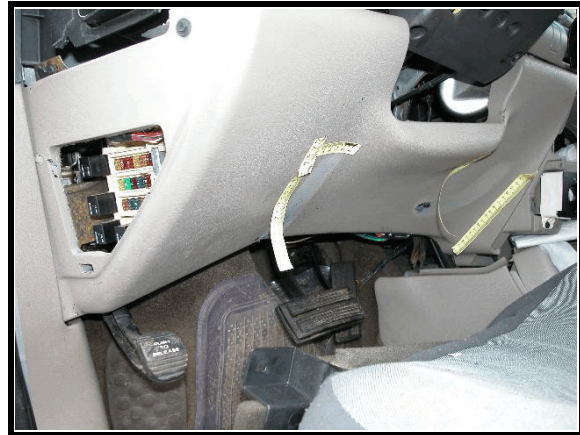
The driver's knee bolster exhibited scuffing to both the left and right aspects due to occupant contact. The center portion of the instrument panel was dislodged and shifted, but part of this likely occurred post-crash, as the stereo/CD player was being removed. The steering wheel rim had completely collapsed to the point that the rim was now 4.5 cm (1.8 in) below the center of the wheel. The glove compartment door was jammed shut at the time of inspection. The windshield had been fractured due to the impact forces. There also appears to have been a crack to the center area of the windshield due to contact from the rear view mirror. The seat back for the front right position was deformed forward. The rear facing portion of the center console that includes the rear air vents was cracked and scuffed. The entire rear seat back was deformed forward at least partially due to loading from cargo in the trunk.

**Figure 7.** Bilateral knee contacts

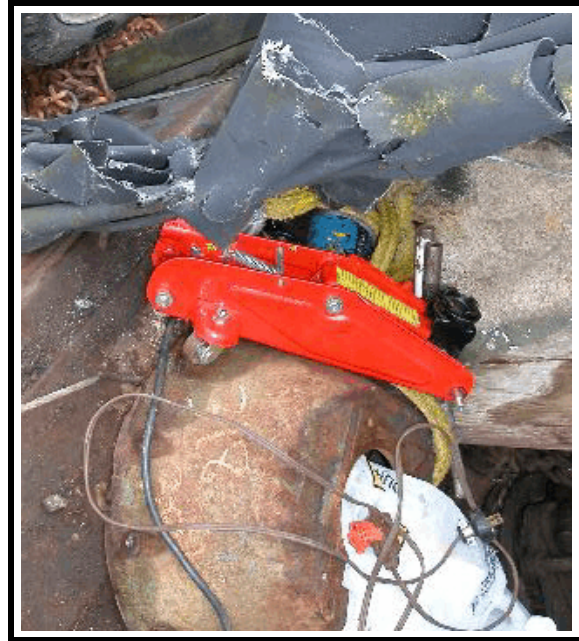
Upon completion of the inspection, the tow operator mentioned that there had been cargo distributed throughout the case vehicle interior. He specifically mentioned a heavy jack stand. Although this item would have inflicted serious injury if it had struck any of the occupants, there were no visible contacts anywhere on it to indicate that this had indeed occurred; no blood, oil, hair or tissue transfers were visible. The medical record likewise showed no visible signs of external trauma to the infant. There were no open wounds, abrasions, contusions, etc. which would have supported the theory of a large, heavy flying object striking the baby.

**Figure 9.** Floor jack that was initially in trunk of case vehicle

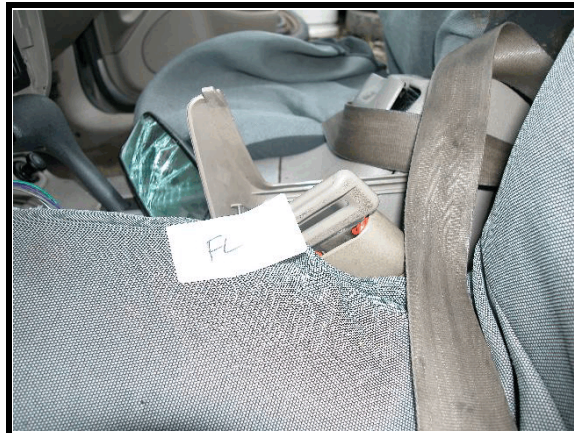
The 1993 Eagle Vision was configured with manual 3-point lap and shoulder belts for each of the four outboard seating positions. Each lap and shoulder belt was configured with emergency locking retractors. The driver's safety belt was equipped with a sliding latch plate; the remaining outboard safety belts were equipped with locking latch plates. The second row middle seat was configured with a manual lap belt. The webbing for the driver's seat had been cut during extrication. The latch plate was still in the buckle at the time of the vehicle inspection. The shoulder belt anchorages for both front seats were in the full down position. There was scuffing found on the front right belt webbing near the bottom anchor. The second row right seat belt latch exhibited scratching to the latch plate that was consistent with historical usage. The buckle for the second row middle lap belt could not be accessed at the time of the vehicle inspection. It was located below and behind the seat bight and was wedged under the seat bottom. The second row left seat belt latch exhibited scratching to the latch plate that was consistent with historical usage.

**Figure 10.** Driver's seat belt latch and buckle

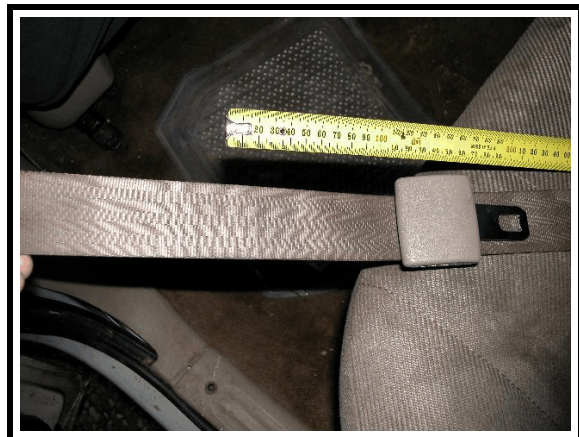
**Figure 11.** Second row middle lap belt

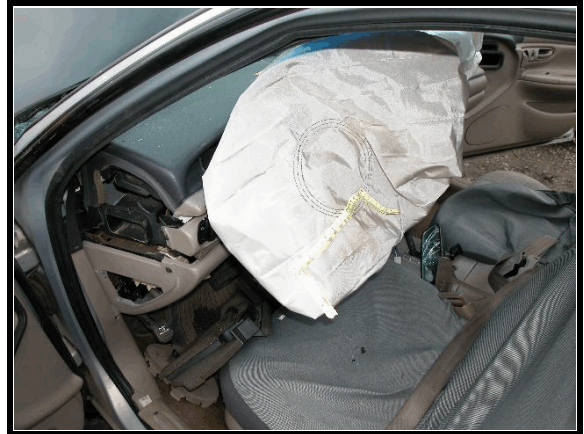
The driver's air bag deployed from the center of the steering wheel hub through symmetrical H-configuration module cover flaps. Each flap measured 16.0 cm (6.3 in) in width and 7.0 cm (2.8 in) in height. The deployed driver's air bag measured 44.0 cm (17.3 in) in its deflated state. The air bag was tethered by a single internal tether. The air bag was internally vented. There were 12 horizontal folds. An irregular cloth transfer was present on the lower left quadrant that measured 9.0 cm (3.5 in) in height and 17.0 cm (6.7 in) in width.

**Figure 12.** Deployed driver's air bag

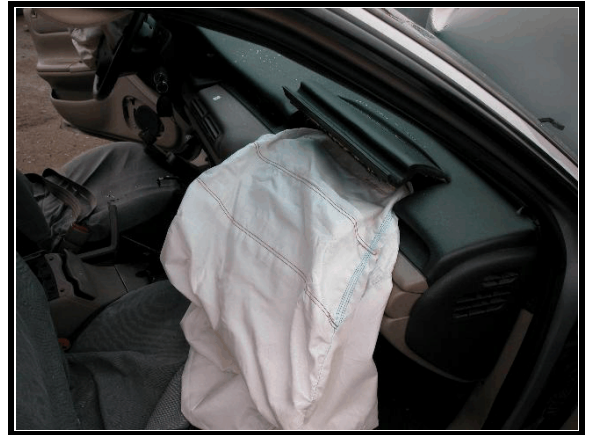
The front right passenger's air bag deployed from a top-mount module with a rectangular cover flap that was hinged at the forward aspect. The module cover flap measured 35.0 cm (13.8 in) in width and 15.0 cm (5.9 in) in height. The deployed front right passenger air bag measured 53.0 cm (20.9 in) in width and 60.0 cm (23.6 in) in height. The air bag had a maximum deployed excursion of 65.0 cm (25.6 in). The air bag will come into contact with the seat back.

**Figure 13.** Deployed front right passenger's air bag

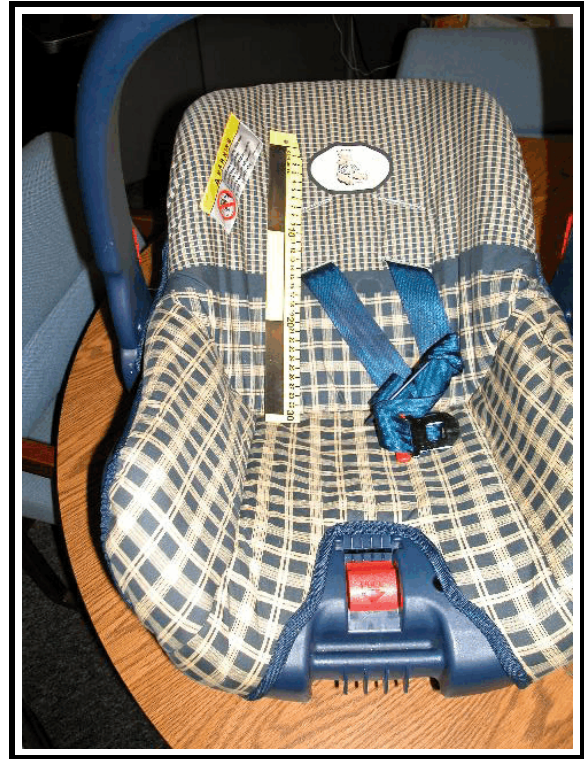
The first individual that arrived at the crash site indicated to his wife that the ISS was still firmly affixed to the case vehicle seat, but that the infant was found laying beside the ISS. It appears most likely that the infant had been placed onto the ISS without being restrained by the use of its 3-point internal harness. The medical report noted as well that it was questionable as to whether the child was restrained properly. There were no integumentary injuries to the torso or legs which would have supported the theory that the child had been properly restrained, but had somehow slid out from the 3-point harness during the crash sequence.

**Figure 14.** Evenflo Discovery Infant Safety Seat

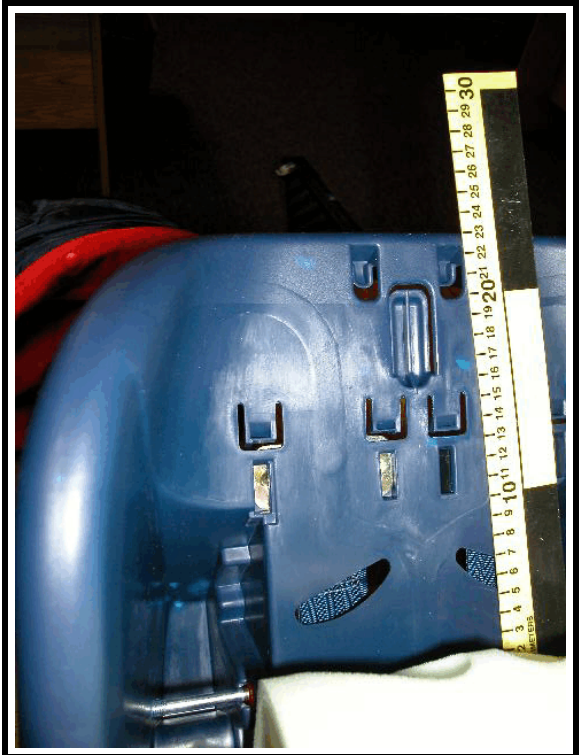
**Figure 15.** Possible stress marks to ISS seat back

The ISS did not show any visible signs of damage, except for small discolorations on the seat back that might be stress marks. There were no obvious or slight deformities to any portion of the ISS which would have indicated that it had been loose in the rear seat of the case vehicle, and unattached during the crash sequence. There was no deformation to the webbing of its internal harness, a possible indication that the infant had been buckled into the 3-point system and somehow slipped out from underneath it as the crash progressed. Nor did the infant sustain any injuries/bruising from the ISS harness which would have been likely. The retainer clip was noted to still be buckled.

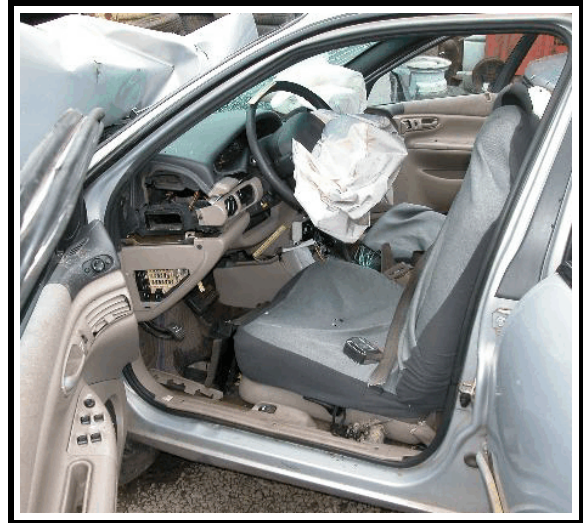
During the forward impacts, the driver moved toward the longitudinal forces. While doing so, the driver loaded the rigid knee bolster with both knees. The driver was located in very close proximity to the steering wheel, and its deploying air bag. Due to her interaction with these components, the steering wheel rim had completely collapsed to the point where the rim was 4.5 cm (1.8 in) below the center of the wheel. The driver was found entrapped between the dash and the steering wheel, and had to be extricated by emergency personnel. She subsequently expired, as did her unborn son.

**Figure 16.** Driver's seated position

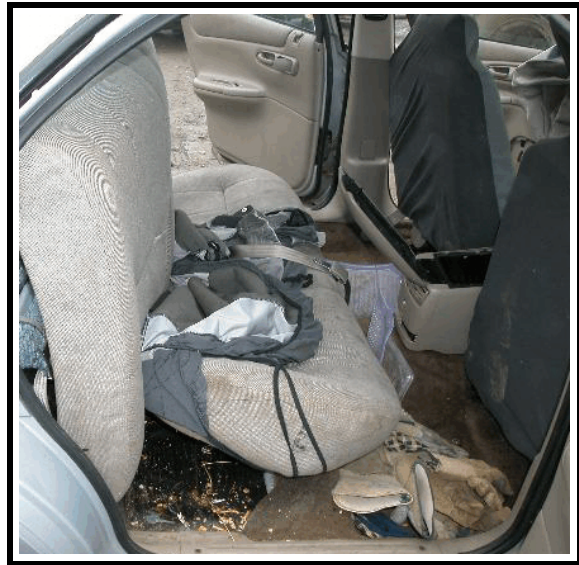
From all indications, the ISS was affixed to the case vehicle's second row middle seat by the use of the case vehicle's lap belt. The child had been placed onto the ISS, but was likely not restrained by its 3-point internal harness. During the initial front-left offset frontal impact, the vehicle rotated in a slight CCW yaw before impacting the second vehicle head-on. An eyewitness indicated that the ISS was firmly attached to the case vehicle when he observed it. The ISS itself shows no signs of having become a projectile in the vehicle interior during the crash. Although the rigid center console between the two front seats sustained damage from some object, it must be noted that there were a number of cargo items inside the vehicle that flew about during the crash. At impact with the Ford Bronco, the case vehicle decelerated rapidly and nosed downward. The vehicle seat bottom shifted upward and the seat back was deformed forward by impact forces and cargo within the trunk. The ISS rotated forward to some degree. Essentially, the ISS seat back was now more horizontal than vertical and likely acted as a ramp. Since the back of the front-right seat had sustained damage, it appears plausible that the infant struck this as he was ejected from the ISS and propelled to final rest.

**Figure 17.** Second row right seat occupant seating position

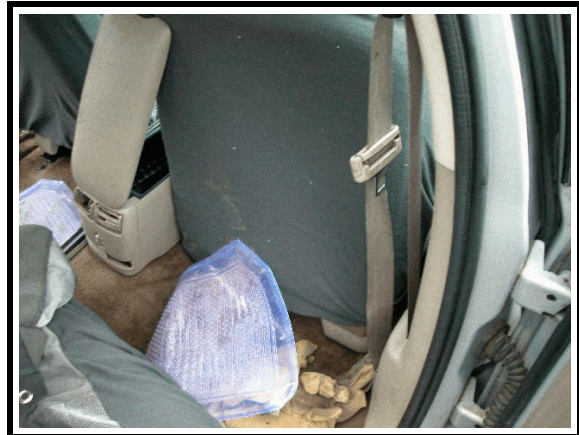
**Figure 18.** Back of front right seat
