**CALSPAN ON-SITE ADULT AIR BAG RELATED FATALITY
INVESTIGATION**

SCI CASE NO.: CA05-003

SUBJECT VEHICLE – 1996 MERCURY GRAND MARQUIS

CRASH DATE – DECEMBER 2004

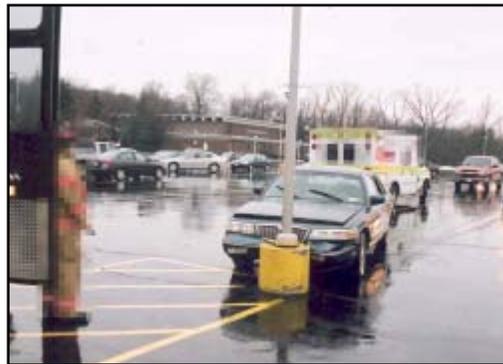
The center aspect of the Mercury's front bumper impacted the concrete base support of the light pole (**Figure 4**) resulting in a 12 o'clock impact force. The damage and trajectory algorithm of the WINSMASH program was used to calculate an impact speed of 24.1 km/h (14.9 mph). As the vehicle crushed to maximum engagement, the grille and header panel engaged the light pole, which cracked the plastic and fiberglass components. The WINSMASH output calculated a delta V for this crash of 24 km/h (14.9 mph). The longitudinal and lateral components were -24 km/h (-14.9 mph) and 0 km/h, respectively. As a result of the impact, the frontal air bag system deployed. It should be noted that impact damage was centered between the front frame rails, therefore the frontal air bag system could have deployed late in the crash event. This model year vehicle was not equipped with an Event Data Recorder (EDR) to support the late deployment. The Mercury came to rest at the point of impact, engaged against the concrete base.

Figure 4. The Mercury at impact and rest.

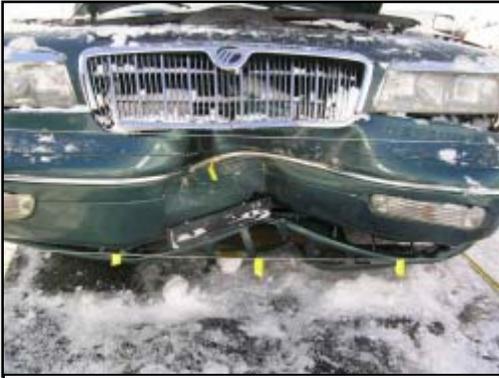
The 1996 Mercury Grand Marquis sustained moderate severity frontal damage as a result of the impact with the concrete base support (**Figures 5 and 6**). The damage consisted of longitudinal deformation of the bumper cover and reinforcement beam. The grille and header panel contacted the base of the pole, which fractured these components. The direct contact damage measured 48 cm (19.1”) which began 16 cm (6.3”) right of the centerline and extended 33 cm (12.8”) left of the centerline. Maximum crush was located 14 cm (5.5”) left of the centerline on the bumper beam and measured 32 cm (12.7”). Six equidistant crush measurements were used to document the crush at the bumper beam using a combined direct and induced damage width of 138 cm (54.5”) and were as follows: C1 = 0 cm, C2 = 19 cm (7.5”), C3 = 32 cm (12.6”), C4 = 24 cm (9.4”), C5 = 10 cm (3.9”), C6 = 3 cm (1.2”). The Collision Deformation Classification (CDC) for this impact was 12-FYEW-2.

Figure 5. Resultant damage from the pole impact.

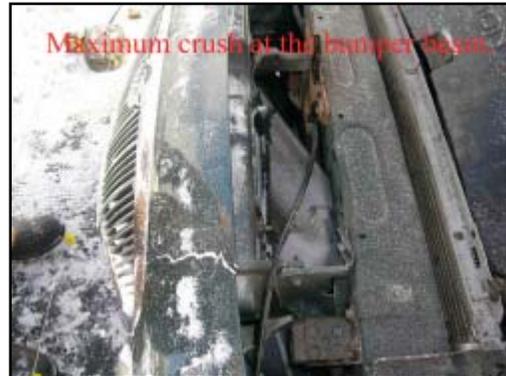
Figure 6. Close up of the impact damage.

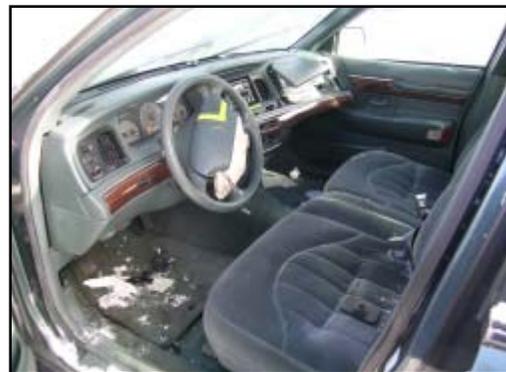
The 1996 Mercury Grand Marquis sustained minor interior damage as a result of occupant contact. There was no intrusion of the passenger compartment. **Figure 7** is an overall view of the driver's area. The driver's head contacted and fractured the windshield, which was evidenced by a tissue transfer (**Figure 8**). The fracture was located 13 cm (5”) below the windshield header and 32 cm (12.5”) inboard of the left A-pillar. Also noted was compression of the steering column, which measured 9 cm (3.5”) from the steering wheel rim to the left instrument panel. There was complete separation of the shear capsules. The left shear capsule was fractured and the compression could not be measured. The right shear capsule was compressed 7 cm (2.8”). The upper aspect of the driver's head contacted the headliner (**Figure 9**), which was evidenced by strands of hair. The first area of contact on the headliner was located

Figure 7. View of the driver's area.

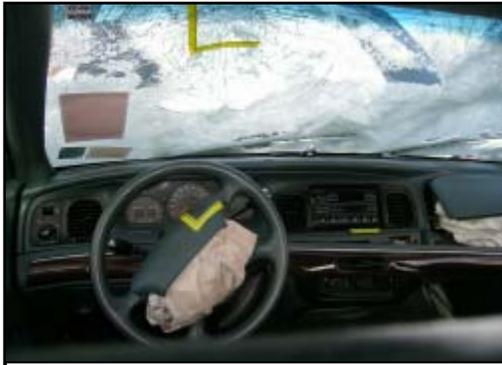
Figure 8. Driver's windshield contact.

The expansion forces redirected the driver's forward movement from the initial crash forces to an upward and rearward direction. As a result of the upward trajectory, the driver's forehead contacted and fractured the windshield directly forward of the steering assembly. This contact resulted in the frontal subgaleal contusion, mid forehead abrasion, and the laceration to the left parietal scalp. The continued expansion of the driver's air bag redirected him rearward as he rebounded into the front left seat. His head contacted the headliner, which was evidenced by strands of hair in the fabric headliner. He came to rest in the driver's seat slumped forward against the steering assembly.

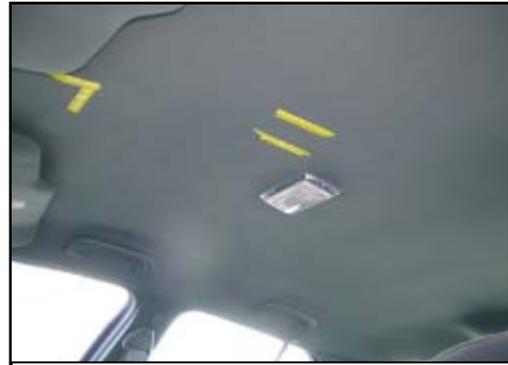
23 cm (9") rear of the windshield header and 57 cm (22.5") inboard of the left roof side rail. The second area of contact on the headliner was located 51 cm (20") rear of the windshield header and 50 cm (19.5") inboard of the left roof side rail. Also noted was a spot of body fluid on the upper air bag cover flap and a strand of hair on the center instrument panel, which did not appear to result from occupant contact.

Figure 9. Headliner contact points.

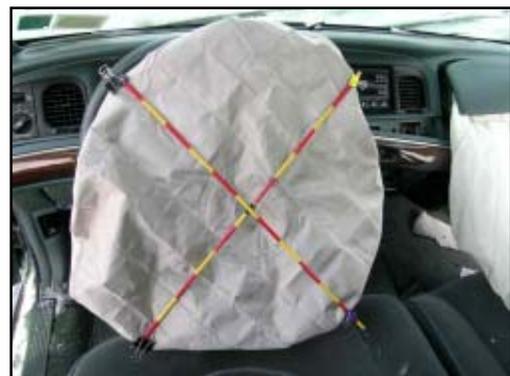
The 1996 Mercury Grand Marquis was equipped with a frontal air bag system that deployed as result of the crash (**Figure 10**). The driver's air bag was configured with asymmetrical H-configuration cover flaps. The top flap measured 17 cm (6.8") wide and 10 cm (4") in height. The lower flap was

Figure 10. Deployed driver's air bag.

17 cm (6.8”) wide by 6 cm (2.3”) in height. The diameter of the air bag was 56 cm (22”) in its deflated state. Four internal tether straps tethered the driver’s air bag. Two symmetrical vent ports vented the air bag at the 11 and 1 o’clock positions on the rear panel of the air bag. Although the driver was in a forward position at the time of deployment, there was no evidence of occupant contact to the face of the air bag membrane. A vinyl transfer from the air bag expansion from within the module was noted on the face of the air bag at the 1 o’clock sector, which was indicative of an impeded deployment.

During the early stage of deployment, the air bag membrane expanded against the driver's chest resulting in multiple bilateral rib fractures with left hemothorax, a fracture of the sternum, a laceration of the descending aortic arch, and a heart contusion. The air bag expansion in conjunction with the driver's forward trajectory in response to crash forces compressed the energy absorbing steering column 7 cm (2.8"), resulting in complete separation of the shear brackets from the mounting blocks. There was no deformation of the steering wheel rim or spokes.
