On-Site Certified Advanced 208 Compliant Crash Investigation
Dynamic Science, Inc. / Case Number: DS05005
2005 Ford Escape
Colorado
April, 2005

1. Report No. DS05005	2. Government Accession No.		3. Recipient Catalog No.	
4. Title and Subtitle On-Site Certified Advanced 208 Compliant Investigation		5. Report Date October 3, 2005

This on-site investigation focused on the performance of the Certified Advanced 208-Compliant air bag system in a 2005 Ford Escape sport utility vehicle. The multi-stage air bags were certified by the manufacturer to meet the advanced air bag requirement of Federal Motor Vehicle Safety Standard (FMVSS) No. 208. There were a total of three occupants in the Ford Escape. The front of the Ford Escape struck the right side of a Toyota Previa in an intersection crash. According to the police report, the driver of the Escape sustained “evident, non-incapacitating” injuries. There were no injuries reported for the other two case vehicle occupants. The driver of the other vehicle sustained a possible injury. There were no indications of transport for the occupants in either vehicle.

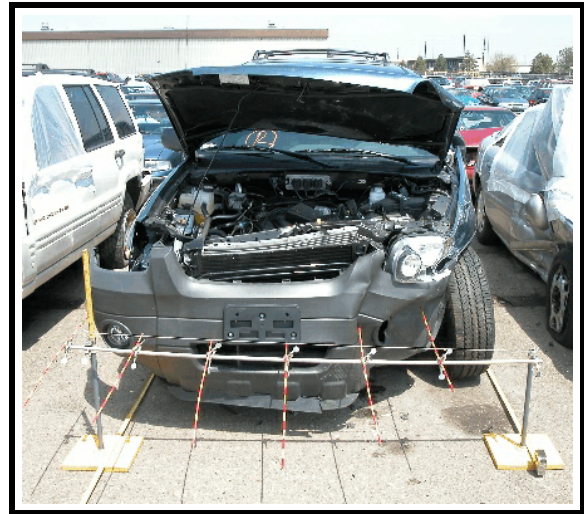
The 2005 Ford Escape sustained moderate front end damage as a result of the impact with the Toyota Previa.

Damage Description:	Moderate front end damage.	
CDC:	11FLEW2	
Delta V:	Total	21.6 km/h (13.4 mph)
	Longitudinal	-20.3 km/h (-12.6 mph)
	Latitudinal	7.4 km/h (4.6 mph)
	Energy	18,002 joules (13,278 ft lbs)

The Ford Escape sustained 21.0 cm (8.3 in) of direct damage along the front bumper beginning at the left bumper corner and extending to the right. Six crush measurements were documented along the front bumper as follows: C1=20.0 cm (7.9 in), C2=10.0 cm (3.9 in), C3=0.0 cm (0.0 in), C4=0.0 cm (0.0 in), C5=0.0 cm (0.0 in), C6=0.0 cm (0.0 in).

Figure 5. Front, 2005 Ford Escape

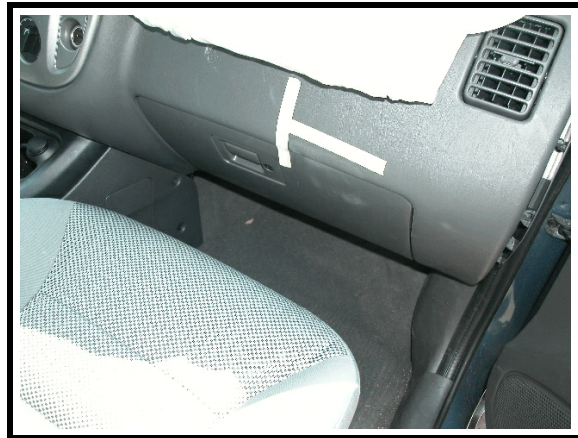
The 2005 Ford Escape sustained minor interior damage due to occupant contacts and normal air bag deployment related damage. There were scuffs on the right instrument panel and glove box. There were scuffs to the rear of the center console and to the right side of the front right seat back.

Figure 6. Contact to the right instrument panel and glove box

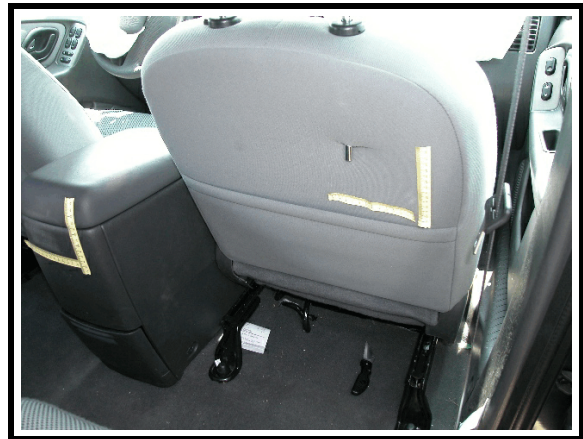
Figure 7. Contacts to right seat back and center console

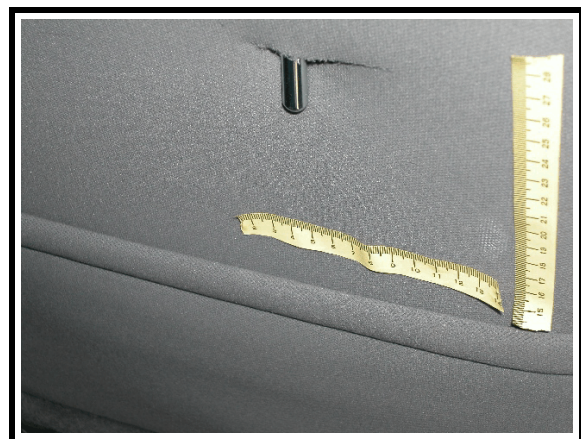
The contact to the seat back caused the head rest adjustment bar to push through the fabric.

Figure 8. Closeup of contact and damage to right seat back

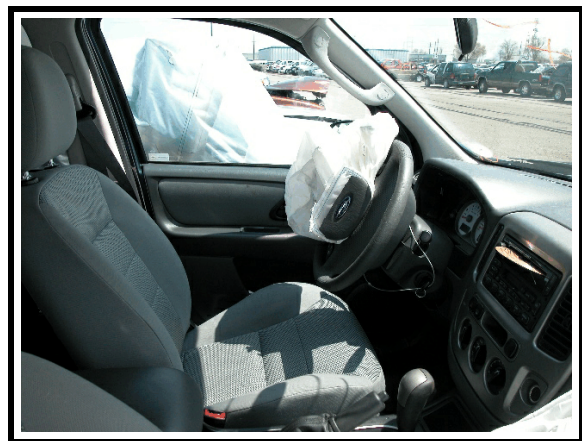
The driver's air bag was mounted in the center of the steering wheel hub. The air bag module had an H configuration. The top flap measured 15.0 cm (5.9 in) wide by 8.5 cm (3.3 in) high. The bottom flap measured 15.0 cm (5.9 in) wide by 6.0 cm (2.4 in) high. The air bag was somewhat oval in shape and measured 52.0 cm (20.5 in) high and 45.0 cm (17.7 in) wide in its deflated state. The air bag had a single internal tether. There were two circular vent ports on the back of the bag at the 3 and 9 o'clock positions.

Figure 9. Side view of driver's air bag

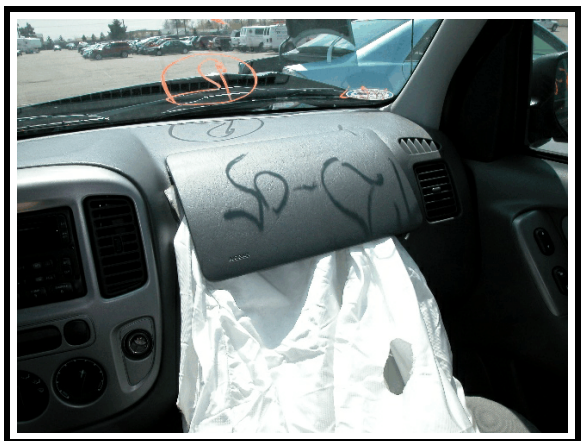
The right front passenger air bag was a mid instrument panel mount. The module had a single forward opening cover that was rectangular in shape and measured 73.0 cm (28.7 in) wide by 33.0 cm (12.9 in) high. The air bag measured 33.0 cm (12.9 in) seam to seam laterally and was 68.0 cm (26.8 in) high. The air bag had a maximum excursion of 65.0 cm (25.6 in) in its deflated state. There were two circular vent ports on the sides of the air bag at the 3 and 9 o'clock positions. There was no damage to either air bag or to the air bag module covers.

Figure 10. Front right passenger's air bag

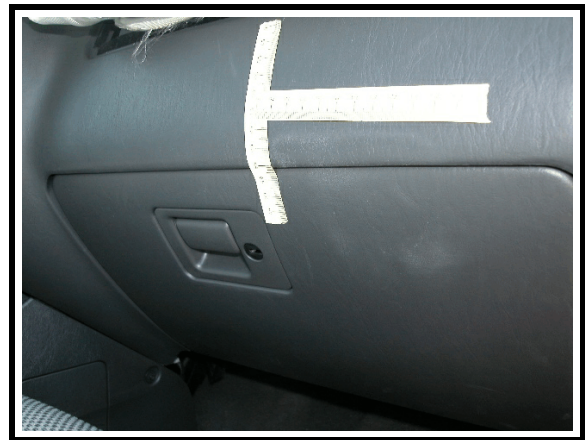
The 15-year-old front right passenger was seated forward facing in the cloth covered bucket seat. The seat was adjusted to the middle track position. The head restraint was slightly above the full down position. He was not wearing the available 3-point lap and shoulder belt. This is based on the lack of loading evidence and the non-actuation of the seat belt pretensioner. The seat back was reclined at a 25 degree angle from the vertical and the seat bottom had a 15 degree angle from the horizontal. At impact, the front right passenger's front air bag deployed. The front right passenger initiated a forward and slightly lateral trajectory towards the 11 o'clock direction of force. It appears that his right knee struck and scuffed the right instrument panel and right glove box. There were no indications of any injuries to this occupant. The occupant was able to exit the vehicle on his own.

Figure 11. Closeup of contact to the right instrument panel and glove box

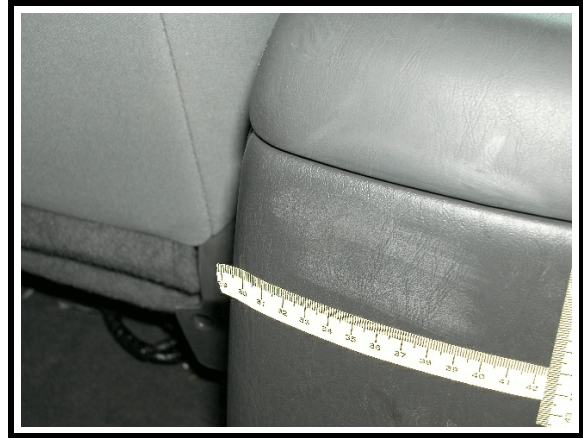
belt. This is based on the lack of seat belt loading evidence and the occupant contacts found on the back of the front right seat and the center console. The seat back was reclined at a 20 degree angle from the vertical and the seat bottom had a 15 degree angle from the horizontal. At impact, this passenger initiated a forward and slightly lateral trajectory towards the 11 o'clock direction of force. It appears that his right knee struck and scuffed the front right passenger's seat back. His left knee likely engaged and scuffed the back of the center console. There were no indications of any injuries to this occupant. The occupant was able to exit the vehicle on his own.

Figure 12. Closeup of contact to back of center console
