Rear Seat Occupant Protection Investigation / Vehicle to Object
Dynamic Science, Inc. / Case Number: DS05006
1998 Ford Escort
Washington
April 2005

Dynamic Science, Inc.
Accident Investigation
Case Number: DS05006

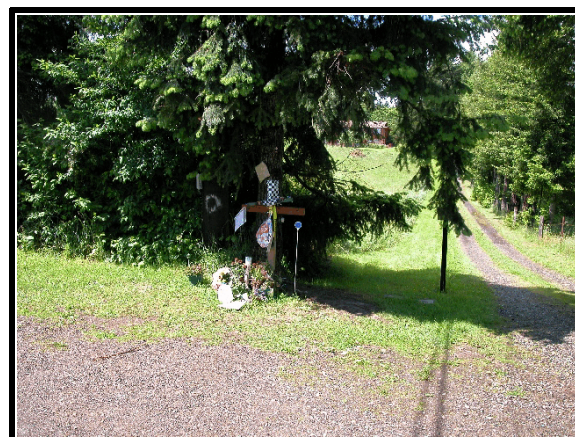
As the vehicle entered a left hand curve, the driver lost control. The Escort departed the roadway and struck a tree with its front end (12FCEW4). The impact resulted in sufficient longitudinal deceleration of the Escort to command the deployment of the frontal air bag system. The barrier routine of the WinSmash program computed a longitudinal delta V of -69.0 km/h (42.9 mph)¹. The Escort rebounded slightly and came to rest near the tree.

Figure 3. Point of impact with tree

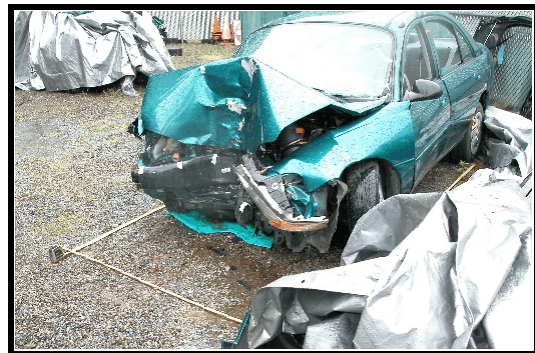
The 1998 Ford Escort sustained major front end damage as a result of the impact with the tree. The direct damage began 39.9 cm (15.7 in) from the right front bumper corner and measured 32.0 cm (12.6 in) in width. There was damage to the hood, grille, and radiator. There was remote buckling to the right roof/B pillar area. All four doors were jammed shut. The left wheelbase was shortened by 25.9 cm (10.2 in); the right by 13.0 cm (5.1 in). Both front tires were restricted. The front right tire was deflated. The windshield was cracked due to impact forces and from contact with the passenger air bag module cover.

Figure 4. Front left, 1998 Ford Escort

Six crush measurements were documented at the bumper level as follows: C1=16.0 cm (6.3 in), C2=45.0 cm (17.7 in), C3=76.0 cm (29.9 in), C4=77.0 cm (30.3 in), C5=37.0 cm (14.5 in), C6=27.0 cm (10.6 in).

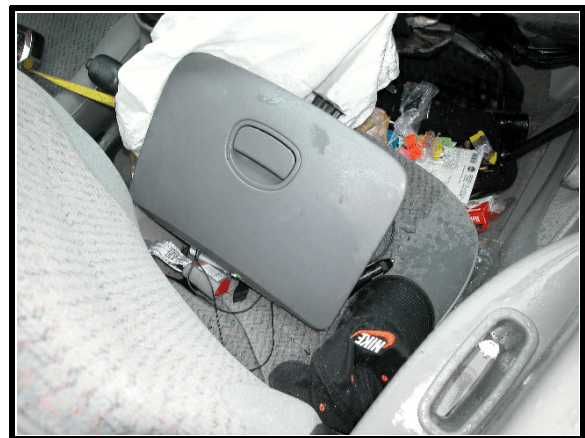
The 1998 Ford Escort sustained moderate interior damage as a result of passenger compartment intrusion and occupant contacts. There was toe pan intrusion on both the right and left sides. Both front seat backs were deformed forward due to rear occupant loading. The seat bight area for the entire rear seat was slightly forward of its normal position. The glove box had opened and was broken away. The lower right instrument panel was scuffed from a right knee contact.

Figure 5. Damage to glove box

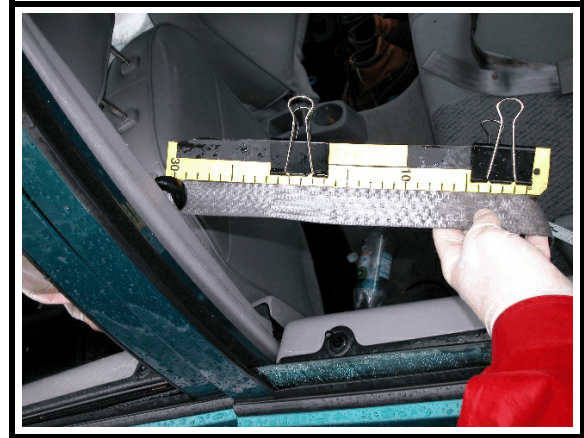
Figure 6. Loading to driver's seat belt—viewed through left rear window

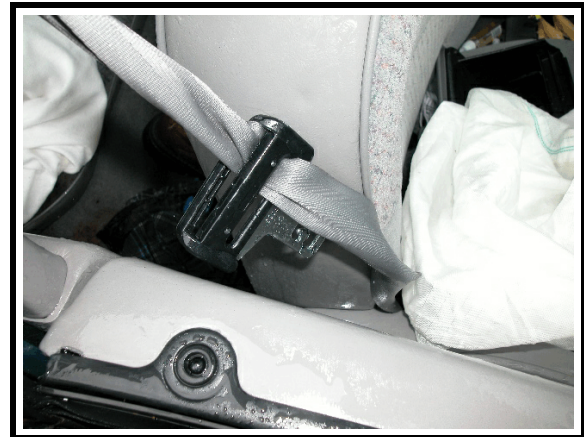
Figure 7. Front right passenger seat belt, webbing trapped in latch plate

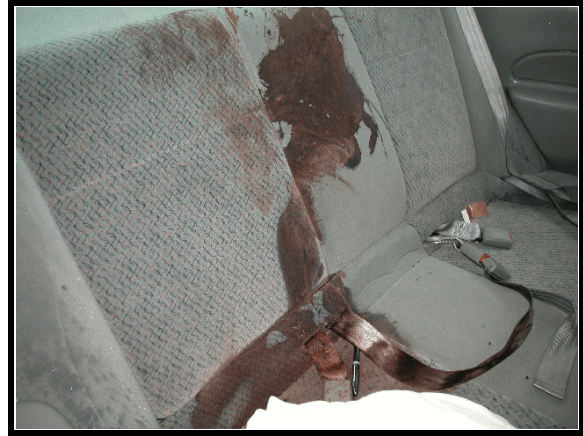
The middle rear seat was configured with a manual Type 1 lap seat belt assembly intended for pelvic restraint. The police measured the circumference of the latched lap belt as 83.8 cm (33 in). During the vehicle inspection, the seat belt length on the right side was measured as 68.0 cm (26.7 in) from the seat bight to the latch locking bar and on the left side was measured as 15.5 cm (6.1 in) from the seat bight to the end of the latch. The belt was measured while latched; the maximum excursion was 40.0 cm (15.7 in) with a base of 36.0 cm (14.2 in). The pathologist measured the waist size of the middle rear occupant as 71.1 cm (28.0 in). Several calculations were made to determine the extent of slack in the belt relative to the occupants's waist size.

Figure 9. Second row middle seat position and lap belt

Area	% difference
Occupant waist circumference = 28 in	62.3 sq in	NA
Police measured lap belt circumference = 33 in	86.7 sq in	+21.2
Maximum belt excursion of 15.7 in with a base of 14.2 in	106.4 sq in	+32.3

At the time of the police investigation, the lap belt was found still latched with the webbing toward the forward aspect folded in half – with the bottom of the fold toward the occupant.

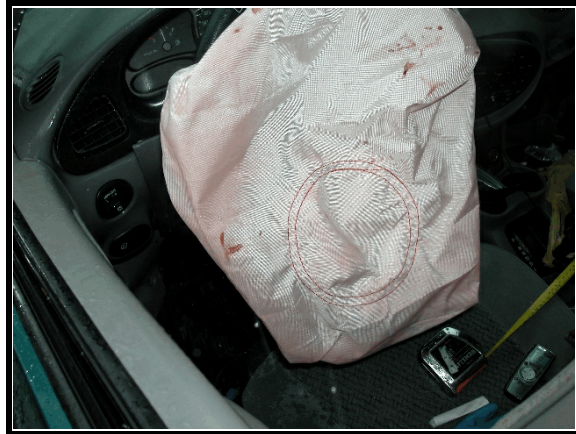
The driver's air bag deployed from the center of the steering wheel hub through symmetrical H-configuration module cover flaps. The top flap measured 20.0 cm (7.9 in) wide and 8.5 cm (3.3 in) high. The bottom flap measured 20.0 cm (7.9 in) wide and 10.5 cm (4.1 in) high. The deployed driver's bag measured 51.0 cm (20.0 in) in its deflated state. The air bag was tethered by a single internal strap attached to the circular stitching in the center of the air bag. Two circular vent ports were located at the 11 and 1 o'clock aspects on the rear of the air bag. There was no air bag or module cover damage. There were blood drops found on the left aspect of the air bag face.

Figure 10. Driver's air bag—top of bag is to the right

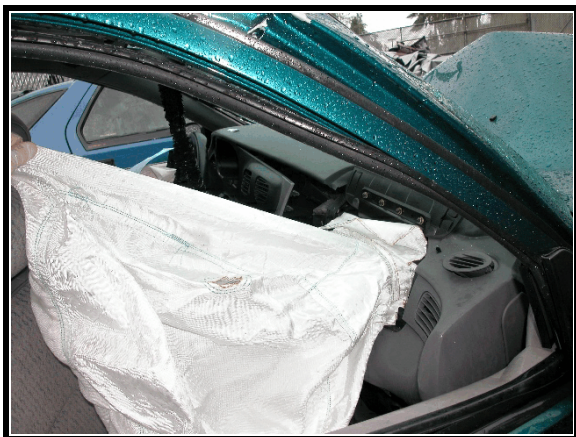
The front right passenger's air bag deployed from a top mount module with a curved rectangular cover flap that was hinged at the forward aspect. The module cover flap measured 31.0 cm (12.2 in) wide by 15.0 cm (5.9 in) high. The deployed front right passenger's air bag measured 41.0 cm (16.1 in) wide seam-to-seam, 90.0 cm (35.4 in) high, and with a maximum excursion of 84.0 cm (33.0 in). There were no tethers. Two circular vent ports were located at the 3 and 9 o'clock aspects of each side panel. The air bag was undamaged. There was scuffing damage to the bottom right cover of the air bag module that likely came from contact with the windshield during deployment.

Figure 11. Front right passenger's air bag

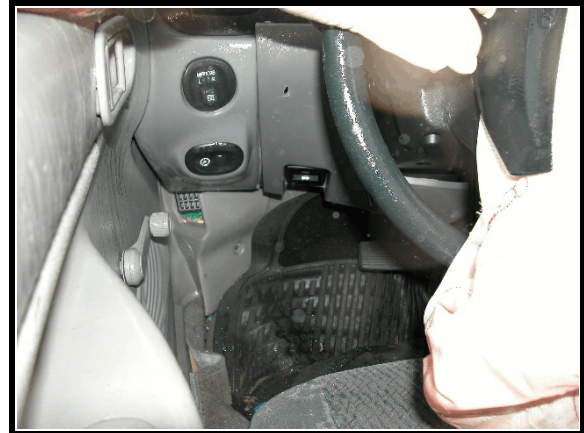
Figure 12. Left lower instrument panel and toe pan

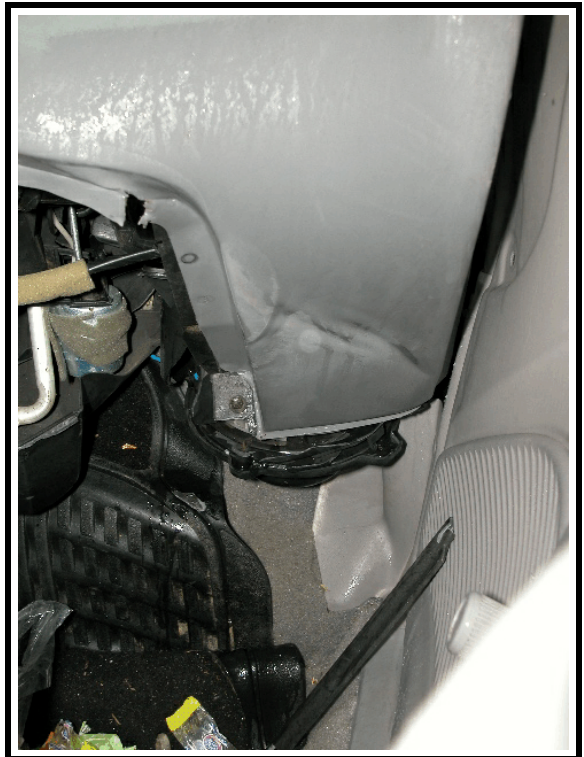
Figure 13. Contact to front right instrument panel, next to glovebox

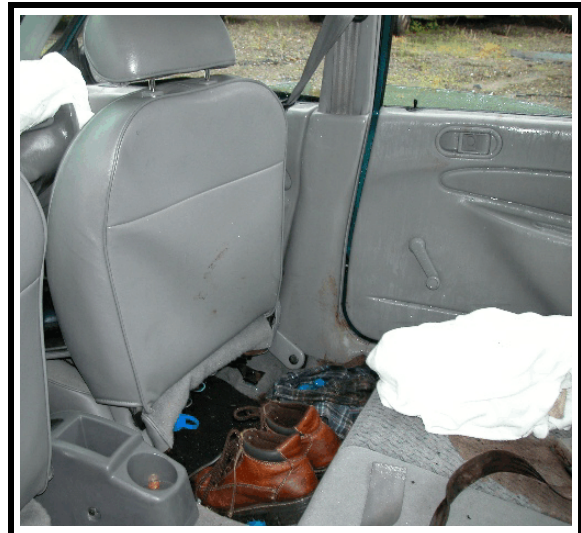
Figure 15. Second row right seat position, deformation to front right seat back

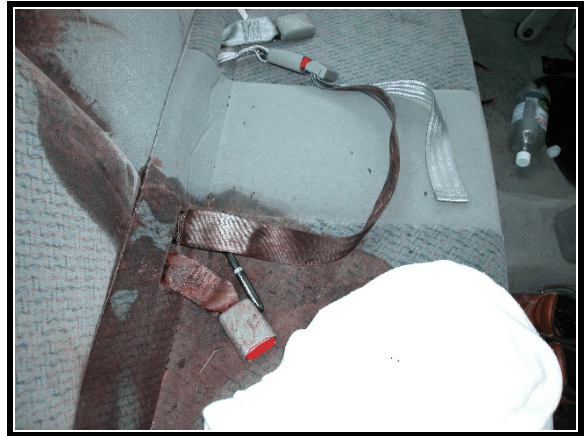
The 22-year-old second row middle male occupant (157 cm/62 in, 68 kg/150 lbs) was seated in an upright posture and was loosely restrained by the manual lap belt. As indicated earlier, there was considerable slack in the belt. He was wearing a cloth belt with a spring type metal buckle. This belt can be released by pressing on one end. He appears to have been wearing the manual lap belt at the abdomen level—above the iliac crests. At impact, he pitched forward sharply, jack knifing about the lap belt. As he engaged the lap belt, the belt folded in half with the fold facing towards the occupant. The thin metal of the buckle may have caused the initial tearing of the skin. The transection began just below the umbilicus. The spine was separated at L2. The ascending aorta was separated at T12. The torso came free and struck the backs of the front seats. The torso then came to rest behind the front right seat, face down. According to the investigating officer, the remainder of this occupant's body remained in place on the seat. The lap belt remained latched throughout the crash. This occupant passed away moments after the crash.

Figure 17. Second row middle seat position with lap belt latched

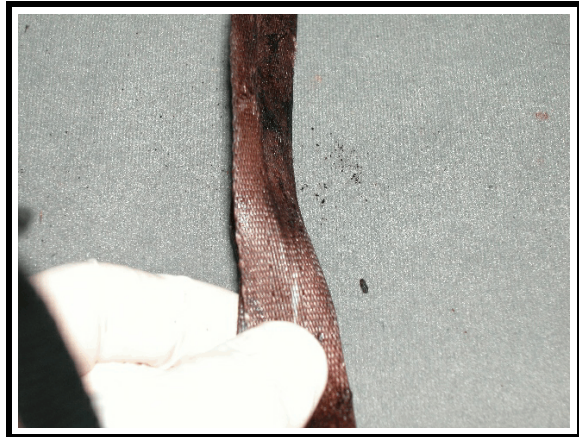
Figure 18. Belt webbing folded over due to loading
