School Bus Investigation/Vehicle to Vehicle
Dynamic Science, Inc./Case Number: DS05010
2003 Bluebird Micro-Bird - GMC Savana Cutaway Van
Utah
June 2006

1. Report No. DS05010	2. Government Accession No.	3. Recipient Catalog No.	
4. Title and Subtitle School Bus Investigation		5. Report Date August 25, 2006

The focus of this on-site investigation was the performance of a 2003 Bluebird Micro-Bird school bus that was involved in a head-on crash with a semi tractor-trailer. The crash occurred at 1511 hours on a two-lane, two way highway in a rural area of Utah. The school bus was being driven by a 22-year-old male. The bus had sixteen additional occupants, two adult counselors and fourteen children. The children were being transported back to a summer camp after a day of swimming. The driver of the bus was restrained with a 3-point manual lap and shoulder belt. This Bluebird Micro-Bird bus did not originally have seat belts in any of the passenger seats, but the owners of the bus had manual lap belts installed in all sixteen passenger seat locations. According to police investigators, some of the children and/or adults were wearing the lap belts, but the police report did not indicate

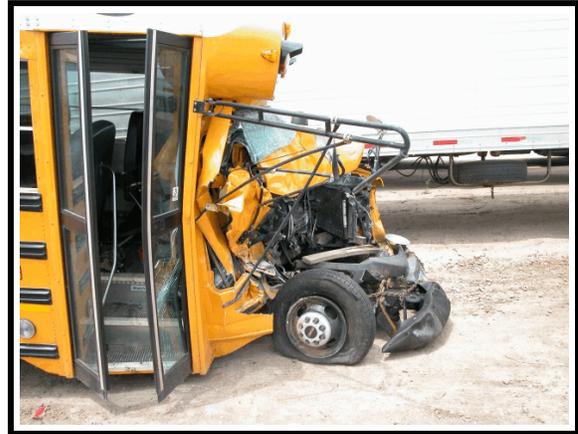
Damage Description: The bus sustained severe front end damage as a result of the impact with the semi tractor-trailer. The 2003 Bluebird Micro-Bird sustained 90.0 cm (35.4 in) of direct damage beginning at the right front bumper corner, extending along the front bumper to the left. The semi tractor overrode the front bumper of the school bus. The location of maximum crush was at the right front bumper corner and measured 50.0 cm (19.7 in) at the bumper and 146.0 cm (57.5 in) at the radiator upper support, averaged to 98.0 cm (38.6 in). Six crush measurements were documented along the front bumper and above the front bumper at the radiator upper support. There was a difference of greater than 13.0 cm (5.1 in) of crush at all of the C locations except C1. The averaged front crush was as follows: C1=37.0 cm (14.6 in), C2=39.5 cm (15.6 in), C3=54.0 cm (21.3 in), C4=79.5 cm (31.3 in), C5=83.5 cm (32.9 in), C6=98.0 cm (38.6 in).

Figure 7. Front right damage

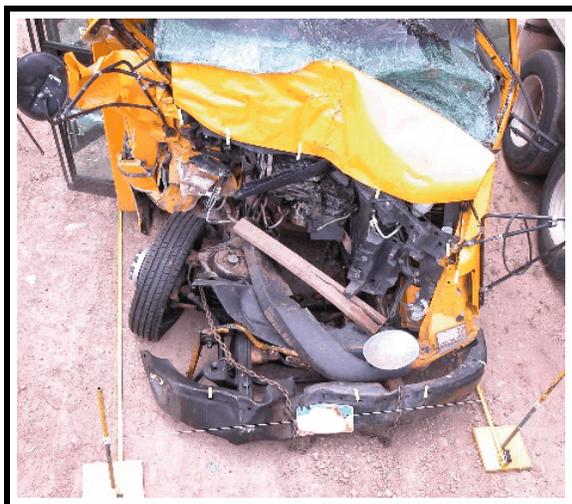
Figure 8. Front end damage

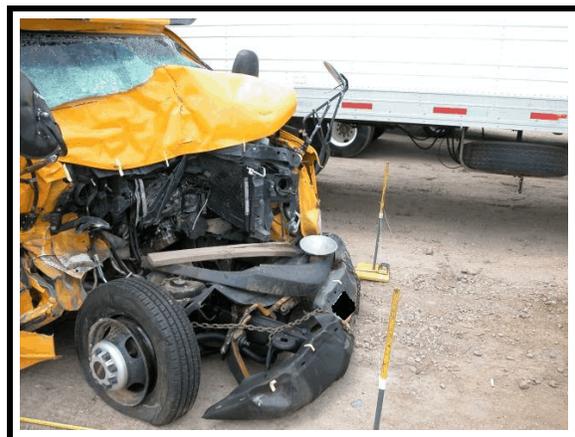
Figure 9. Crush profile

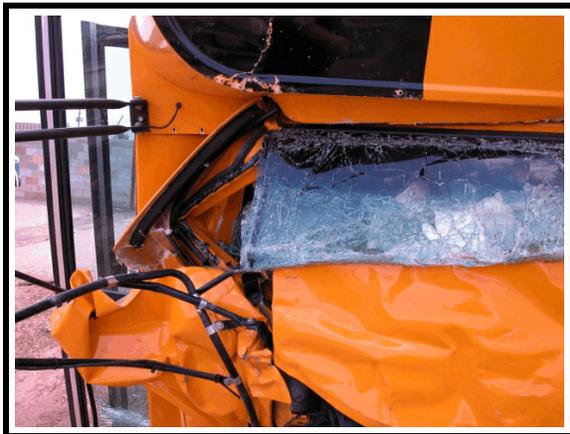
There was integrity loss to the windshield and to the right side entrance door due to damage and resulting intrusion that occurred during the front end impact. The right entrance doors were stuck partially open and the bottom glazing in the lower right entrance door was cracked and deformed. The passenger compartment rearview mirror was cracked but remained in place. There were scuffs and indentations to nearly all of the seat backs in rows 2- 4. See Figure 13 for more information on the type and location of seat back occupant contacts that were found during the inspection. There were several bloodstains found in the passenger compartment interior.

Figure 12. Windshield integrity loss - right side

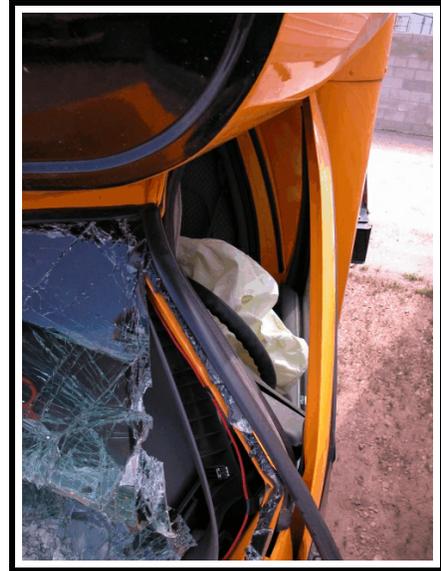
The driver's front air bag deployed as a result of the impact between the two vehicles. There was no damage or contact evidence located on either side of the air bag. Due to instrument panel intrusion, the steering wheel had shifted 15.0 cm (5.9 in) to the left.

Figure 10. Damage to steering wheel/column and windshield integrity loss

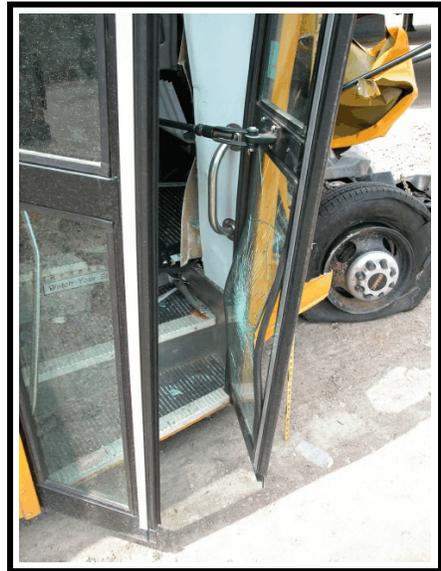
Figure 11. Damaged front entrance door

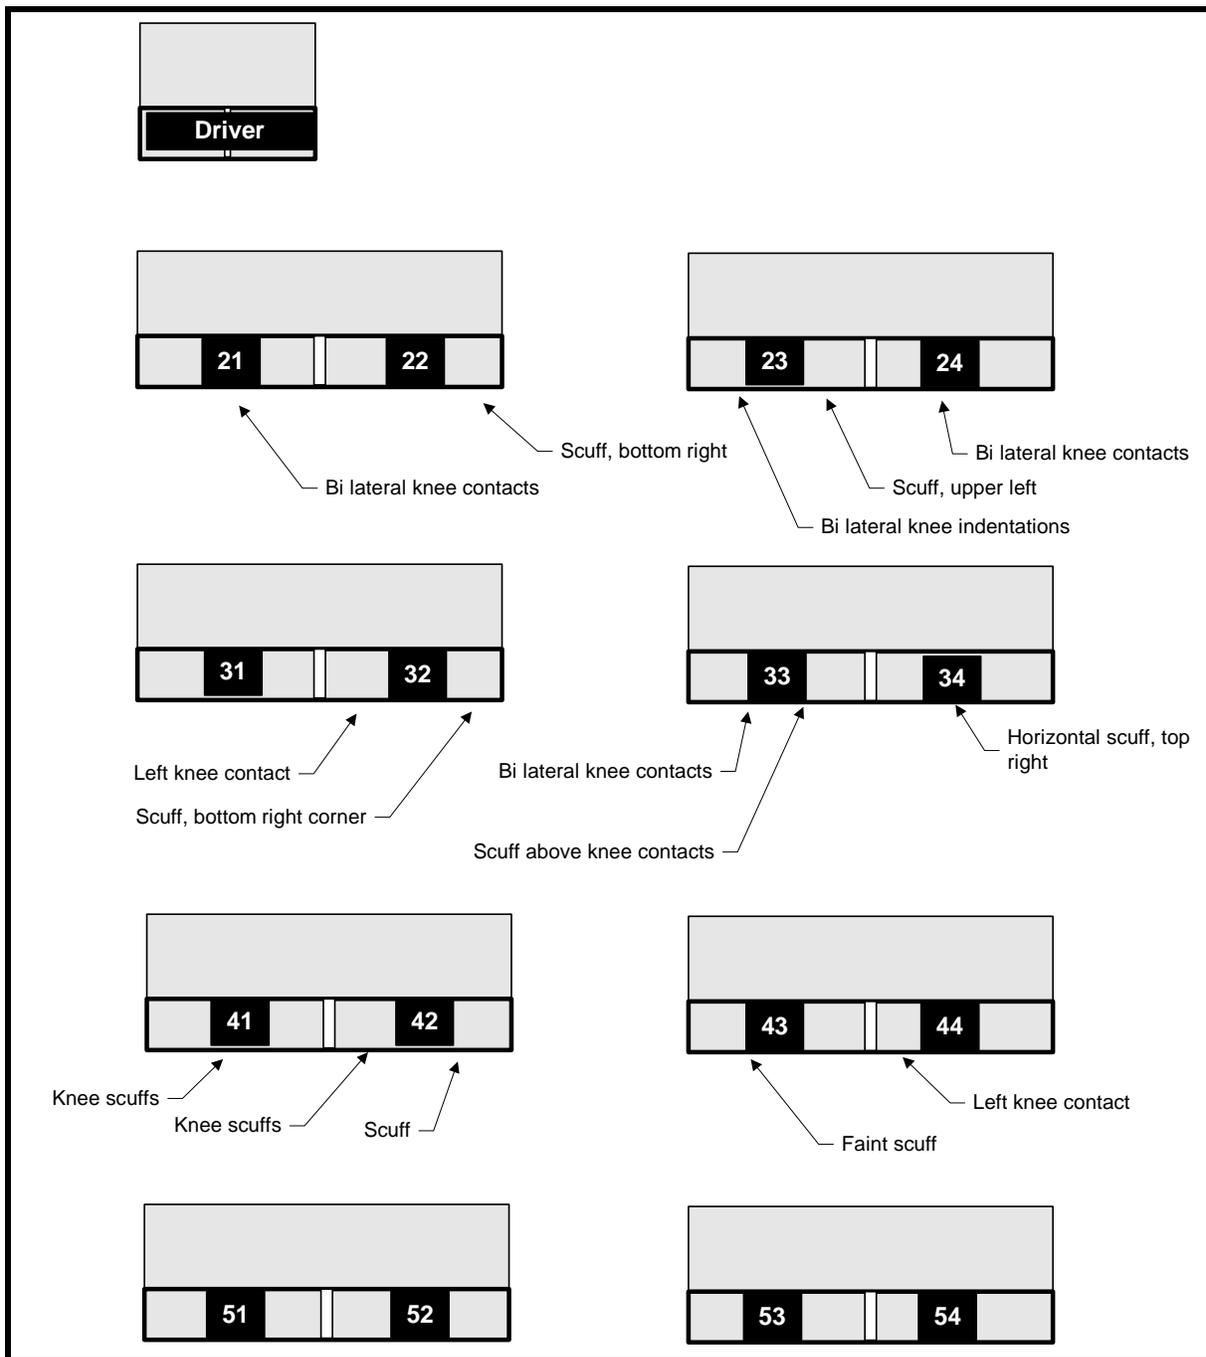
Figure 13. Occupant contact points

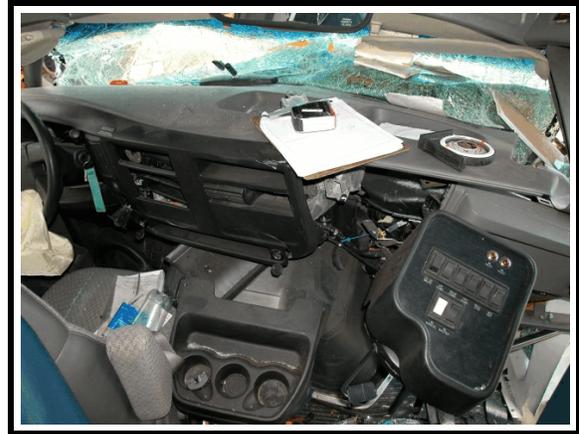
There was intrusion of multiple components into the passenger compartment. The steering wheel, instrument panel, toe pan and engine cowl intruded longitudinally into the driver's seating area. The instrument panel and engine cowl also intruded longitudinally into the right front area. Many of the seat backs intruded into the seating areas of other passengers, due to occupant contact. Please see Figure 15 for more information on the post-crash seat back angles of each of the bucket seats. The specific passenger intrusions were documented as follows:

Figure 14. Instrument panel damage/intrusion

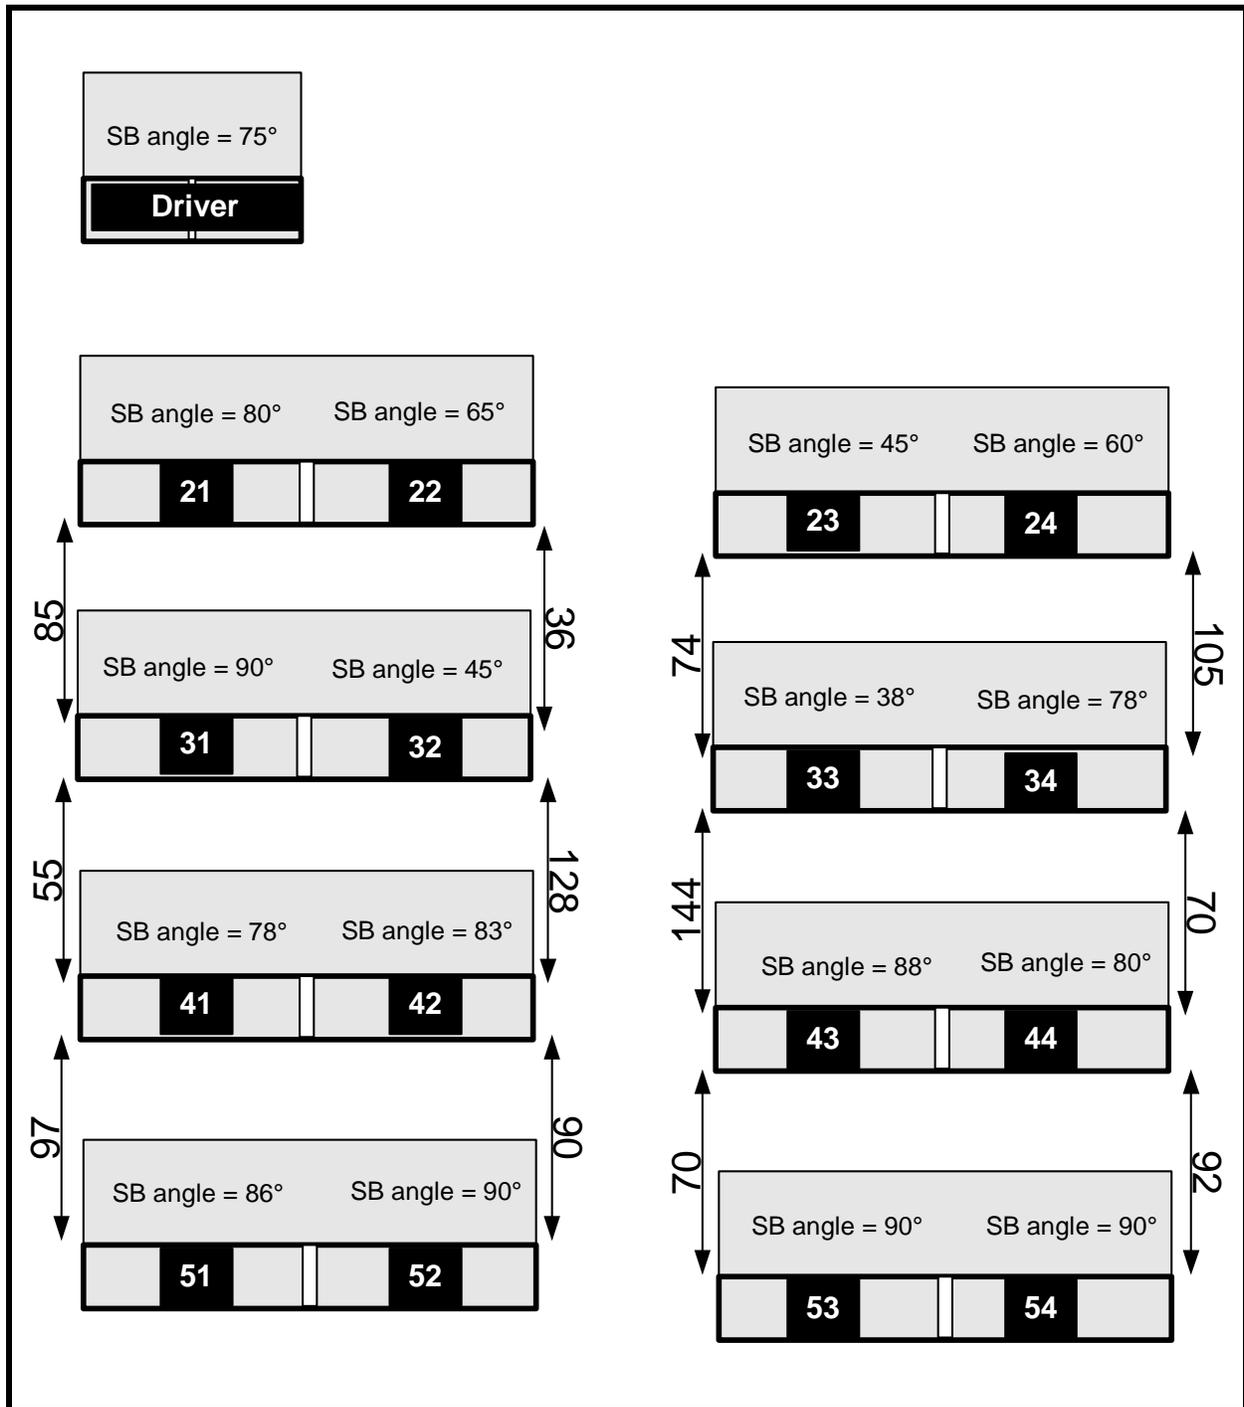
Figure 15. Post-crash seat back angles and distances between seat backs

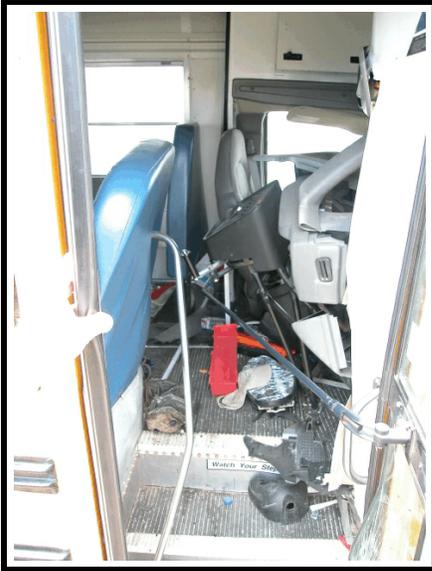
Figure 16. Instrument panel intrusion and damage to the right front door mechanics

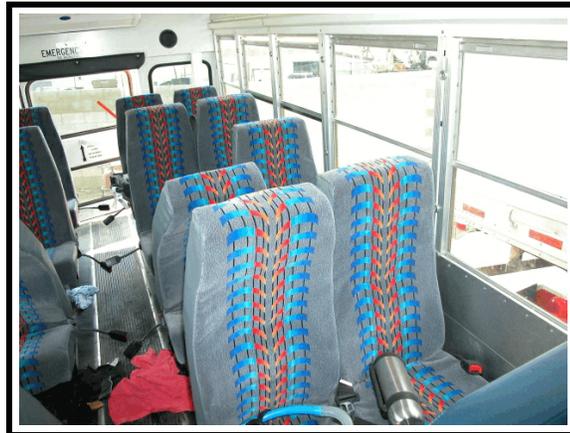
Figure 17. Passenger seat damage - left side

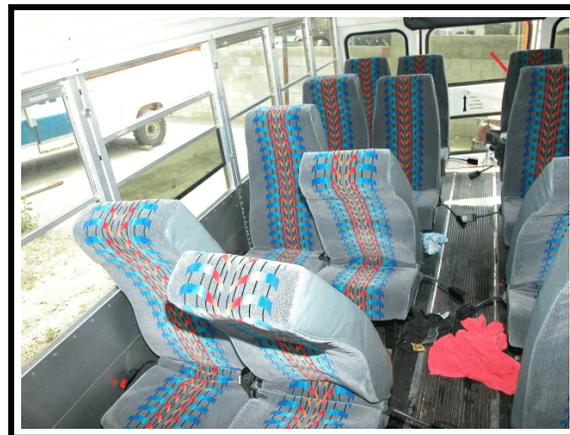
Figure 18. Passenger seat damage - right side

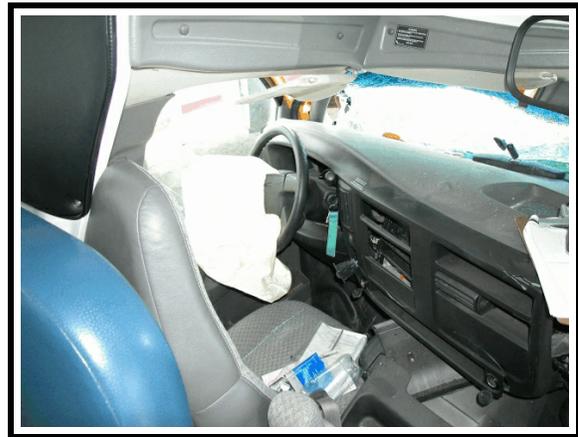
The 2003 Bluebird/GMC 3500 was equipped with a driver frontal air bag. During the impact, the driver's air bag deployed from the center of the steering wheel through symmetrical H-configuration module cover flaps. Each flap measured 11.5 cm (4.5 in) in height and 7.0 cm (2.8 in) in width. The deployed air bag measured 44.0 cm (17.3 in) in diameter in its deflated state. The air bag was tethered by a single internal tether. Two circular vent ports were located at the 11 and 1 o'clock aspects on the rear of the air bag. The deployed air bag was not damaged and showed no signs of occupant contact.

Figure 23. Driver's air bag

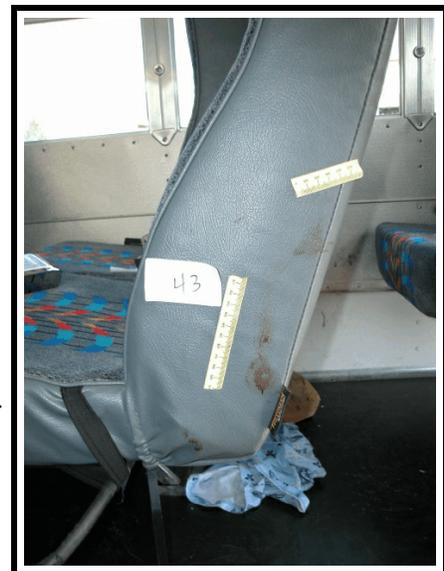
Figure 39. Blood (likely from this occupant) on seat back, Seat 43
