# INDIANA UNIVERSITY

## ON-SITE CHILD SAFETY SEAT INVESTIGATION

CASE NUMBER - IN-05-013  
LOCATION - MICHIGAN  
VEHICLE - 1994 FORD ESCORT LX STATION WAGON  
CRASH DATE - December 2004

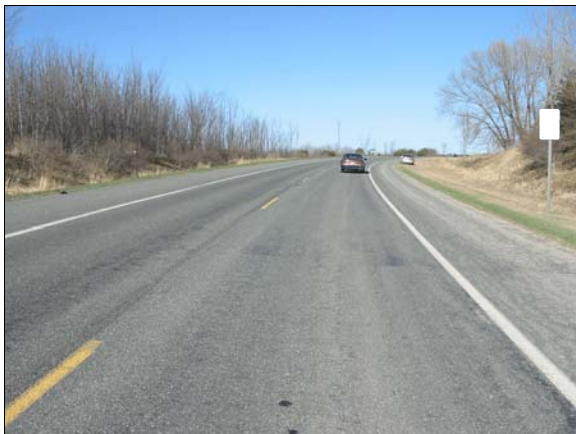
**Pre-Crash:** The case vehicle was traveling northeast in the northeastbound lane in a right curve (**Figure 1**). The Chevrolet was traveling southwest in the southwestbound lane (**Figure 2**). The case vehicle's driver was intending to continue northeastbound. The Chevrolet's driver was intending to continue southwestbound. According to a southwestbound witness, the case vehicle entered the southwestbound lane and traveled almost off the north side of the roadway before the driver steered back to the right. The witness vehicle nearly collided with the case vehicle. The Chevrolet was directly behind the witness vehicle, and the Chevrolet's driver steered left and braked in an attempt to avoid the crash. It is not known what, if any, avoidance actions were taken by the case vehicle's driver. The crash occurred in the southwestbound lane near the center line (**Figure 3**).

**Figure 1:** Overview of case vehicle's northeastbound approach

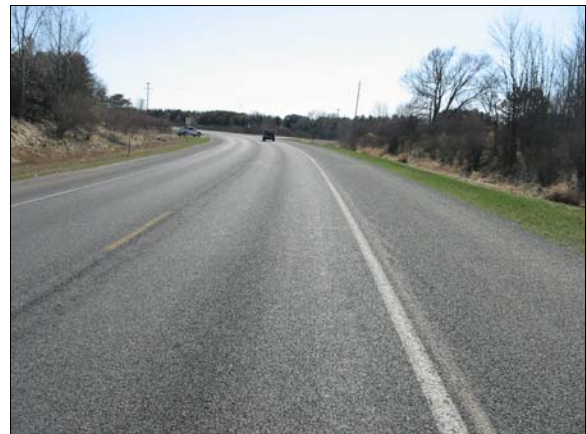
**Figure 2:** Overview of Chevrolet's southwestbound approach

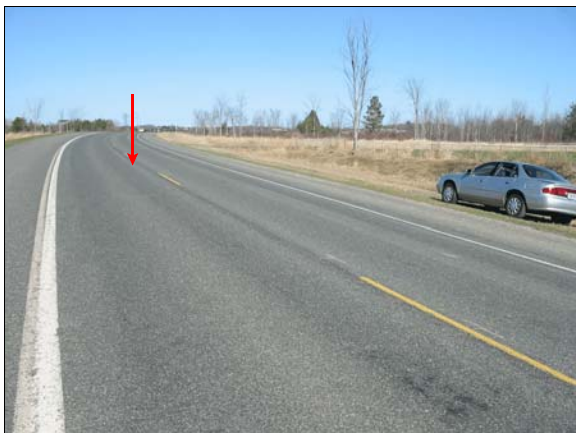
**Figure 3:** Approach of case vehicle to area of impact (arrow), view northeast

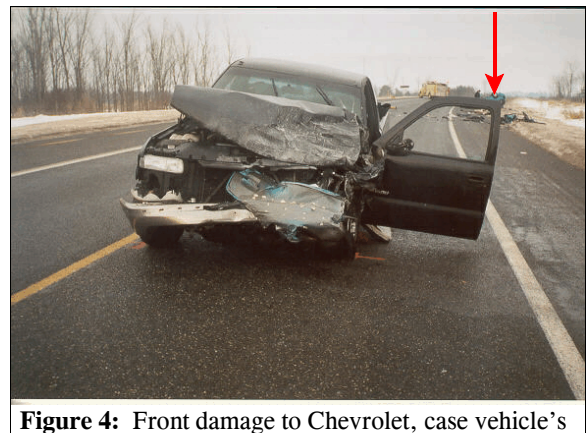
**Figure 4:** Front damage to Chevrolet, case vehicle's driver door sheet metal is jammed on bumper, arrow shows rest position of case vehicle, view northeast

**Crash:** The front of the Chevrolet (**Figure 4**) impacted the left side of the case vehicle (**Figures 5 and 6** below). The initial contact with the case vehicle began just behind the left front wheel. The impact tore the left front door, left rear door, left quarter panel and left rear wheel off the case vehicle. The impact caused the case vehicle's driver air bag to deploy. The Chevrolet's driver air bag also deployed. As a result of the impact, the case vehicle rotated counterclockwise across

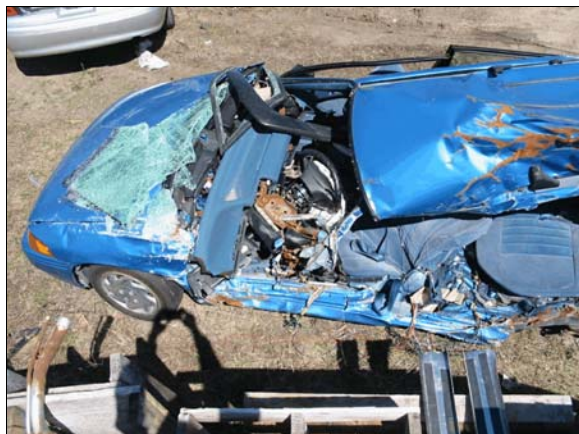
**Figure 5:** Damage to left side of case vehicle due to impact with the Chevrolet

**Exterior Damage:** The case vehicle's impact with the Chevrolet involved most of the left side. The direct damage began 8 centimeters (3.1 inches) rear of the left front axle and extended 432 centimeters (170 inches) rearward along the left side. The left front door, left rear door, left side

pillars, quarter panel and left rear wheel were torn off the vehicle by the impact. In addition, the direct damage involved the left side of the roof. No crush measurements could be taken due to the missing left side structural components. The wheelbase on the case vehicle’s left side was extended 10 centimeters (3.9 inches) while the right side wheelbase was shortened 1 centimeter (0.4 inches). There was direct damage to the hood, roof, right quarter panel and roof side rail from the rollover. The induced damage involved the hood, both fenders, roof, tailgate, and right quarter panel. The windshield’s glazing was also separated from the vehicle.

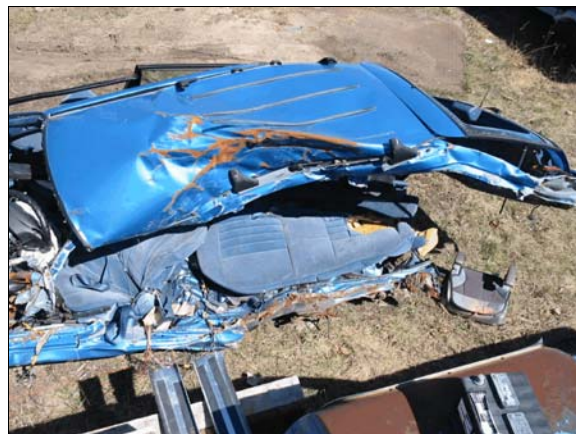
**Figure 6:** Damage to left side of case vehicle due to impact with the Chevrolet

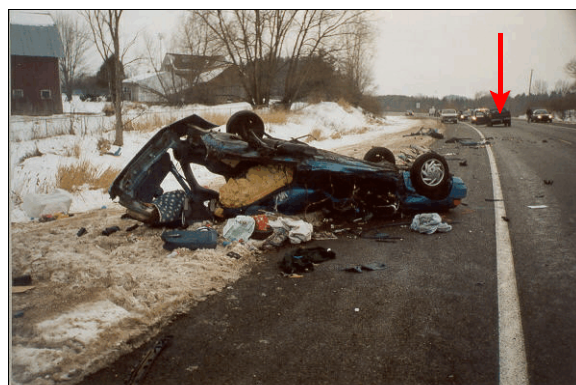
**Post-Crash:** The case vehicle came to rest on its roof facing northwest on the south side of the roadway (**Figure 7** below). The front portion of the case vehicle was on the bituminous shoulder and the rear half was on the snow covered roadside. The Chevrolet continued southwest bound and came to rest in the northeastbound lane facing slightly southwest (**Figure 4** above and **Figure 7**).

**Figure 7:** Case vehicle's final rest position, arrow shows rest position of Chevrolet, view southwest

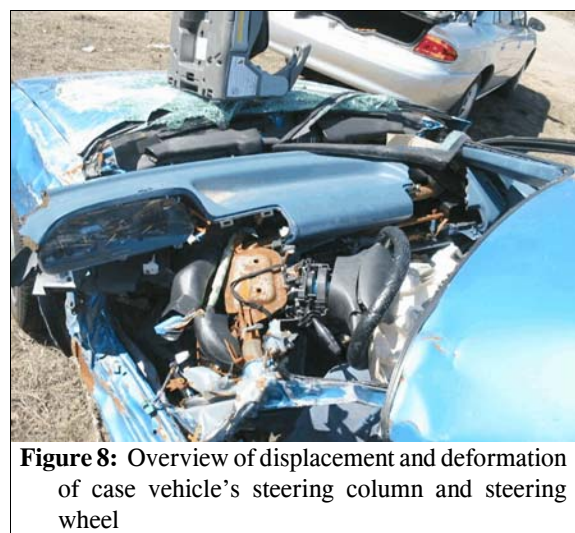
**Figure 8:** Overview of displacement and deformation of case vehicle’s steering column and steering wheel

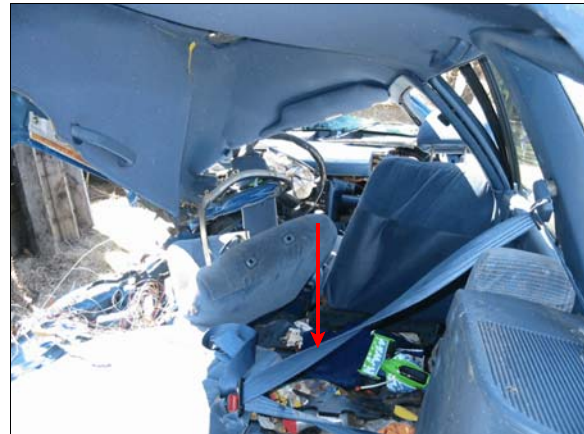
**Vehicle Interior:** Inspection of the case vehicle’s interior revealed blood deposit and a possible scuff on the ceiling to the right of the dome light. No other evidence of occupant contact was observed. There was likely driver contact to the left front door. However, the left front had been torn off in the crash and was not present at the case vehicle inspection. There was significant deformation of the steering wheel and lateral displacement of the steering column (**Figure 8**). The deformation to the steering wheel was due to crash damage and not occupant contact. There were numerous intrusions to the case vehicle’s passenger compartment. The majority of the intrusions were due to the damage to the roof (**Figure 9** below).

The most severe intrusions were 55 centimeters (21.6) of vertical roof intrusion into the driver’s seat position, 53 centimeters (20.1 inches) of vertical and 35 centimeters (13.8 inches) of lateral left roof side rail intrusion into the driver’s seat position, 52 centimeters (20.5 inches) of vertical roof intrusion and 51 centimeters of vertical left roof side rail intrusion into the back left and back center seat positions.

**Figure 9:** Overview of case vehicle's roof intrusion, back right safety belt found buckled (arrow) and was observed to be buckled in police on-scene photos

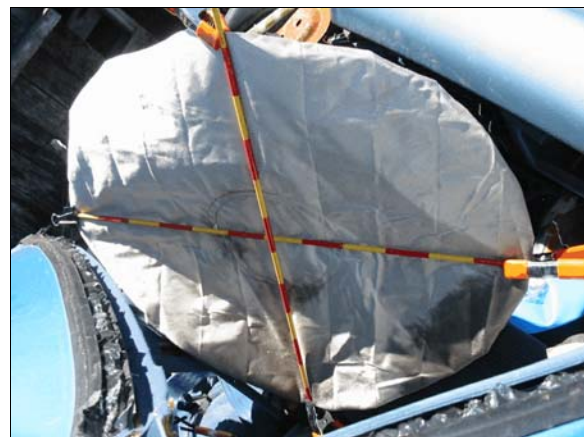
The case vehicle's driver air bag was located in the steering wheel hub. An inspection of the air bag module cover flaps and the air bag fabric revealed that the cover flaps opened at the designated tear points and sustained no damage. The driver's air bag was designed with four tethers, each approximately 6 centimeters (2.4 inches) in width. The deployed driver's air bag (**Figure 10**) was round with a diameter of approximately 62 centimeters (24.4 inches) and had two vent ports (**Figure 11**), each approximately 5 centimeters (2 inches) in diameter, located at the 11 and 1 o'clock positions. . An inspection of the driver's air bag fabric revealed no evidence of occupant contact; however, there was a 5 centimeter (2 inches) cut in the lower center portion of the back of the air bag. This was most likely due to interaction with damaged components during the crash.

**Figure 10:** Case vehicle's driver air bag, each increment on rods in 5 cm (2 in)

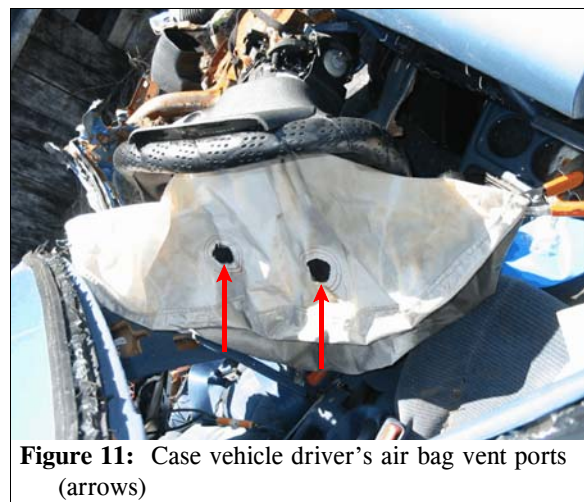
**Figure 11:** Case vehicle driver's air bag vent ports (arrows)

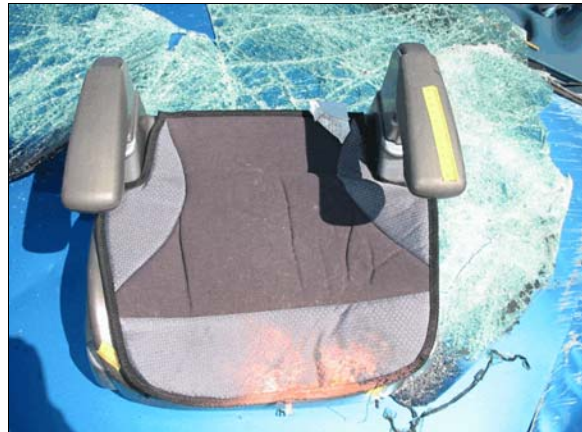
Inspection of the booster seat revealed a few scratches on the left plastic cup holder, on the left arm rest and on the front corners of the seat. No evidence of loading of the seat by the occupant or the safety belt were observed.

**Figure 12:** Case vehicle back right passenger’s booster seat, yellow tape shows location of scratches on the seat

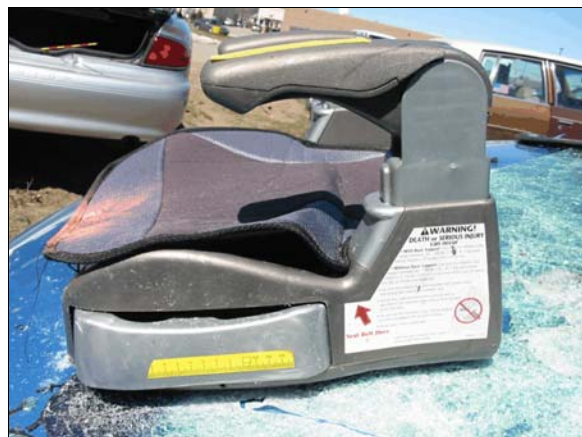
**Figure 13:** Left side view of booster seat, yellow tape shows location of scratches on retractable cup holders

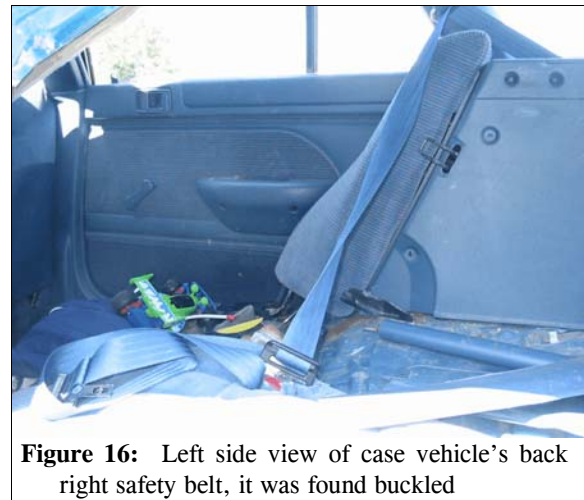
**Figure 16:** Left side view of case vehicle's back right safety belt, it was found buckled

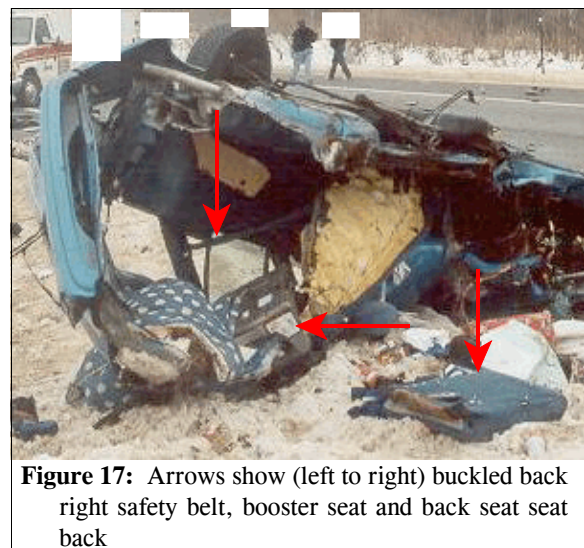
**Figure 17:** Arrows show (left to right) buckled back right safety belt, booster seat and back seat seat back

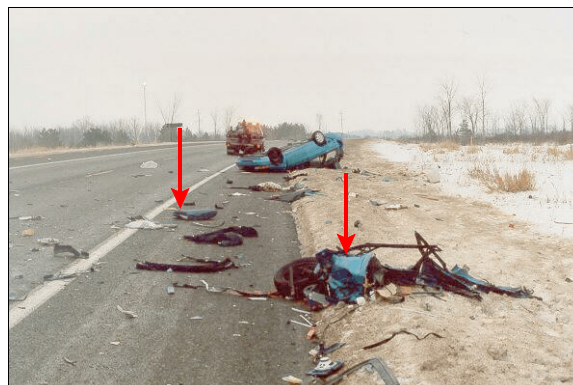
likely been ejected and deposited in the same area as the damaged left quarter panel and left rear door (**Figure 18**), which were located approximately 17 meters (56 feet) prior to the case vehicle's rest position. Lastly, it is likely the child would have sustained fatal injuries had he been seated in the back left seat position.

**Figure 18:** Arrows show (left to right) back seat seat back and case vehicle's left front door, left rear door/quarter panel and left rear wheel assembly

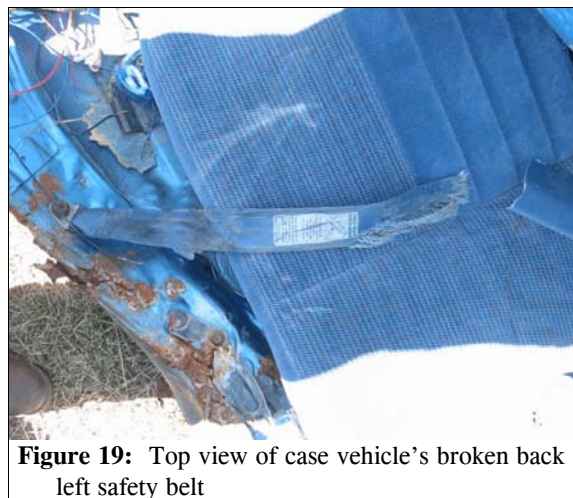
**Figure 19:** Top view of case vehicle's broken back left safety belt

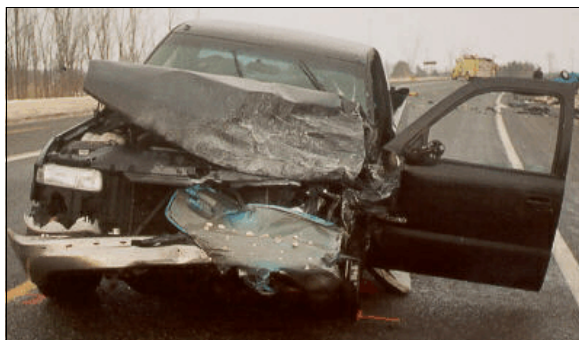
**Exterior Damage:** Based on the police on-scene photographs, the Chevrolet's impact with the case vehicle directly damaged the front bumper, left headlamp/turn lamp assembly, grille and the hood (**Figures 19 and 20**). The Chevrolet's crush profile could not be determined because the Chevrolet was not inspected. It had been sold at auction. The Chevrolet's wheelbase was 302 centimeters (118.9 inches).

**Figure 20:** Front damage to Chevrolet from impact with left side of case vehicle, case vehicle's left front door sheet metal stuck to front bumper

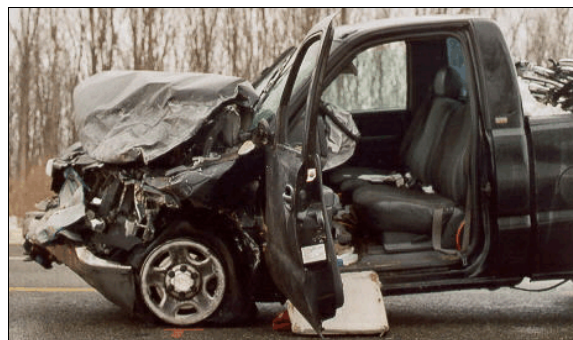
**Figure 21:** Police on-scene photo of front damage to Chevrolet

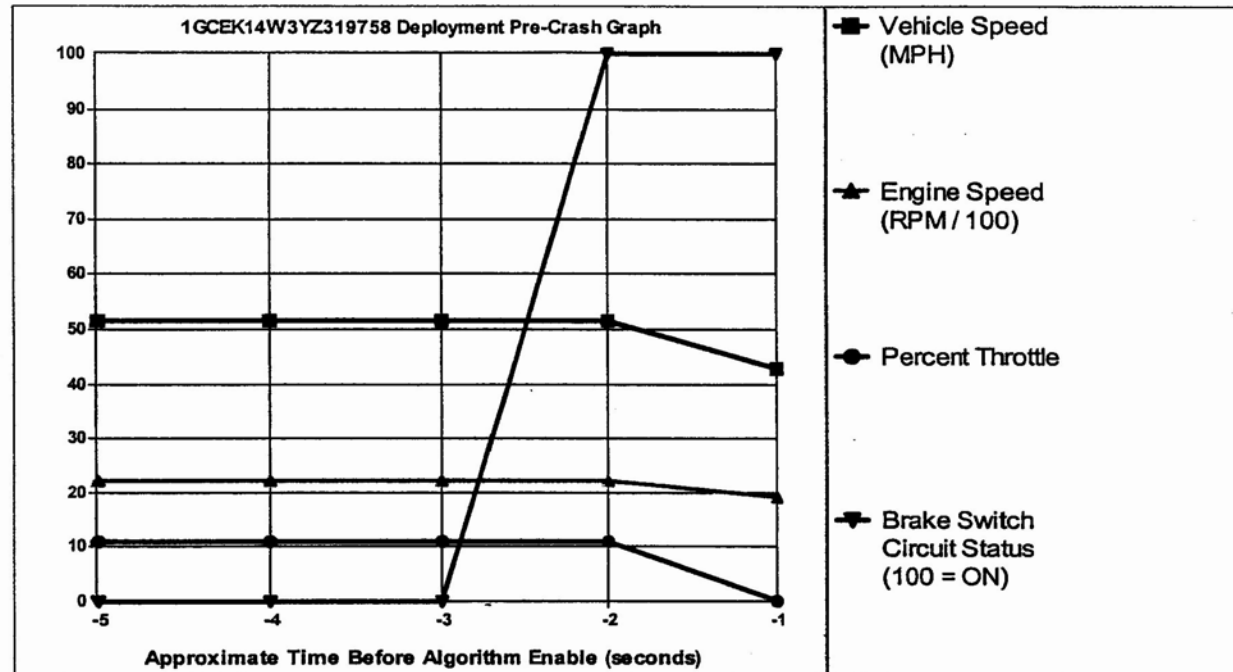
Figure 24: Chevrolet's System Status at Deployment and Pre-Crash Data

indicated that the SIR warning lamp was recorded off, the driver's safety belt circuit switch was recorded buckled and the front right passenger air bag suppression switch circuit was recorded as suppressed. The adjusted algorithm velocity change data indicated that the deployment criteria was met at approximately 20 milliseconds following algorithm enable (AE) and the maximum recorded longitudinal Delta V was: -25.57 km.p.h. (-15.89 m.p.h.) occurring at 90 milliseconds following AE. In addition, the pre-crash data indicated that the Chevrolet was traveling 83 km.p.h. (52 m.p.h.) five seconds prior to AE at 11% throttle. The Chevrolet's brake switch was recorded on at 2 seconds prior to AE and remained on at one second prior to AE with the Chevrolet's speed recorded as 69 km.p.h. (43 m.p.h.).
