ON-SITE CERTIFIED ADVANCED 208- COMPLIANT VEHICLE INVESTIGATION

CASE NUMBER - IN-05-016

VEHICLE - 2003 CHEVROLET K1500 SILVERADO

CRASH DATE - April 2005

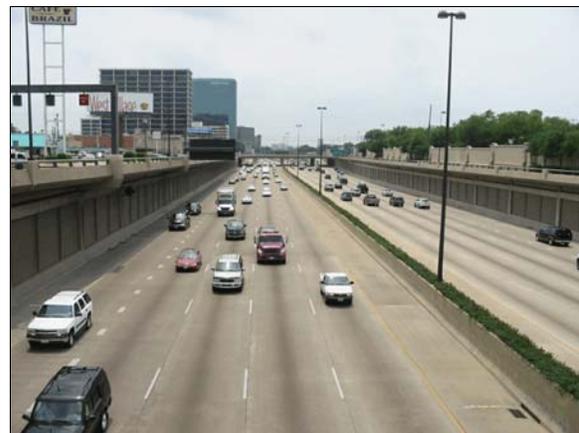
Crash Environment: The trafficway on which all vehicles were traveling was a ten-lane, divided, urban, U.S. highway, traversing in a north-south direction (**Figure 1**). There were four through lanes and one exit lane on the vehicle's roadway. Each lane was approximately 3.7 meters (12 feet) wide. Roadway pavement markings consisted of broken white lane lines, white edge line and a yellow median line. The trafficway was divided by a positive concrete median barrier. At the time of the crash the light condition was dawn, the atmospheric condition was cloudy, and the roadway pavement was dry, level, traffic polished concrete with an estimated coefficient of friction of 0.65. Traffic density was heavy and the site of the crash was urban commercial. See the Crash Diagram at the end of this report.

Figure 1: Overview of the trafficway and view south opposite case vehicle's approach

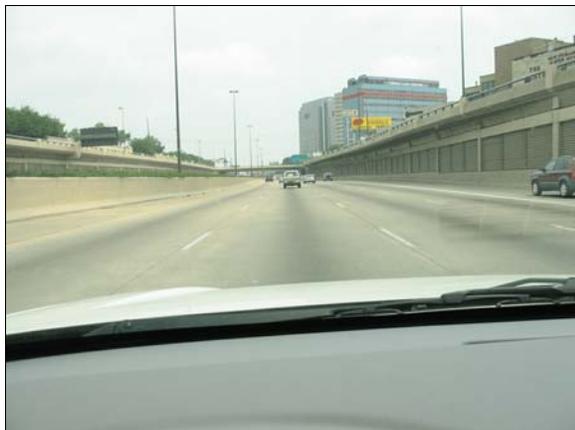
Pre-Crash: The case vehicle was traveling north in the inside center lane (**Figure 2** below), and the driver was intending to continue straight ahead. The Mercury was traveling north in the outside lane, and its driver was intending to proceed straight ahead. Meanwhile, the non-contact vehicle was traveling in the exit lane on the east side of the expressway. The non-contact vehicle veered left into the outside lane and into the Mercury's travel path. The Mercury's driver steered to the left to avoid a collision with the non-contact vehicle and crossed the outside center lane and entered the path of the case vehicle. It is unknown if the case vehicle's driver made any steering

Figure 2: Approach of case vehicle to area of impact, impact occurred somewhere prior to overpass

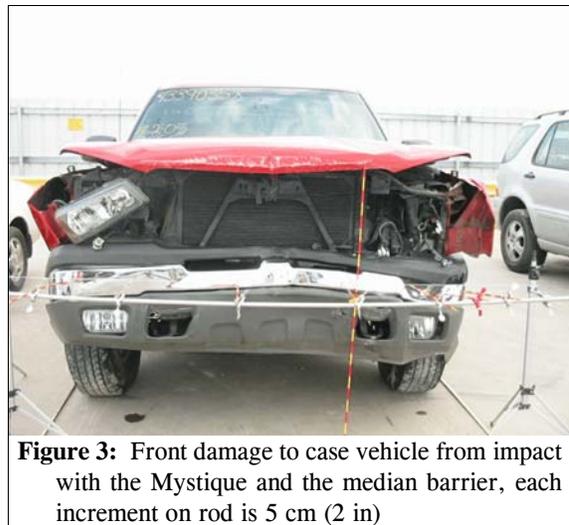
Figure 3: Front damage to case vehicle from impact with the Mystique and the median barrier, each increment on rod is 5 cm (2 in)

Crash: The front of the case vehicle (**Figure 3**) impacted the left front side of the Mercury, causing the case vehicle's driver air bag to deploy. The EDR data indicated that only the first stage of the dual-stage air bag activated. The impact caused the case vehicle to deflect to the left and its front impacted the concrete median barrier. The EDR recorded a deployment level event for this impact. A deployment level event is an event that would have been severe enough to deploy the air bag had it not deployed previously in the crash sequence. The impact caused the Mercury to rotate clockwise. The police crash report indicates that the front of the Mercury also impacted the concrete median barrier.

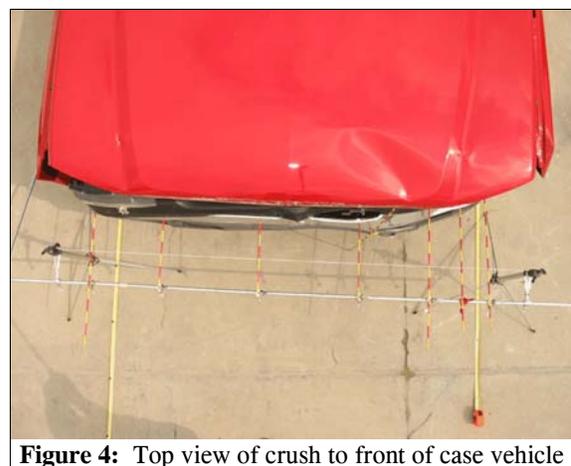
Exterior Damage: The case vehicle’s impacts with the Mercury and concrete median barrier involved the front plane. The case vehicle’s front bumper, bumper fascia, grille, left turn signal and headlamp assemblies, left fender, and hood were directly damaged and crushed rearward. Direct damage began at the front left bumper corner and extended 168 centimeters (66.1 inches) along the front bumper. Residual maximum crush was measured as 25 centimeters (15.5 inches) occurring 11 centimeters (6.8 inches) to the right of C₁ (**Figure 4**). The table below shows the case vehicle’s crush profile due to both impacts.

Figure 4: Top view of crush to front of case vehicle

The case vehicle’s left side wheelbase was shortened 2 centimeters (0.8 inch) while the right side wheelbase was extended 1 centimeter (0.4 inch). Induced damage involved the hood, right headlamp/turn signal assembly and both fenders. No obvious induced damage or remote buckling was noted to the remainder of the case vehicle’s exterior.

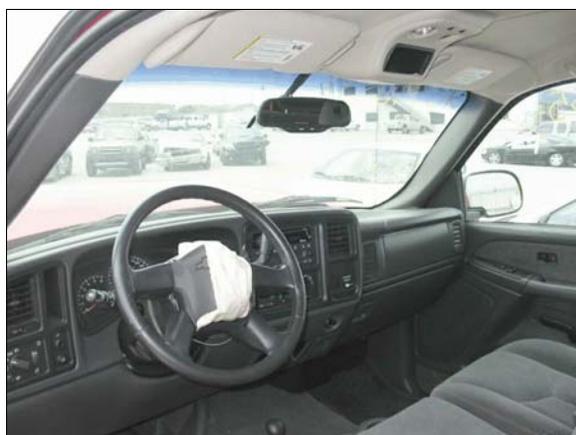
Vehicle Interior: Inspection of the case vehicle’s interior (**Figure 5**) revealed a deployment of the case vehicle driver’s air bag. Though there was no obvious contact evidence, it was most likely contacted by the driver. There was loading of the driver’s shoulder belt as evidenced by a slight friction burn to the shoulder belt webbing. In addition, the driver’s shoulder belt was jammed in the shoulder belt guide. Lastly, there was no occupant compartment intrusions and no evidence of compression of the steering column or deformation of the steering wheel (**Figure 6**).

Figure 5: Overview of instrument panel, windshield and steering wheel

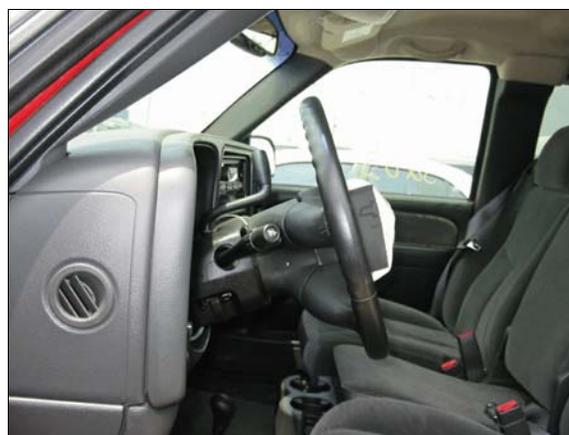
Figure 6: Case vehicle’s steering assembly showing lack of deformation

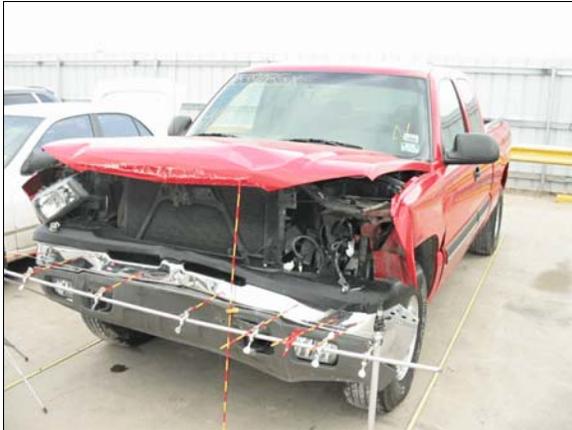
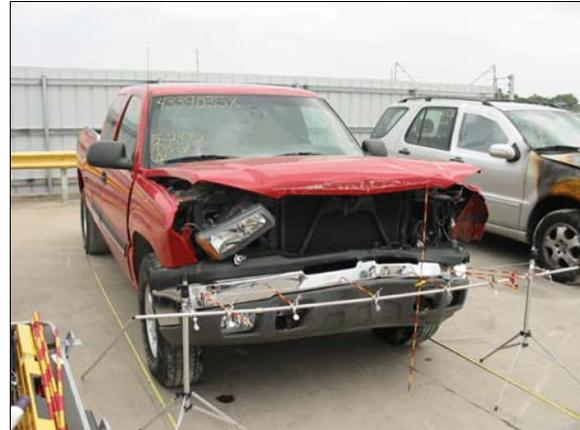
Damage Classification: The case vehicle sustained two frontal impacts producing overlapping damage that could not be separated (**Figures 7 and 8** below). Therefore, one CDC was assigned to describe the totality of the damage to the front end, and a second CDC was assigned based on what could be distinguished from the damage and to account for both impacts. The CDC to describe the totality of the damage to the front of the case vehicle was determined to be: **12-FDEW-2 (10 degrees)**. The second CDC was determined to be: **12-FDEW-9 (unknown extent zone)**. The WinSMASH reconstruction program could not be used to calculate the case vehicle’s Delta V due to the overlapping damage. The EDR recorded a maximum longitudinal Delta V of

-14.61 km.p.h. (-9.08) m.p.h for the deployment event (i.e., impact with the Mercury) and a maximum Delta V for the deployment level event (i.e., impact with the concrete median barrier) of -22.55 km.p.h. (-14.01 m.p.h.). The case vehicle was towed due to damage.

Figure 7: Overview of front damage from the front left corner

Figure 8: Overview of front damage from front right corner

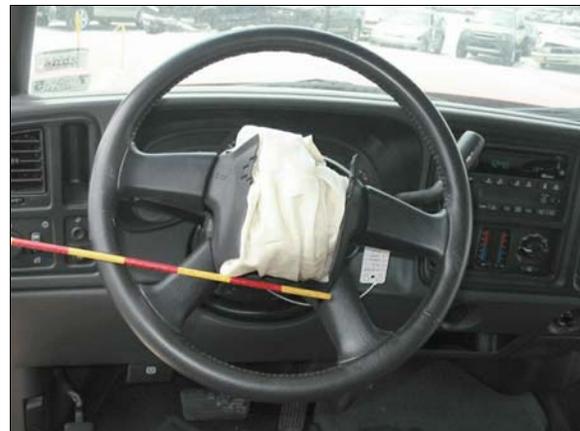
The case vehicle's driver air bag was located in the steering wheel hub. An inspection of the air bag module cover flaps and the air bag fabric revealed that the cover flaps opened at the designated tear points (**Figure 9**). The module cover consisted of "I" configuration cover flaps made of pliable vinyl. Each cover flap was approximately 7.3 centimeters (2.9 inches) in width at the top, 5 centimeters (2 inches) in width at the bottom and 12 centimeters (4.7 inches) in length along the vertical tear seam. There was no evidence of damage during the deployment to the air bag or the cover flaps. The driver's air bag was designed with two tethers, each approximately 12 centimeters (4.7 inches) in width. The driver's air bag had two vent ports, each approximately 3 centimeters (1.2 inches) in diameter, located at the 10:30 and 2:30 clock positions (**Figure 10**). The deployed driver's air bag (**Figure 11** below) was round with a diameter of approximately 65 centimeters (25.6 inches). There was no evidence of driver contact to the air bag. The distance between the mid-center of the driver's seat back, as positioned at the time of the vehicle inspection

Figure 9: Driver's air bag module flaps

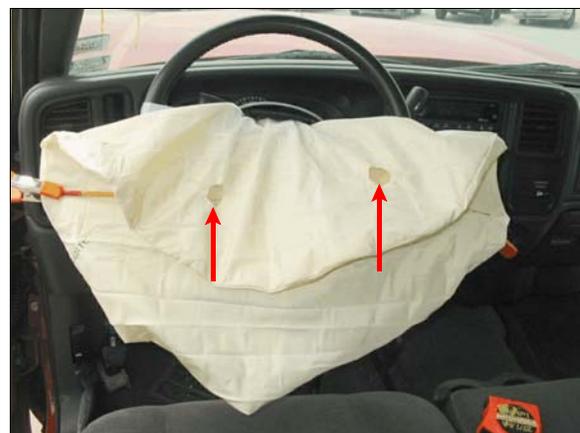
Figure 10: Driver's air bag vent ports

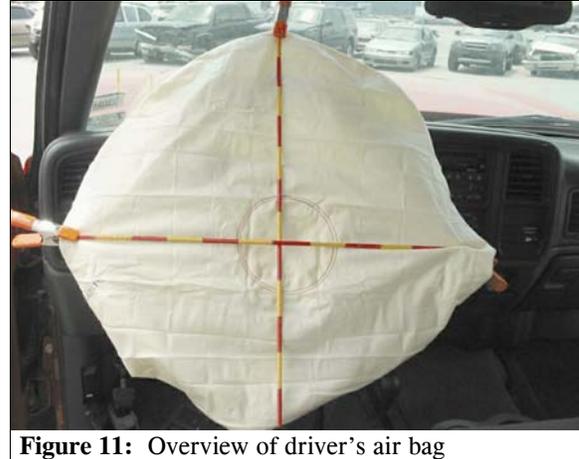
Figure 11: Overview of driver's air bag

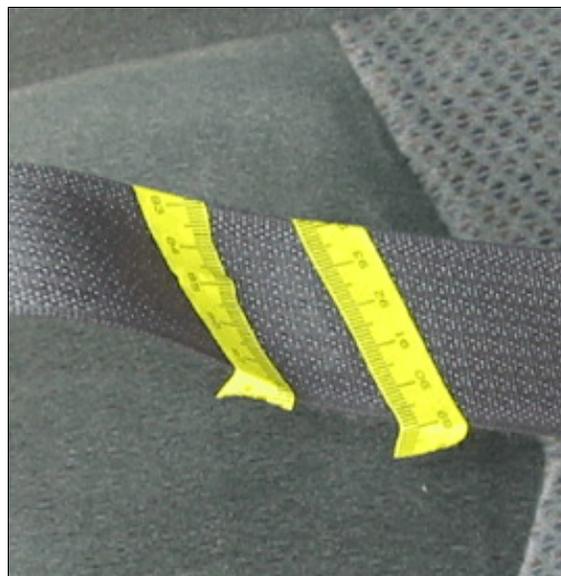
Based on this contractor's vehicle inspection and supported by the EDR data, the case vehicle's driver was restrained by his integrated, three-point, lap-and-shoulder safety belt system. Inspection of the driver's safety belt assembly showed evidence of loading. There was a slight friction burn on the safety belt webbing (**Figure 12**) from the sliding latch plate, and the shoulder belt was stuck in the corner of the integrated shoulder belt guide (**Figure 13**).

Figure 12: Close view of friction burn on driver's safety belt webbing

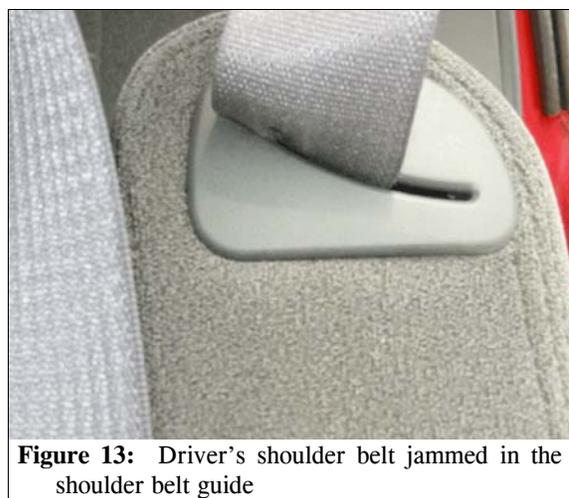
Figure 13: Driver's shoulder belt jammed in the shoulder belt guide

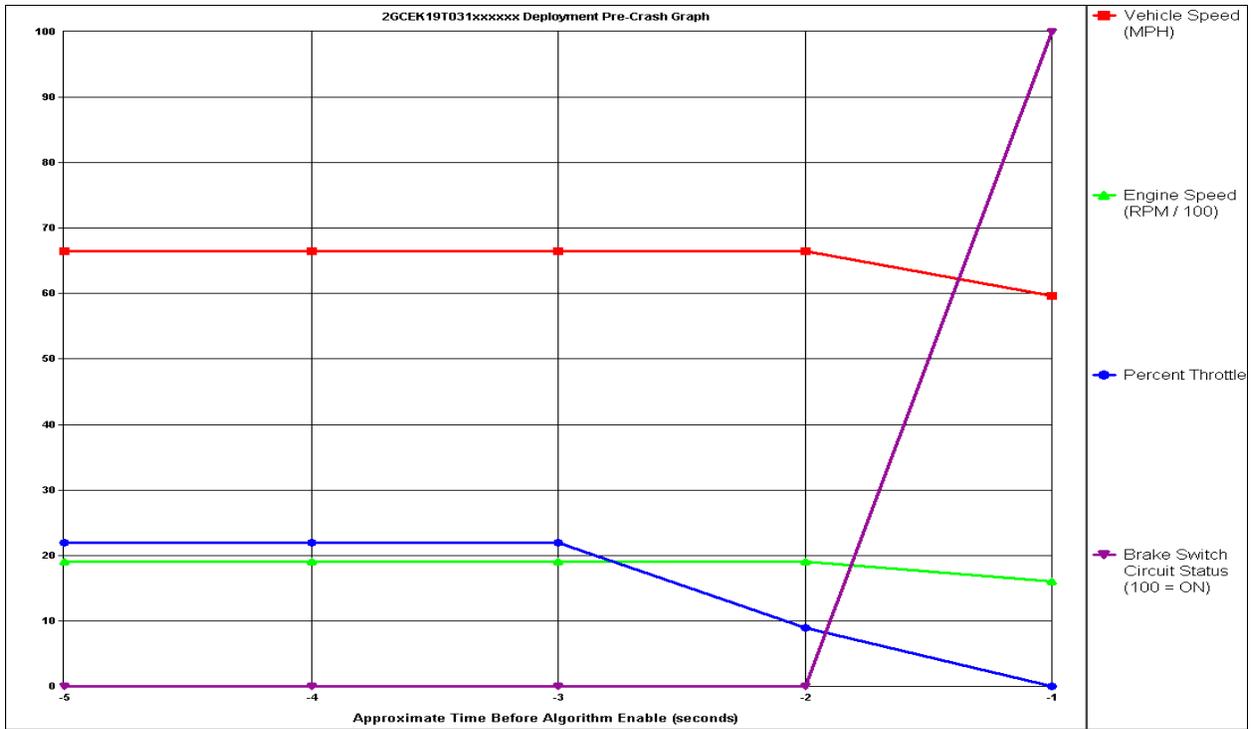
The deployment event pre-crash data indicated that the case vehicle was traveling 108 km.p.h. (67 mph) at 22% throttle five seconds prior to AE. The case vehicle remained at this speed for the next three, one second sample periods. At one second prior to the AE, the brake switch is recorded as on indicating the driver applied the brakes to avoid the impact with the Mercury.

Figure 15: Case vehicle's Deployment Pre-Crash Data Graph

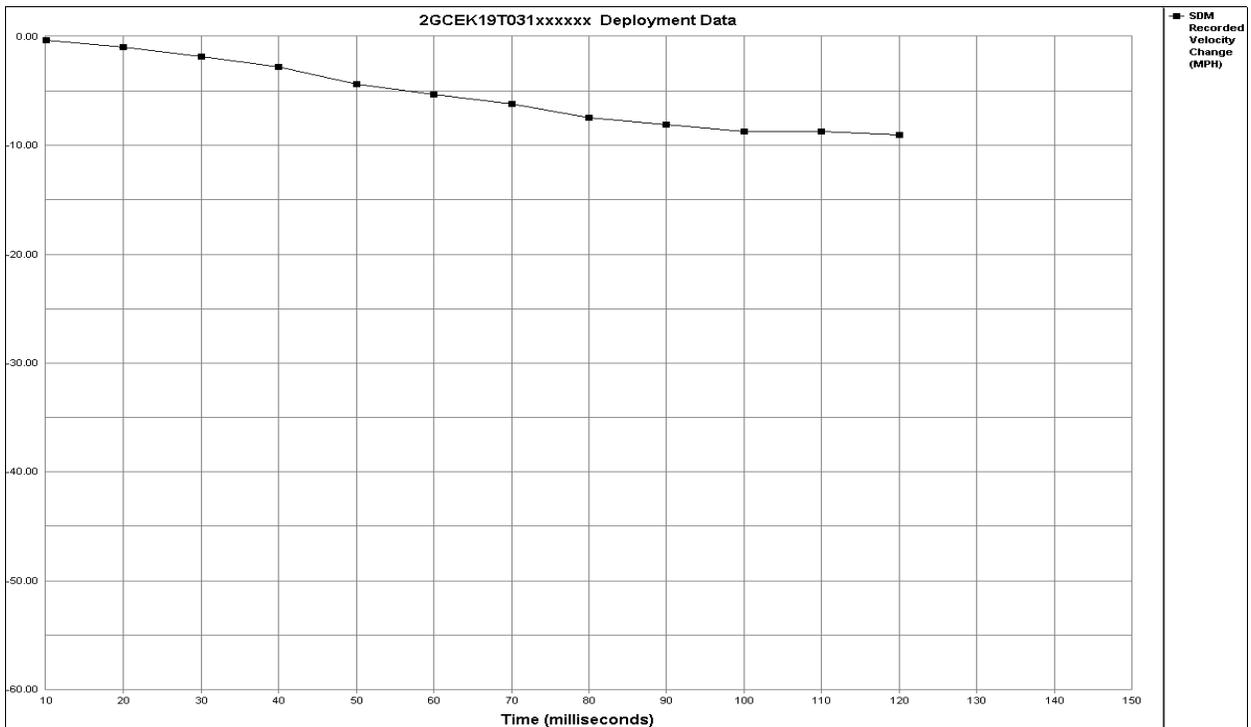
Figure 16: Case vehicle's deployment SDM Recorded Velocity Change graph

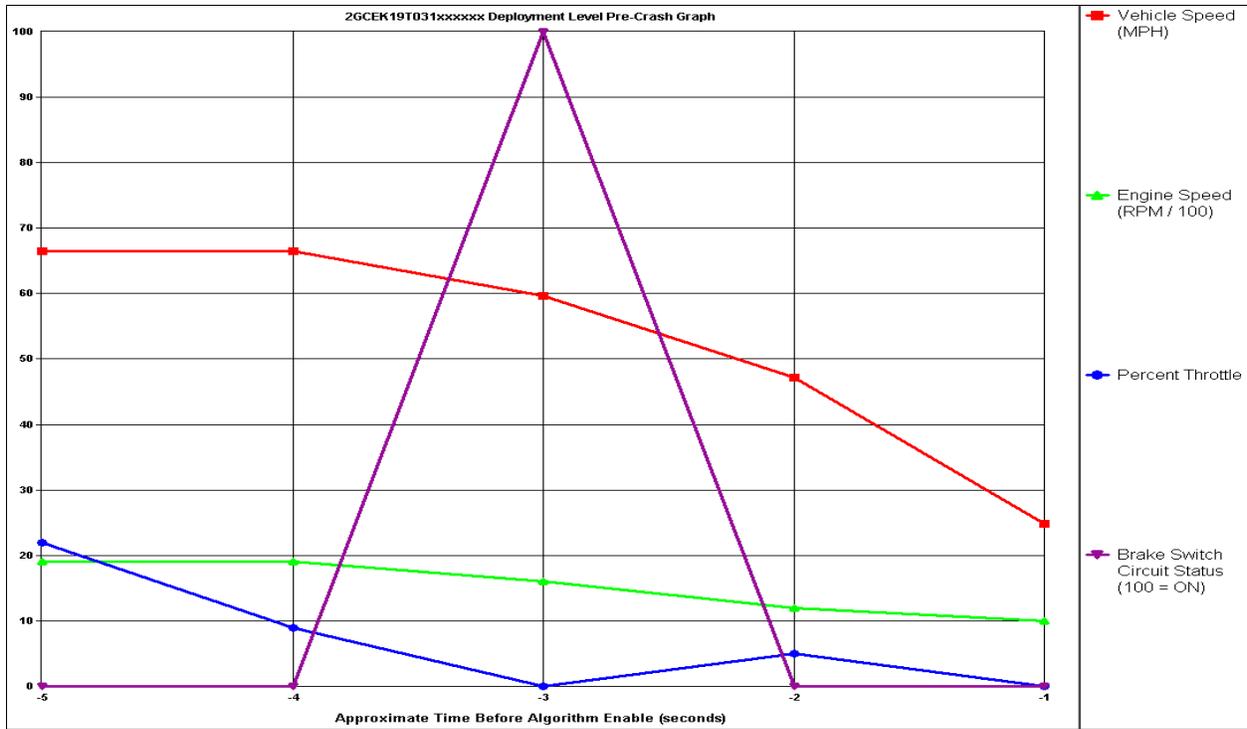
Figure 18: Case vehicle's Deployment Level Pre-Crash Graph

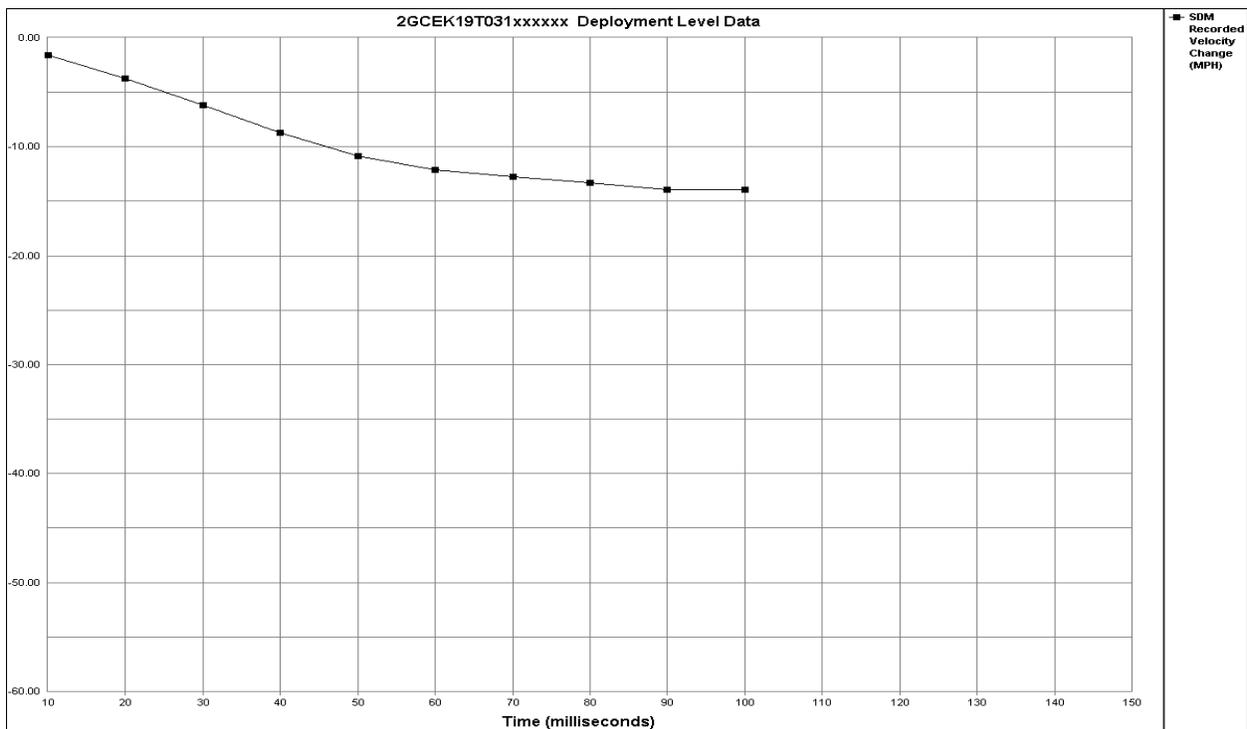
Figure 19: Case vehicle's deployment level SDM Recorded Velocity Change graph
