**CALSPAN ON-SITE CHILD SAFETY SEAT CRASH INVESTIGATION**  
**SCI CASE NO: CA05-017**

**VEHICLE: 2002 FORD TAURUS**  
**LOCATION: PENNSLYVANIA**  
**CRASH DATE: MARCH, 2005**

<i>15. Supplementary Note</i> An investigation of an Evenflo Rear Facing Child Safety Seat (RFCSS) in use during a two vehicle opposite direction crash.			
<i>16. Abstract</i> This investigation focused on the crash dynamics and injury sources that resulted in a double fatality in a 2002 Ford Taurus. The Ford was occupied by a 24 year old restrained male driver and a four month old male center rear occupant. The infant was restrained within an Evenflo PortAbout Rear-Facing Child Safety Seat (RFCSS). The Ford was involved in an opposite direction angular impact with a 1998 Dodge Grand Caravan. The Dodge was driven by a 41 year old male and was the vehicle's sole occupant. The front left aspect of the Dodge impacted the Ford at the left front corner and then continued to engage the left side of the Taurus to its C-pillar. The force of the angular impact resulted in severe intrusion into the Ford driver's occupant space. The driver was trapped within the vehicle and had to be extricated. The driver suffered a c

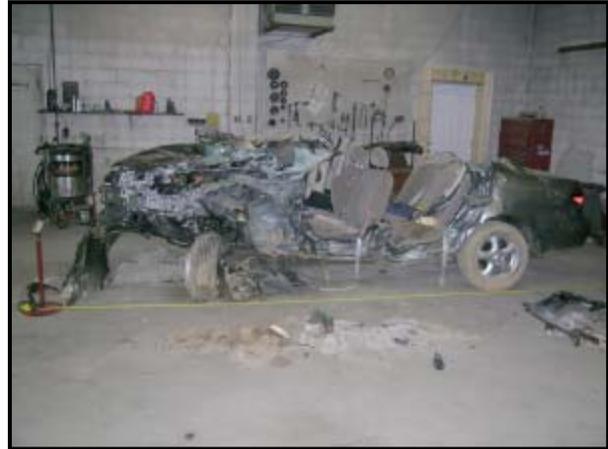
**Figure 1: Left side view of the Ford.**

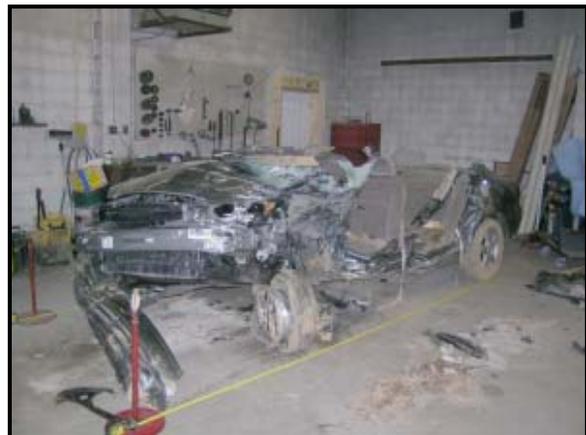
**Figure 5** is a the front left oblique view of the Ford Taurus. The vehicle sustained an impact to the left front corner with sustained contact along its left side to the C-pillar. Initial inspection revealed the left aspect of the front bumper fascia had separated and the bumper reinforcement was exposed. Inspection of the bumper reinforcement bar determined that the impact occurred at the extreme left end of the reinforcement. The direct and induced frontal damage extended across the entire 150 cm (59 in) frontal end width of the Taurus. The direct contact damage began 56 cm (22 in) left of center and extended 18 cm (7 in) to the left corner. This impact was outboard of the uni-body structure of the Taurus. There was no deformation to the forward aspect of the uni-body fore structure that supported the bumper reinforcement. The deflection of the bumper

**Figure 5: Left front view of the Ford.**

reinforcement was primarily induced damage caused by the left side deformation in the area of the left front suspension, cowl, and A-pillar. The residual deformation of the bumper reinforcement was as follows: C1 = 55 cm (21.8 in), C2 = 36 cm (14.2 in), C3 = 25 cm (10.0 in), C4 = 15 cm (5.9 in), C5 = 10 cm (4.1 in), C6 = 1 cm (0.5 in).

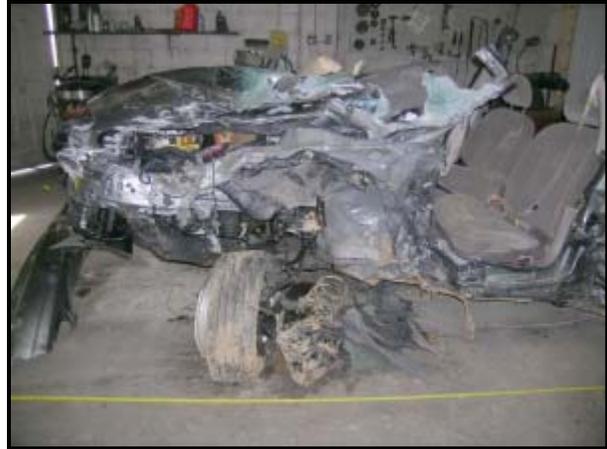
The front of the Dodge then engaged along the left side of the Taurus, **Figure 6**. The direct contact damage ended in the left C-pillar area 34 cm (13.5 in) forward of the left rear axle location. The left front wheel assembly was directly involved in the impact with the entire assembly separating at the lower control arm and transmission output shaft. The left front wheel was fractured and egg shaped. There was major intrusion of the left structures into the driver's compartment. The left lower sill buckled and was crushed inboard 28 cm (11 in) at the leading edge of the driver seat. The jammed left front door and roof were removed

**Figure 6: Left side view of the Ford.**

during the extrication of the driver. The left rear door buckled outward and reportedly separated from the vehicle during the impact. The upper and lower aspects of the left B-pillar were cut and the pillar was also removed from the vehicle. The lateral deformation of the roof measured 20 cm (8 in) at the upper B-pillar location. The right doors remained operational. There was no measurable change in the right wheelbase dimension. The Collision Deformation Classification (CDC) was 10-FLEE9. Analysis of this impact was beyond the scope of the WINSMAH model due to the two planes of direct contact damage and the violation of the common velocity assumption.

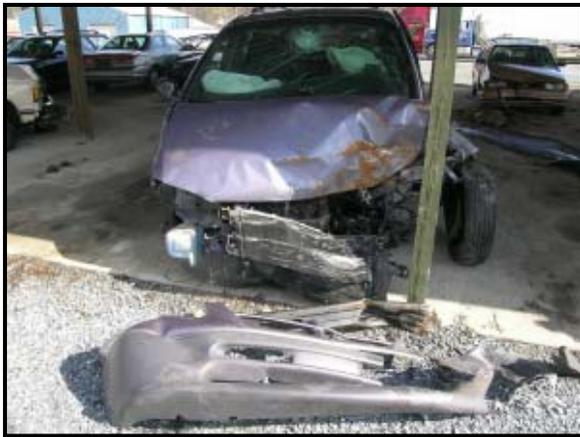
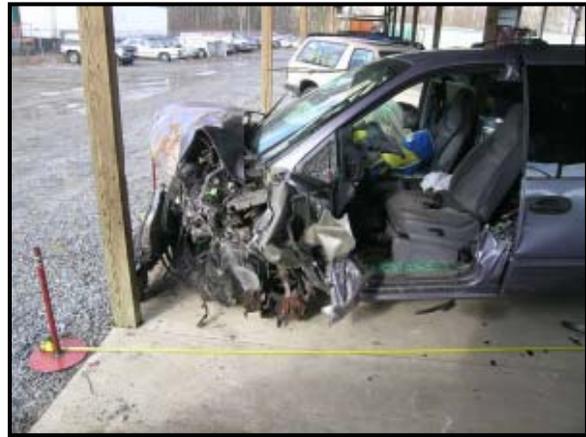
**Figures 7 and 8** are the front and left lateral views of the Dodge Grand Caravan. The front plane of the Dodge sustained direct and induced damage that extended across the entire 157 cm (62 in) end width of the vehicle. The impact damage was biased to the left indicative of the offset nature of the crash configuration. The front fascia and bumper reinforcement bar separated from the vehicle during the impact. Inspection of these components revealed that initially the left aspect of the Dodge's front plane impacted the left corner of the Ford. The left aspect of the bumper fascia was fractured in multiple places with major fracture points located 25 cm (10 in) left and 50 cm (19.5 in) left of center respectively. The direct damage on the reinforcement bar began 15 cm (6 in) left of center and extended to its left end. As the Dodge began to rotate counterclockwise, the left and center aspects of the vehicle engaged the left side of the Ford. The direct contact at the hood elevation began 17 cm (6.5 in) right of center and extended to the left corner. The hood buckled rearward and folded at the designed points. The left front fender was crushed to the left A-pillar. The separation of the reinforcement bar necessitated crush measurement to the upper and lower radiator support. The residual crush profile along the upper radiator support was as follows: C1 = 46 cm (18.2 in), C2 = 34 cm (13.3

in), C3 = 25 cm (9.9 in), C4 = 17 cm (6.5 in), C5 = 6 cm (1.8 in), C6 = 5 cm (2.0 in). The crush of the lower radiator support was: C1 = 66 cm (25.8 in), C2 = 39 cm (15.3 in), C3 = 17 cm (6.5 in), C4 = 9 cm (3.5 in), C5 = 6 cm (2.5 in), C6 = 0. The left front wheel assembly was directly involved in the impact. The left front wheel rim was deformed and the outer sidewall of the tire was cut. The left wheelbase was reduced 34 cm (13.3 in). The right wheelbase was unchanged. The left front door was jammed shut by impact damage. It was removed along with the left B-pillar was cut during the extrication of the driver. All other doors remained closed during the crash and were operational post-crash. The interior surface of the windshield exhibited a 4 cm (1.5 in) bulging fracture from an interior loose object. The fracture was located 2.5 in left of center and 13 in below the header. A baseball was found on the floor between the front seats of the Dodge and was the probable source of the fracture. The estimated delta V of the Dodge based on SCI field experience was 24 km/h to 32 km/h (15 mph to 20 mph). The CDC of the impact was 12-FYEW4.

Figure 7: Front view of the Dodge.

Figure 8: Left side view.

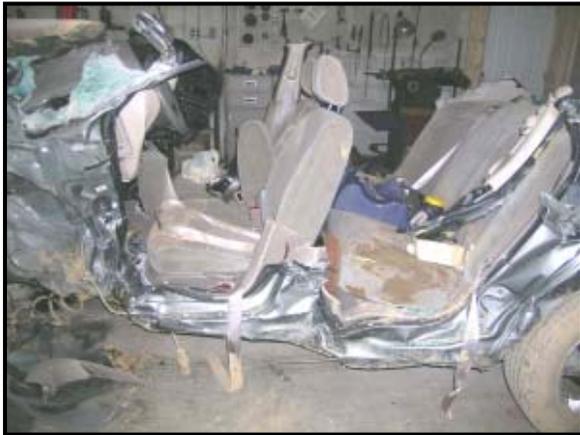
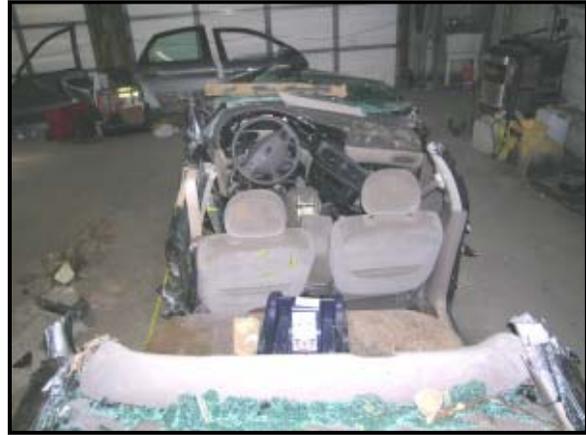
The interior damage to the Ford Taurus consisted of severe intrusion of the left side structures due to the 10 o'clock exterior force of the crash. There was a reduction in the volume of the driver's occupant space. The intrusion into the driver's position is summarized in the table below:

Component	<i>Row 1 Left Position</i>	
	Magnitude of intrusion	
	Longitudinal	Lateral
Left instrument panel	43 cm (17 in)	34 cm (13.5 in)
Sill forward driver seat	----	28 cm (11 in)
Left B-pillar (at sill)	15 cm (6 in)	19 cm (7.5 in)
Steering wheel	13 cm (5 in)	25 cm (10 in)

**Figure 9: Left interior view.**

**Figure 10: Overhead interior view.**

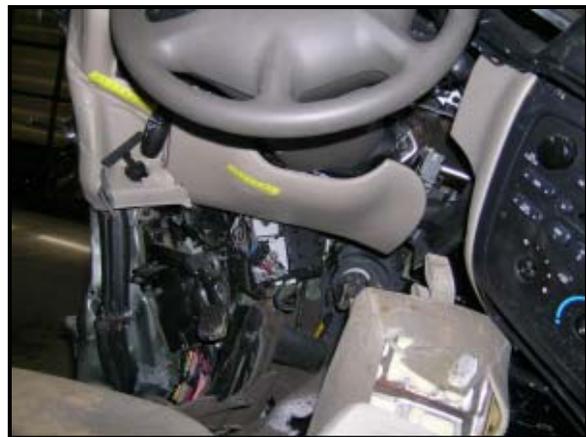
The driver's lower extremities contacted the knee bolster **Figure 11**. The driver's left knee contacted the outboard aspect of the bolster evidenced by pocketed deformation to the panel. This contact resulted in a left femur fracture. The right lower extremity contacted the bolster evidenced by a 6 cm (2.5 in) scuff mark. The mark was located 17 cm (6.5 in) left of the steering column centerline. This contact did not result in an injury. The interior surface of the left front door panel was contacted by the left flank of the driver evidenced by a 8 cm (3 in) wide scuff mark to the central aspect of the arm rest that extended up to the belt line.

**Figure 11: Knee bolster contacts.**

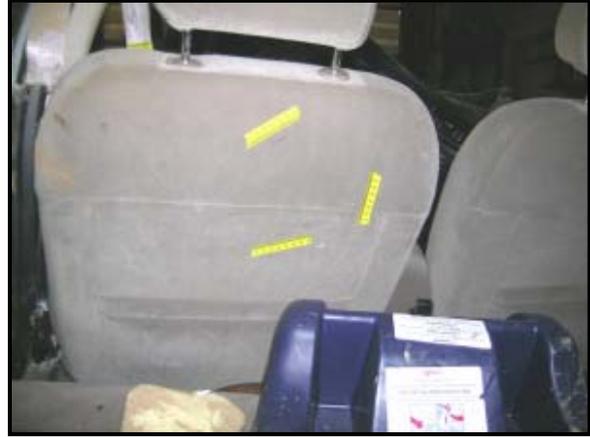
the seat back and the upper right aspect of the child seat shell. **Figure 12** is a view of the driver seat back and the contact evidence. A 3 cm (1 in) blue colored transfer was noted to the seat's fabric. The mark began on the centerline of the seat and extended to the right. It was located 6 cm (2.5 in) below the top of the seat. A 5 cm x 5 cm (2 in x 2 in) L shaped cut in the fabric was located 13 cm (5 in) left of the inboard aspect of the seat and 15 cm (6 in) below the top. A 5 cm (2 in) long fabric abrasion was located 19 cm (7.6 in) below the top and 18 cm (7 in) left of the inboard edge of the seat.

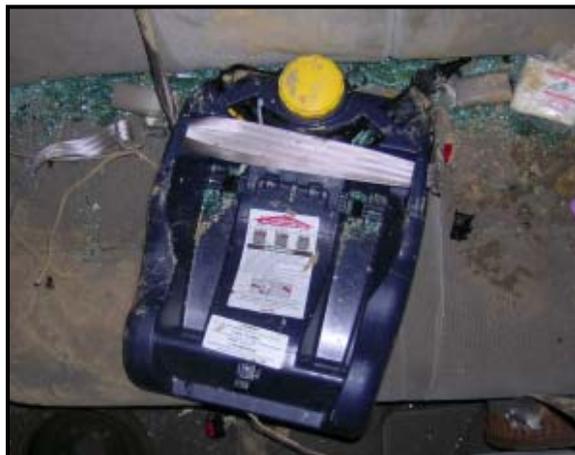
The Rear Facing Child Safety Seat (RFCSS) base was restrained by the manual restraint in the center position, **Figure 13**. The belt was routed through the belt path designed into the RFCSS base and the latch plate was buckled. A locking clip was not used and the ALR was probably not set. At the time of the inspection, the base could be moved laterally approximately 7.1 cm (2.8 in) as a result of slack in the belt system. During the course of the inspection, this restraint was unbuckled and examined. There was no crash related evidence identified on the belt or the latch plate. Refer to the *Child Safety Seat Data* section of this report for further information regarding the RFCSS and its method of restraint.

**Figure 14: View of the RFCSS base.**

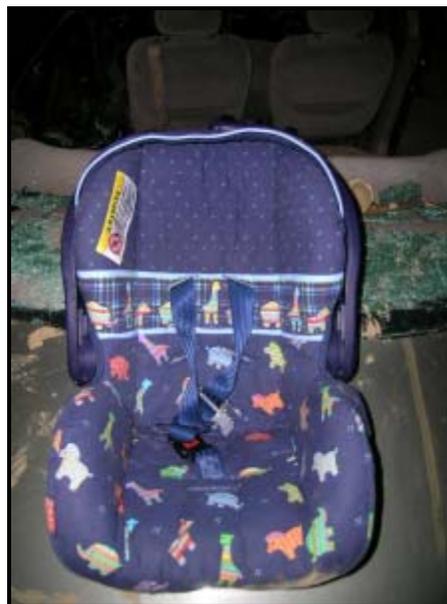
**Figure 15** is a front view of the Rear Facing Child Safety Seat (RFCSS) in use at the time of the crash. The RFCSS was an Evenflo Port About RFCSS Model No: 5581333N1, manufactured February 6, 2004. The base of the RFCSS was restrained in the center rear position of the Ford by the vehicle's 3-point lap and shoulder belt. The seat was labeled for use by infants 2.2 kg to 10 kg (5 lb to 22 lb) with a height of 66 cm (26 in) or less. The manufacture's labels were intact and legible. The instruction manual was not present. The locking clip was in place on the back aspect of the shell.

**Figure 15: View of the RFCSS shell.**

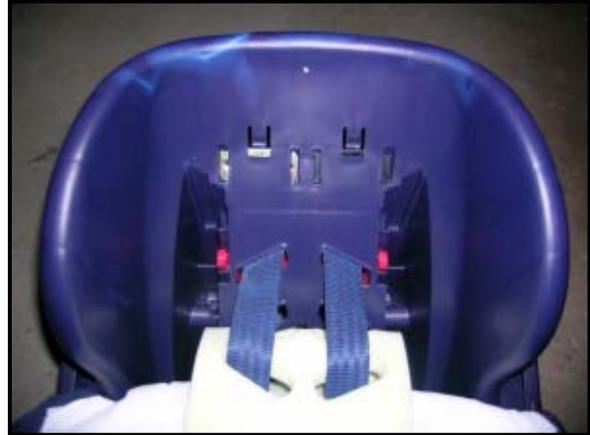
The shell was inspected for crash related physical evidence. The fabric covering was removed. The upper aspect of the shell exhibited stress marks that extended across the full width related to its contact with the driver seat back. Refer to **Figure 16**. The stress marks appeared heavier on the right indicative of the direct contact. Additional stress marks were observed on the right arm of the carrier handle. The presence of these marks indicated the carrier handle had been rotated to the proper position (for use in a vehicle) at the time of the crash.

**Figure 16: View of the stress marks to the RFCSS.**

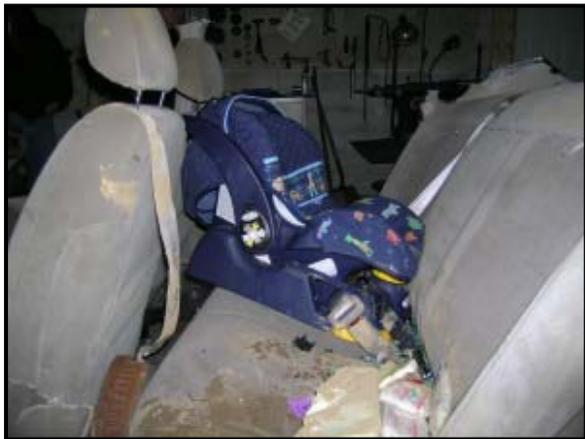
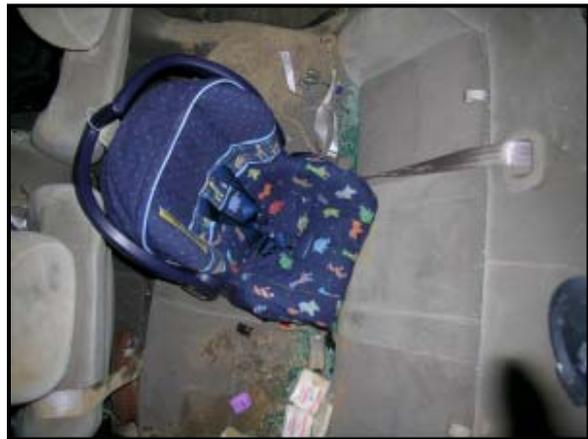
**Figures 17 and 16** are views of the reconstructed position of the RFCSS. The RFCSS base fully engaged the depth of the seat cushion. The measured angle of the shell was 60 degrees and the manufacturer's inclinometer was in the "Green" zone. The upper right aspect of the seat was in-close proximity to the driver's seat back.

**Figure 17: Overhead view of the RFCSS.**

**Figure 18: Left view of the RFCSS.**
