## ON-SITE CERTIFIED ADVANCED 208- COMPLIANT VEHICLE INVESTIGATION

CASE NUMBER - IN-05-017  
LOCATION - TEXAS  
VEHICLE - 2005 DODGE MAGNUM  
CRASH DATE - April 2005

1. <i>Report No.</i> IN-05-017		2. <i>Government Accession No.</i>		3. <i>Recipient's Catalog No.</i>	
4. <i>Title and Subtitle</i> On-Site Certified Advanced 208-Compliant Vehicle Investigation Vehicle - 2005 Dodge Magnum Location - Texas			5. <i>Report Date:</i> April 19, 2006

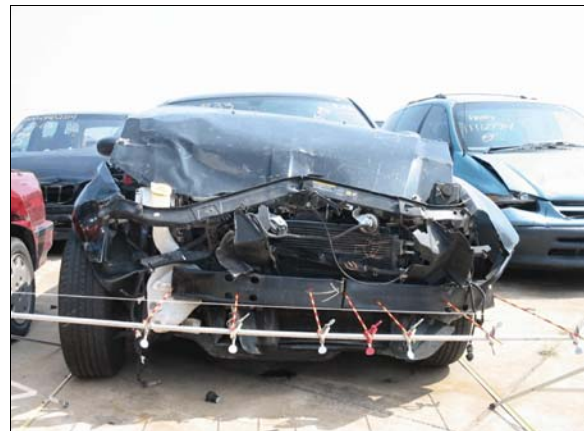
**Figure 4:** Damage to front of case vehicle due to impact with the Lexus, front bumper fascia is missing

**Crash:** The front of the case vehicle (**Figure 4**) impacted the left center of the Lexus (**Figure 5** below), causing the case vehicle's driver air bag to deploy. It is unknown whether more than one stage of the multi-stage air bag activated. The case vehicle's front right passenger air bag did not deploy because there was no front right passenger in the vehicle. Following the impact the Lexus rotated counterclockwise and rolled over, passenger side leading, three quarter turns (**Figure 6** below). During the rollover, the Lexus departed the southeast edge of the southwest leg of the intersection where the hood impacted a fire hydrant and the right quarter panel impacted a utility pole guy-wire.

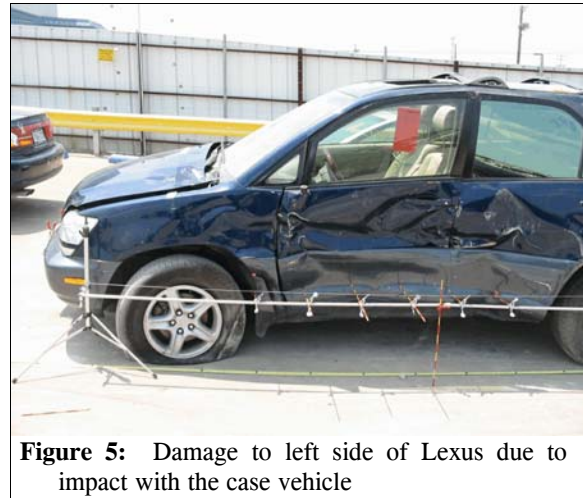
**Figure 5:** Damage to left side of Lexus due to impact with the case vehicle

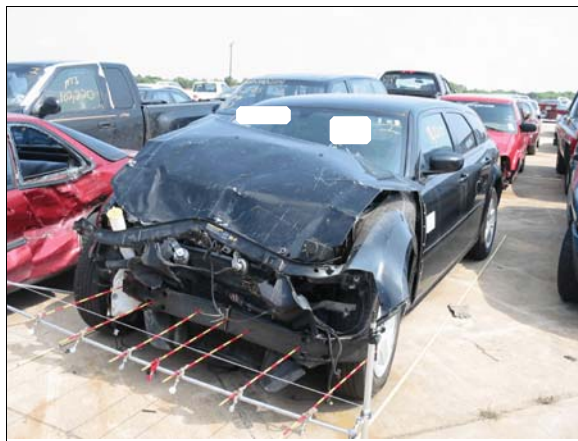
**Exterior Damage:** The case vehicle’s impact with the Lexus directly damaged the front bumper, grille, hood and both headlamp/turn signal assemblies (**Figures 8 and 9**). The direct damage began at the front right bumper corner and extended 150 centimeters (59.1 inches) across the front end. The residual maximum crush was measured as 38 centimeters (15 inches) occurring 12 centimeters (4.7 inches) right of C<sub>3</sub> (**Figure 10**). The table below shows the case vehicle’s crush profile.

**Figure 8:** Overview of damage to front of case vehicle due to impact with the Lexus

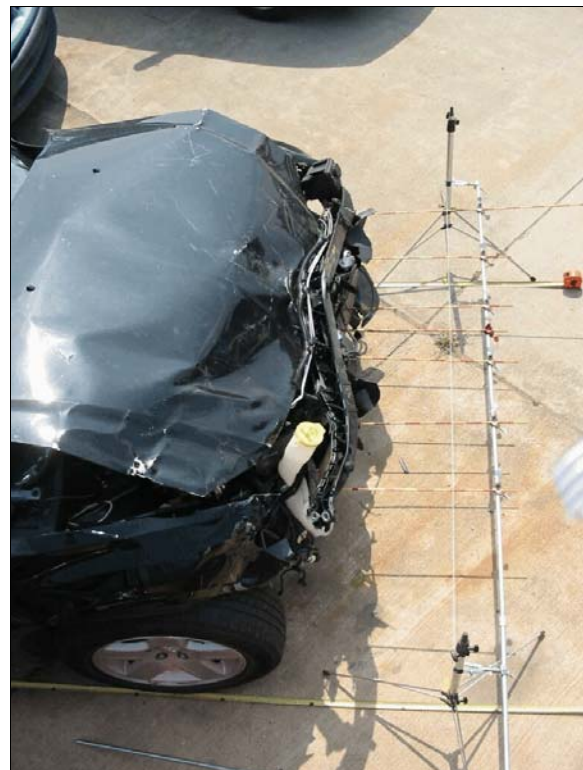
Units	Event	Direct Damage		Field L	C <sub>1</sub>	C <sub>2</sub>	C <sub>3</sub>	C <sub>4</sub>	C <sub>5</sub>	C <sub>6</sub>	Direct	Field L
		Width CDC	Max Crush								±D	±D
cm	1	150	38	134	37	25	32	32	24	22	0	0
in		59.1	15.0	52.8	14.6	9.8	12.6	12.6	9.4	8.7	0.0	0.0

**Figure 10:** Top right view of crush [each stripe on rods is 5 cm (2 in) ] to front of case vehicle

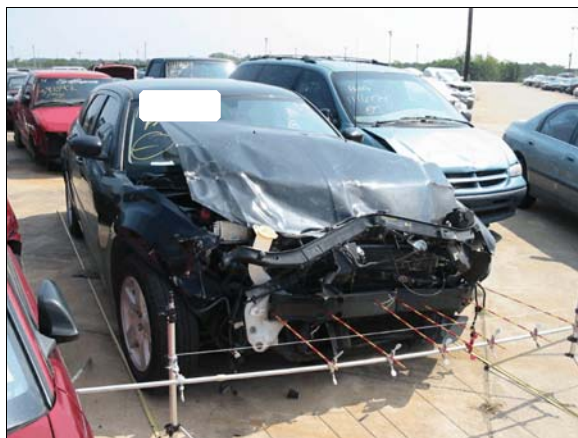
**Figure 9:** Overview of damage to the front of the case vehicle due to impact by with the Lexus

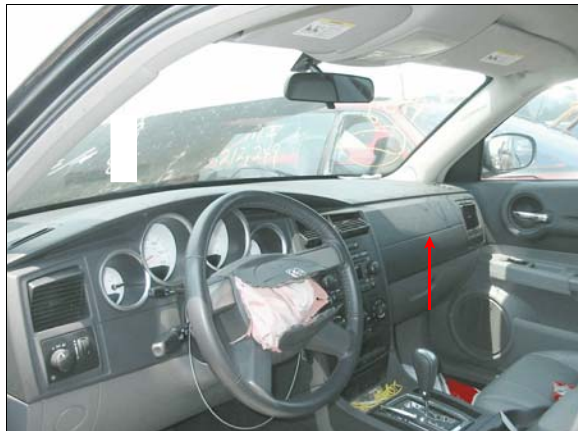
**Vehicle Interior:** Inspection of the case vehicle’s interior (**Figures 11 and 12**) revealed occupant contact evidence on the console. No other occupant contact evidence was found and no intrusion of the passenger compartment was observed. Finally, there did not appear to be compression of the energy absorbing steering column; however, the top of the steering wheel rim was deformed (**Figure 13** below) due to driver loading through the air bag.

**Figure 11:** Overview of case vehicle’s steering wheel, instrument panel and windshield, arrow shows location of front right passenger air bag

The front right passenger's air bag was located in the middle of the instrument panel (**Figure 11** above). The deployment of the front right air bag was suppressed by the case vehicle's advanced occupant protection system because there was no front right passenger in the case vehicle at the time of the crash.

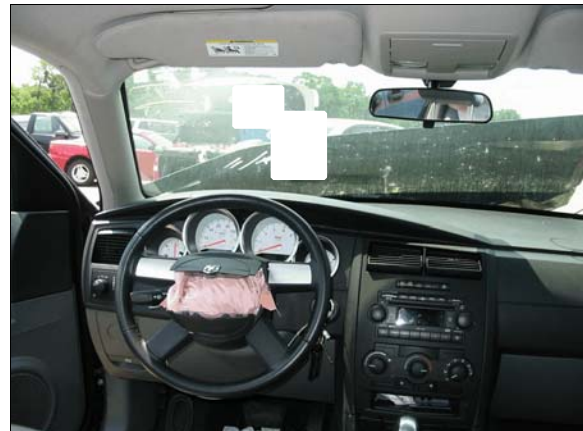
**Figure 12:** Overview of steering wheel, instrument panel and windshield

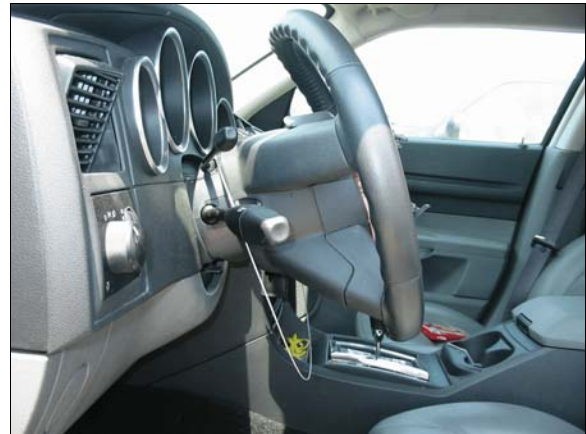
Figure 13: Left side view of deformation to steering wheel rim

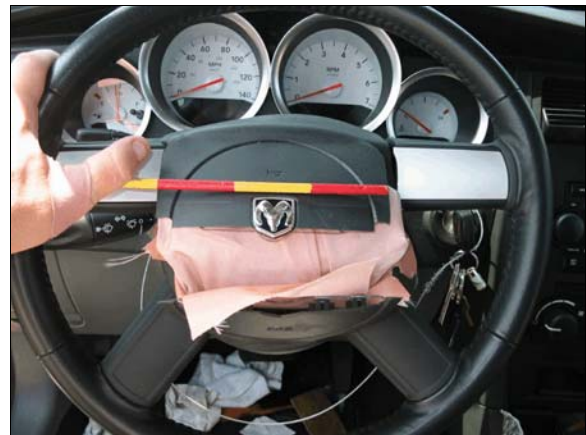
The case vehicle's driver air bag was located in the steering wheel hub. An inspection of the air bag module cover flaps and the air bag fabric revealed that the cover flaps opened at the designated tear points (**Figure 14**). There was no evidence of damage during the deployment to the air bag module cover flaps or the air bag fabric. Both module cover flaps were semi-circular in shape. The Chrysler "Ram" emblem was located in the bottom center of the top flap. There was a small pointed section of the emblem protruding from the bottom of the flap that fit into a recessed contour at the top center of the bottom flap. The top flap was 15 centimeters (5.9 inches) in width and 8.5 centimeters (3.3 inches) in height at the center. The bottom flap was 15 centimeters (5.9 inches) in width and 6 centimeters (2.4 inches) in height at the center. The deployed driver's air bag (**Figure 15**) was round with a diameter of approximately 60 centimeters (23.6 inches). The air bag was designed with two tethers, each approximately 5 centimeters (2 inches) in width and had two vent ports (**Figure 16** below), each approximately 4 centimeters (1.6 inches) in diameter, located at the 11 and 1 o'clock positions. The distance between the mid-center of the driver's seat back, as positioned at the time of the vehicle inspection (i.e., seat track at full rear position, seat back slightly reclined), and the air bag's fabric at approximate full excursion was 38 centimeters (15 inches). Lastly, no occupant contact marks were observed on the air bag.

Figure 14: Case vehicle's driver air bag module cover flaps

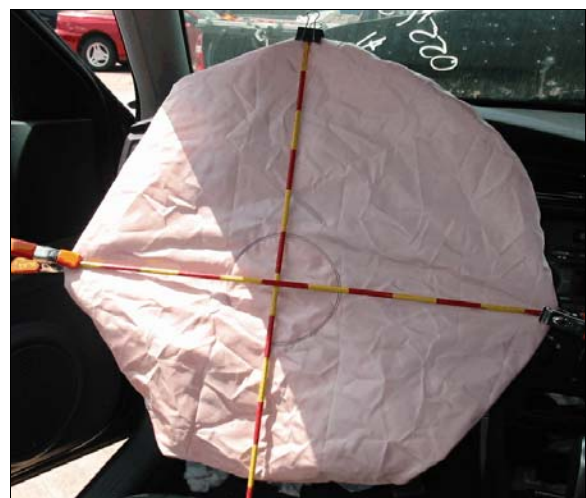
Figure 15: Case vehicle's deployed driver's air bag

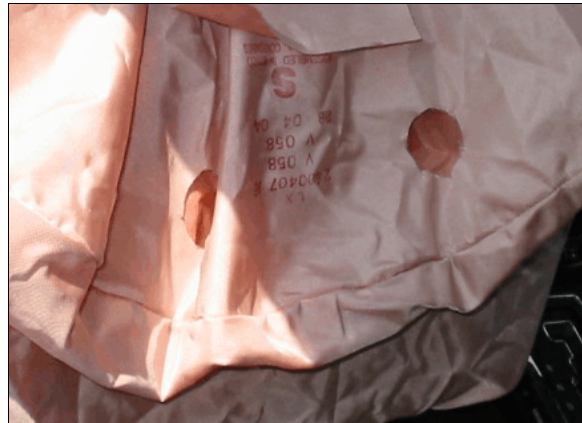
**Figure 16:** Case vehicle driver's air bag vent ports

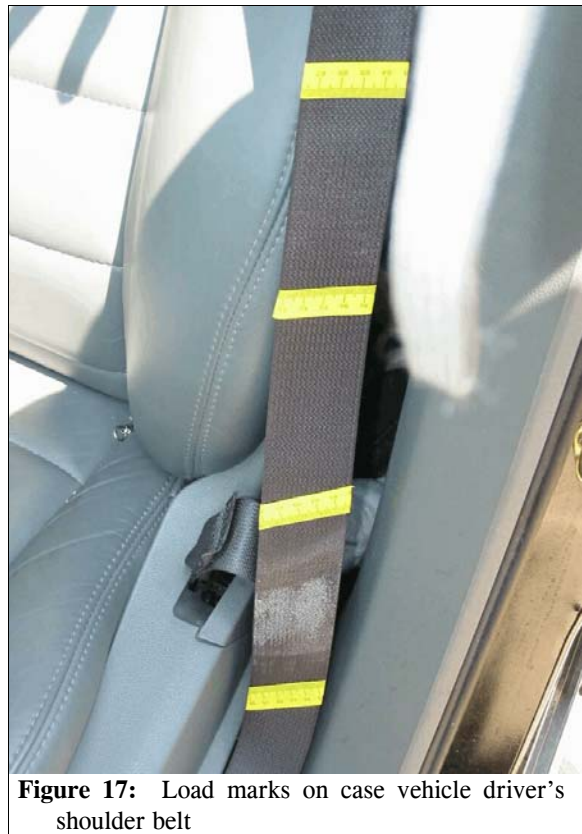
The case vehicle's driver was restrained by his manual, three-point, lap-and-shoulder safety belt system. The shoulder belt had abrasion's on a length of the belt (**Figure 17**) due to loading the D-ring consistent with activation of the constant force retractor, which gradually releases the safety belt during the crash to control the belt forces on the occupant. In addition, there were corresponding abrasions in the plastic D-ring (**Figure 18** below).

**Figure 17:** Load marks on case vehicle driver's shoulder belt

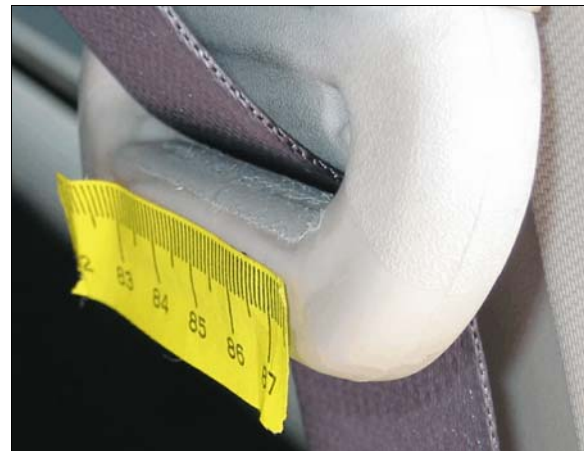
**Figure 18:** Load marks in case vehicle driver’s safety belt D-ring

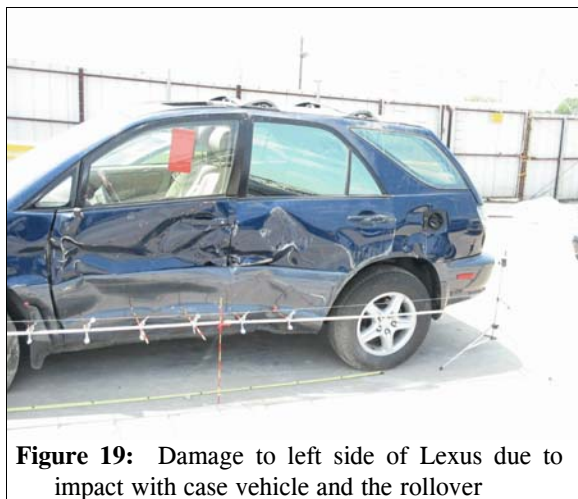
**Exterior Damage:** The Lexus’ impact with the case vehicle involved the left side doors (**Figure 19**). Direct damage began 76 centimeters (29.9 inches) forward of the left rear axle and extended 139 centimeters (54.7 inches) along the left side of the Lexus. Crush measurements were taken at the mid door level. The maximum residual crush was measured as 16 centimeters (6.3 inches) occurring at C<sub>4</sub> (**Figure 20**). The direct damage from the rollover involved the right side, left side and roof (**Figure 21** below) of the Lexus. The impact with the fire hydrant that occurred during the rollover involved the hood and windshield (**Figure 22** below). The guy wire impact that occurred during the rollover appeared to have involved a narrow area of the right quarter panel. The table below shows the Lexus’ crush profile for the side impact.

**Figure 19:** Damage to left side of Lexus due to impact with case vehicle and the rollover

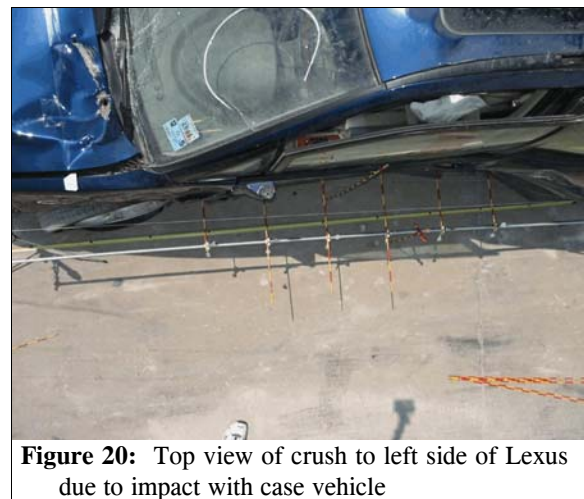
Units	Event	Direct Damage		Field L	C <sub>1</sub>	C <sub>2</sub>	C <sub>3</sub>	C <sub>4</sub>	C <sub>5</sub>	C <sub>6</sub>	Direct	Field L
		Width CDC	Max Crush								±D	±D
cm	1	139	16	183	0	11	15	16	14	13	14	7
in		54.7	6.3	72.0	0.0	4.3	5.9	6.3	5.5	5.1	5.5	2.8

**Figure 20:** Top view of crush to left side of Lexus due to impact with case vehicle

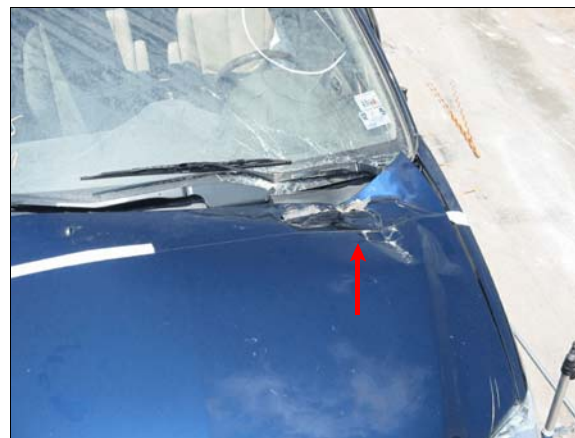
**Figure 22:** Damage to Lexus' hood and windshield due to fire hydrant impact during the rollover
