Child Safety Seat Fatality Investigation/Vehicle Rollover
Dynamic Science, Inc./Case Number: DS05018
1996 Isuzu Oasis LS Minivan
North Dakota
September 2005

1. Report No. DS05018	2. Government Accession No.	3. Recipient Catalog No.	
4. Title and Subtitle Child Safety Seat Fatality Investigation		5. Report Date June 14, 2006

The focus of this on-site investigation was on a child safety seat installed in the second row right seating position of a 1996 Isuzu Oasis LS minivan. This single vehicle crash occurred in September, 2005 at 1550 hours in the state of North Dakota. The crash occurred on a two-lane divided highway. The posted speed limit was 105 km/h (65 mph).

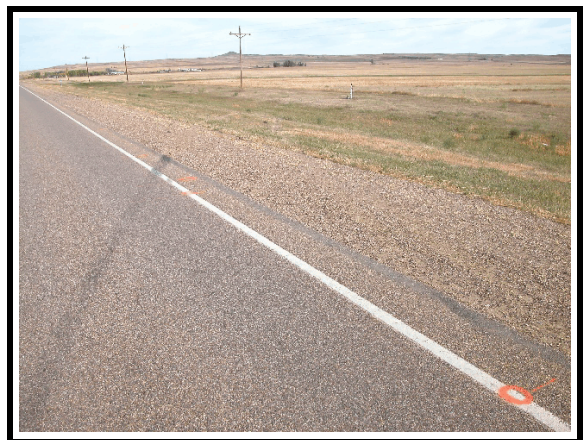
The case vehicle was traveling northbound at an unknown rate of speed. The coroner's report indicated that prior to the crash the mother had been glancing in the rearview mirror, in order to check on the infant male and her 3-year-old daughter. She was singing songs with her daughter. With the driver distracted, the vehicle drifted across the southbound lane and onto the left shoulder. As the minivan came into contact with the gravel on the west shoulder, the driver steered sharply to the right in an attempt to reenter the roadway. This over-steering caused the vehicle to begin a clockwise yaw as it traversed both travel lanes and exited the roadway to the east (Figure 3).

Figure 3. Area of roadway departure

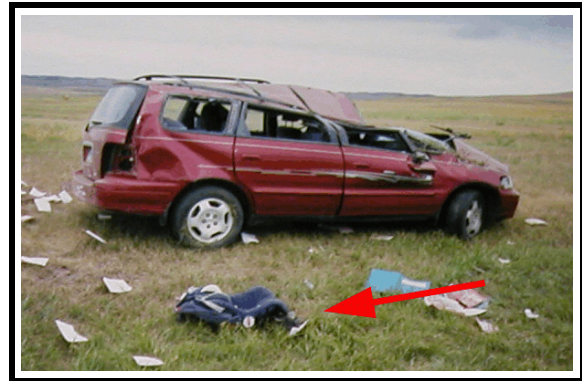
The case vehicle departed the east side of the roadway while in the clockwise rotation. The vehicle tripped as it departed the right side of the roadway, and began to overturn. During the rollover sequence the infant seat became disconnected from its stay-in-vehicle base. Subsequently the child and the infant seat were ejected; the base remained inside the case vehicle. The infant came to rest near the case vehicle, still secured in the child seat.

Figure 4. Final rest. Looking southwest. Ejected child seat in foreground.

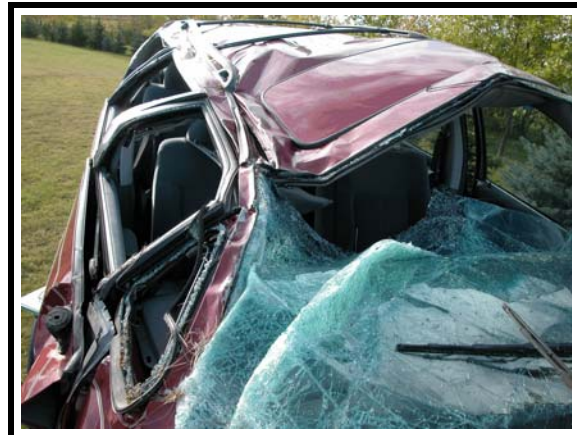
Damage Description: The vehicle sustained 41.0 cm (16.1 in) of crush to the roof area, with the greatest crush being located along the right side rail. This would indicate that the vehicle had rolled with its left side leading. There was integrity loss through the windshield bond separation and all of the right side window glazing fractured. Those windows disintegrated as the vehicle rolled onto its roof; the majority of the impact took place along the right roof side rail area. The windshield glazing pulled away from the bond itself, which constituted integrity loss. The sunroof glazing also disintegrated. Both right side doors and the hatchback were jammed shut.

CDC: 00TDRO4

Figure 5. Top/right side of case vehicle

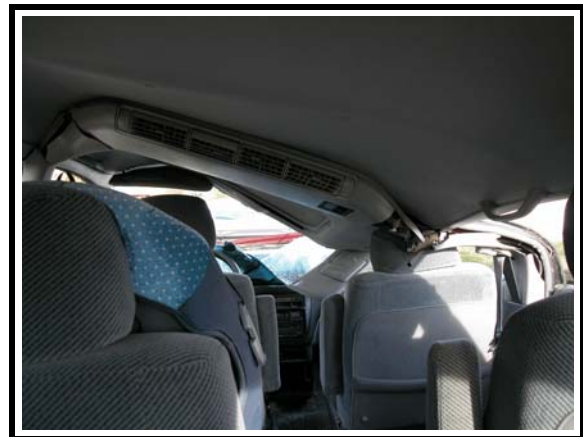
The vehicle sustained significant intrusion along the right roof, pillars and side rail areas (Figure 6). These field measurements were obtained from the floor vertically, and an exemplar vehicle was located in order to obtain comparative, undamaged measurements (Figure 7).

Position	Intruded Component	Magnitude of Intrusion	Direction
RF	A Pillar	32.0 cm (12.6 in)	Lateral
RF	B Pillar	31.0 cm (12.2 in)	Lateral
RR	B Pillar	31.0 cm (12.2 in)	Lateral
RF	A Pillar	27.0 cm (10.6 in)	Vertical
RF	Windshield header	26.0 cm (10.2 in)	Vertical
RF	Roof	26.0 cm (10.2 in)	Vertical
RF	Roof side rail	21.0 cm (8.3 in)	Vertical
RR	C Pillar	17.0 cm (6.7 in)	Lateral
RR	Roof	13.0 cm (5.1 in)	Vertical
RR	Roof side rail	10.0 cm (3.9 in)	Vertical

Figure 6. Overview of passenger compartment intrusion

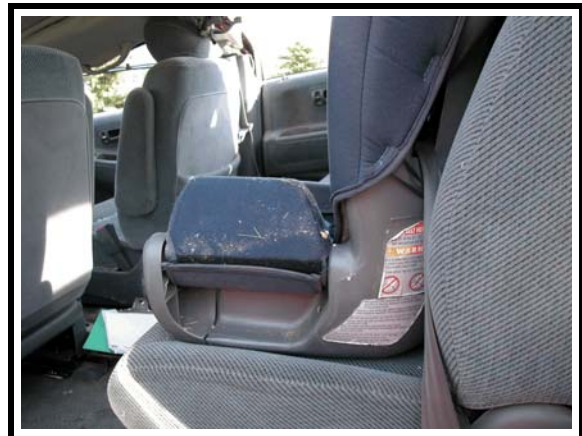
The second row left seat was occupied by a 3-year-old female. The girl had been in a high back Century Next Step booster seat. It was secured to the vehicle by the use of the manual 3-point lap and shoulder belt. There were visible signs of loading to the seat belt webbing which were consistent with its having been used during the crash. This seat belt consisted of a switchable seat belt retractor (ELR/ALR) and had a sliding latch plate. When viewed at the time of the vehicle inspection the retractor was noted to have been switched to the ALR mode. It did not have an adjuster mechanism for the shoulder belt webbing. All seat belt components were found to be fully operational; however, the lap and shoulder belt appeared to have been routed incorrectly as the belt webbing was bunched through the rear frame of the booster seat.

This Century Next Step booster seat was anchored to the case vehicle by the use of the manual 3-point lap and shoulder belt. There were visible signs of loading to the seat belt webbing which were consistent with its having been used during the crash. This seat belt consisted of a switchable seat belt (ELR/ALR) and had a sliding latch plate. When viewed at the time of the vehicle inspection it was noted to have been switched to the ALR mode. All seat belt components were found to be fully operational. When inspected, this seat was still tightly anchored to the case vehicle. It exhibited 3.8 cm (1.5 in) of lateral movement and 2.5 cm (1.0 in) of forward top movement.

Figure 9. High back booster seat belt routing path - webbing bunched up

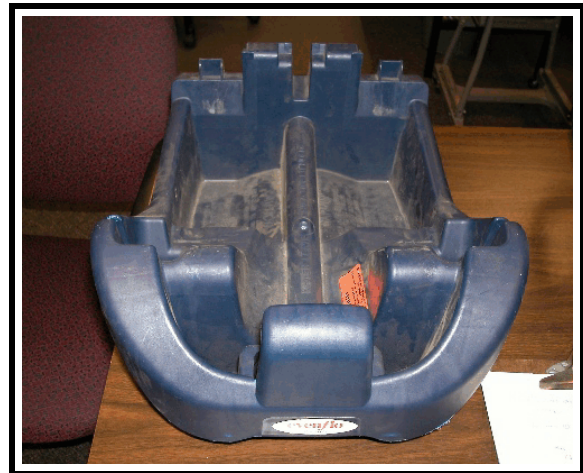
The infant seat base had been anchored to the case vehicle by the use of the vehicle's 3-point lap and shoulder harness. The lap and shoulder belt had been switched to the ALR mode and was still in the ALR mode at the time of inspection.

Figure 11. Stay-in-vehicle base

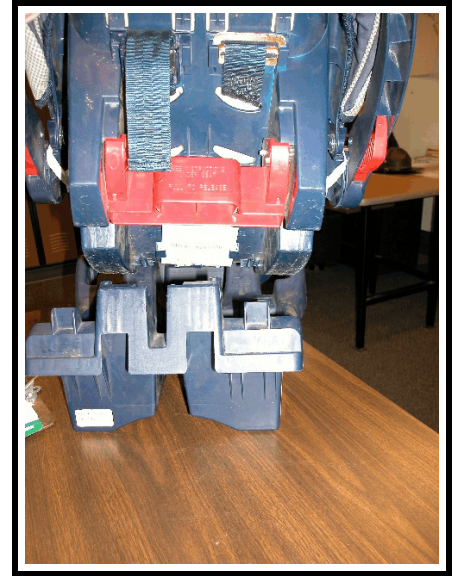
The infant seat used in this particular crash was manufactured on March 23, 2002 with a model number of 4791270P1. The internal 3-point harness had its shoulder strap webbing located in the upper slot (top) and the handle was found in the downward position. Post-crash photos also show the handle in the down position. The infant seat base did not exhibit any signs of stressing or flexing as a result of the crash (Figure 11). This particular base was no longer in the case vehicle, but was being held at the highway patrol office when it was inspected. An examination of the seat and seat base revealed that the locking mechanism attaching the seat to the seat base was functioning correctly. There were no indications of stressing or flexing at the locking points. It appears likely that the child safety seat had been placed on the seat base, but had not been properly locked down.

The infant seat, minus the detachable base, had been ejected from the case vehicle. The avenue of ejection was through the right rear glazing area, which disintegrated during the rollover sequence. There was no visible damage to the base or to the mechanism whereby the child seat was secured to the base. There were no signs of any failures in this area.

Figure 12. Seat to seat base locking mechanism

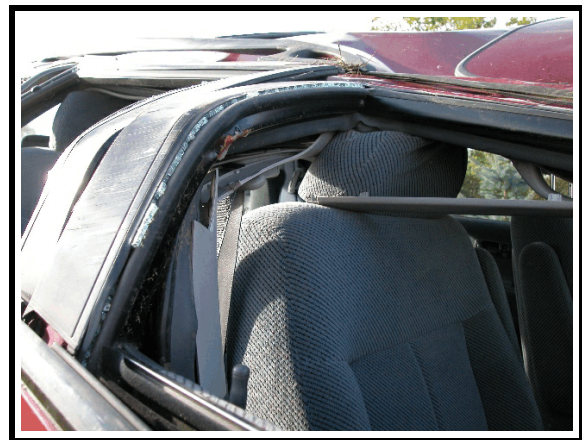
As the vehicle rolled with the left side leading, this 7-month-old male infant remained secured inside the Evenflo Discovery Infant child safety seat by the use of its 3-point internal harness. As the vehicle rolled onto the roof's right side rail, the infant seat became detached from the base. The infant seat, with the child still in it, was ejected through the right rear window (glazing had disintegrated-see Figure 13). The child and the seat came to rest to the right of the case vehicle. According to police and a witness statement, the mother removed the unconscious child from the safety seat, and began to run down the roadway, towards the nearest town. The child sustained significant head trauma as a result of being ejected.

Figure 13. Second row, right side window

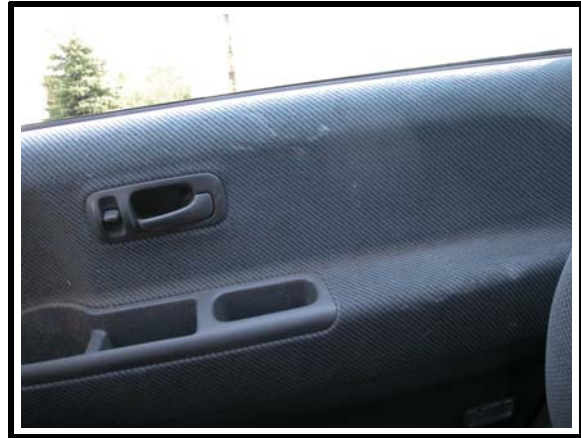
Occupant contact evidence inside the case vehicle was very minimal. There was scuffing along the right rear door which may have come from the infant seat as it was being ejected from the vehicle. There was also molding broken along the rear of the right B pillar. The avenue of occupant ejection was determined to have been through the right rear glazing area, which disintegrated as the vehicle was rolling over. The only other possible contact point found was an area of scuffing along the roof in the front row seating area.

A passerby picked up the occupants of the case vehicle and drove them to town where they were met by an ambulance. The ambulance transported the injured infant to a trauma center ICU, where he was admitted. A CT scan revealed a right frontal skull fracture and subarachnoid hemorrhage. The child never regained consciousness and was declared brain dead the following day. The child was removed from the ventilator and expired at 0640 hours. There were no indications of occupant contact to the window frame or other interior components in this infant's general seating area. It appears that the child's head injuries were related to contact with the ground, which occurred during the ejection (Figure 14).

Figure 14. Possible child seat contact to second row, right side door
