### **ON-SITE CERTIFIED ADVANCED 208- COMPLIANT VEHICLE INVESTIGATION**

CASE NUMBER - IN-05-018  
LOCATION - TEXAS  
VEHICLE - 2003 CADILLAC C1500 ESCALADE  
CRASH DATE - March 2005

April 26, 2006  
Revised: March 31, 2008

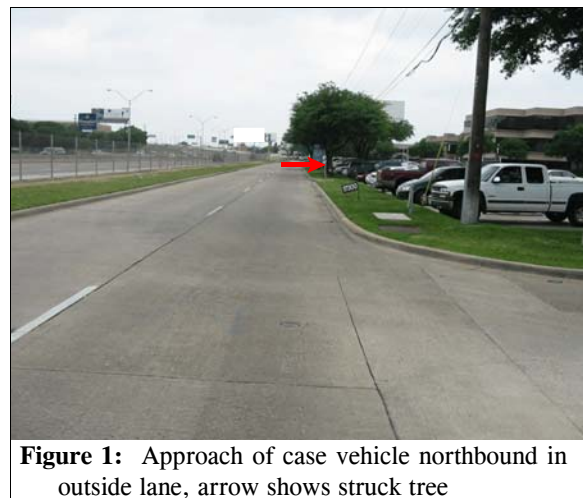
**Pre-Crash:** The case vehicle was traveling north in the right lane (**Figure 1**). The driver was intending to proceed straight ahead. The case vehicle driver reported to police that her dog jumped into her lap. As she tried to push the dog off her lap, she drove over the east curb. The police crash report also indicated the driver was under the influence of alcohol and/or drugs and refused to submit to an alcohol/drug test. Evidence in the case vehicle indicated there was in fact a dog in her vehicle. The EDR data supports driver brake application just prior to the crash. In addition, it appears the driver steered left in an attempt to avoid the cash. The crash occurred on the east side of the roadway.

**Figure 1:** Approach of case vehicle northbound in outside lane, arrow shows struck tree

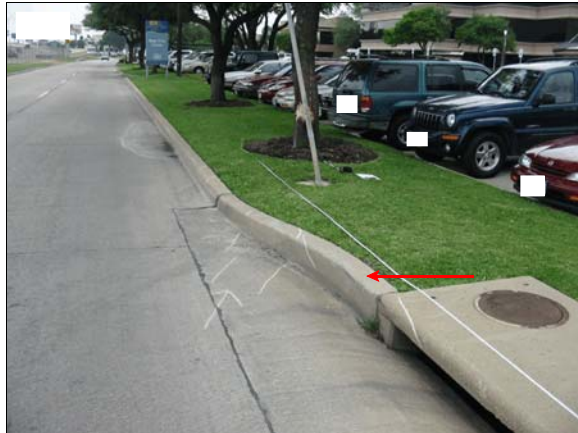
**Crash:** The case vehicle drove over the east curb of the roadway (**Figure 2** below) and the center portion of the case vehicle's front bumper (**Figure 3** below) impacted a metal street sign pole and bent it over. The front right corner of the case vehicle then immediately impacted a 34 centimeter

**Figure 2:** Approach of case vehicle to impact with curb (arrow), sign post and tree

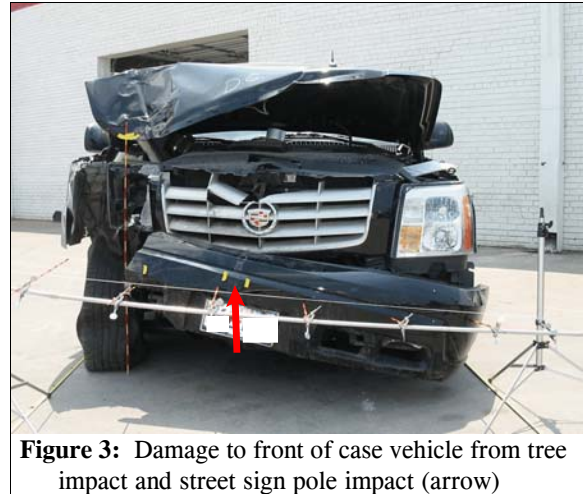
**Figure 3:** Damage to front of case vehicle from tree impact and street sign pole impact (arrow)

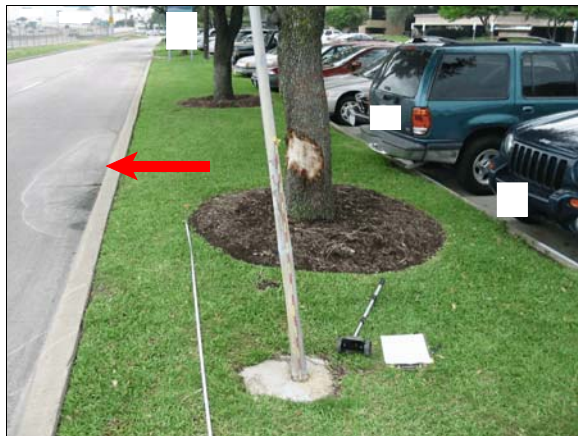
(13.4 inch) diameter tree (**Figure 4**), which caused the case vehicle driver’s air bag to deploy. The downloaded EDR data indicated only the first stage of the dual stage air bag activated. The case vehicle’s front right air bag did not deploy because there was no front right passenger seated in the case vehicle.

**Figure 4:** Impacted sign post and tree, arrow shows fluid spill stain on roadway at case vehicle’s final rest location, each increment on rod is 5 cm (2 in)

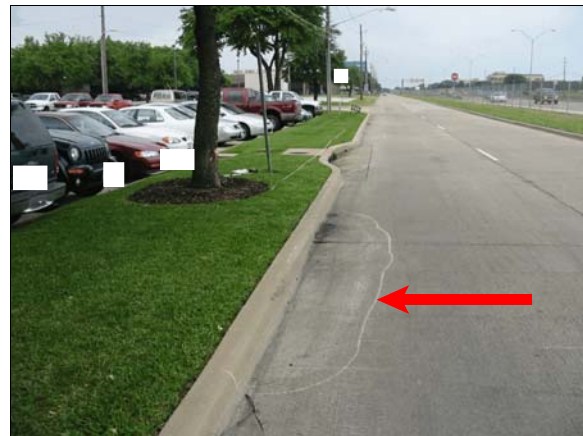
**Figure 5:** View to south opposite case vehicle’s approach showing fluid stain (arrow) at case vehicle’s final rest location

**Post-Crash:** The case vehicle deflected northwest off the tree and reentered the roadway. The police scene schematic showed the case vehicle on the roadway facing north, adjacent and parallel to the east curb, and north of the impacted tree at final rest. In addition, there was a fluid spill stain on the pavement in this area supporting the police reported final rest position (**Figure 5**).

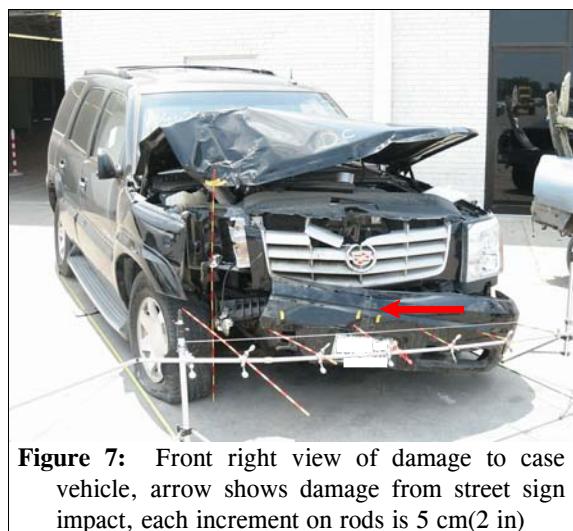
**Exterior Damage:** The case vehicle's impact with the metal street sign pole involved the center portion of the front bumper, just to the right of the case vehicle's centerline (**Figure 7**). The direct damage began 91 centimeters (35.8 inches) left of the bumper corner and extended 8 centimeters (3.1 inches) along the bumper. Residual crush could not be determined due the subsequent impact with the tree. The case vehicle's impact with the tree involved the right portion of the front bumper, as well as the right headlamp/turn signal assembly, grille, hood and right fender (**Figure 7** and **Figure 8** below). The direct damage began at

Figure 7: Front right view of damage to case vehicle, arrow shows damage from street sign impact, each increment on rods is 5 cm(2 in)

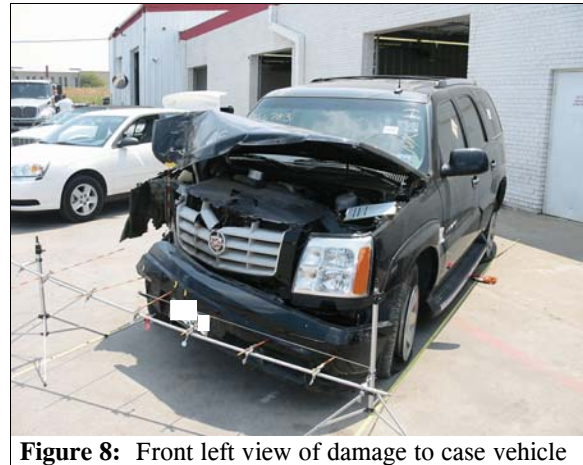
Figure 8: Front left view of damage to case vehicle

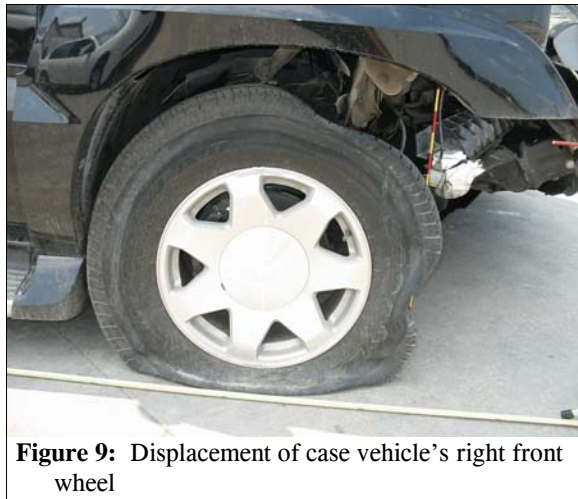
the right bumper corner and extended 47 centimeters (18.5 inches) along the bumper. The right portion of the front bumper, right fender and hood were crushed rearward. In addition, the right front wheel was crushed rearward to the back of the right front wheelhouse (Figure 9), and the end of the right frame member was engaged and bent upward. Crush measurements were taken to the front bumper bar behind the bumper fascia, due to rebound of the bumper fascia and loss of the right corner portion of the bumper fascia. The residual maximum crush was determined to be 42 centimeters (16.5 inches) occurring at C<sub>6</sub> (Figure 10). The table below shows the case vehicle's front crush profile for the tree impact.

Figure 9: Displacement of case vehicle's right front wheel

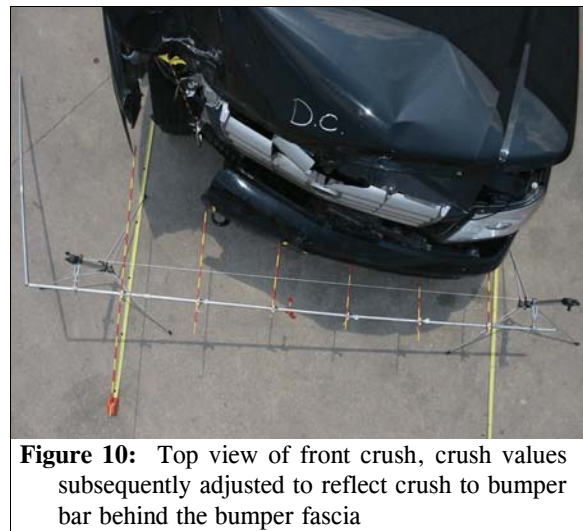
Figure 10: Top view of front crush, crush values subsequently adjusted to reflect crush to bumper bar behind the bumper fascia

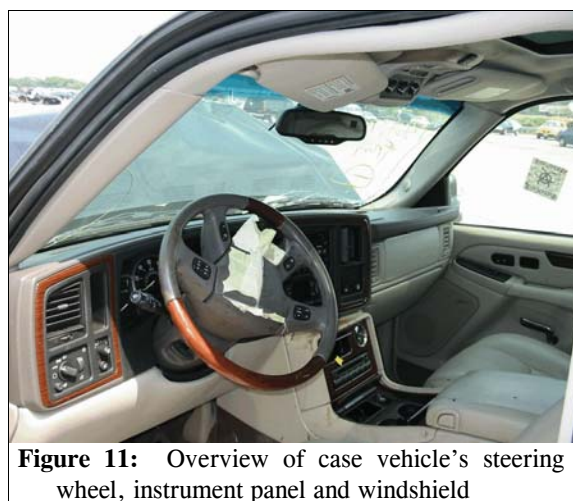
**Vehicle Interior:** Inspection of the case vehicle’s interior (**Figure 11**) revealed a possible scuff below the air vent, left of the steering wheel. There was also blood and white hair on the gear shift level (**Figure 12**), as well as blood splatter on the steering wheel, windshield, center instrument panel, console, front right seat, right front door, back of the front right seat and on the back seat cushion. This was most likely related to an injury sustained by the dog that the driver reported was in the vehicle. This was not related to a driver injury because the police crash report stated the driver only complained of back pain and refused transport to a treatment facility. Lastly, there was no intrusion of the passenger compartment, and no deformation of the steering wheel rim (**Figure 13** below). Some minor compression of the energy absorbing steering column may have occurred, but this could not be confirmed.

**Figure 11:** Overview of case vehicle’s steering wheel, instrument panel and windshield

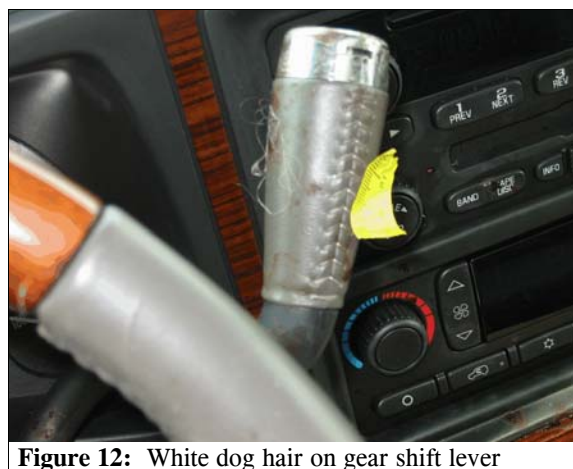
**Figure 12:** White dog hair on gear shift lever

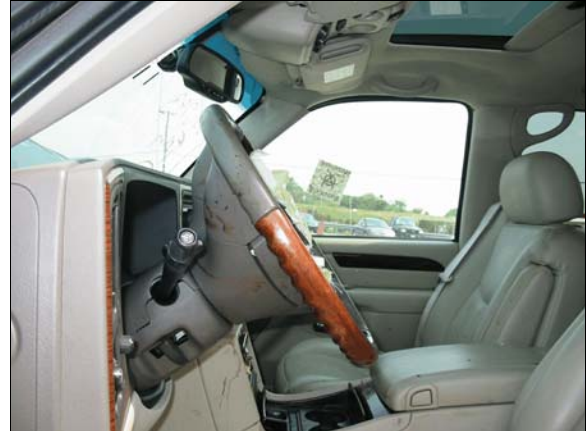
**Figure 13:** Left side view of case vehicle's steering column and steering wheel showing lack of deformation, steering column moved to full up position

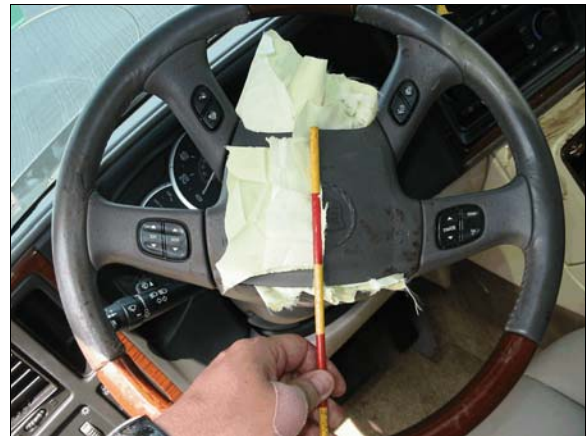
The case vehicle's driver air bag was located in the steering wheel hub. An inspection of the air bag could not be completed because it had been cut out of the air bag module (**Figure 14**). Inspection of the module cover flaps revealed that they opened at the designated tear points. There was no damage due to deployment to the module cover flaps. The air bag module cover consisted of symmetrical "I" configuration cover flaps made of pliable vinyl approximately 2 millimeters (0.08 inch) thick. Each module cover flap was approximately 7.3 centimeters in width at the top, 4.1 centimeters (1.6 inches) in width at the bottom and 11 centimeters (4.3 inches) in height along the center tear seam. Inspection of the remaining air bag material indicated that the driver's air bag was designed with two tethers, each approximately 10 centimeters (3.9 inches) in width.

**Figure 14:** Driver's air bag was cut out of case vehicle, steering wheel upside down, measurement rod shows height of cover flaps, each increment on rod is 5 cm (2 in)

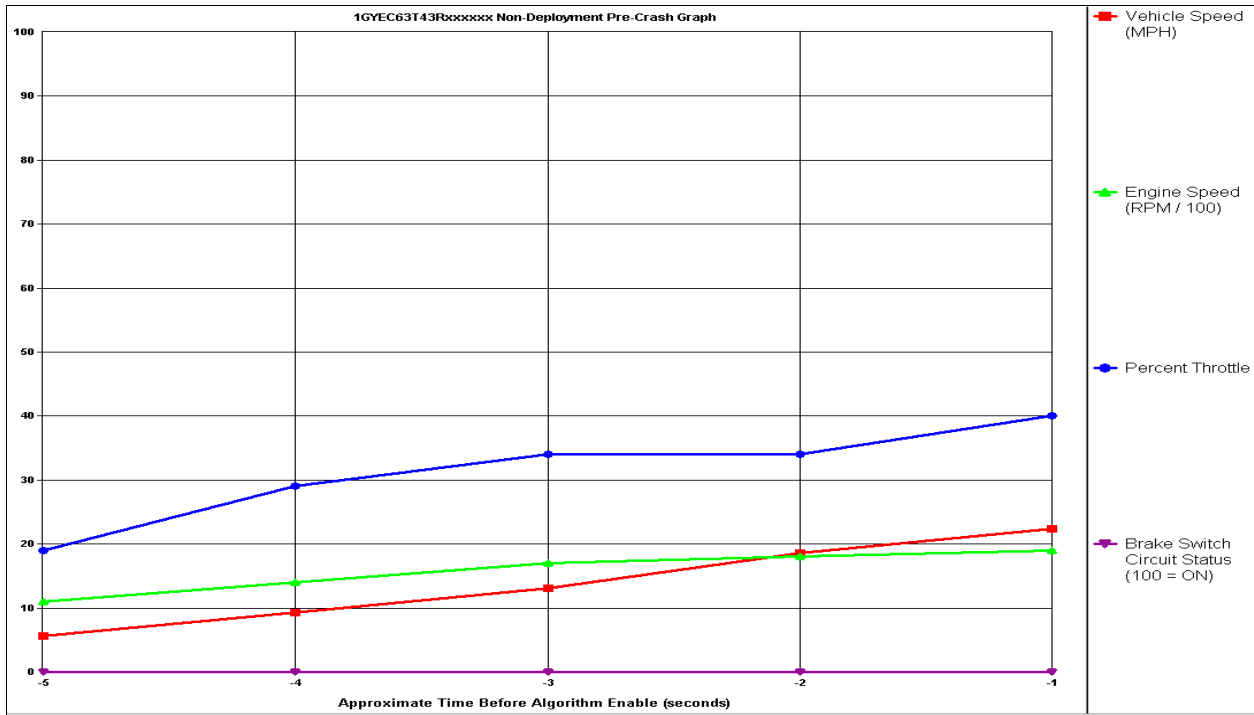
The download of the case vehicle's EDR was done during the vehicle inspection via connection to the case vehicle's data link connector. The EDR reports are presented in **Figures 16 - 21** at the end of this report. The downloaded data indicated that a non-deployment event and deployment event were recorded. The non-deployment event occurred during this crash because it was recorded on the same ignition cycle as the deployment event. The non-deployment event is most likely related to the case vehicle's right front wheel impact with the curb. The system status reports show that the SIR warning lamp was recorded as off, and the driver's seat belt switch circuit was recorded as unbuckled. In addition, the maximum SDM recorded velocity change was recorded as -31.94 km.p.h. (-19.85 m.p.h.) for the deployment event occurring 167.5 milliseconds after algorithm enable (AE), and -1.29 km.p.h. (-0.80 m.p.h.) for the non-deployment event occurring 82.5 milliseconds after AE. The system status report for the deployment event shows that the first stage deployment criteria for the driver's air bag was met 17.5 milliseconds after AE. The driver's air bag second stage deployment criteria was not met. In addition, the report indicates the time between the non-deployment event and the deployment event was 0.6 seconds, which is consistent with the non-deployment event occurring when the case vehicle impacted the curb.

Figure 17: Case vehicle's Non-Deployment Pre-Crash Graph

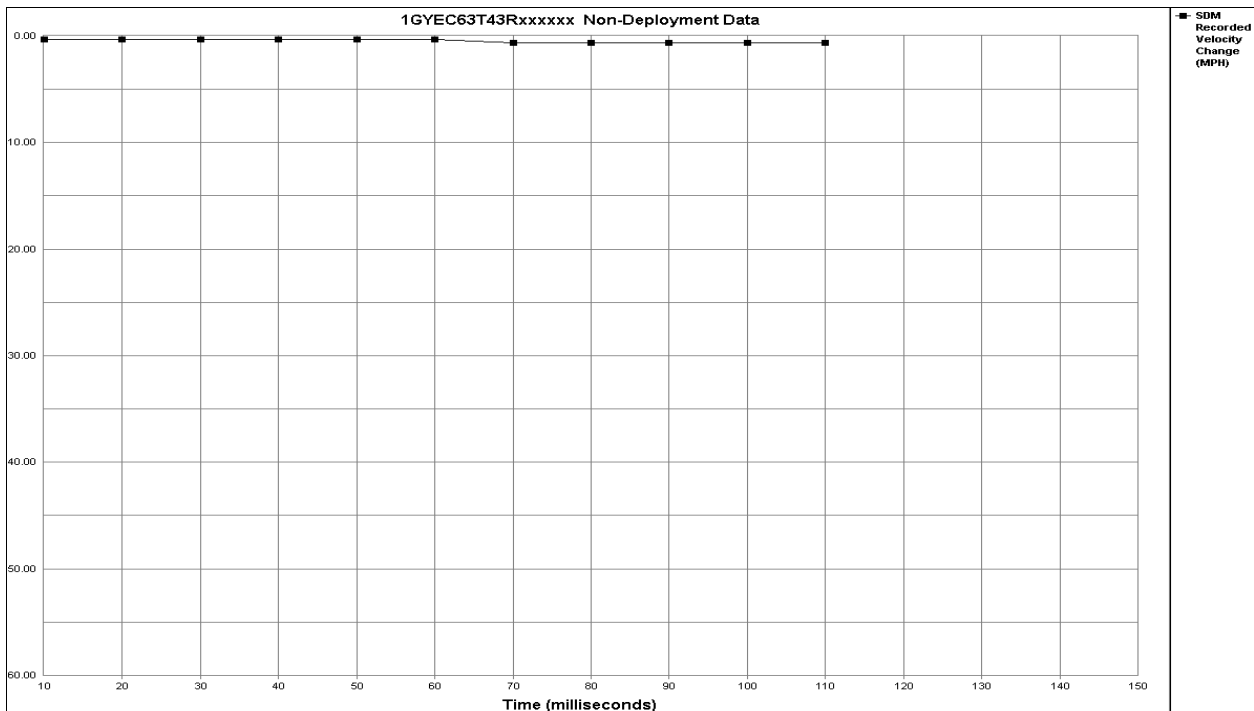
Figure 18: Case vehicle's non-deployment SDM Recorded Velocity Change graph

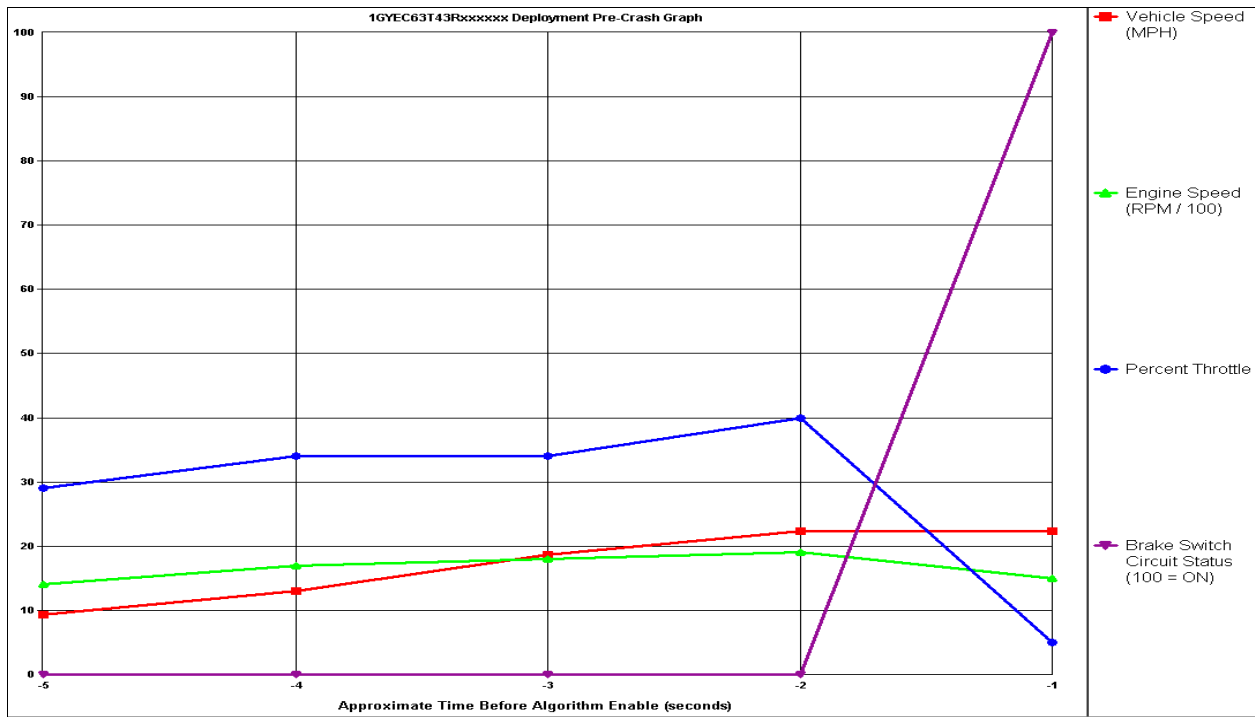
The non-deployment and deployment event pre-crash data indicate that the case vehicle had accelerated from 9.7 km.p.h. (6 mph) to 35.4 km.p.h. (22 m.p.h) just prior to the crash. The deployment event pre-crash data also shows that the brake switch circuit was recorded on one second prior to the tree impact. This indication supports driver brake application just prior to the curb impact. In addition, the EDR reported pre-crash speed and acceleration data support the likelihood that the driver had just turned onto the roadway from the side street just south of the crash site. The driver's residence was within one-half mile of the crash site.

Figure 20: Case vehicle's Deployment Pre-Crash Graph

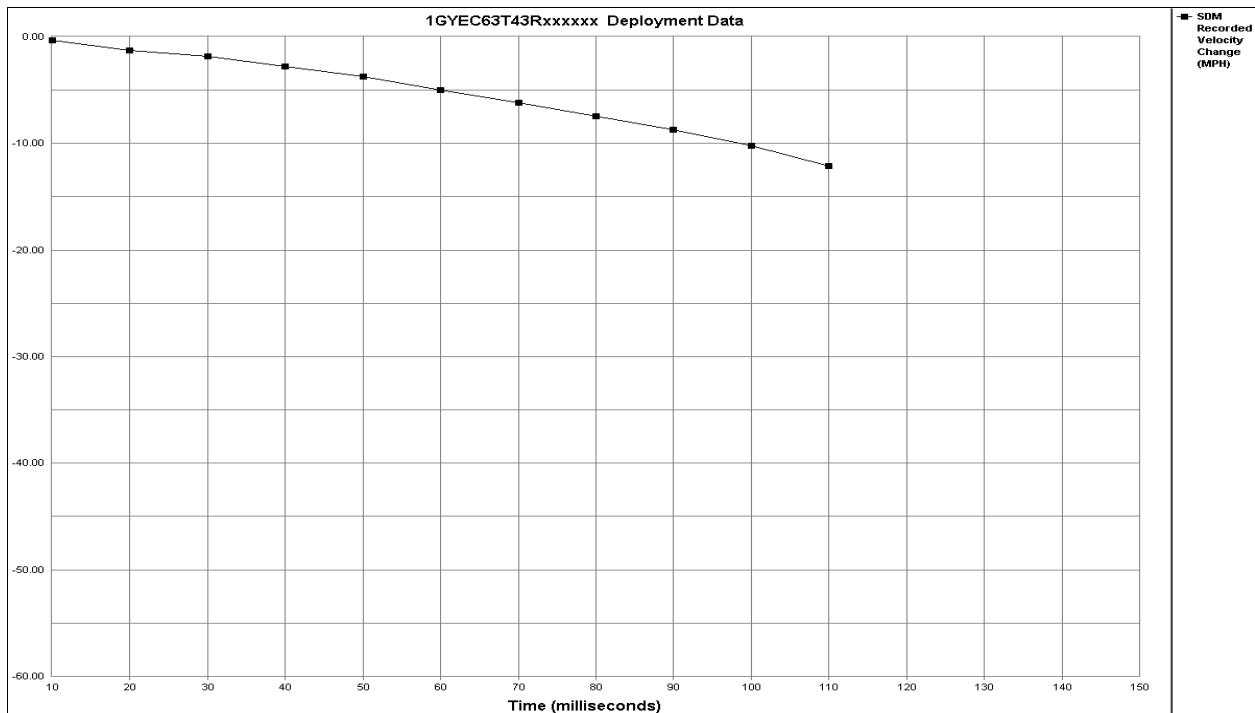
Figure 21: Case vehicle's deployment SDM Recorded Velocity Change graph
