# INDIANA UNIVERSITY

## ON-SITE CHILD SAFETY SEAT INVESTIGATION

CASE NUMBER - IN-05-019

VEHICLE - 1994 GEO TRACKER SPORT

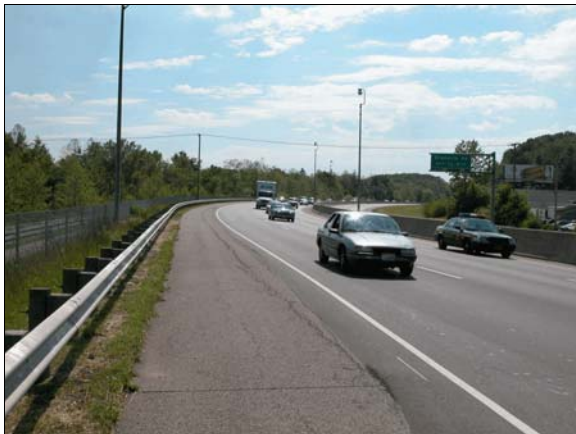
**Figure 1:** View to southwest at case vehicle's approach on the divided highway, photo taken adjacent to mouth of exit ramp

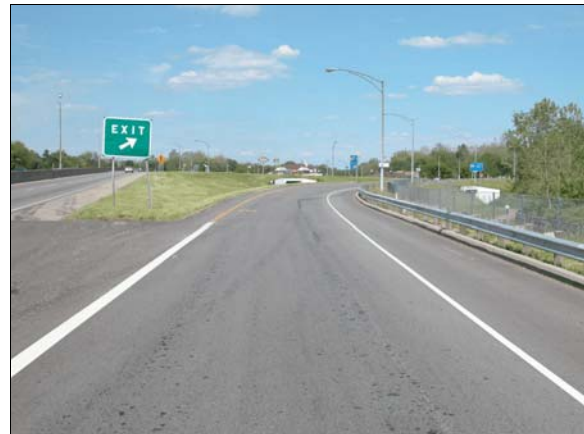
**Figure 2:** Approach of case vehicle northeastbound on the exit ramp

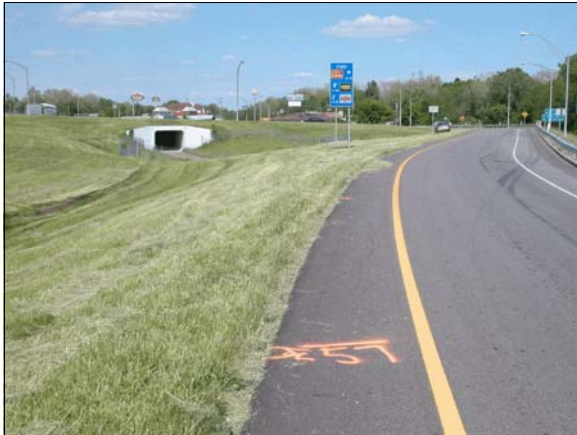
**Figure 3:** Area of case vehicle's roadway departure

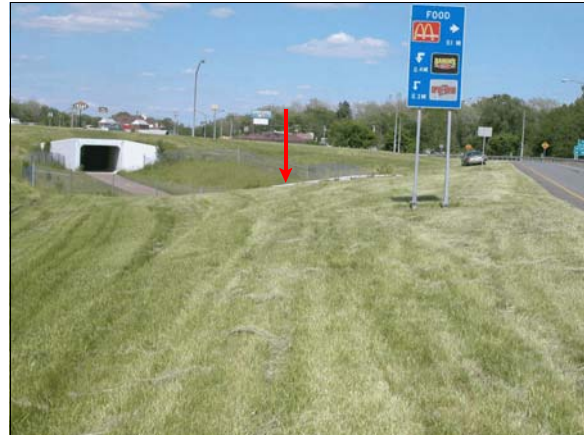
**Figure 4:** Approach of case vehicle to impact (arrow) with back, top section of bicycle tunnel header wall

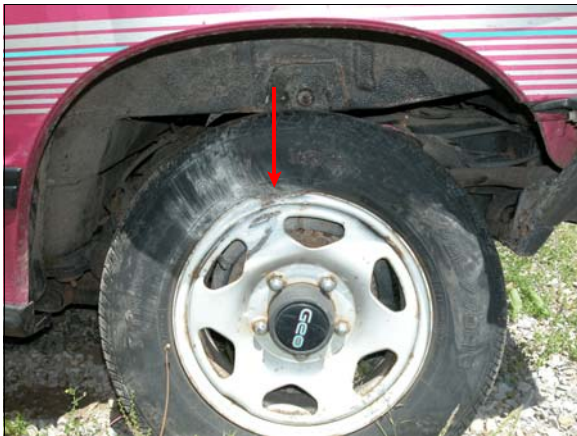
**Figure 5:** Damage to left rear wheel (arrow) from impact with header wall

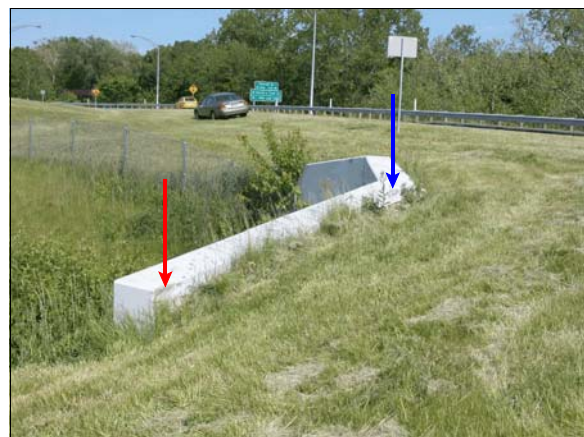
**Figure 6:** Overview of impact to bicycle header wall, red arrow shows left rear wheel impact, blue arrow shows left front wheel impact

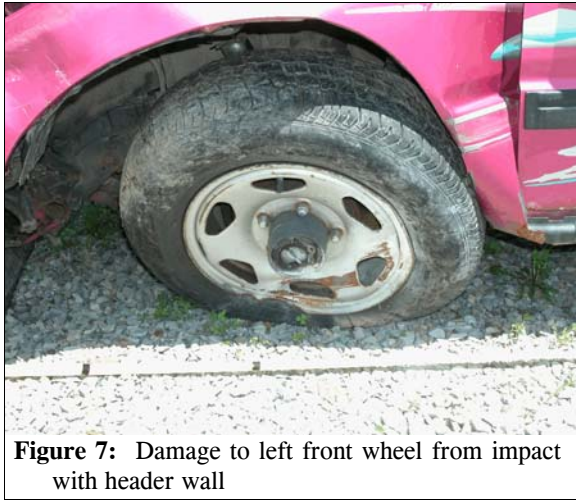
**Figure 7:** Damage to left front wheel from impact with header wall

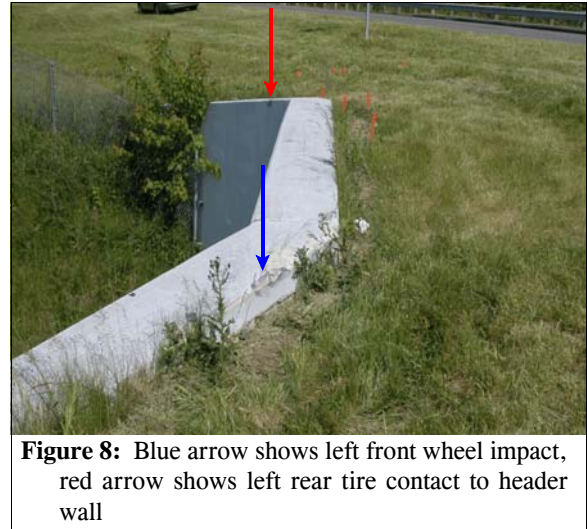
**Figure 8:** Blue arrow shows left front wheel impact, red arrow shows left rear tire contact to header wall

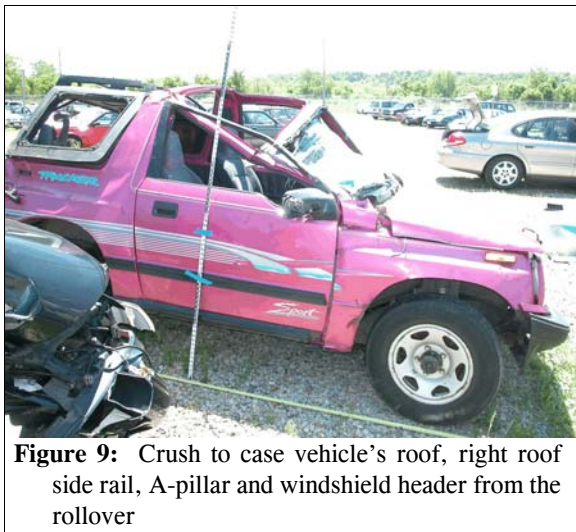
**Figure 9:** Crush to case vehicle's roof, right roof side rail, A-pillar and windshield header from the rollover

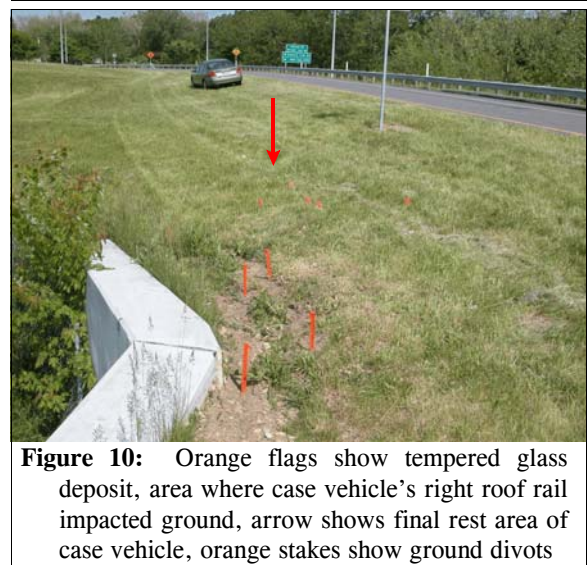
**Figure 10:** Orange flags show tempered glass deposit, area where case vehicle's right roof rail impacted ground, arrow shows final rest area of case vehicle, orange stakes show ground divots

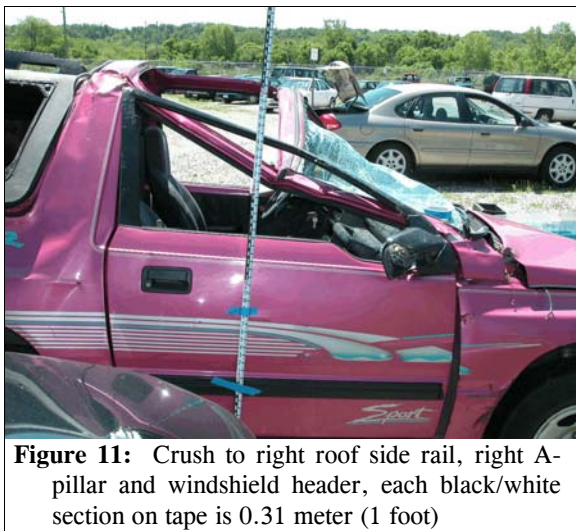
**Figure 11:** Crush to right roof side rail, right A-pillar and windshield header, each black/white section on tape is 0.31 meter (1 foot)

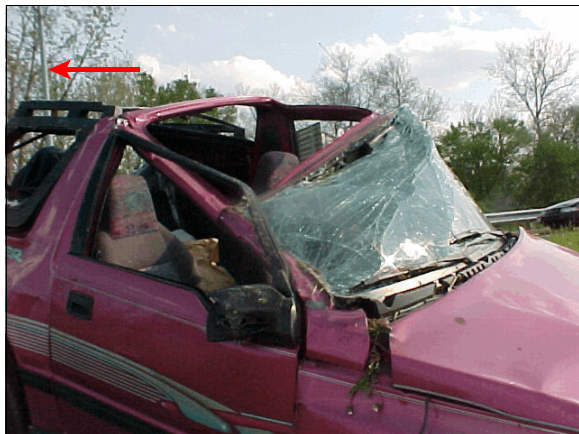
**Figure 12:** Police on-scene photo of case vehicle at its final rest position, view is to southwest back to roadway, arrow shows sign post in photo 13

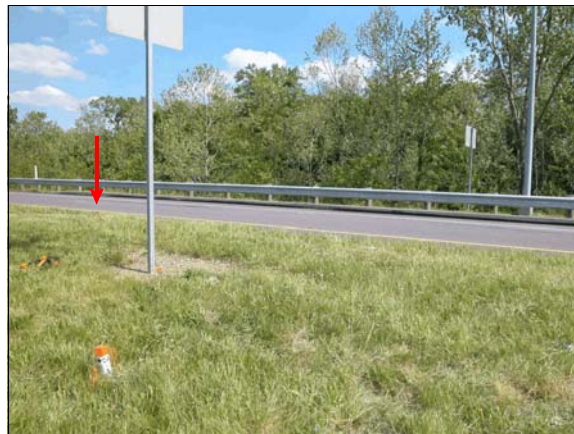
**Figure 13:** View northwest back to roadway through case vehicle's final rest position to area of final rest of ejected driver (arrow), can with orange top shows case vehicle's right rear wheel position

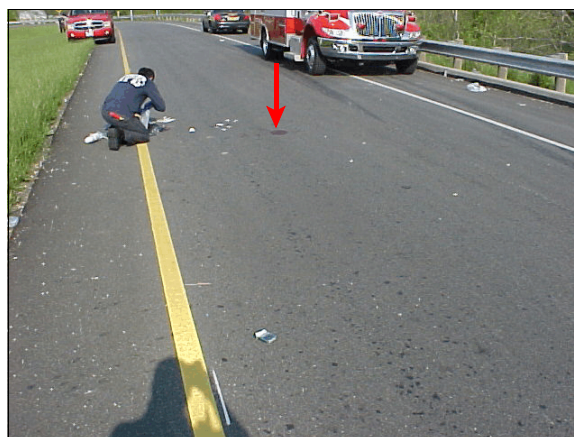
**Figure 14:** Police on-scene photo showing blood spot (arrow) in roadway at driver's final rest position

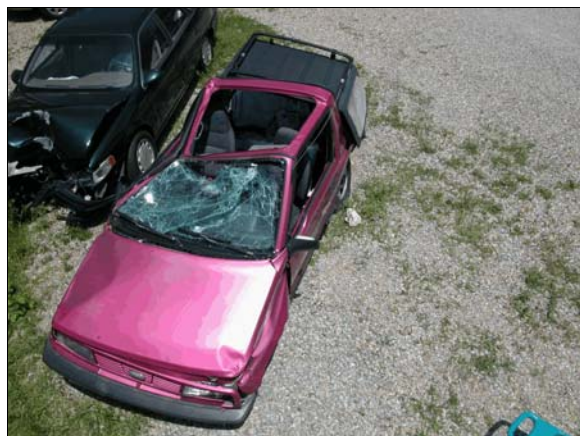
**Exterior Damage:** The case vehicle's impact with the back of the top section of the bicycle tunnel header wall involved the left rear and left front wheels. The rim was bent on both wheels. The left front wheel was bent inward at the bottom and driven into the back of the wheel house. The rollover involved the roof, right side and front left corner. The primary components damaged during the rollover were the right roof side rail, roof, windshield header, windshield, right A-pillar and right portion of the hood (**Figures 15 and 16** below). The residual maximum roof crush was 42 centimeters (16.5 inches) occurring at the right roof side rail near where it joins the right A-pillar (**Figure 11** above). The left side wheelbase was reduced 17 centimeters (6.7 inches). The right side wheelbase was extended 2 centimeters (0.8 inches). Induced damage involved the entire case vehicle.

Figure 15: Top view of damage to case vehicle

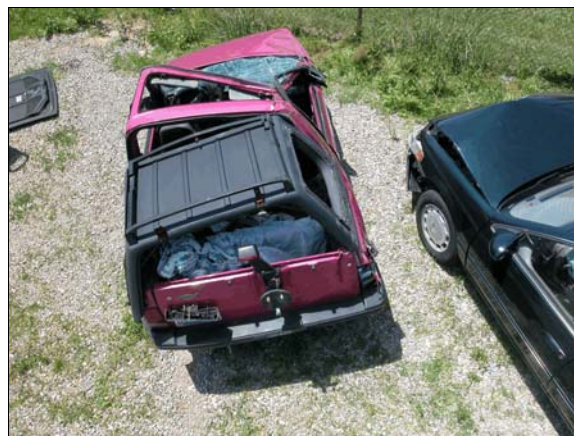
Figure 16: Top view of damage to case vehicle

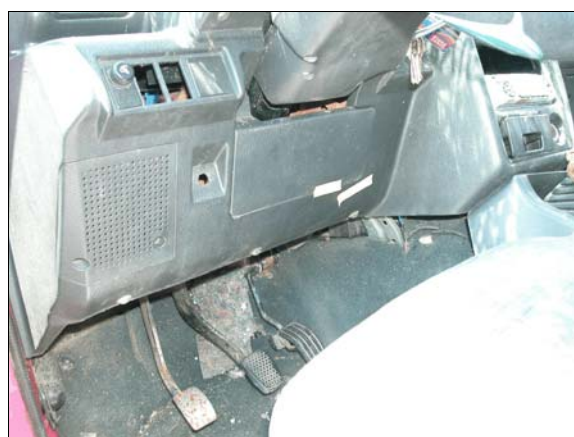
**Vehicle Interior:** Inspection of the case vehicle’s interior revealed two scuffs on the lower instrument panel (Figure 17) right of the steering wheel, probably due to contact by the driver’s right knee. There were also multiple occupant contact marks on the driver’s door (Figure 18 below). In addition, the driver’s door was bowed outward slightly (Figure 19 below) due to loading by the driver. The driver’s door window, which was partially open at the time of the crash, was also broken out due to driver impact to the door. A small scuff and dent were observed in the vinyl side panel adjacent to the back right seat (Figure 20 below) where the child was seated in his child

Figure 17: Tapes show location of probable knee scuffs on lower instrument panel

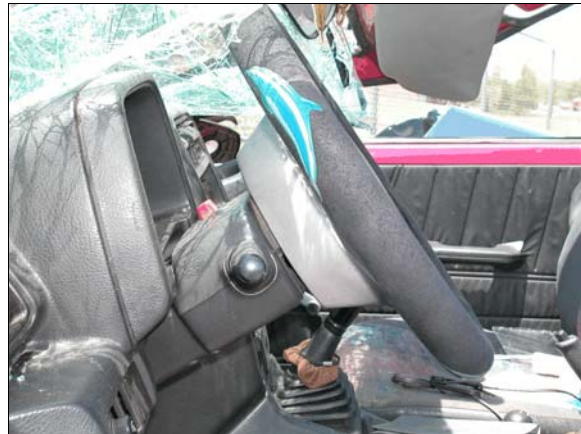
**Figure 22:** Left side view of steering column and steering wheel showing lack of deformation

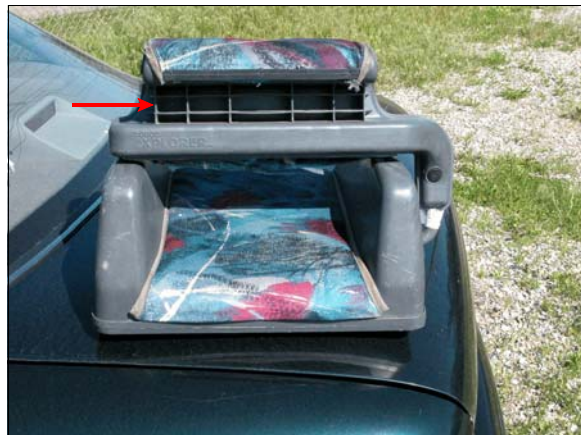
**Figure 23:** Front of child seat, arrow shows guide for safety belt

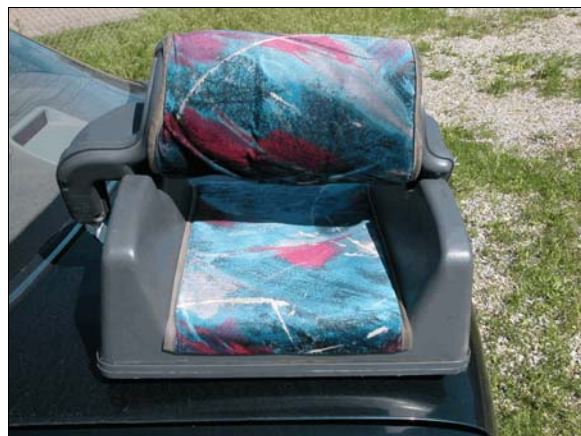
**Figure 24:** Back view of child seat

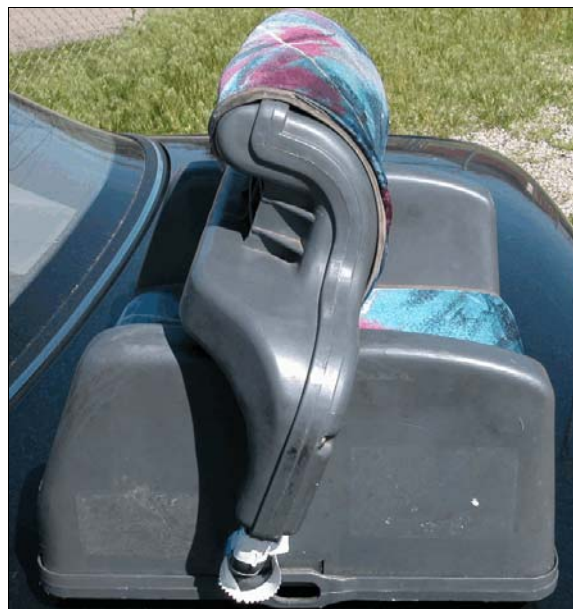
**Figure 25:** Left side view of child seat showing swivel mount for shield

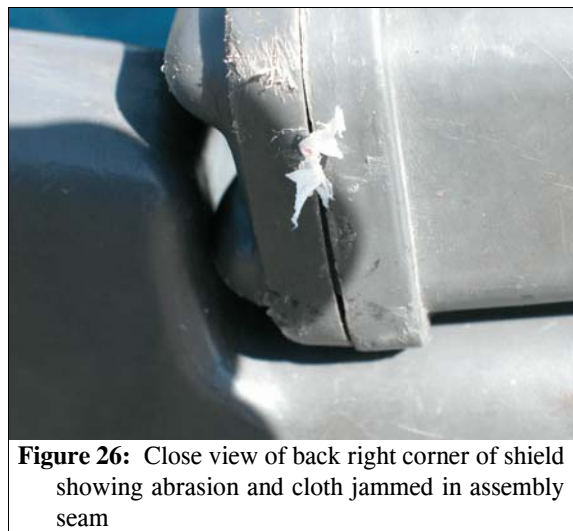
Inspection of the child seat revealed no deformation or fractures to the seat or the shield. There were several areas of minor scratches and abrasions on the child seat. In addition, there were wear abrasions on the top of the sides of the child seat due to the shield being moved in and out of the restrained position. There was also a localized area of heavy abrasion and a small piece of cloth jammed in the assembly seam on the right lower corner of the shield (**Figure 26**). The cloth was not of the same material as the blanket that was found draped over the seat back. The source of these abrasions and the cloth could not be determined and appeared unrelated to this crash. A small area of abrasion was also noted on the left corner of the belt guide on the front of the shield. This abrasion was determined not to be related to this crash. Lastly, no warning or instruction labels were affixed to the child seat.

**Figure 26:** Close view of back right corner of shield showing abrasion and cloth jammed in assembly seam
