## ON-SITE AIR BAG-RELATED FATALITY INVESTIGATION

CASE NUMBER - IN-05-020

VEHICLE - 1998 NISSAN SX

CRASH DATE - May 2005

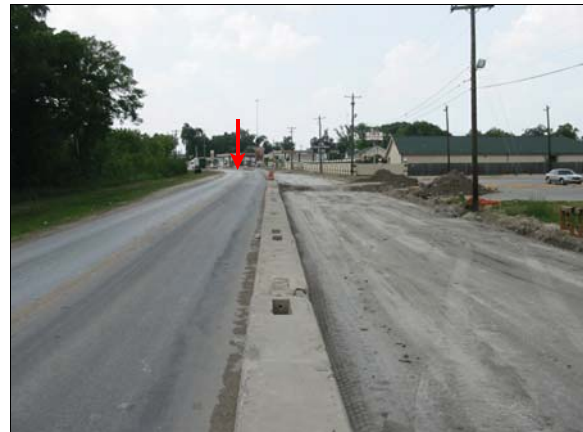
**Pre-Crash:** The case vehicle was traveling northwest at a high rate of speed in the northwestbound lane (**Figure 1**) in a left curve. The driver was intending to continue northwest bound. The driver had just taken abducted his son and step son from his estranged wife and was fleeing the area. The crash occurred at the concrete construction barriers on the north side of roadway in the left curve.

**Figure 1:** Approach of case vehicle northwest bound to crash location, arrow shows area of impact

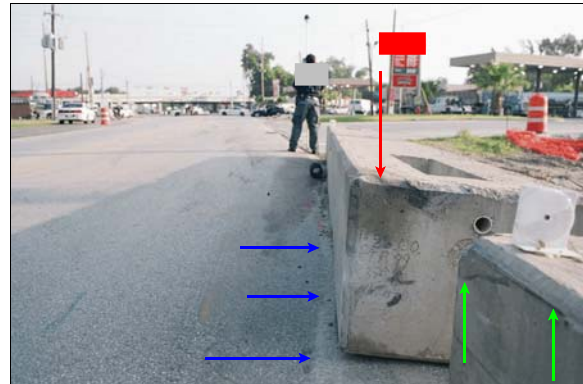
**Crash:** As the case vehicle was negotiating the left curve, the right side of its front bumper sideswiped one of the barriers (event 1, **Figures 2** and **3** below). The case vehicle's front right corner (**Figure 4** below) then immediately impacted the end of the next barrier (event 2, **Figures 2** and **3** below) in a narrow engagement involving primarily the right front wheel, right front door and sill. The front right corner impact with the second barrier caused the case vehicle's driver and front right air bags to deploy. There was minimum engagement to the right corner of the front bumper from this impact, and the right front wheel engaged the barrier as did the sill and front of the right front door. The impact tore the right front wheel off the case vehicle and displaced

the right front door rearward and bowed it outward, significantly separating it from the “A”-pillar, upper door frame and sill. The police on-scene photographs show that the second impacted barrier had been placed such that it was slightly offset toward the roadway from the other barriers and exposed an errant vehicle to a narrow portion of the bluff end of the barrier (**Figures 2 and 3**).

**Figure 2:** Police on-scene photo showing construction barriers impacted by case vehicle, green arrows shows initial sideswipe paint transfer, red arrow shows location of case vehicle’s front right corner impact, light color of pavement (blue arrows) shows outline of barrier’s pre-crash location

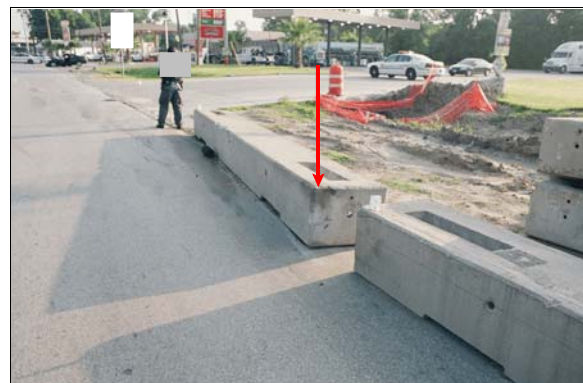
**Figure 3:** Police on-scene photo showing overview of impacted barriers

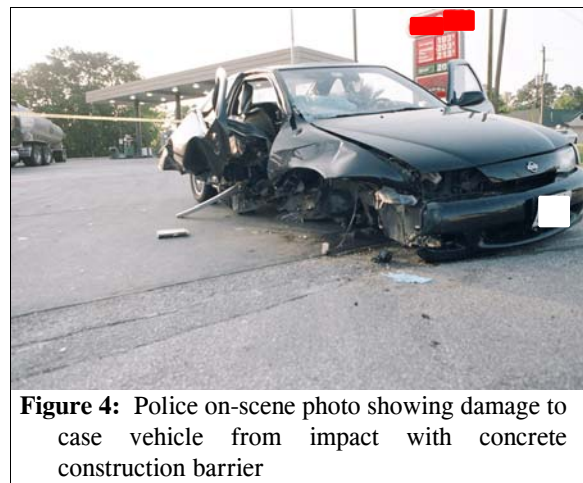
**Figure 4:** Police on-scene photo showing damage to case vehicle from impact with concrete construction barrier

**Exterior Damage:** The case vehicle’s initial impact with the concrete construction barrier involved the right corner of the front bumper and right fender. As the case vehicle continued to engage the barrier the right front wheel, right front door and sill were engaged. The right front wheel was torn off the vehicle, and the right front door was bowed outward, significantly separating it from the “A”-pillar, upper door frame and sill. The direct damage extended down the right side of the vehicle and involved approximately two thirds of the right front door. Direct damage from the impact with the end of the barrier began at the right corner of the front bumper and extended 11 centimeters (4.3 inches) along the bumper. Crush measurements were taken at the front bumper; however, the crush to the bumper was minimal because the bumper bar was not engaged. The maximum crush at the bumper was only 6 centimeters (2.4 inches) occurring at C<sub>6</sub>. The table below shows the case vehicle’s front bumper crush.

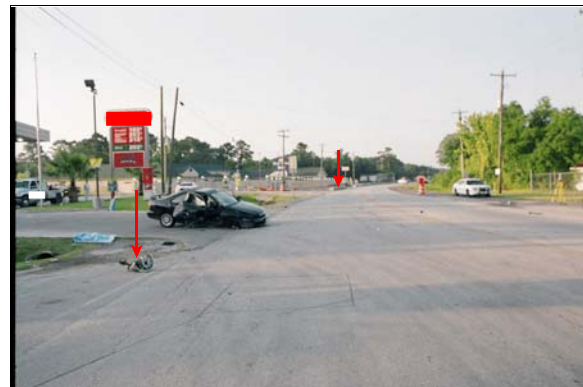
**Post-Crash:** Based on the police crash report and the police on-scene photographs, the impact displaced the concrete barrier several inches to the northeast and approximately 20 centimeters (8 inches) northwest. The case vehicle rotated clockwise approximately 270 degrees and traveled northwest approximately 56 meters (185 feet) and came to rest in a service station driveway heading southwest (**Figure 5** below).

**Figure 5:** Police on-scene photo showing case vehicle’s final rest position and view back to case vehicle’s approach, arrows show impact area and right front wheel/suspension assembly

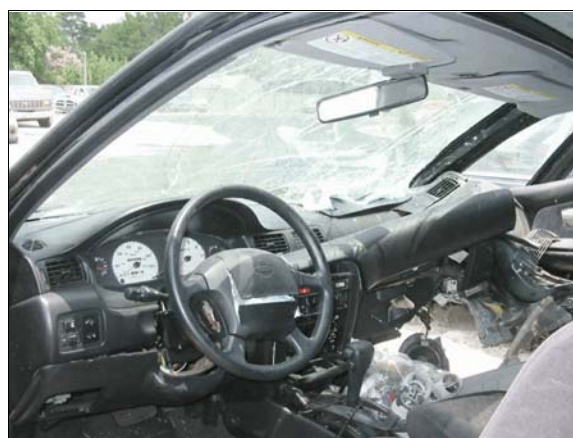
**Vehicle Interior:** Inspection of the case vehicle’s interior (**Figure 6** and **Figure 7**) revealed that the driver and front right air bags had been cut out of the case vehicle. It was noted in the police crash report that the air bags were cut out by police and sent to the medical examiner for DNA testing. Numerous deposits of tissue, and what appeared to be brain matter from the front right passenger were also found throughout the right side interior of the case vehicle. These deposits were observed on the right sun visor, roof immediately behind the right “A”-pillar, lower right instrument panel, right front door, front right seat cushion and seat back, roof over the back right seat, upper backlite, backlite header, right “C” pillar, back right shoulder belt and the back right seat back. A skull fragment was also found on the front right seat cushion. This was also noted in the police crash report. In addition, a small scuff was observed on the back of the front right seat headrest, which was likely associated with contact by the unrestrained back right passenger. Several passenger compartment intrusions occurred in the front right seat position. The right instrument panel intruded longitudinally 25 centimeters (9.8 inches), the sill intruded laterally 21 centimeters (8.3 inches), the back portion of the right front door intruded laterally 20 centimeters (7.9 inches), and the front right seat cushion intruded laterally 12 centimeters (4.7 inches). Lastly, there was no evidence of deformation of the steering column or steering wheel (**Figure 8** below).

**Figure 6:** Overview of windshield, instrument panel and steering wheel

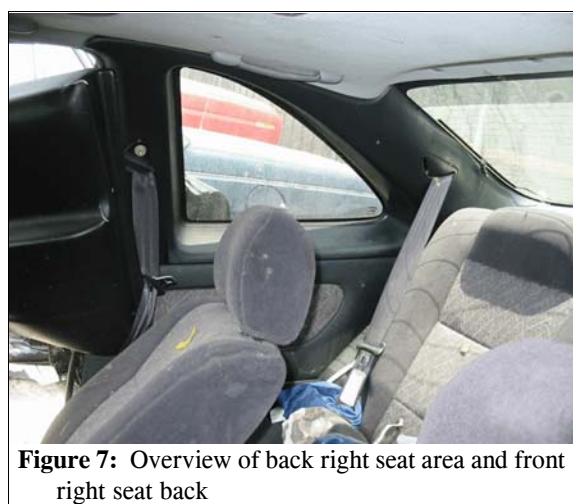
**Figure 7:** Overview of back right seat area and front right seat back

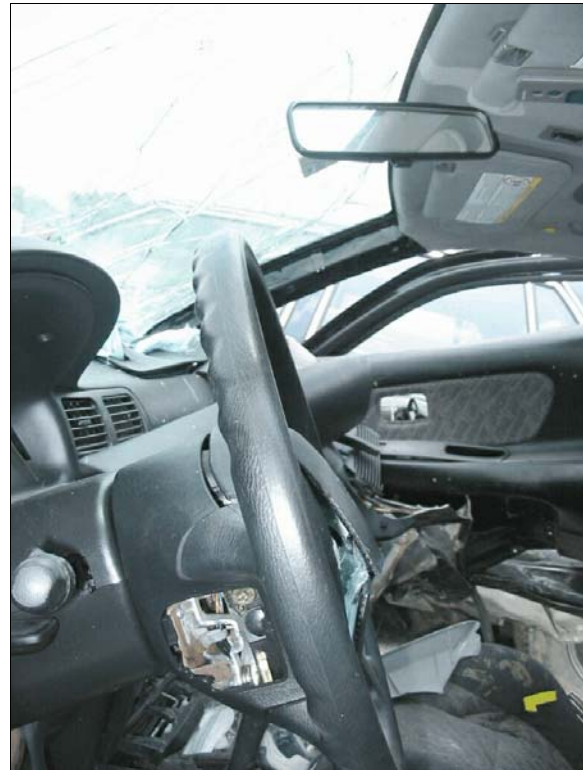
**Figure 8:** Steering column and steering wheel showing lack of deformation

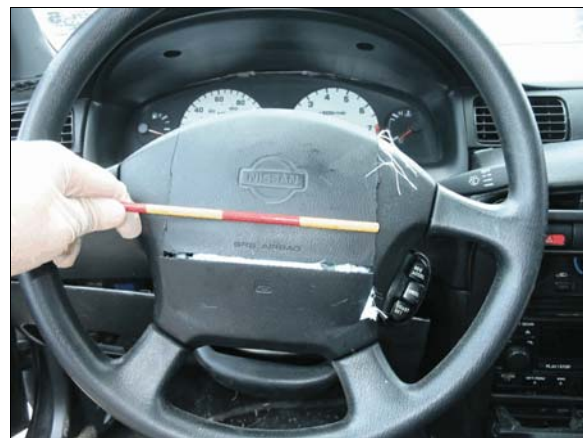
The driver's air bag was located in the steering wheel hub and the front right passenger air bag was located in the top of the instrument panel. Inspection of these air bags could not be conducted because they had been cut out of the vehicle by police and sent to the medical examiner for DNA testing. Inspection of the driver and front right passenger air bag's module flaps indicated that the flaps had opened at the designated tear points (**Figure 9** and **Figure 10** below). The driver's top air bag module cover flap was rounded on top and rectangular at the tear seam. It was 10 centimeters (3.9 inches) in height at the center and 14 centimeters (5.5 inches) in width. The driver's bottom air bag cover flap was rectangular in shape. It was 14 centimeters (5.5 inches) in width and 4 centimeters (1.6 inches) in height. The front right passenger air bag module cover and cover flaps were bent due to the crash induced deformation of the right instrument panel. The upper air bag cover flap was rectangular in shape and was 25 centimeters (9.8 inches) in width and 3 centimeters (1.2 inches) in height. The lower air bag cover flap was rectangular in shape and was 25 centimeters (9.8 inches) in width and 5 centimeters (2 inches) in height.

**Figure 9:** Driver's air bag module cover flaps, the air bag was cut out of the module by police

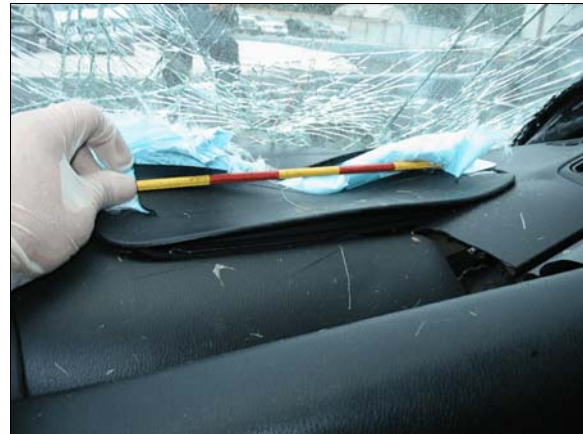
**Figure 10:** Front right passenger's air bag module cover flaps, the air bag was cut out by police

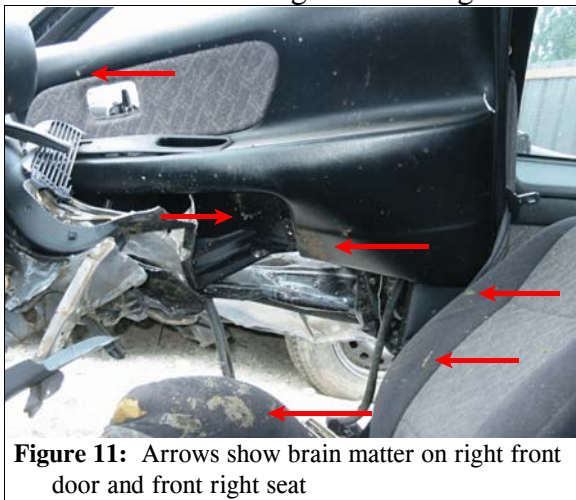
Based on the available evidence, the case vehicle's driver made no known pre-crash avoidance maneuvers. As a result, the front right passenger's pre-impact body position did not change just prior to impact. The case vehicle's initial contact with the concrete construction barrier involved only a small portion of the right corner of the front bumper. The primary engagement occurred when the right front wheel assembly impacted the barrier, which was in turn driven back into the wheel house and the barrier engaged the right front door and sill. The initial narrow end engagement and subsequent wheel interaction (i.e., similar to a sideswiping impact that starts on the side but results in pocketing) resulted in the air bag deploying late during the impact sequence. This delayed deployment occurred due to the prolonged change in time (Delta T) relative to the change in speed (magnitude of Delta V—i.e., ramp versus spike). In addition, the barrier's engagement of the right front wheel and sill produced a vertical force on the vehicle as well as a longitudinal force. As a result, the impact caused the infant to move forward and upward along a path opposite the case vehicle's 0 degree direction of principal force as the case vehicle decelerated. As a result, given the infant's small stature and weight, he most likely moved forward like a projectile and contacted the case vehicle's right knee bolster with his forehead, prior to the air bag's deployment. Because of the vertical force discussed above, the infant's head rebounded upward from its initial impact with the knee bolster, leaving the child obliquely positioned with its head higher than its feet. When the front right passenger air bag deployed, it impacted the infant and redirected him downward and backward, in a head-over-heels fashion, causing the infant's head to lead as the child moved backwards. However, because the case vehicle was rotating clockwise as a result of its impact with the barrier, the back right side of the child's head most likely impacted the lower interior surface of the right front door, which had bowed outward from the crash forces but also rotated into the backward path of the child as the case vehicle rotated clockwise. In addition, the infant's back contacted the front of the front right seat's cushion contusing the child's right lung and pleural surfaces. As a result of the impact to the lower right door surface, the infant sustained multiple skull fractures and, according to the police on-scene photographs, at least one skull fragment came to rest on the front right seat cushion. In addition, brain matter was found on the front right seat cushion and on the damaged

right front door (**Figure 11**). In this contractor’s opinion, the infant rebounded upward and rearward after striking the bowed door surface and front of the seat cushion and impacted the front right seat back. The infant front right passenger most likely fell onto the front right seat cushion as the case vehicle continued to rotate clockwise and traveled northwestward toward its final rest position. Based on information from an emergency medical technician, the infant was found wedged between the right “A”-pillar and the damaged right front door window frame. Brain matter was found on the door and the damaged instrument panel components in this area (**Figure 12**). As a direct result of all the rotation, blood and brain matter were splayed throughout the interior of the case vehicle. For example, blood and brain matter were spattered on the right sun visor and roof immediately rearward of the right “A”-pillar (**Figure 13**). Furthermore, brain matter was found on the front right seat back, right “C”-pillar, roof, back right shoulder belt, backlite header and upper backlite glazing (**Figures 13 and 14**). In addition, an on-scene photograph of the front right passenger air bag appears to show blood on the air bag’s front and underneath surfaces (**Figure 15** below). This contractor believes that this blood evidence occurred when the infant was impacted by the air bag and redirected backward after the infant sustained lesions from contacting the front right knee bolster.

**Figure 11:** Arrows show brain matter on right front door and front right seat

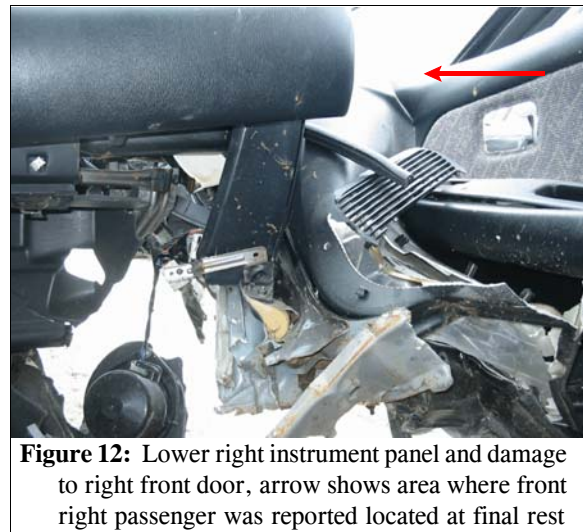
**Figure 12:** Lower right instrument panel and damage to right front door, arrow shows area where front right passenger was reported located at final rest

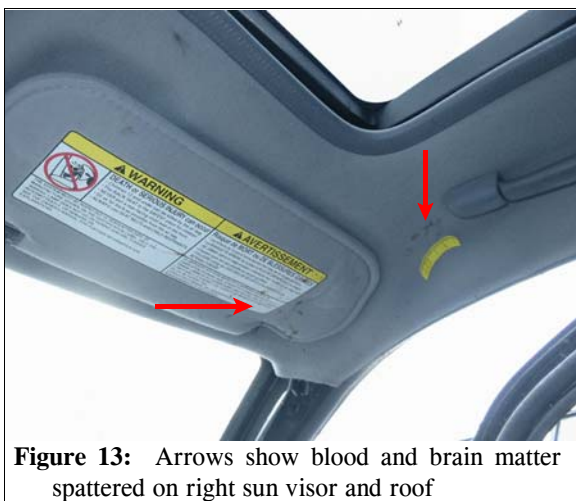
**Figure 13:** Arrows show blood and brain matter spattered on right sun visor and roof

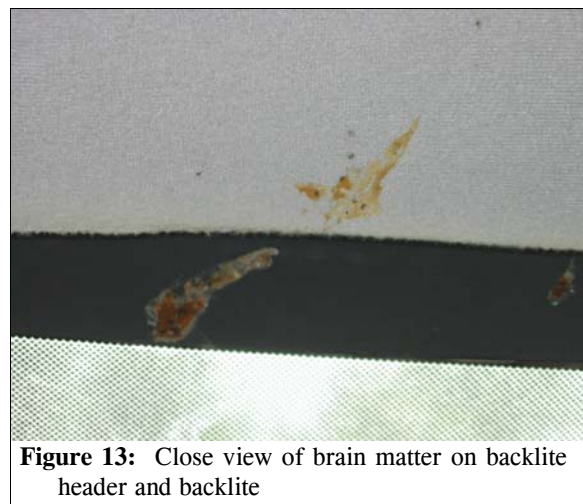
**Figure 13:** Close view of brain matter on backlite header and backlite

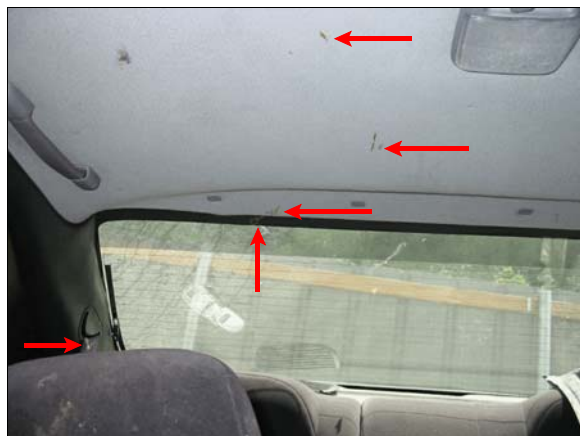
**Figure 14:** Arrows show brain matter on roof, backlite header, backlite and back right shoulder belt

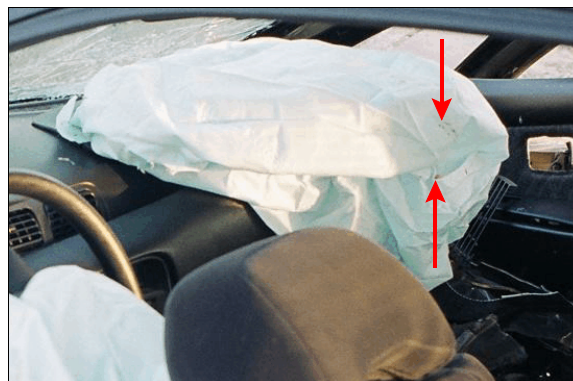
**Figure 15:** Close view of police on-scene photo showing what appears to be blood (arrows) on front right passenger air bag
