Redesigned Air Bag Investigation / Vehicle to Vehicle
Dynamic Science, Inc. / Case Number: DS05022
1998 Plymouth Breeze
Idaho
September, 2005

1. Report No. DS05022	2. Government Accession No.	3. Recipient Catalog No.	
4. Title and Subtitle Redesigned Air Bag Investigation		5. Report Date May 1, 2006

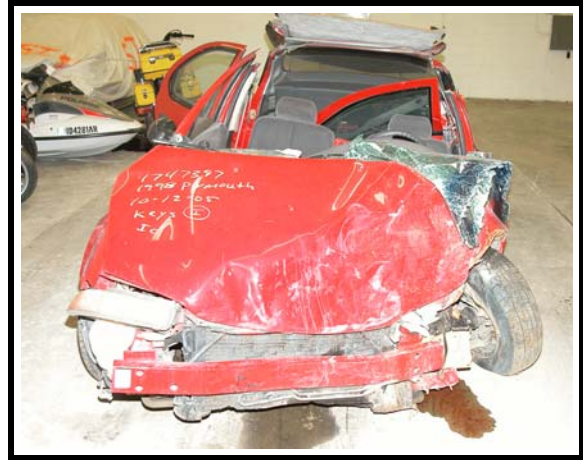
Figure 1. Front, 1998 Plymouth Breeze

Damage Description: The 1998 Plymouth Breeze sustained major front end damage as a result of the impact with the Geo Storm. The left side wheelbase was shortened by 32.0 cm (12.6 in). Both left side doors were deformed and jammed shut. The roof was cut off the vehicle during the extrication of the driver. The windshield sustained fracture damage from impact forces. The driver's side window disintegrated during the impact.

The direct damage began at the front left bumper corner and extended laterally 104.0 cm (40.9 in) along the frontal plane. Six crush measurements were documented at the bumper level as follows: C1 = 54.0 cm (21.3 in), C2 = 48.0 cm (18.9 in), C3 = 40.0 cm (15.7 in), C4 = 30.0 cm (11.8 in), C5 = 25.0 cm (9.8 in), C6 = 3.0 cm (1.2 in). The Breeze appeared to have sustained only minor damage due to the impact with the pole.

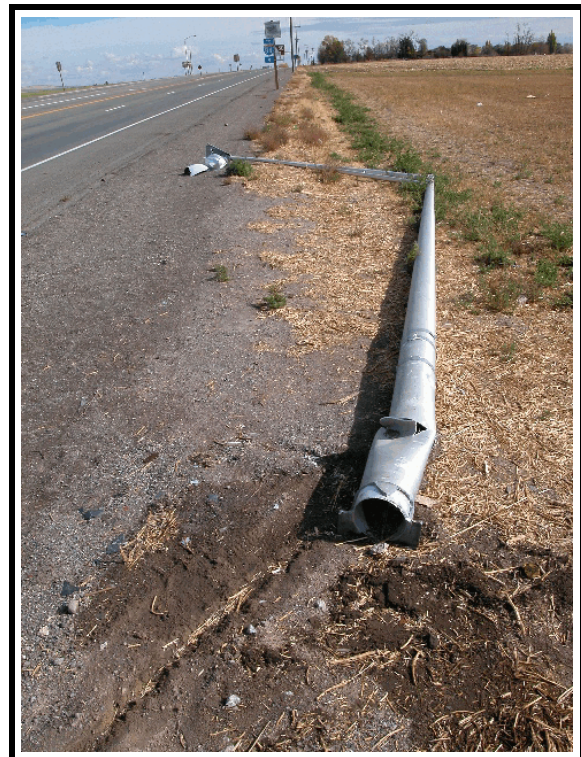
The Breeze was deflected to the right and struck a metal light pole in the southeast corner of the intersection. The light pole sheared at the base. The Geo Storm came to rest east of the intersection facing northeast.

Figure 4. Damaged light pole

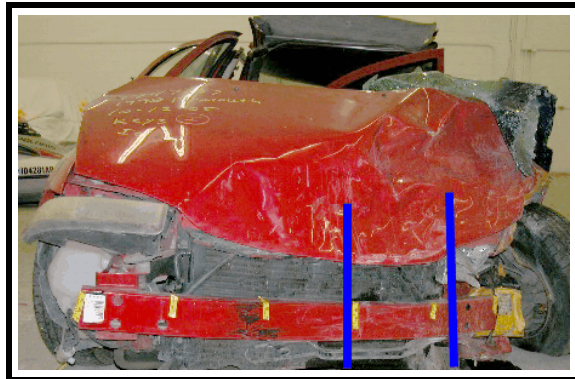
Figure 5. Area of contact with pole

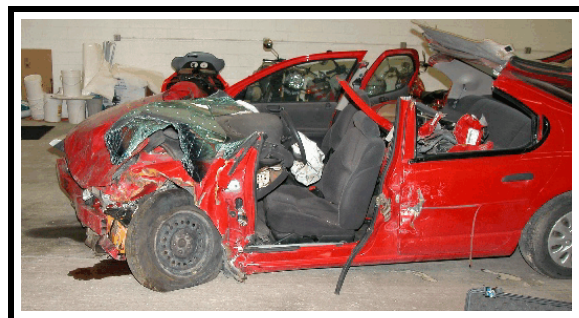
Figure 6. Left side view, Plymouth Breeze

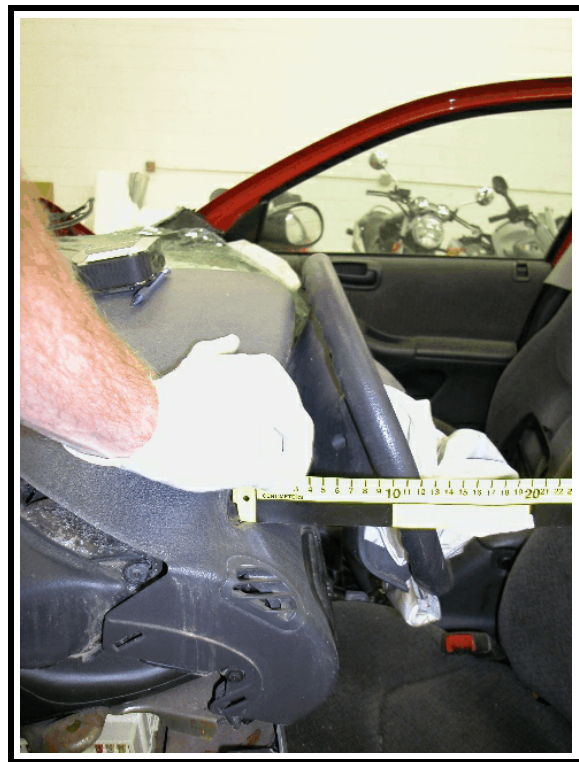
The steering column was loaded and collapsed approximately 8.0 cm (3.1 in) to a point almost touching the top of the instrument panel. The distance from the steering wheel center to the B pillar was 55.0 cm (21.6 in). The steering wheel rim was found rotated 180 degrees (with the top facing down) and had a 65 degree angle. The distance from the top of the rim (as found in the vehicle) to the seat back was 50.0 cm (19.7 in). The distance from the bottom of the rim to the seat back was 28.0 cm (11.0 in).

Figure 7. Steering column movement

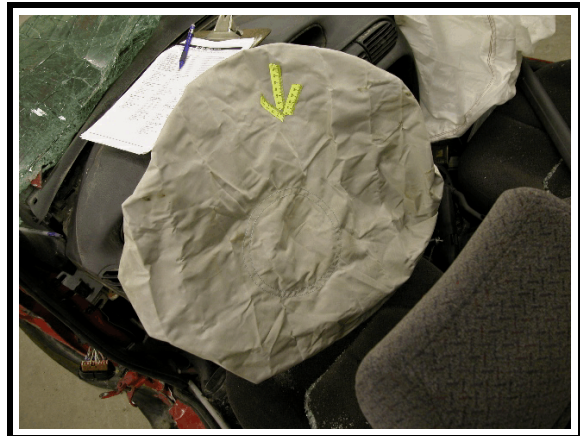
The driver's air bag deployed from the center of the steering wheel hub through H configuration module cover flaps. The top flap measured 23.0 cm (9.0 in) wide by 8.0 cm (3.1 in) high. The lower flap measured 23.0 cm (9.0 in) wide by 7.0 cm (2.8 in) high. The top flap was found trapped behind the steering wheel rim. The deployed driver's air bag measured 52.0 cm (20.5 in) in diameter in its deflated state. There was a patterned abrasion to the left upper quadrant that was likely from the module cover flap. There were blood droplets found along the edges of the air bag face and a blood/saliva smear was found near the center of the air bag just below the tether stitching. There was blood found on the back of the air bag near the vent port. There was a single tether that was attached to an 18.0 cm (7.0 in) diameter center stitch in the center of the air bag face. There was a single circular vent port on the back of the air bag at the 12 o'clock position. The maximum post-deployment excursion for the air bag was 24.0 cm (9.4 in) from the air bag module. The distance from the maximum excursion to the seat back was 16.0 cm (6.3 in).

Figure 8. Driver's air bag

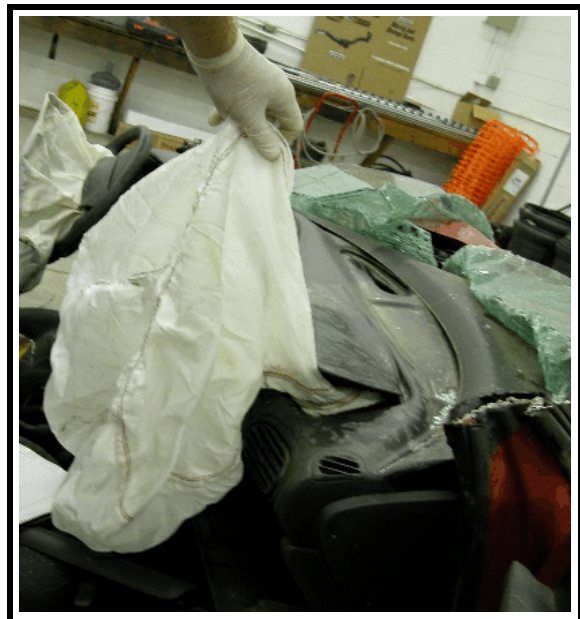
Figure 9. Front right passenger air bag

The front right passenger air bag deployed from a top-mount module cover that was hinged at the forward aspect. The module cover measured 38.0 cm (14.9 in) along the top seam, 22.0 cm (8.7 in) on the left, 16.0 cm (6.3 in) on the right, and 36.0 cm (14.2 in) along the bottom. The deployed front right passenger air bag measured 49.0 cm (19.3 in) wide seam to seam, 53.0 cm (20.9 in) high, and had a maximum excursion of 51.0 cm (20.5 in).

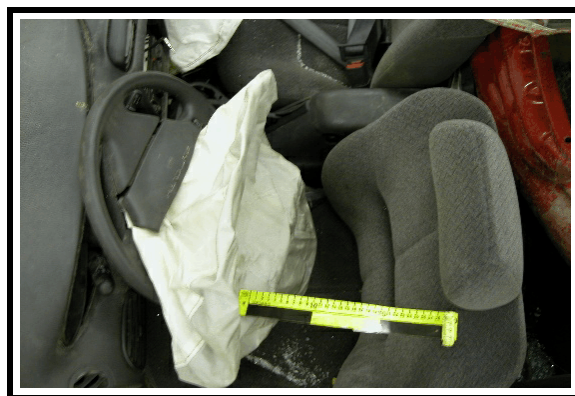
Figure 10. Overhead view of driver's seated position

lower instrument panel/knee bolster. Her head was forced rearward as she loaded the air bag/steering column and her neck was hyperextended—causing the C2 fracture. The driver's glasses were knocked off. The frame was bent but the lenses remained intact. There were no eye injuries of any kind. The driver rebounded to some degree. She remained in her initial sitting position due to the seat belt. The case vehicle continued forward and struck a metal light pole with its front end. This did not appear to be a substantial impact. The driver likely pitched forward to some degree but remained held in place by the lap and shoulder belt.
