## ON-SITE CHILD SAFETY SEAT INVESTIGATION

CASE NUMBER - IN-05-022

VEHICLE - 1999 TOYOTA COROLLA

CRASH DATE - June 2005

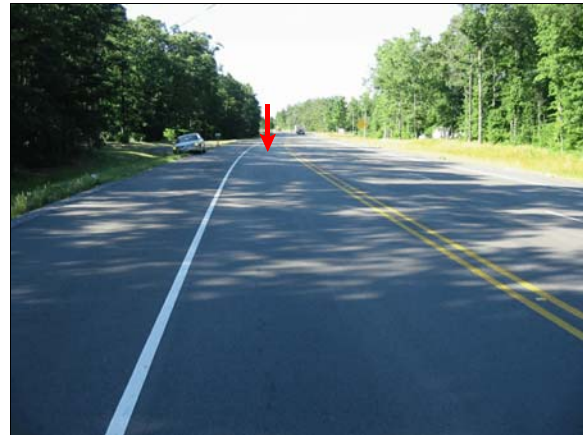
**Figure 1:** Approach of case vehicle to impact (arrow), southbound in northbound lane

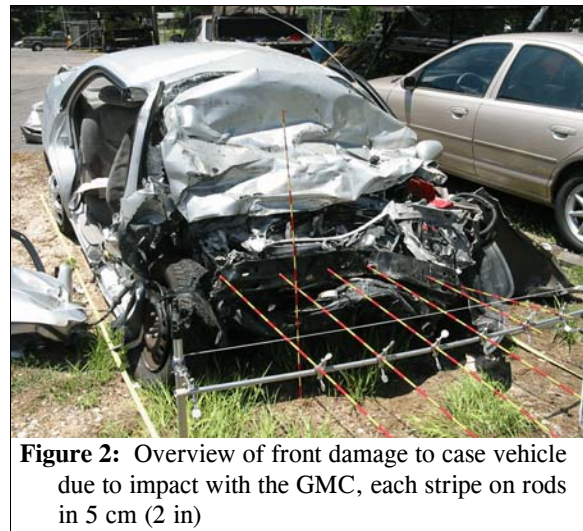
**Figure 2:** Overview of front damage to case vehicle due to impact with the GMC, each stripe on rods in 5 cm (2 in)

**Exterior Damage:** The case vehicle's contact with the GMC involved the entire front end. The case vehicle's front bumper, bumper fascia, grille, radiator, turn lamp and headlamp assemblies, left and right fenders and hood were directly damaged and crushed rearward. The direct damage began at the front right bumper corner and extended 114 centimeters (44.9 inches) across the bumper bar. The Field-L was determined to be 112

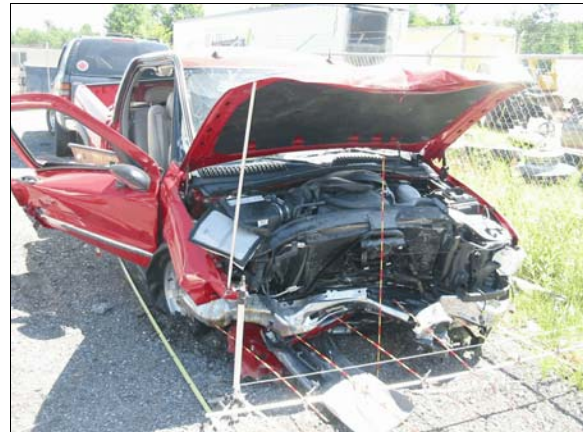
**Figure 3:** Overview of damage to front of GMC due to impact with the case vehicle

**Exterior Damage:** The GMC’s impact with the case vehicle involved the front end. The front bumper, grille, left headlamp/ turn signal assembly and hood were directly contacted and crushed rearward. The direct damage began at the front right bumper corner and extended 149 inches across the front of the vehicle. The residual maximum crush was measured as 75 centimeters (29.5) occurring at C<sub>6</sub> (**Figure 18**). The table below shows the GMC’s front crush profile.

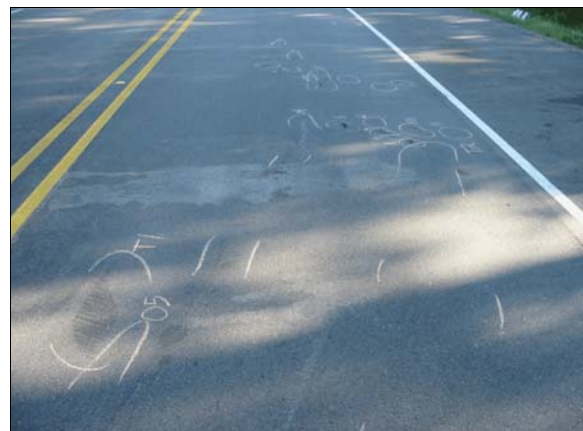
**Post-Crash:** The case vehicle was driven backwards by the impact, rotated slightly clockwise and came to rest in the northbound lane with its front still in contact with the front of the GMC. According to emergency personnel, the case vehicle's left rear wheel was just east of the east fog line with the remainder of the case vehicle in the northbound lane heading slightly southwest. The GMC rotated slightly clockwise and came to rest in the northbound lane (**Figure 4**) heading northeast.

**Figure 4:** View north (GMC's approach) to impact area and area of final rest

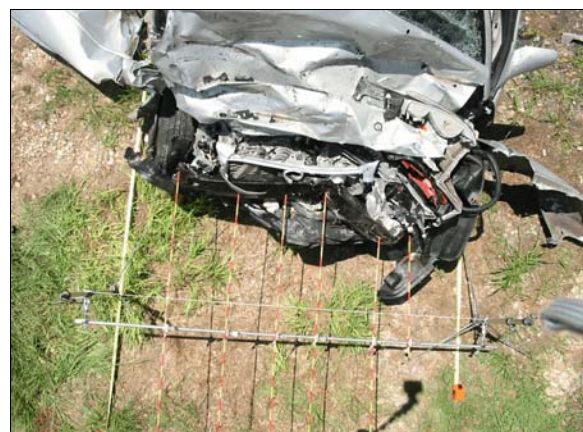
**Figure 5:** Top view of case vehicle's front crush, baseline is set 42 cm (16.5 in) short, final crush values reflect adjustment for this

centimeters (44.1 inches). Residual maximum crush at the bumper was measured as 92 centimeters (36.2 inches) occurring at C<sub>6</sub> (**Figure 5** above). A second set of crush measurement was taken above the bumper with the residual maximum crush measured as 113 centimeters (44.5 inches), also occurring at C<sub>6</sub>. The table below shows the average of the case vehicle’s bumper and above bumper crush.

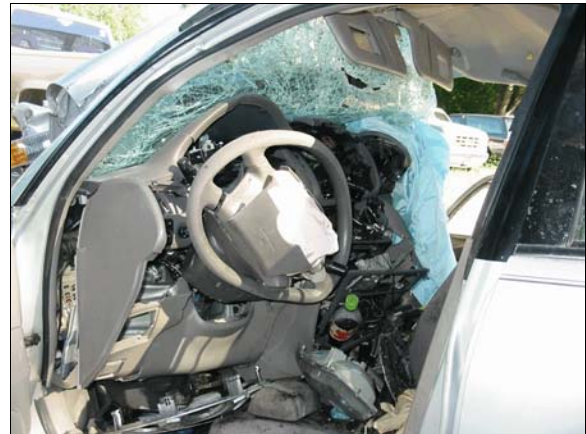
**Vehicle Interior:** Inspection of the case vehicle’s interior (**Figures 6** and **7** below) revealed evidence of occupant contact on the driver and front right passenger air bags, knee bolster, lower and upper right instrument panel and the steering wheel rim. There was significant longitudinal intrusion to the case vehicle’s front seating row. The primary intrusions into the front seating row were: 53 centimeters (20.9 inches) of longitudinal and 34 centimeters (13.4 inches) of vertical center instrument panel intrusion, 48 centimeters (18.9 inches) of longitudinal right toe pan intrusion, 31 centimeters (12.2 inches) of longitudinal left toe pan intrusion, 32 centimeters (12.6 inches) of longitudinal and 28 centimeters (11 inches) of vertical right instrument panel intrusion, 29 centimeters (11.4 inches) of longitudinal left instrument panel intrusion, 28 centimeters (11

Figure 6: Overview of case vehicle's steering wheel, instrument panel and windshield

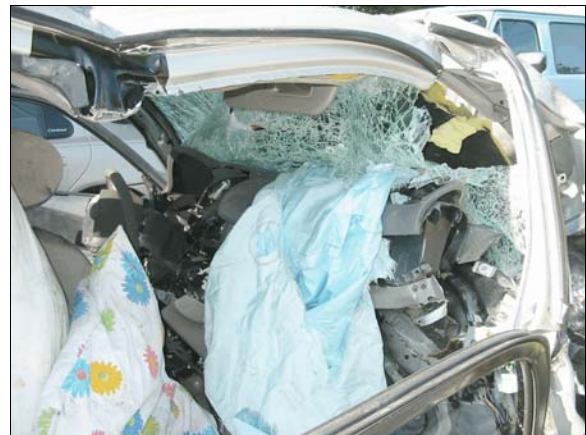
Figure 7: Overview of case vehicle's front interior and front right passenger air bag

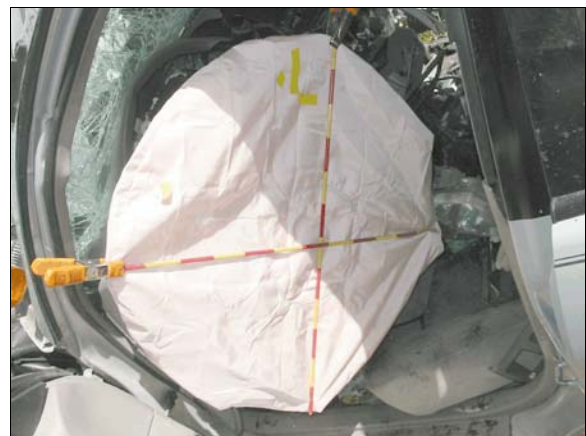
The case vehicle driver's air bag was located in the steering wheel hub. An inspection of the air bag module cover flaps and the air bag fabric revealed that the cover flaps opened at the designated tear points. Damage occurred to the air bag during the deployment. Small holes were found on the upper, upper, center portion of the air bag, as well as a one centimeter (0.4 inch) cut at the left center portion of the air bag. Larger holes and cuts were also found on the back, upper, left portion of the air bag. These holes were most likely due to interaction of the air bag with the broken windshield during the crash. The air bag module cover consisted of "H"-configuration cover flaps made of medium thickness pliable vinyl. The upper cover flap was 16 centimeters (6.3 inches) in width and 6 centimeters (2.4 inches) in height. The Toyota logo was located in the center of the flap. A semicircular portion of the logo extended down from the upper flap and fit into a corresponding cut-out on the lower flap. The lower flap was 16 centimeters (6.3 inches) in width at the tear seam, 12 centimeters (4.7 inches) in width at the bottom and 9 centimeters (3.5 inches) in height. The deployed driver's air bag (**Figure 8**) was round with a diameter of approximately 64 centimeters (25.2 inches), and was

Figure 8: Case vehicle's driver air bag

designed with two tethers, each approximately 11 centimeters (4.3 inches) in width. The driver's air bag had two vent ports, each approximately 2 centimeters (0.8 inches) in diameter, located at the 11 and 1 o'clock positions.

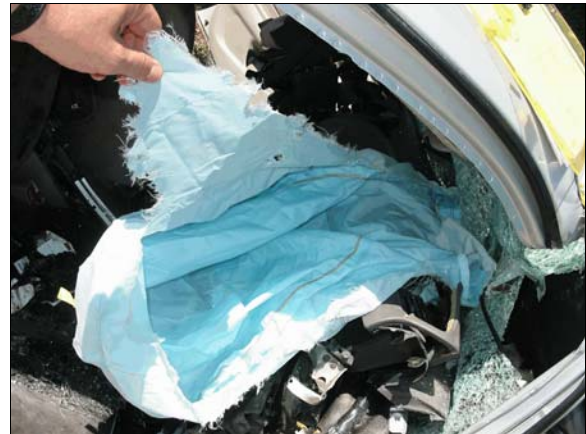
The front right passenger's air bag was located in the top of the instrument panel. An inspection of the air bag module cover flaps revealed that the cover flaps opened at the designated tear points. The air bag module cover consisted of two rectangular cover flaps. The upper flap was approximately 22 centimeters (8.7 inches) in width and 6 centimeters (2.4 inches) in height. The lower flap was approximately 23 centimeters (9.1 inches) in width and 6 centimeters (2.4 inches) in height. The cover flaps were severely bent due to the intrusion and deformation of the instrumental panel. Inspection of the front right passenger air bag revealed two very large tears, both starting at the right vent port (**Figure 9**). One tear extended approximately 53 centimeters (20.9 inches) toward the air bag module, and the other extended approximately 40 centimeters (15.7 inches) to the left across the back of the air bag. In addition, there were numerous cuts on the front and top of the air bag. The source of the large tear in the right side of the air bag may have been the result of rescue activities when the right "A"-pillar was cut and the doors were removed. The source of the cuts to the front and top of the air bag were most likely due to its interaction with the broken windshield during the crash. The front right passenger's air bag was designed without tethers and had two vent ports, each approximately 5.5 centimeters (2.2 inches) in diameter. Location of these vent ports could not be precisely determined due to the extent of damage to the air bag, but they appeared to be located on the sides of the air bag at the approximate 3 and 9 o'clock positions. The deployed front right air bag was rectangular but its height and width could not be determined because of the damage to the air bag.

**Figure 9:** Damage to case vehicle's front right air bag

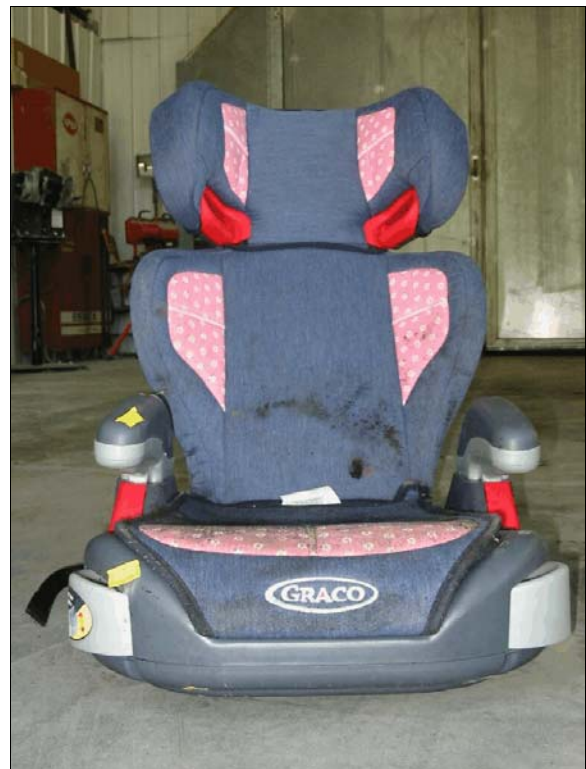
**Figure 10:** Overview of case vehicle's back left belt-positioning booster seat

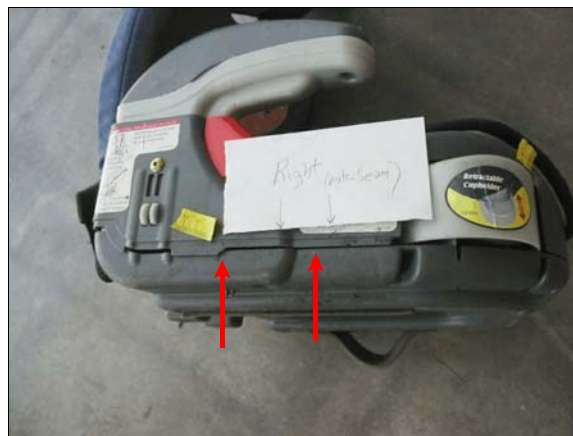
Inspection of the belt-positioning booster seat revealed only minor deformation of the seat as a result of the crash. A small stress mark (white discoloration of the gray plastic shell) was found at the right front corner of the seat as well as a separation of the two sections of the base on the right side (**Figure 11** below). In addition, there were three small stress marks in the plastic of the seat cushion as well as a stress line that extended 13.5 centimeters (5.3 inches) from the right side to the middle of the seat (**Figure 12** below). A probable occupant scuff mark was found at the end of the right arm rest as well as a deep, perpendicular scratch at the center of the right arm rest (**Figure 12**). No other stress marks or damage was found on the belt positioning booster seat. No information regarding the installation and historical usage of the seat was obtained because both of the child’s parents were fatally injured in the crash.

The stress marks in the plastic of the booster seat and the separation of the two sections of the booster seat base were most likely due to loading of the seat during this high severity crash. The occupant loaded against the safety belt and the child seat loaded against the occupant during the crash most likely causing these deformations.

**Figure 11:** Displacement of seam on right side of case vehicle’s back left booster seat

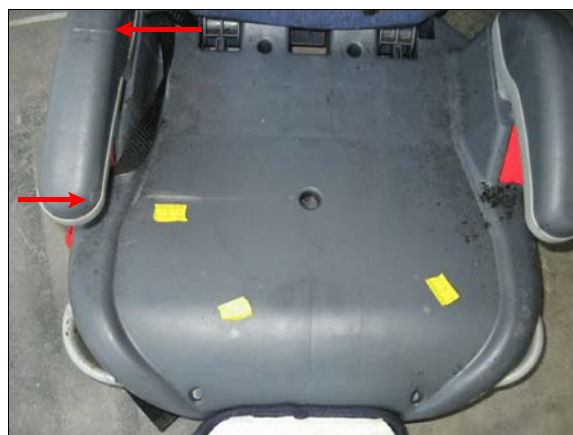
**Figure 12:** Yellow tape shows stress marks in plastic of case vehicle’s back left booster seat, arrows show probable occupant contact scuff on end of right arm rest and a scratch at center of arm rest

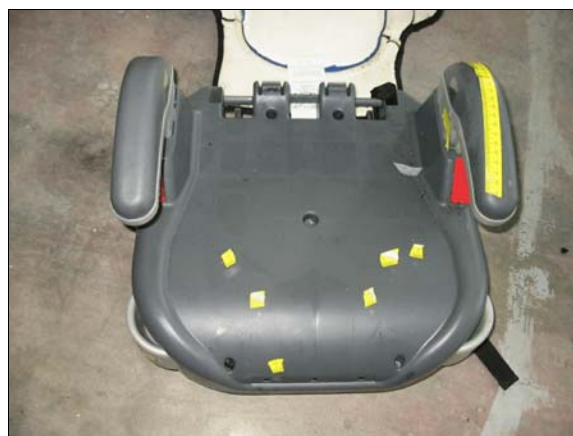
Inspection of the belt-positioning booster seat revealed a few small stress marks in the plastic of the seat cushion. Stress marks, a scuff mark, and a few strands of hair and cloth threads were also found on the inside of the left arm rest (**Figure 13**). In addition, there was a small area of separation and damage (**Figure 14** below)at the assembly seam on the left side of the booster seat. Finally, a scrape in the booster seat base was observed on the right side. The warning and information labels were the same as indicated above for the back left booster seat.

**Figure 13:** Case vehicle’s back right belt-positioning booster seat, yellow tape on booster seat shows small stress marks in plastic and possible occupant contact scuff and few strands of hair and cloth threads on inside of left arm rest

The stress marks in the plastic of the booster seat and the small area of separation and compression at the assembly seam on the left base of the booster seat were most likely due to loading of the seat during this high severity crash. The passenger loaded against the safety belt and the child seat loaded against the occupant during the crash most likely causing these deformations.

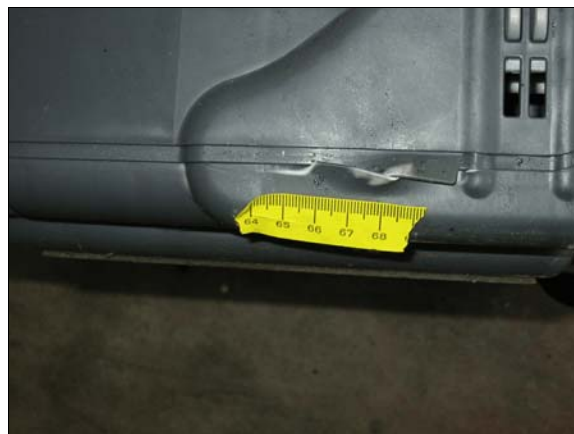
**Figure 14:** Displacement and damage at assembly seam on left base of case vehicle's back right booster seat

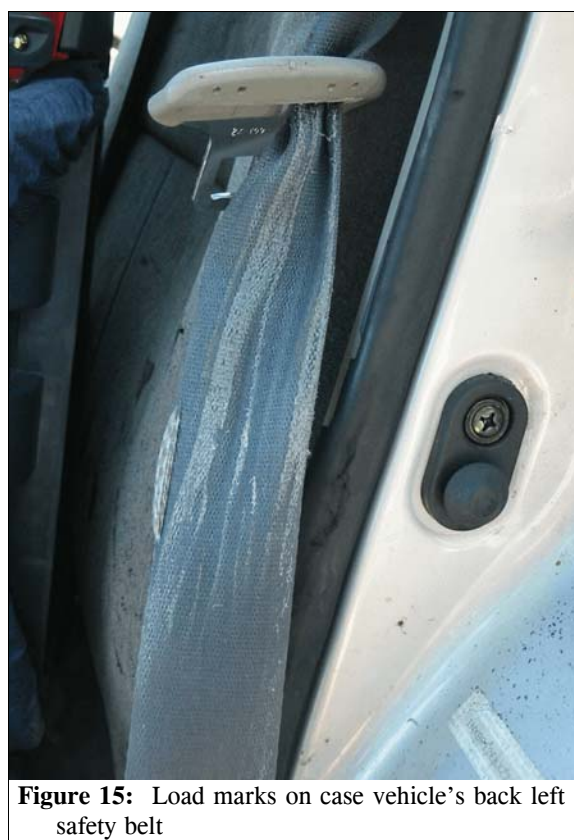
Based on this contractor's vehicle inspection, the case vehicle's back left passenger was restrained by her manual, three-point, lap-and-shoulder safety belt system. Inspection of the safety belt webbing and latch plate showed significant friction burns to the shoulder belt webbing (**Figure 15**), as well as the sliding latch plate belt guide. In addition, the belt was bunched up in a corner of the latch plate belt guide due to loading.

**Figure 15:** Load marks on case vehicle's back left safety belt

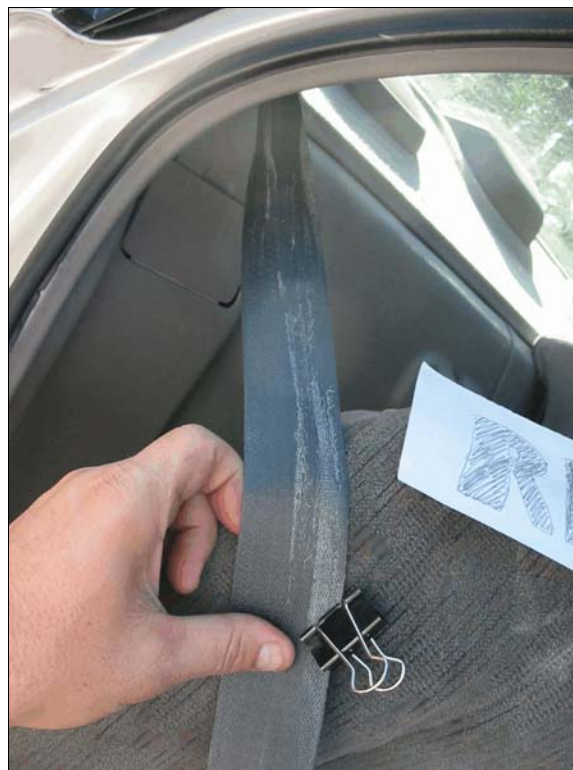
Based on this contractor's vehicle inspection, the case vehicle's back right passenger was restrained by his manual, three-point, lap-and-shoulder safety belt system. Inspection of the safety belt webbing and latch plate showed significant friction burns to both the shoulder belt (**Figure 16** below) and the sliding latch plate belt guide. In addition, the belt was bunched up in a corner of the latch plate belt guide due to loading.

**Figure 16:** Load marks on case vehicle's back right safety belt

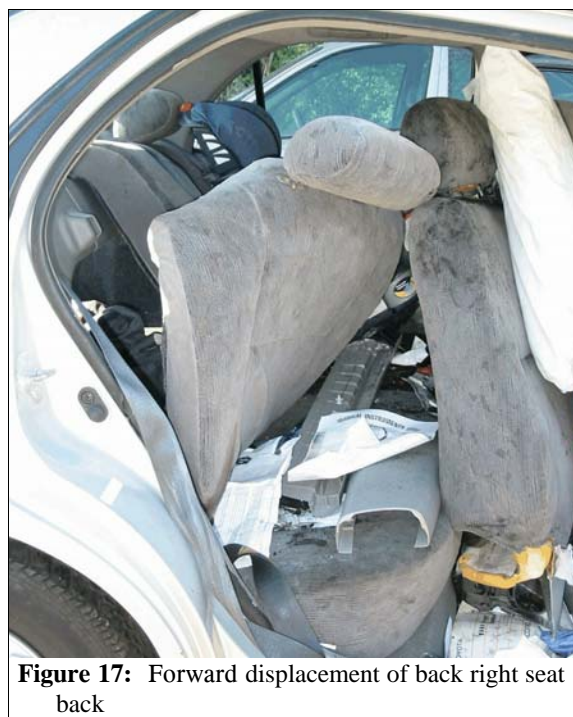
**Figure 17:** Forward displacement of back right seat back

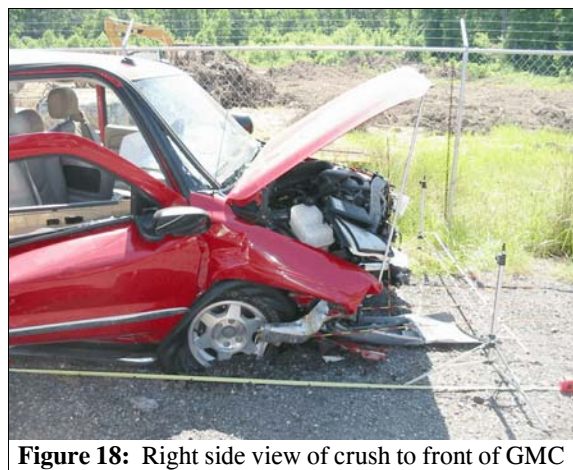
**Figure 18:** Right side view of crush to front of GMC

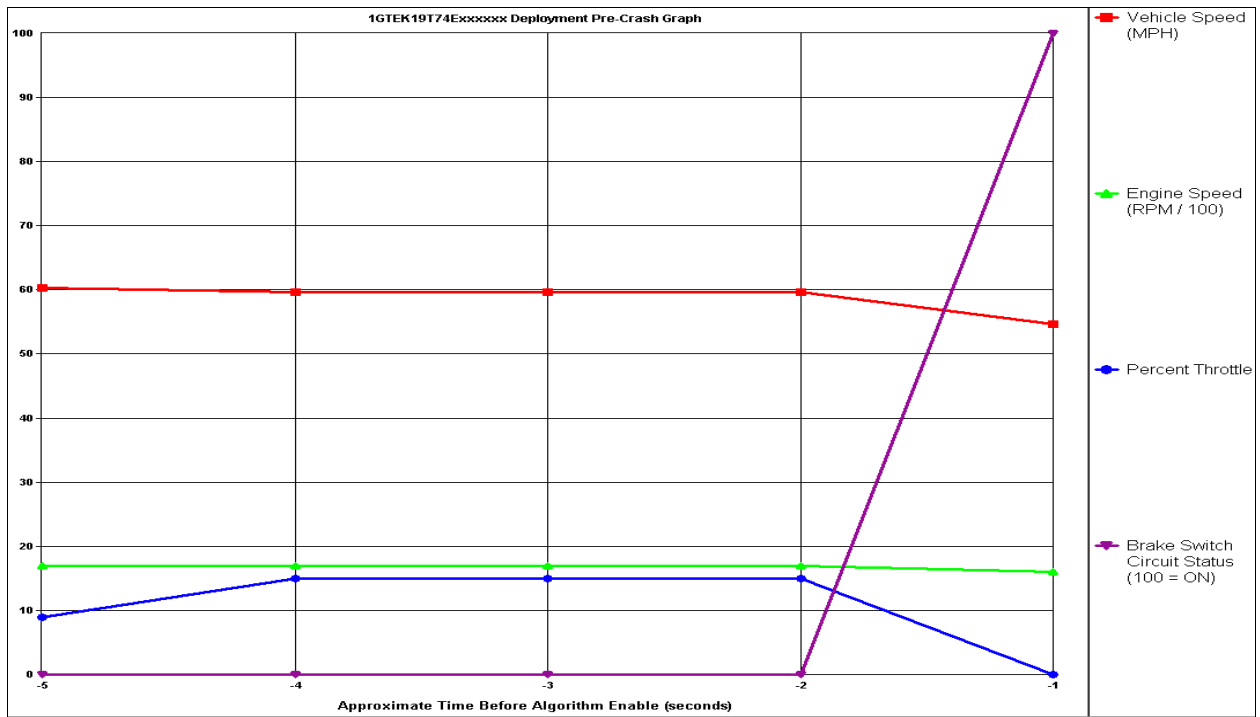
Figure 22: GMC's Deployment Pre-Crash Graph

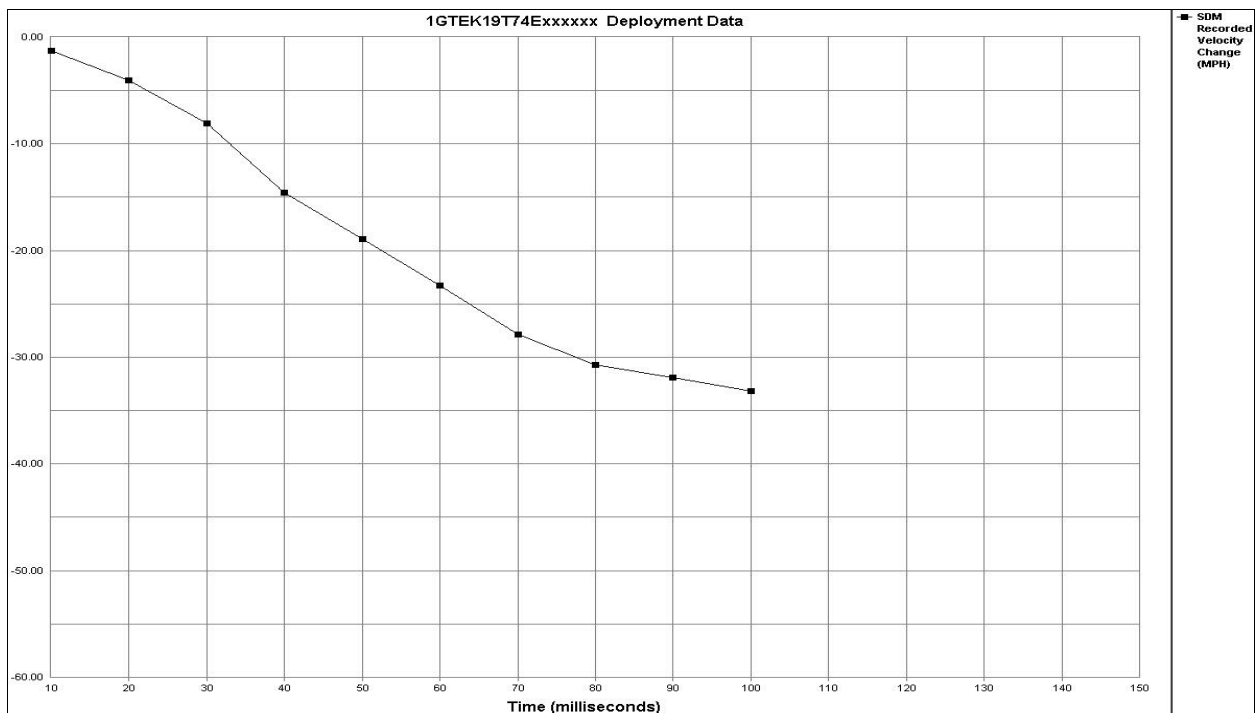
Figure 23: GMC's Deployment SDM Recorded Velocity Change graph

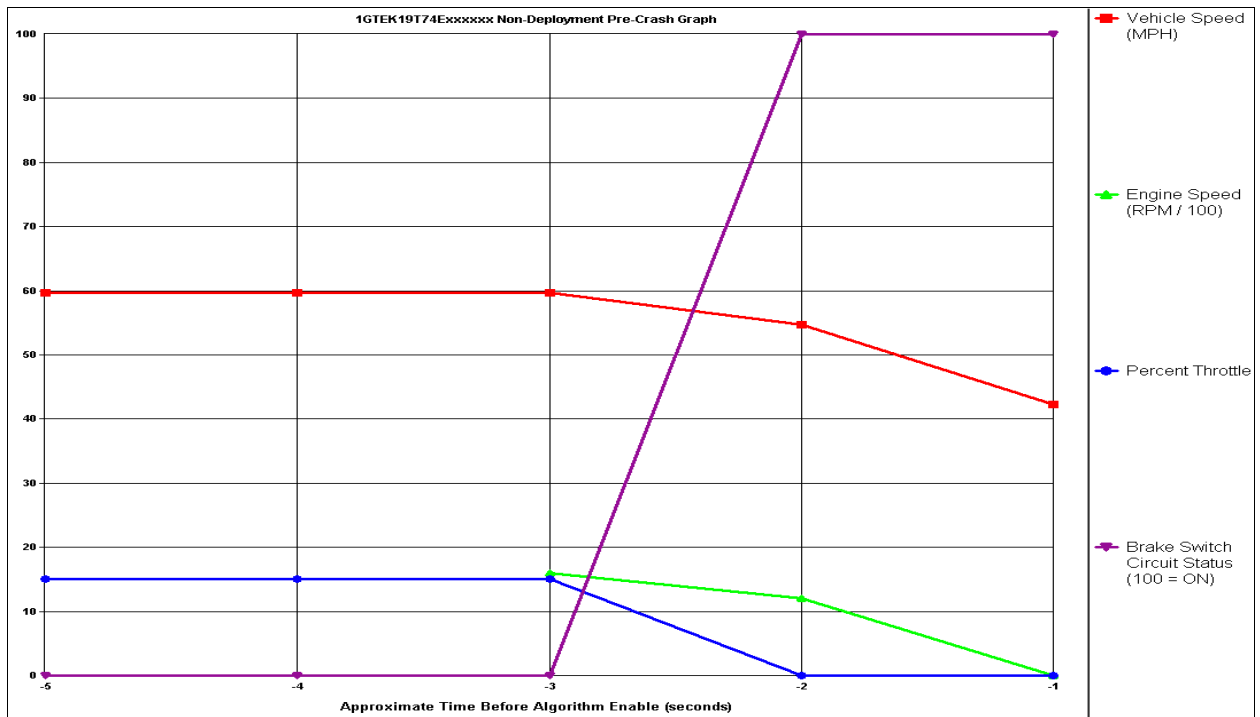
Figure 25: GMC's Non-Deployment Pre-Crash Graph

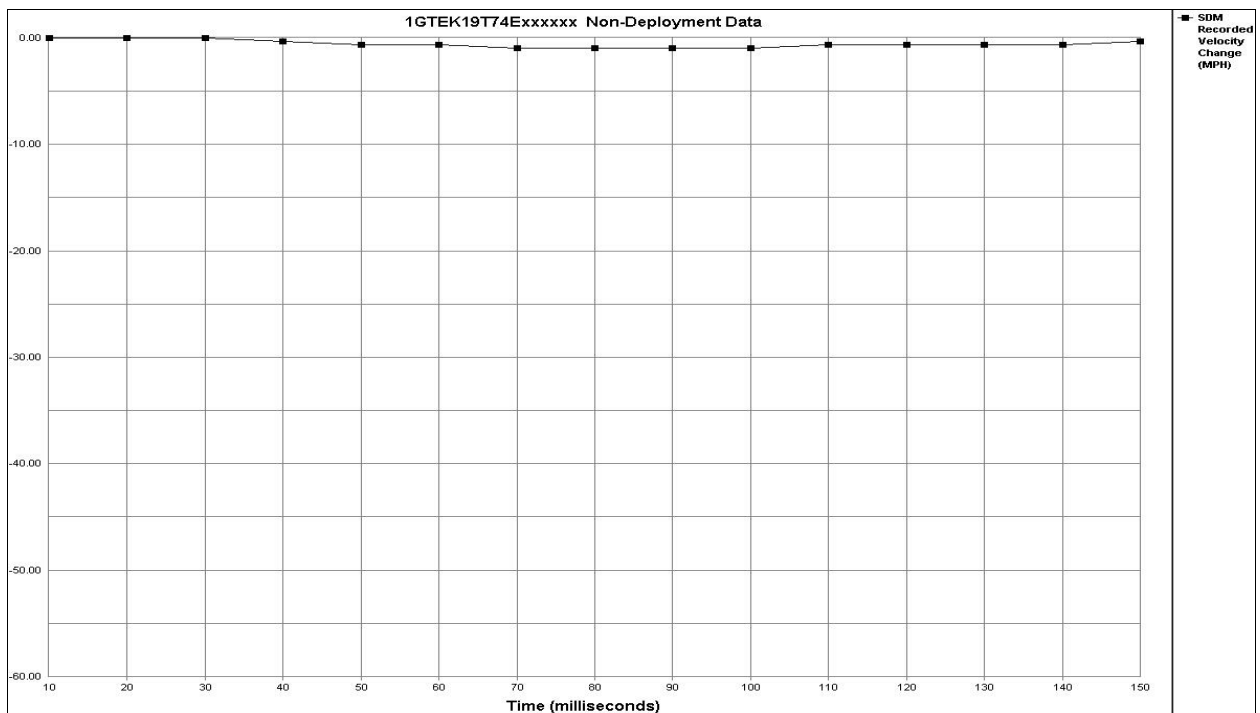
Figure 26: GMC's Non-deployment SDM Recorded Velocity Change graph
