CALSPAN REMOTE CHILD AIR BAG RELATED FATAILITY INVESTIGATION

CASE NO: CA05-022

VEHICLE: 1997 SATURN SL1

CRASH DATE: APRIL 2005

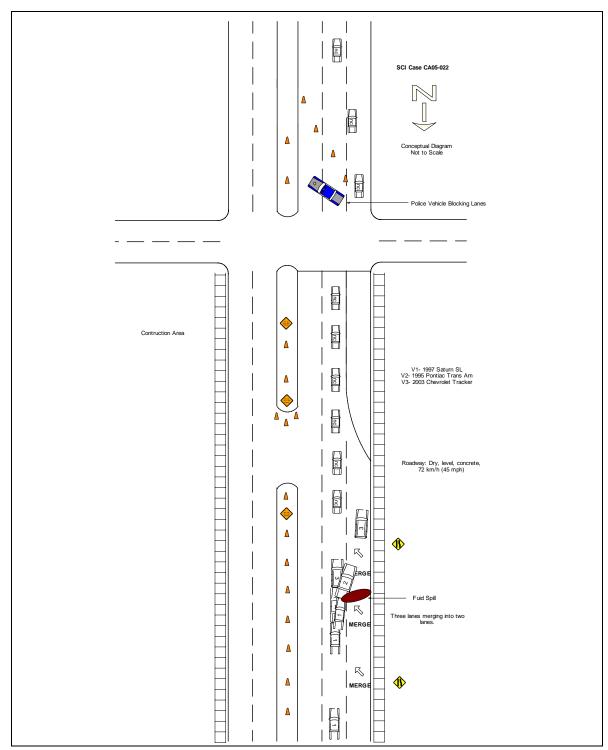
Figure 14 – Conceptual SCI Crash Schematic

This three-vehicle crash occurred on a well-traveled asphalt state highway during daylight hours in April 2005. The crash occurred in the center southbound lane of a three-lane divided highway. At the time of the crash, the weather was clear and the roadway was dry. The outboard curb lane was utilized to distribute the flow of traffic and then merge traffic from the right lane into the center lane. The lane displayed large white painted arrows and the word "merge." The lanes were delineated by painted white broken lane lines and white painted fog lines. A curbed grassy center median separated north and southbound traffic. The roadside environment consisted of sporadic dwellings and natural growth. The roadway led to an intersection approximately 0.2 km (1/8 mile) further south. Construction signs and orange cones were located in the center median warning motorists of an approaching active work zone. Shortly after the approaching intersection, only the right lane was open to traffic as a police vehicle blocked off the center and left lanes. The north/south roadway had a police-reported posted speed limit of 72 km/h (45 mph). Speed reduction signs due to construction were not reported or viewed through the provided photographic images. An SCI conceptual crash schematic is included as **Figure 14** at the end of this narrative report.
