Side Curtain Air Bag Investigation/Vehicle to Vehicle
Dynamic Science, Inc./Case Number: DS05023
2005 Lexus RX330
Utah
October 2005

1. Report No. DS05023		2. Government Accession No.		3. Recipient Catalog No.	
4. Title and Subtitle Side Curtain Air Bag Investigation				5. Report Date June 23, 2006

Dynamic Science, Inc.
Crash Investigation
Case Number: DS05023

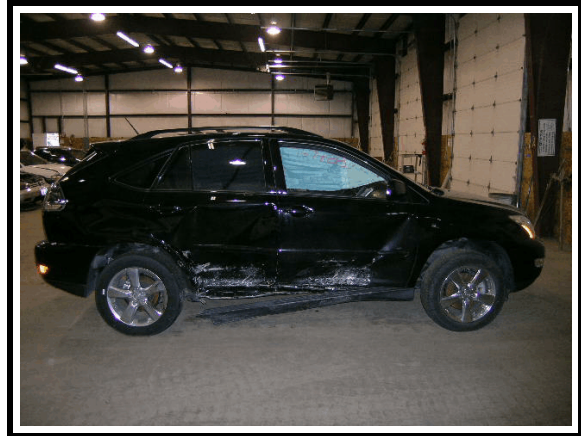
Figure 1. Right side impact damage - 2005 Lexus RX330

The 2005 Lexus RX330 sustained moderate right side damage as a result of the impact with the Volkswagen Jetta. The Lexus sustained 178.0 cm (70.1 in) of direct damage along the right side of the vehicle, beginning 21.0 cm (8.3 in) forward of the right rear axle, extending forward. The combined direct and induced damage measured 202.0 cm (79.5 in) in length and also began 21.0 cm (8.3 in) forward of the right rear axle, extending forward. Six crush measurements were documented along the damaged lower right side as follows: C1=1.0 cm (0.4 in), C2=13.0 cm (5.1 in), C3=11.0 cm (4.3 in), C4=11.0 cm (4.3 in), C5=11.0 cm (4.3 in), C6=5.0 cm (2.0 in). C1 had to be projected past the right rear tire due to the height of the impact. C6 had to be projected beyond the contour gauge because the gauge itself was not long enough to capture the entire length of the direct and induced damage.

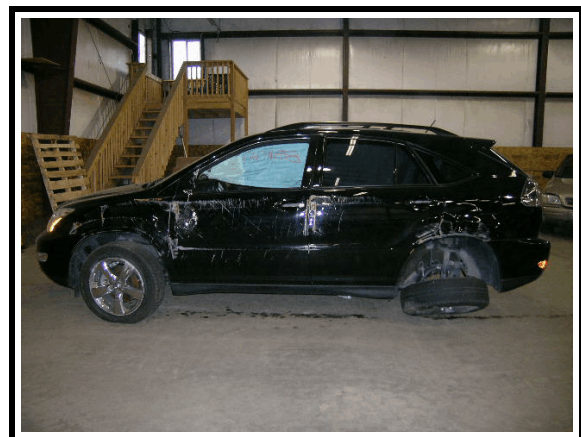
Figure 2. Left side rollover damage - 2005 Lexus RX330

The case vehicle sustained moderate left side damage as a result of the rollover event. There was 3.0 cm (1.2 in) of lateral crush at the max crush location, 47.0 cm (18.5 in) aft of the left front axle. There was no vertical crush from the rollover event. The left rear tire was partially separated from the axle. It is possible that this damage occurred as result of the snag between the front end of the Jetta and the case vehicle's right rear tire. The snag may have caused the Lexus to tip to its left, shifting the vehicle's weight to the left tires. The partial separation of the tire from the axle likely occurred as the vehicle tipped, further evidenced in the damage found to the fuel tank and tank shield.

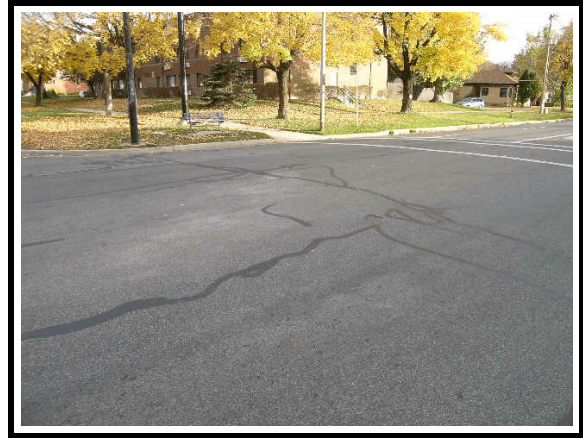
The impact severity was moderate, but the front left of the Jetta snagged on the right rear tire on the Lexus. The snagging and the force of the impact caused the Lexus to rotate clockwise as it traveled laterally towards the southeast corner of the intersection. The Lexus rolled over one-quarter turn to its left (00LDAO2) which resulted in the deployment of both the right and left side curtain air bags.

Figure 5. General rollover location - 2005 Lexus RX330 (southeast)

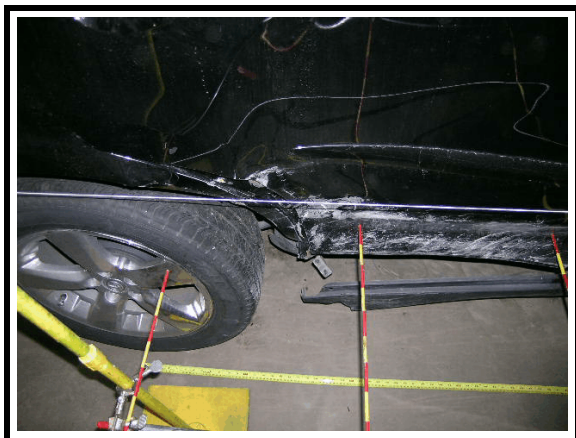
Figure 6. Case vehicle's right rear tire - Location of possible snag

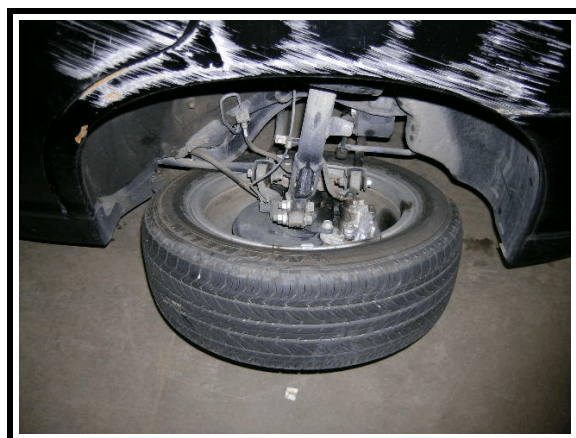
Figure 7. Damaged left rear axle - 2005 Lexus RX330

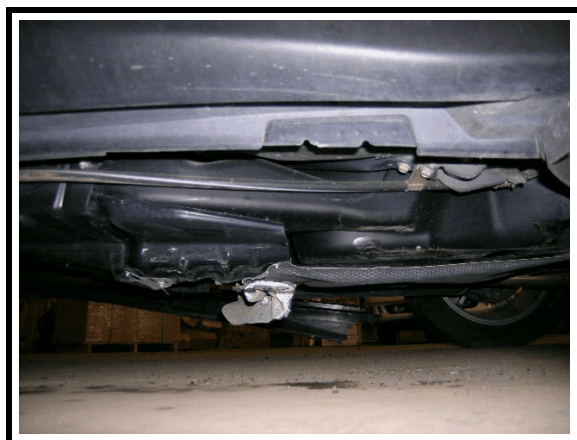
The non-metallic fuel tank, mounted on the left side, forward of the rear axle, was abraded but there was no leakage. The shield was crumpled and abraded. This damage likely occurred as the left rear tire partially broke away from the axle and the undercarriage contacted the ground just prior to the rollover event.

Figure 8. Damage to case vehicle's fuel tank and shield

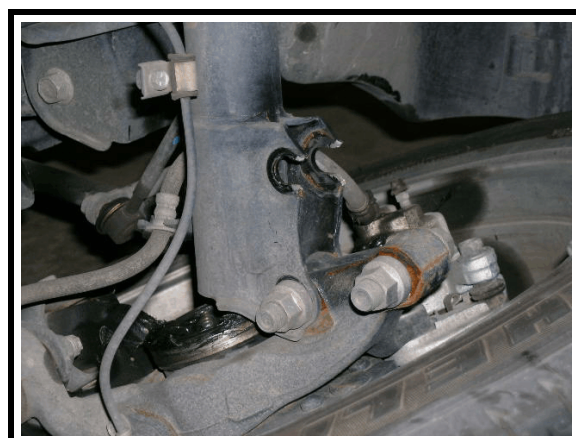
Figure 9. Close-up damage to the case vehicle's left rear tire/axle attachment point

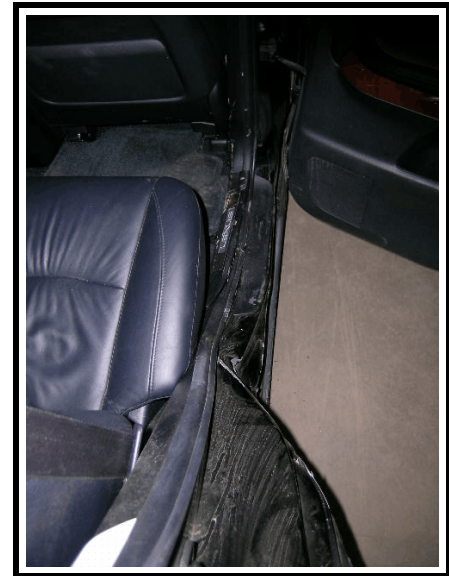
Position	Intruded Component	Magnitude of Intrusion	Direction
RR	Sill	5.0 cm (2.0 in)	Lateral

Figure 10. Second row, right sill intrusion

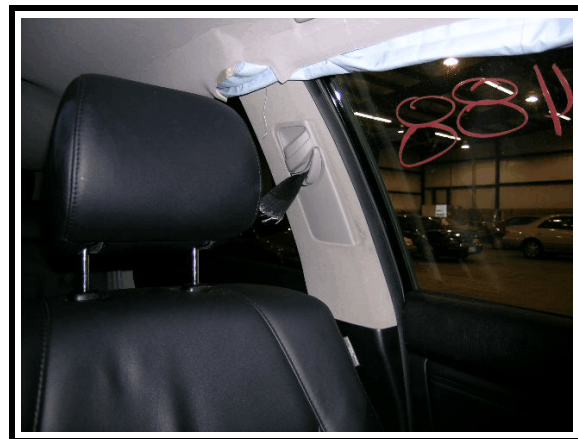
The driver's seat belt B pillar pretensioner actuated during the collision and was still locked in place post-crash. In order to remove the driver, fire/rescue personnel cut the driver's seat belt. There was no integrity loss. The only intrusion was to the sill in the second row right seating area. The four doors and rear hatch all remained closed and operational. There was no glazing damage.

Figure 11. Driver's seat belt, cut by fire/rescue personnel.

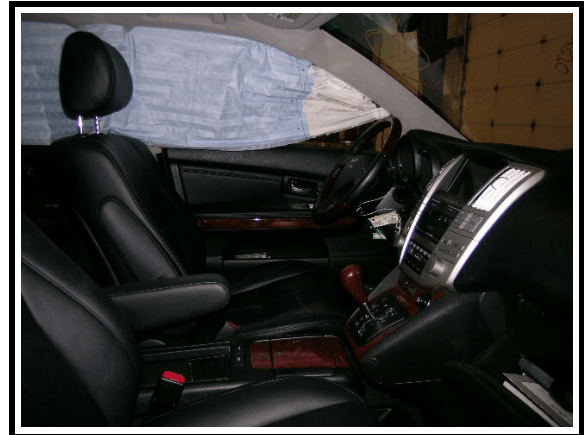
There was a faint black transfer and a brown discoloration found on the inner left side curtain in the driver's area. This was likely due to occupant contact with the bag. There was slight cosmetic damage on the outer portion of the second row, right side curtain which consisted of black transfers. The transfers were attributed to the right rear door trim, which was found hanging and in contact with the side curtain material.

Figure 12. Left side curtain air bag, front row

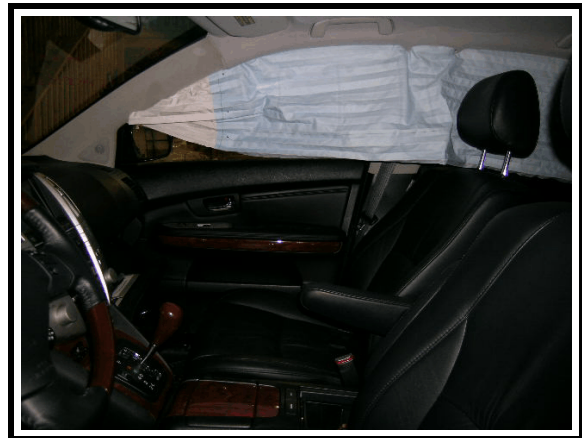
Figure 13. Right side curtain air bag, front row

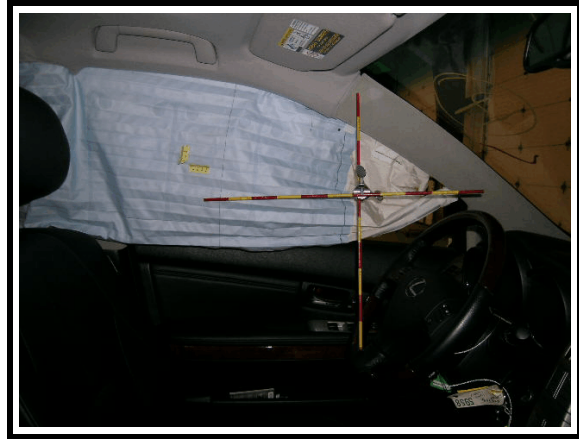
There were scuffs to the left kick panel, possibly from the driver's left ankle and/or foot. In the front row, there was a slight black transfer and brown discoloration on the inside portion of the left side curtain air bag.

Figure 14. Possible occupant contact, Left side curtain air bag
