ON-SITE ADAPTIVE CONTROL-EQUIPPED VEHICLE INVESTIGATION

CASE NUMBER - IN-05-023

VEHICLE - 1994 FORD E350 R.V. CUTAWAY WITH BUS BODY

CRASH DATE - July 2005

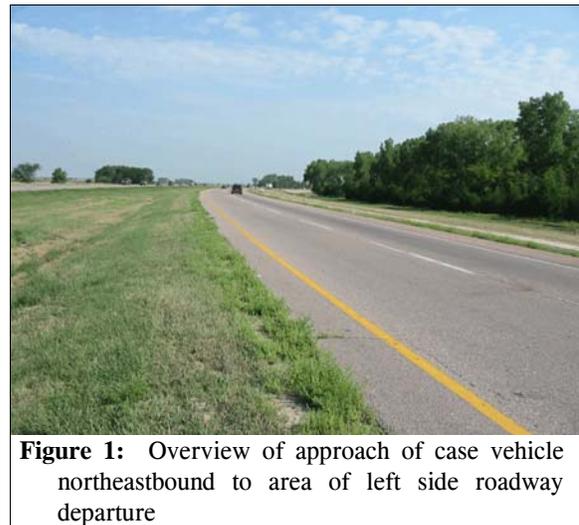
Pre-Crash: The case vehicle was traveling northeast in the left lane (**Figure 1**) negotiating a gentle right curve. The driver was intending to continue northeastbound. The driver stated to police that he was traveling approximately 97 to 105 km.p.h. (60 to 65 m.p.h.). For an unknown reason, the case vehicle departed the left side of the roadway and entered the median (**Figure 2** below). The case vehicle traveled in the median (**Figure 3** below), the driver steered right and the case vehicle began to rotate clockwise and it reentered the roadway (**Figure 4** below). As the case vehicle crossed the roadway heading to the east side of the roadway, the driver steered hard left, which put the case vehicle into a severe counterclockwise rotation (**Figure 5** below). The crash occurred on the east side of the roadway.

Figure 1: Overview of approach of case vehicle northeastbound to area of left side roadway departure

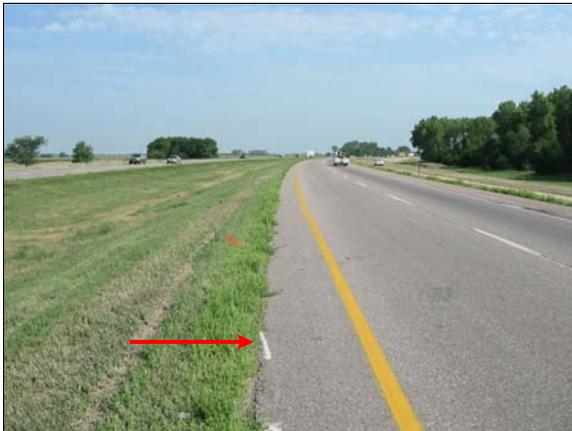
Figure 2: Arrow shows location of case vehicle's roadway departure

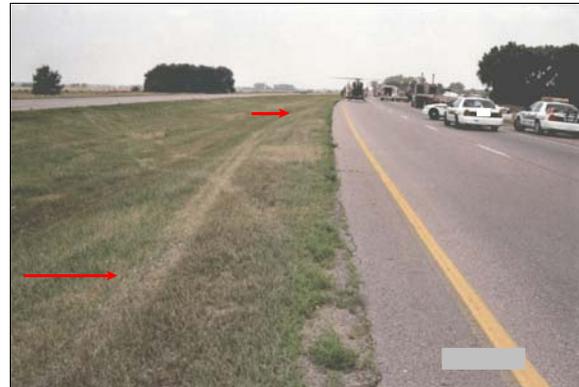
Figure 3: Police on-scene photo showing travel path of case vehicle in median, arrows show left side tire marks in grass

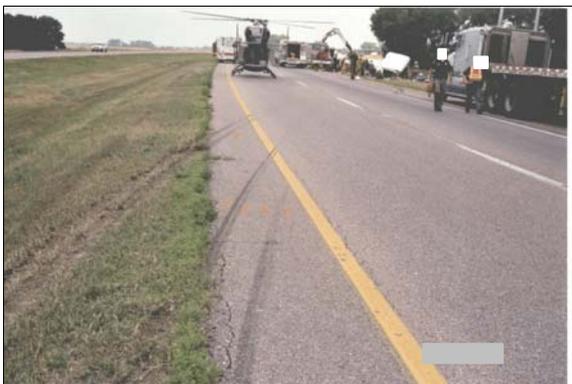
Figure 4: Case vehicle's yaw marks as it reenters roadway in clockwise rotation

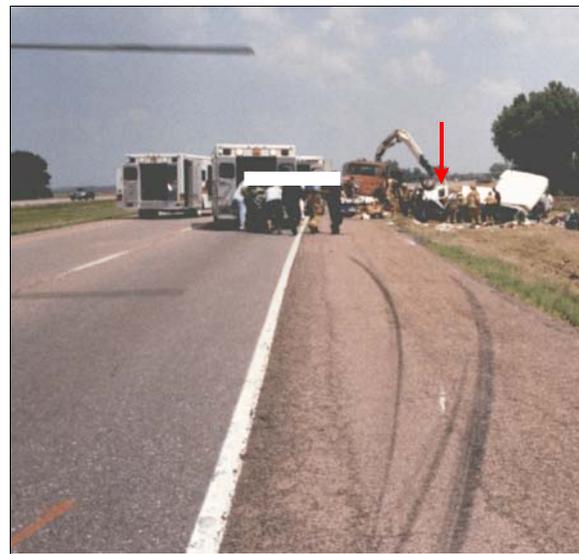
Figure 5: Police on-scene photo showing case vehicle's yaw marks leading to area of rollover initiation, case vehicle in counterclockwise rotation, arrows shows case vehicle at rest on its top in background

Crash: As the case vehicle entered the outside shoulder, the counterclockwise rotation increased significantly (**Figure 5**) and the case vehicle began to rollover, passenger side leading. The case vehicle sustained a hard ground impact on the left roof side rail and left roof (**Figure 6** below) at the end of the second quarter roll, and the bus body began to break apart and separate from the chassis. As the case vehicle continued to roll over, the bus body completely separated from the chassis (**Figures 7 and 8** below) near the end of the rollover (**Figure 9** below). The second row right outboard passenger (43-year-old male), the third row left outboard passenger (25-year-old female) and the enclosed area right wheelchair passenger (75-year-old male) were ejected from the case vehicle near the end of the rollover, most likely during the fifth or sixth quarter rolls. The case vehicle rolled over a total of one-and-one-half times (six quarter rolls) across a distance of approximately 25 meters (82 feet).

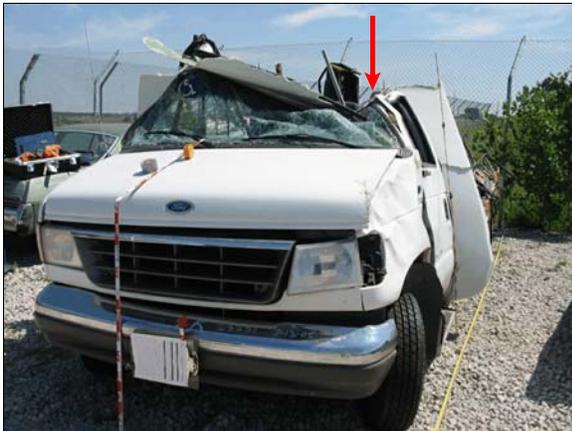
Figure 6: Damage to case vehicle's left roof and roof side rail from ground impact

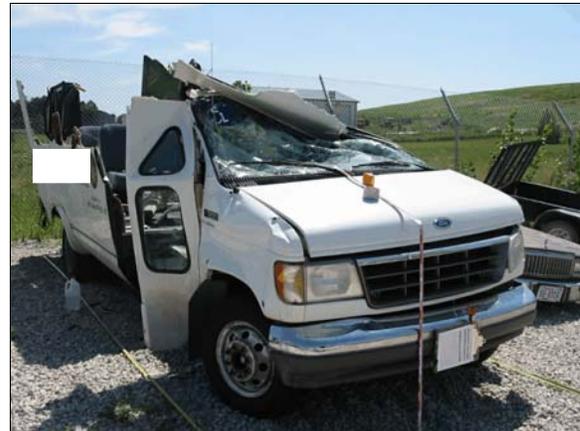
Figure 7: Front right view of damage to case vehicle

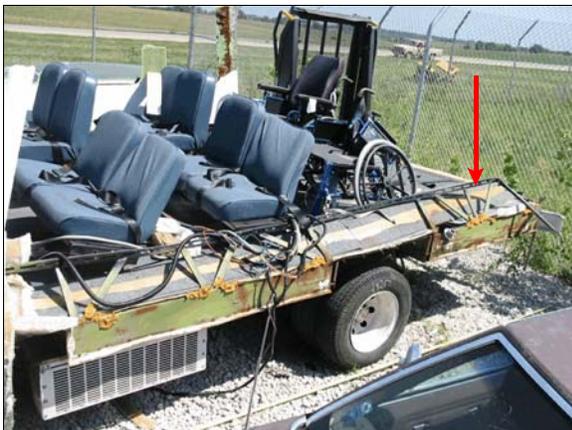
Figure 8: Left side view of passenger area, bus body was screwed to metal frame (arrow)

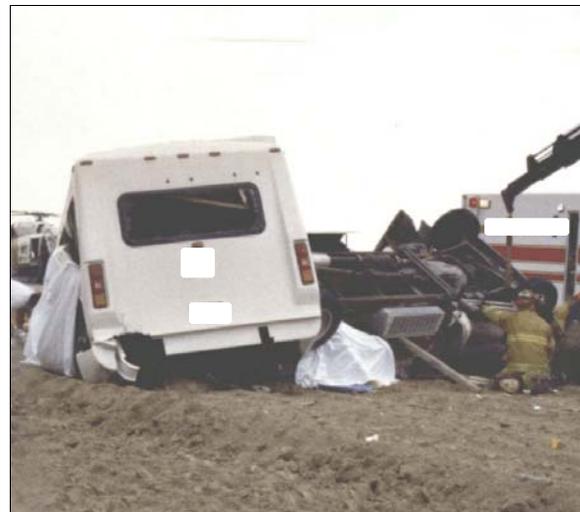
Figure 9: Police on-scene photo showing rest position of case vehicle on its top, view is back toward roadway, front of vehicle is to right, bus body separated from chassis and laying on rear portion of vehicle

Post-Crash: The case vehicle came to rest on its top facing northwest (**Figure 9**). The driver was entrapped in the vehicle. The remaining wheelchair passenger and two other passengers were entrapped under the vehicle between the ground and their seats/wheelchair. The three ejected occupants came to rest near the right side of the case vehicle.

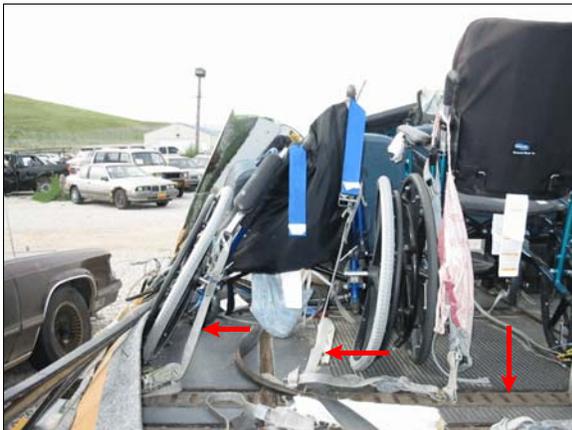
Figure 10: Deformation of left wheelchair, arrows show wheelchair securement straps secured to wheelchair and securement anchorage plate

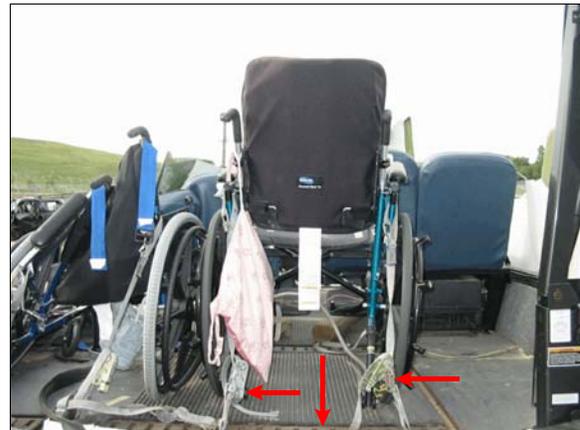
Figure 11: Right wheel chair, arrows show wheelchair securement straps secured to wheelchair and securement anchorage plate

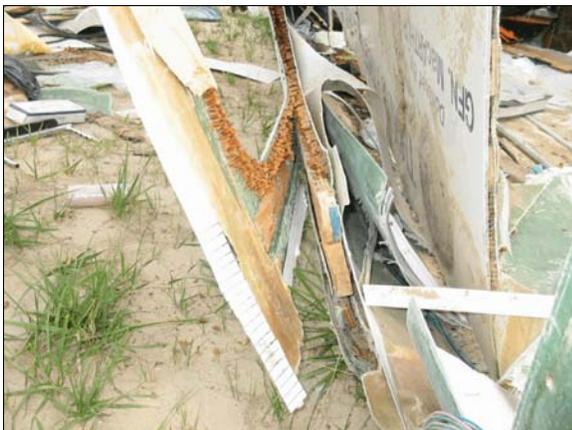
Figure 12: View of left front of bus body showing wooden frame and fiberglass construction

The bus body was constructed of a wooden frame with fiberglass panels approximately 5 mm (0.2 inch) thick glued to the wooden frame members (**Figure 12** above). The individual frame boards were 3.5 centimeters (1.4 inches) thick. The space between the inner and outer fiberglass side panels contained a cardboard honeycomb-type material (**Figure 12** above). The bus body was screwed to a metal frame that extended along each side of the vehicle chassis (**Figure 13** above and **Figure 8** above). The metal frame extended above the bus floor approximately 27 centimeters (10.6 inches).

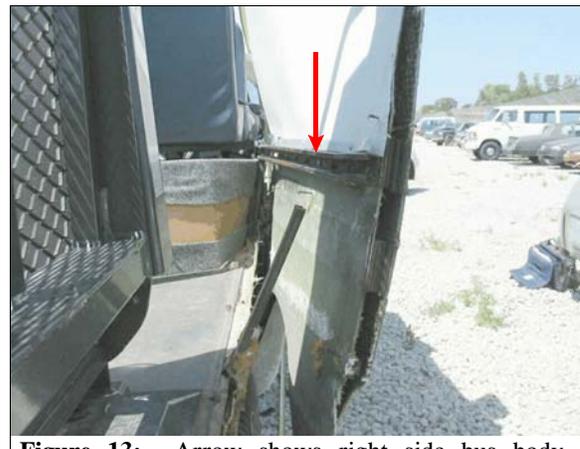
Figure 13: Arrow shows right side bus body screwed to metal frame that runs length of passenger compartment.

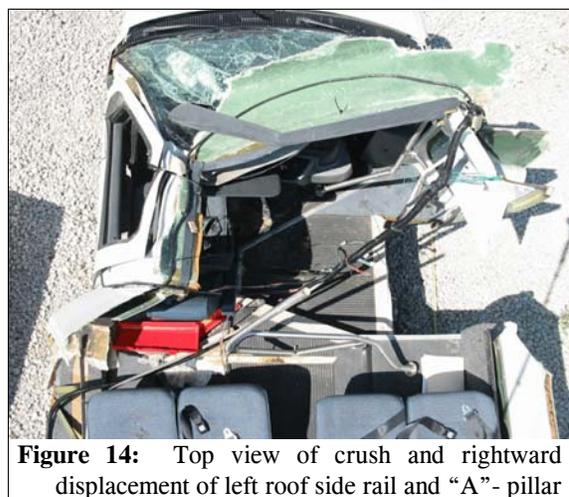
Exterior Damage: The rollover directly damaged the top and both sides of the case vehicle. The left roof and left roof side rail sustained the hardest ground impact, which crushed the roof, left “A”-pillar and left roof side rail (**Figure 14**). The bus body fractured and separated from the vehicle chassis on the left side and separated from the bus body along the base of the windows on the right side (**Figures 7 and 8** above). The case vehicle’s left side wheelbase was reduced approximately 6 centimeters (2.5 inches) while the right side wheelbase was extended approximately 8 centimeters (3.1 inches). Induced damage involved the hood, both fenders and the left and right front doors.

Figure 14: Top view of crush and rightward displacement of left roof side rail and “A”- pillar

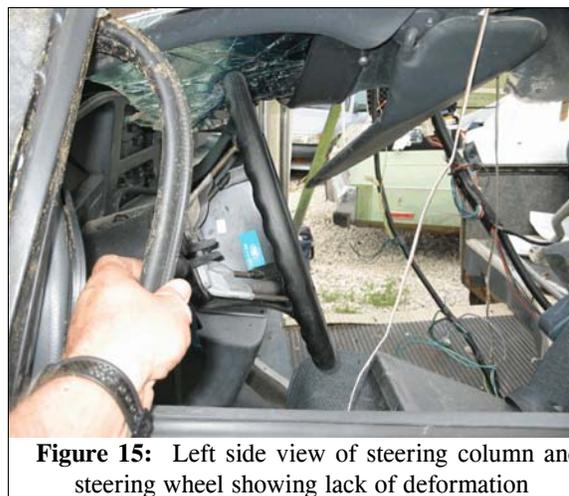
Vehicle Interior: Inspection of the case vehicle's interior revealed blood on the nap of the roof above the driver's seat. No other evidence of occupant contact to any interior surfaces or components was observed. There were numerous intrusions into the passenger compartment. The most severe intrusions that could be documented involved 40 centimeters (15.7 inches) of vertical roof and windshield header intrusion into the driver's seating area and 31 centimeters (12.2 inches) of lateral "B"-pillar intrusion into the driver's seating area. There was no evidence of compression of the energy absorbing steering column and no deformation of the steering wheel rim was observed (Figure 15).

Figure 15: Left side view of steering column and steering wheel showing lack of deformation

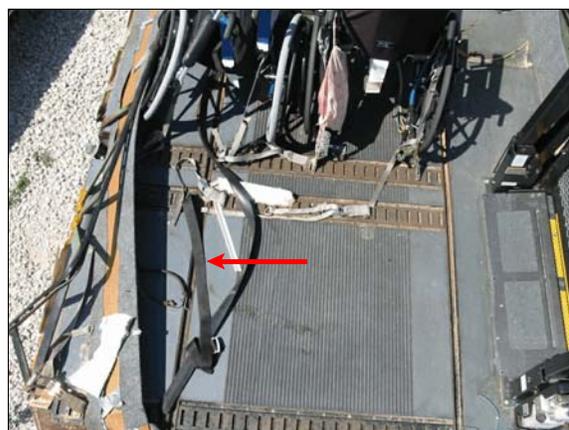
Figure 16: Arrow shows left wheelchair passenger's lap belt

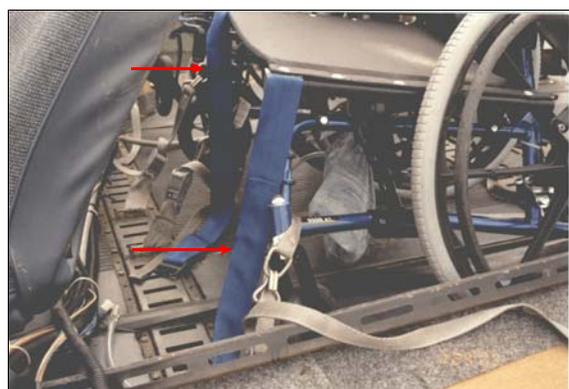
Based on the vehicle inspection and correspondence with police personnel, this passenger was restrained by a removable two-point lap belt, which was attached to the securement anchorage plate behind the left wheelchair (**Figure 16**). In addition, the passenger was secured in the wheelchair by the thigh straps located at the front of the wheelchair cushion (**Figure 17**).

Figure 17: Arrows show left wheelchair passenger's leg straps
