**CALSPAN ON-SITE CERTIFIED ADVANCED 208-COMPLIANT
VEHICLE CRASH INVESTIGATION**

CASE NO: CA05-025

VEHICLE: 2005 HONDA ACCORD

CRASH DATE: MARCH 2005

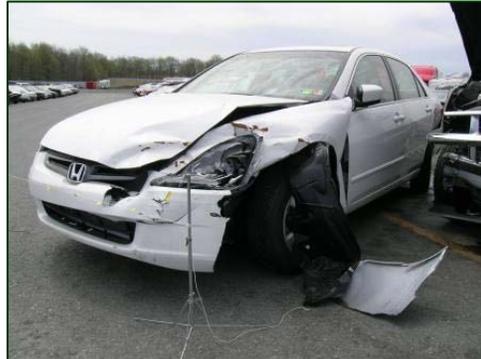
Figure 1. Frontal damage to the 2005 Honda Accord.

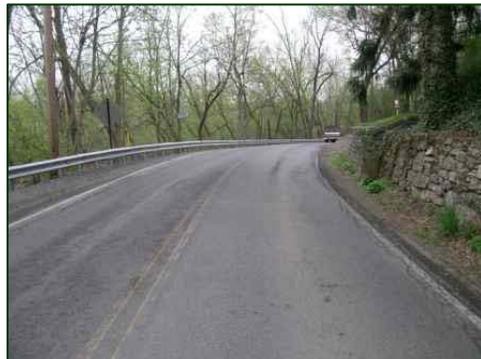
Figure 2. Eastbound view of the crash site; Honda Accord's approach view.

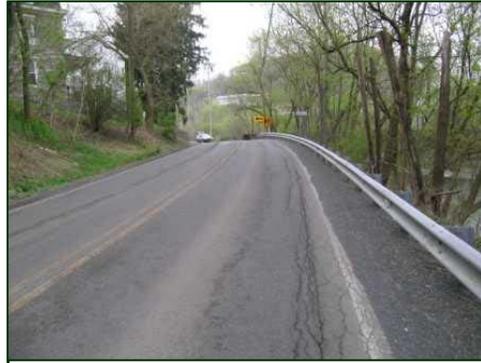
The driver of the 2005 Honda Accord was traveling in an easterly direction on the two-lane roadway, negotiating the right curve with a positive grade. The driver of the 1988 Pontiac Grand Prix was westbound on the roadway and was traveling at a police reported high-rate of speed for the conditions and the curvature of the roadway (**Figure 3**). As the driver of the Pontiac attempted to negotiate the left curve, he lost control on the wet asphalt. The vehicle initiated a counterclockwise yaw and crossed into the opposing travel lane, into the path of the Honda Accord. The driver of the Honda steered right and applied the brakes in an attempt to avoid the impact.

Figure 3. Westbound trajectory view of the Pontiac Grand Prix.

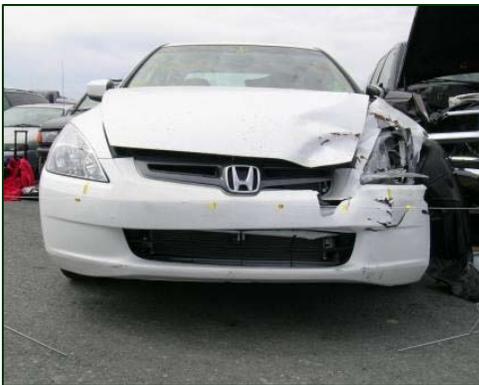
The direct contact damage on the frontal plane began 21 cm (8.25”) left of center and extended 56 cm (22”) to the front left corner (**Figure 4**). The impact involved the bumper system, hood, left headlamp assembly and the left front fender. The leading edge of the left front fender was contacted and crushed. The large headlamp assembly consumed the majority of this area. Maximum bumper crush was 8 cm (3”) located on the bumper beam 24 cm (9.5”) left of center (**Figure 5**). At this location, the beam buckled from the corner impact sequence. The crush profile was documented at the level of the bumper beam over its width of 112 cm (44”). The crush profile was as follows: C1 = 5 cm (2”), C2 = 6 cm (2.25”), C3 = 2 cm (0.75”), C4 = 0 cm, C5 = 0 cm, C6 = 0 cm. The Collision Deformation Classification (CDC) for this event was 12-FYEW-1.

Figure 4. Frontal view of the front right corner damage to the Honda Accord.

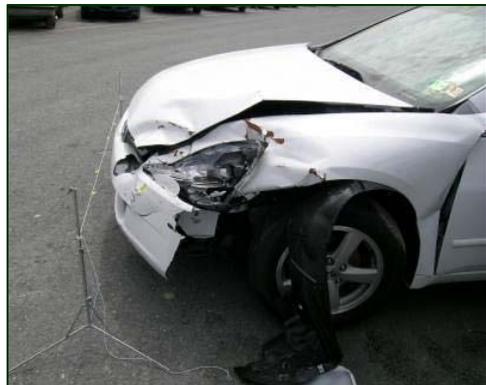
Figure 5. Lateral view identifying the extent of frontal crush and left side contact.

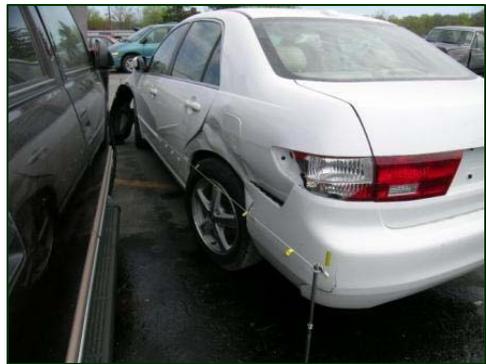
The Pontiac disengaged the Honda as it continued to rotate in a counterclockwise (CCW) direction. The right rear quarter panel area side slapped the left rear side area of the Honda (**Figure 6**). The direct contact damage began on the left rear door, 34 cm (13.5”) aft of the B-pillar and extended 173 cm (68”) rearward onto the left rear quarter panel and the side of the rear bumper fascia. The impact also involved the left rear tire and wheel as the axle position was deflected in a CCW direction resulting in a steer angle of approximately 12 degrees. The total length of direct and induced damage was 173 cm (68”).

Figure 6. Left rear side damage to the Honda Accord.

The majority of the side slap impact was absorbed by the left rear axle. Maximum lateral crush was 13 cm (5") located at the trailing edge of the left rear wheel opening. The crush profile at the level of the rub strip was as follows: C1 = 0 cm, C2 = 4 cm (1.5"), C3 = 13 cm (5"), C4 = 5 cm (2"), C5 = 0 cm, C6 = 0 cm. The 0 cm points involved paint transfers. The CDC for this event was 09-LZEW-1.

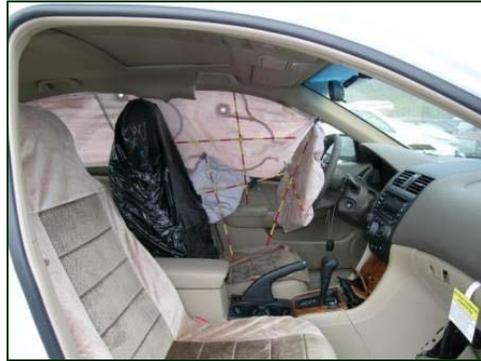
The interior of the Honda Accord sustained minor severity damage as a result of air bag deployment and minimal driving loading evidence. There was no intrusion of the interior compartment. The driver's space was muddy from pre-crash activity by the driver. A plastic garbage bag was placed over the aftermarket seat cover on the driver's seat. As the left front side impact air bag deployed, the bag deployed through the aftermarket seat cover and plastic bag. The headliner was deformed from the deployment of the left side curtain air bag. The driver's frontal air bag deployed as designed through the air bag module cover flaps.

Figure 7. Lateral view of the driver's compartment and the deployed air bags.

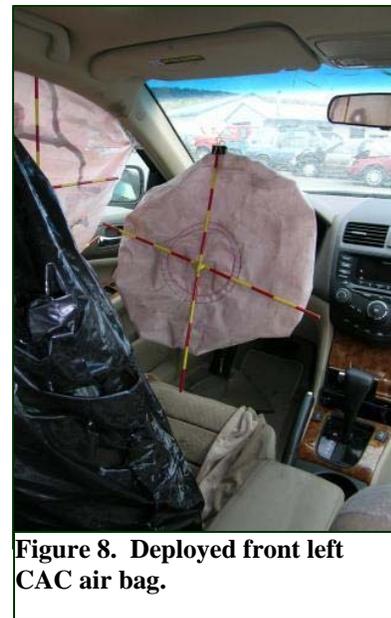
The CAC frontal air bag system consisted of dual stage air bags for the driver and front right passenger positions, seat track positioning sensors, safety belt retractor pretensioners with buckle switches, and a front right occupant presence sensor incorporated into the seat cushion. The manufacturer of this vehicle has certified that the Accord meets the advanced air bags requirements for FMVSS 208. The driver was the sole occupant of the vehicle, therefore the driver's air bag deployed and the front right air bag was suppressed due to the unoccupied position. The driver's air bag deployed from an H-configuration module cover. Both rectangular flaps measured 12 cm (4.75") in width at the horizontal tear seam. The vertical height of the upper flap was 8 cm (3") while the lower flap was 6 cm (2.5"). The driver's air bag measured 58 cm (23") in diameter (**Figure 8**) in its deflated state and was tethered by two internal straps at the 2 and 6 o'clock positions. The air bag was vented by

Figure 8. Deployed front left CAC air bag.

two 4 cm (1.75") diameter ports located at the top of the bag, 15 cm (6") forward of the peripheral seam. The driver's air bag was stamped with the following nomenclature:

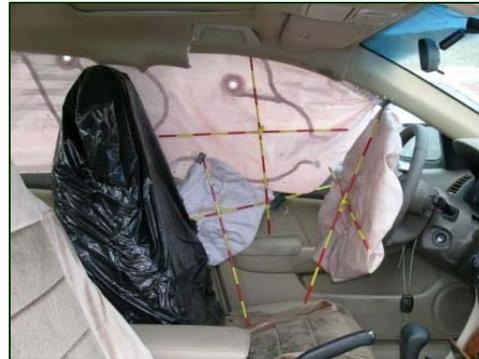
The Honda Accord was equipped with seat mounted side impact air bags in the front positions and Inflatable Curtain (IC) air bags that offered protection to the four outboard seated positions. The left side impact air bag and the left IC deployed as a result of the secondary left side impact (**Figure 9**). The seat mounted side impact air bag deployed through the OEM leather seat cover, plus through the side surface of the aftermarket seat cover and the plastic garbage bag that was placed over the aftermarket cover. The latter two covers were torn in the area of deployment and did not impede the deployment of the air bag. The OEM seat cover was torn vertically 36 cm (14.25").

Figure 9. Deployed left side impact air bag and IC.

The left side impact air bag was a thoracic bag that measured 25 cm (10") in length and 37 cm (14.75") in height (deflated). Two 6 mm (0.25") diameter vent ports were located on the inboard face of the bag and circled with a stitch pattern. The torso side air bag was not tethered. There was no driver contact evidence on the air bag or damage associated with deployment.

The left IC deployed from the left roof side rail area by expanding and separating the headliner from the side rail. The overall dimensions of the left IC air bag were 38 cm (15") vertically and 163 cm (64") in length. Based on the inspection of the IC, the rectangular IC had three inflation chambers, one in the area of the driver's position that measured approximately 41x43 cm (16x17") vertically x horizontally; a second that was 15 cm (6") wide located aft of the B-pillar; and a third at the area of the rear seat position. This chamber was 24 cm (9.5") in height and 33 cm (13") in length. There was no damage or driver contact evidence to this IC bag. It was stamped with the following nomenclature:

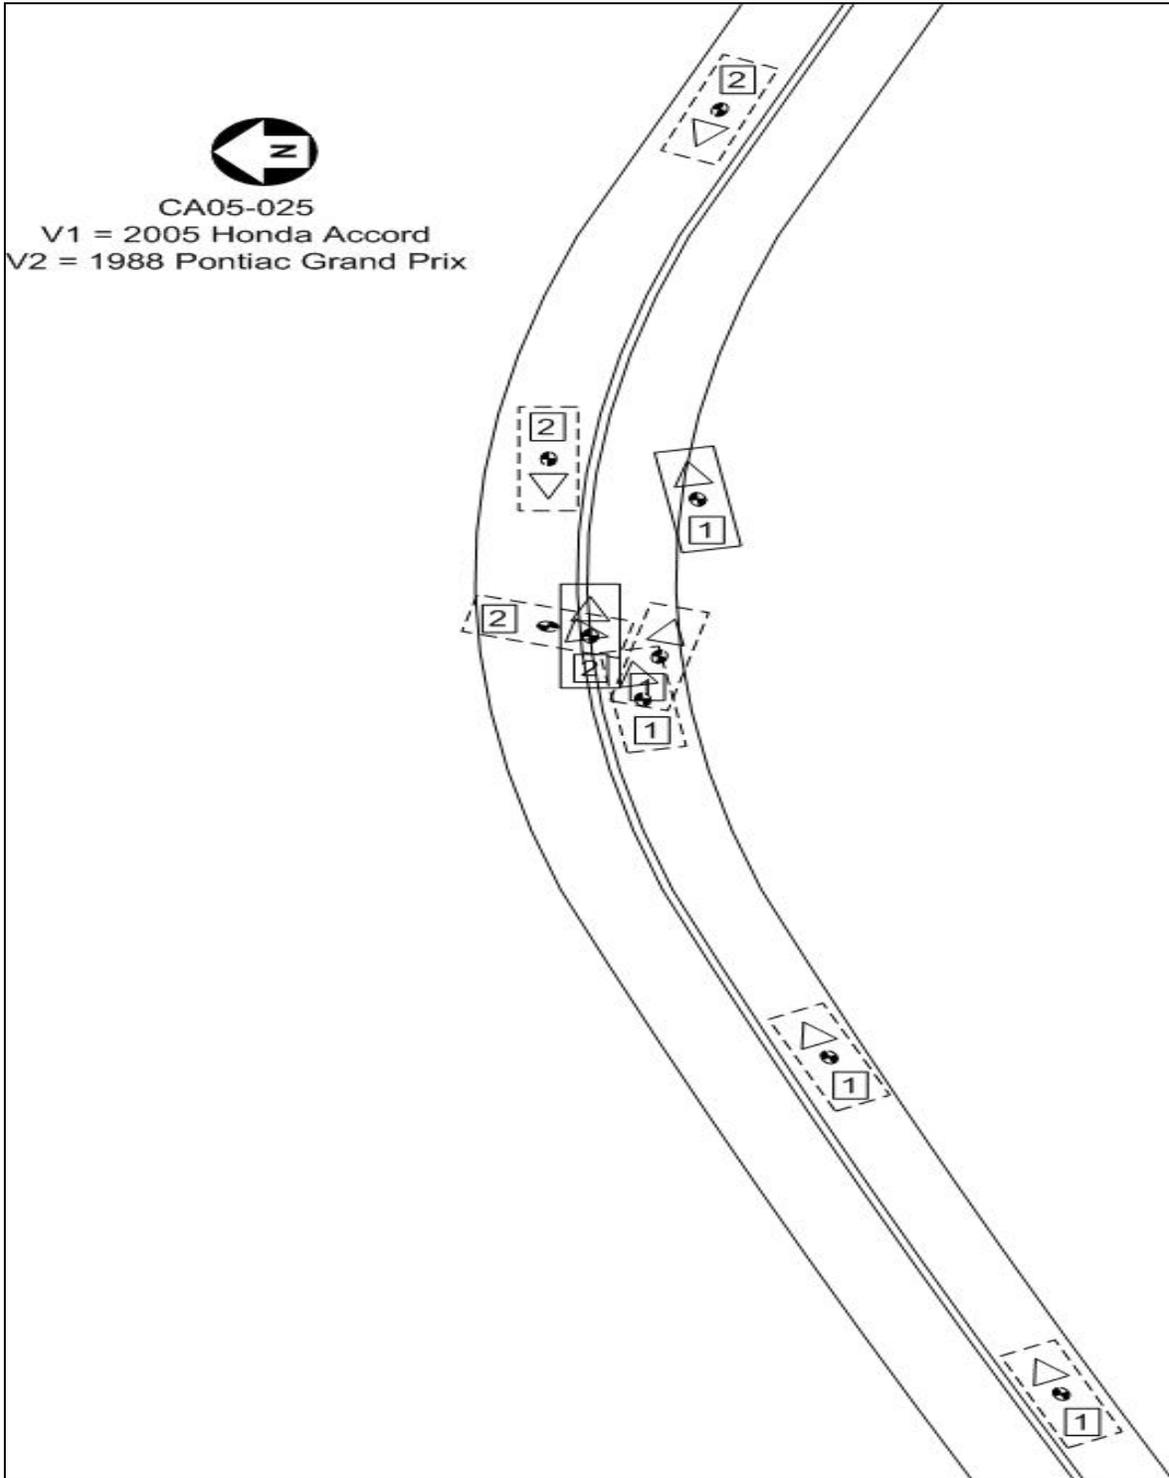
Figure 10 – Scene Schematic

embankment at the south edge and a W-beam guardrail at the north road edge. The radius of curvature was measured at 81.6 m (268'). The roadway had a positive grade to the east of 4 percent. At the time of the crash, the asphalt road surface was police reported as wet. There was no physical evidence remaining at the crash site at the time of the SCI investigation. **Figure 2** is an overall view of the crash site from the Honda's direction of travel. The Scene Schematic is included as **Figure 10** of this report.
