ON-SITE CERTIFIED ADVANCED 208-COMPLIANT VEHICLE INVESTIGATION

CASE NUMBER - IN-05-027

VEHICLE - 2005 CHRYSLER PACIFICA

CRASH DATE - July 2005

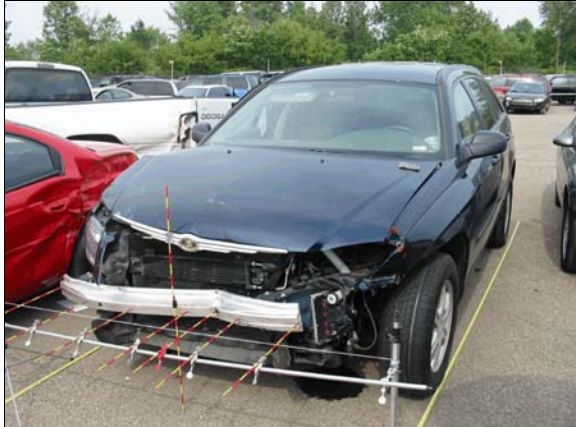
Figure 4: Overview of damage to front of case vehicle from impact with the Sebring, each increment on the rods is 5 cm (2 in)

Crash: The front of the case vehicle (**Figure 4**) impacted the right side of the Sebring (**Figure 5**) causing the case vehicle's driver air bag to deploy. The front right passenger air bag did not deploy. It is unknown whether more than one stage of the driver's multi-stage air bag deployed. In addition, the case vehicle driver's inflatable knee blocker also deployed. As a result of the impact, the Sebring was deflected to the left. It traveled across the intersection and into the north leg of the intersection. The front of the Sebring then impacted the front of the Chevrolet.

Exterior Damage: The case vehicle’s contact with the Sebring involved the entire frontal plane (Figure 4 above). The case vehicle’s front bumper, bumper fascia, grille, left headlamp/turn signal assembly, front portion of the left fender, and hood were directly damaged and crushed rearward. Direct damage began at the left front bumper corner and extended 152 centimeters (59.8 inches) across the bumper. The Field L was measured as 143 centimeters (56.2 inches) and residual maximum crush was measured as 27 centimeters (10.6 inches) occurring 14 centimeters (5.5 inches) right of C₂ (Figure 6). The table below shows the case vehicle’s crush profile.

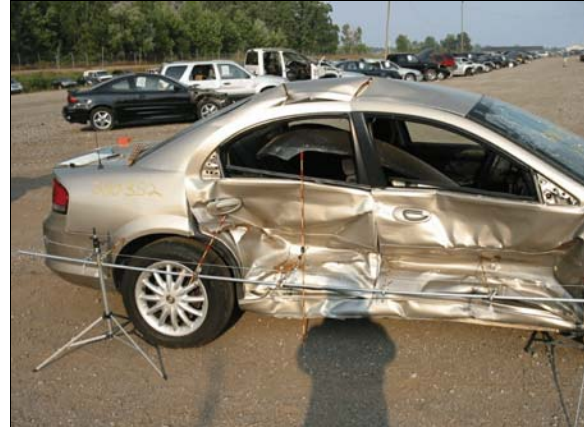
Figure 5: Damage to right side of the Sebring from impact with the case vehicle

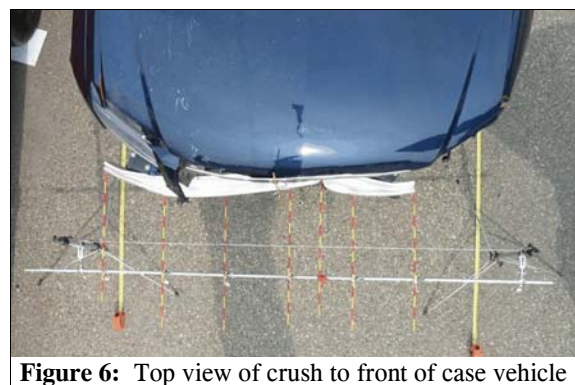
Figure 6: Top view of crush to front of case vehicle

Units	Event	Direct Damage		Field L	C ₁	C ₂	C ₃	C ₄	C ₅	C ₆	Direct	Field L
		Width CDC	Max Crush								±D	±D
cm	1	152	27	143	10	18	25	22	17	18	0	0
in		59.8	10.6	56.3	3.9	7.1	9.8	8.7	6.7	7.1	0.0	0.0

The case vehicle’s left side wheelbase was extended 3 centimeters (1.2 inches) while the right side wheelbase was shortened 2 centimeters (0.79 inches). There was induced damage to the right headlamp/turn signal assembly, hood, and both fenders and left and right frame rails. No obvious induced damage or remote buckling was noted to the remainder of the case vehicle’s exterior.

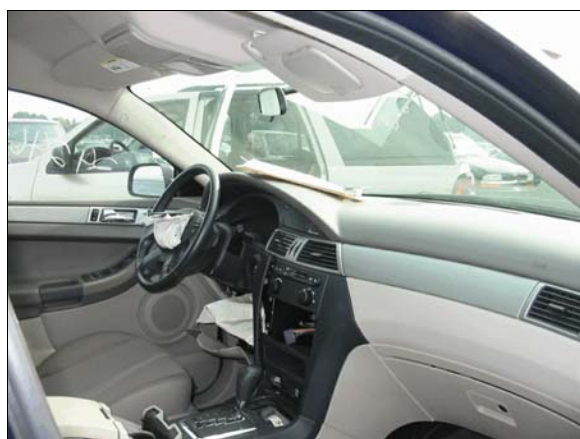
Vehicle Interior: Inspection of the case vehicle’s interior (**Figure 7**) revealed no evidence of occupant contact to any interior surfaces or components. A small dirt scuff was observed on the lower left quadrant of the driver air bag; however, this did not appear to be an occupant contact mark. There was no passenger compartment intrusion, and no evidence of deformation of the steering wheel or compression of the energy absorbing steering column was observed (**Figure 8**).

Figure 7: Overview of case vehicle’s instrument panel, windshield and steering wheel

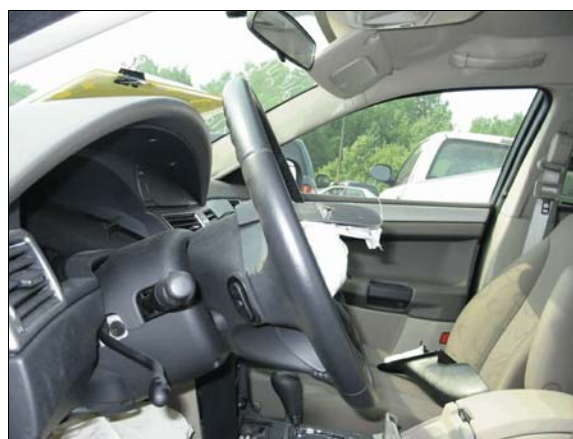
Figure 8: Left side view of steering wheel and steering column showing lack of deformation

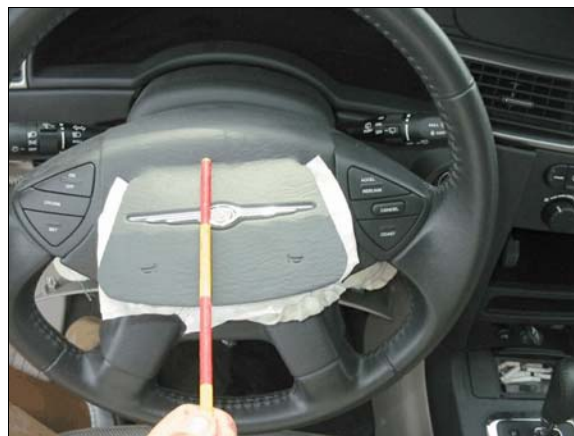
The case vehicle's driver air bag was located in the steering wheel hub. An inspection of the air bag module cover flap (**Figure 9**) and the air bag fabric revealed that the cover flaps opened at the designated tear points. There was no evidence of damage during the deployment to the air bag or the cover flap. The air bag module cover consisted of a single trapezoidal-shaped cover flap constructed of pliable vinyl. The cover flap was 11 centimeters (4.3 inches) in width at the top, 15 centimeters (5.9 inches) in width at the bottom and 10 centimeters (3.9 inches) in height. The driver's air bag was designed with two tethers, each approximately 11 centimeters (4.3 inches) in width. The driver's air bag had one vent port (**Figure 10** below), approximately 3 centimeters (1.2 inches) in diameter, located at the 12 o'clock position. The deployed driver's air bag (**Figure 11**) was round with a diameter of approximately 60 centimeters (23.6 inches). The distance between the mid-center of the driver's seat back, as positioned as the time of the vehicle inspection (i.e., seat between middle and forward-most track position, seat back slightly reclined), and the front surface of the air bag's fabric at approximate full excursion was 30 centimeters (11.8 inches). An inspection of the driver's air bag fabric revealed no evidence of occupant contact.

Figure 9: Driver's air bag module cover flap

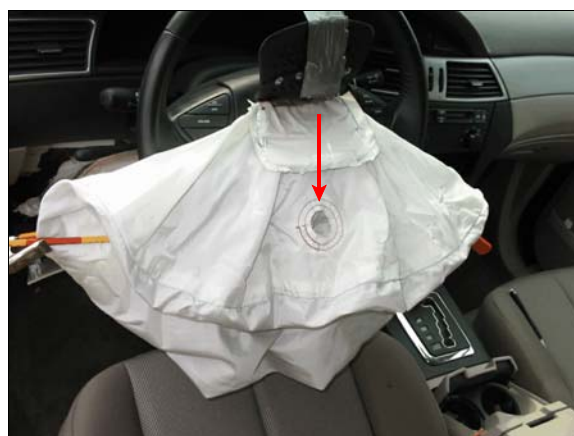
Figure 10: Case vehicle driver's air bag vent port

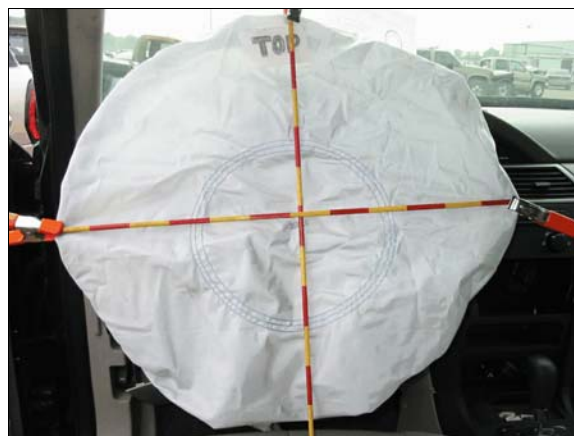
Figure 11: Case vehicle driver's air bag

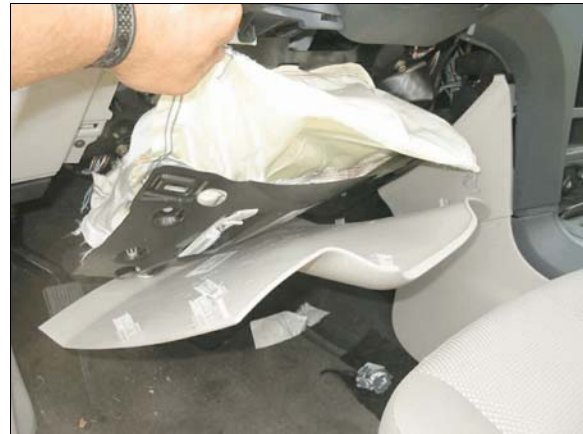
The case vehicle was also equipped with an inflatable driver knee blocker located behind the driver's knee bolster panel (**Figure 12** below). The knee blocker also inflated in this crash. There was no evidence of damage to the knee blocker or the knee bolster panel. The knee blocker was approximately 40 centimeters (15.7 inches) in width and 33 centimeters (13 inches) in height. It was attached to a thin steel plate located directly behind the knee bolster panel. Inflation of the knee blocker provides a cushion to absorb energy as the driver's knees and lower legs load into the knee bolster panel during a crash. The evidence indicated that the knee blocker performed as designed.

Figure 12: Case vehicle driver's inflatable knee blocker

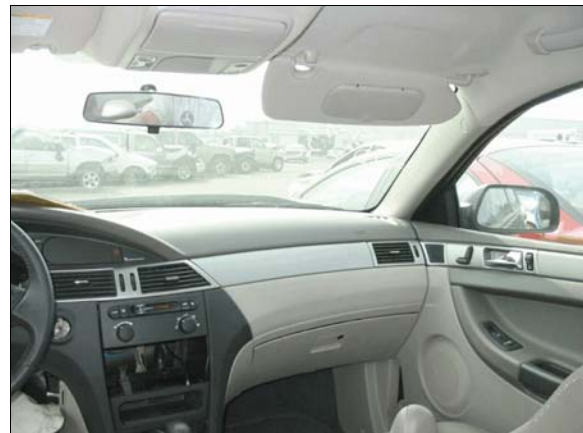
The front right passenger's air bag was located in the top of the right instrument panel (Figure 13). This air bag did not deploy in the crash. The case vehicle's advanced occupant protection system most likely suppressed the deployment of the air bag. The 13-year old female front right passenger was restrained by her three-point, lap-and-shoulder safety belt system and weighed 41 kilograms (90 pounds).

Figure 13: Case vehicle's front right air bag located in top of right instrument panel

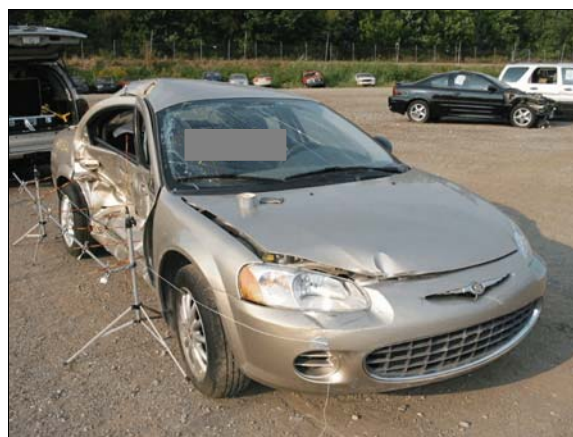
Exterior Damage: The Sebring's impact with the case vehicle involved the right side doors (**Figure 14**). Both the right front and right rear doors were directly damaged and crushed inward into the passenger compartment. The direct damage began 19 centimeters (7.5 inches) forward of the right rear axle and extended 182 centimeters (71.6 inches) forward along the right side. The Field L was determined to be 237 centimeters (93.3 inches), and the residual maximum crush was 36 centimeters (14.2 inches) occurring at C₄ (**Figure 15**). The table below shows the Sebring's right side crush profile.

Figure 14: Overview of front and right side damage to the Sebring

The Sebring's impact with the Chevrolet involved approximately the right two-thirds of the front bumper and right portion of the hood (**Figure 14** above). The direct damage began at the right bumper corner and extended 89 centimeters (35 inches) along the bumper. There was no residual crush to the front bumper. Induced damage involved the hood and the right headlamp/turn signal assembly.

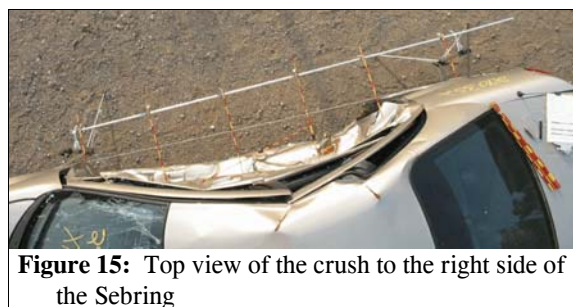
Figure 15: Top view of the crush to the right side of the Sebring

Units	Event	Direct Damage		Field L	C ₁	C ₂	C ₃	C ₄	C ₅	C ₆	Direct	Field L
		Width CDC	Max Crush								±D	±D
cm	1	182	36	237	0	24	29	36	34	0	-26	-44
in		71.7	14.2	93.3	0.0	9.4	11.4	14.2	13.4	0.0	-10.2	-17.3
