Certified Advanced Compliant Air Bag Investigation / Vehicle to Vehicle  
Dynamic Science, Inc. / Case Number: DS05027  
2005 Lexus RX330  
California  
October 2005

1. Report No. DS05027	2. Government Accession No.		3. Recipient Catalog No.	
4. Title and Subtitle Certified Advanced Compliant Air Bag Investigation		5. Report Date May 27, 2006

**Dynamic Science, Inc.**  
**Crash Investigation**  
**Case Number: DS05027**

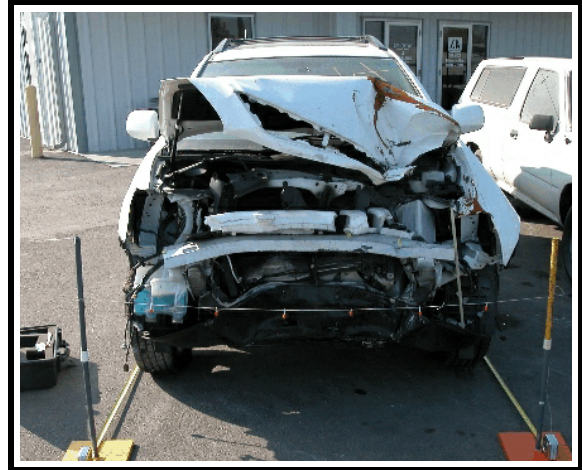
**Figure 1.** Front view, 2005 Lexus RX330

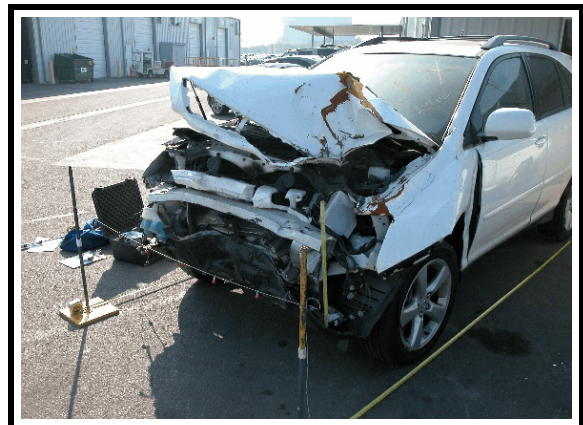
**Damage Description:** The 2005 Lexus RX330 sustained moderate front end damage as a result of the impact with the semi truck. The direct damage began at the left front corner and extended 107.0 cm (42.1 in) laterally to the right. The bumper fascia was knocked off and the bumper backing bar was rotated upward 90 degrees. The distance from the center of the bumper to the ground was 83.0 cm (32.7 in). The direct and induced damage extended across the entire front end and measured 176.0 cm (69.3 in). The hood was buckled and the windshield was fractured.

**CDC:** 12FDEW2

<b>Delta V<sup>1</sup>:</b>	<b>Total</b>	55.0 km/h (34.2 mph)
	<b>Longitudinal</b>	-55.0 km/h (-34.2 mph)
	<b>Latitudinal</b>	0 km/h (0 mph)
	<b>Energy</b>	291,134 joules (161,625 ft lbs)

Six crush measurements were documented at the bumper backing bar level: C1 = 30.0 cm (11.8 in), C2 = 31.0 cm (12.2 in), C3 = 34.0 cm (13.4 in), C4 = 34.0 cm (13.4 in), C5 = 28.0 cm (11.0 in), C6 = 23.0 cm (9.0 in).

**Figure 3.** Front left, 2005 Lexus RX330

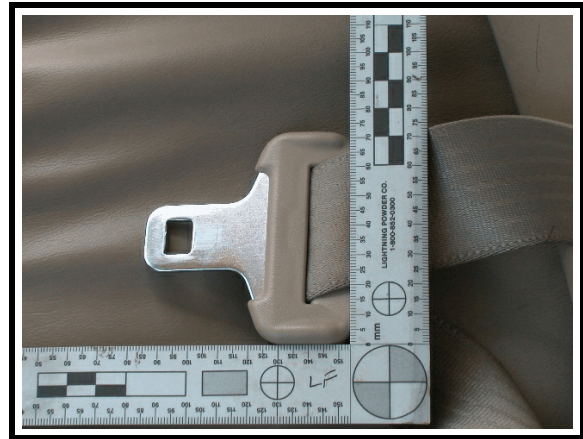
The 2005 Lexus RX330 was configured with manual 3-point lap and shoulder belts for each seating position. Both front safety belts were equipped with retractor pretensioners and adjustable shoulder belt anchorages that were in the full down position. The driver's seat belt was configured with a sliding latch plate and an Emergency Locking Retractor (ELR). At the time of the vehicle inspection, the driver's belt was extended in the used position as a result of the pretensioner actuation. The distance from the upper anchorage to the plastic stop button was 72.0 cm (28.3 in).

**Figure 5.** Driver's seat belt tang

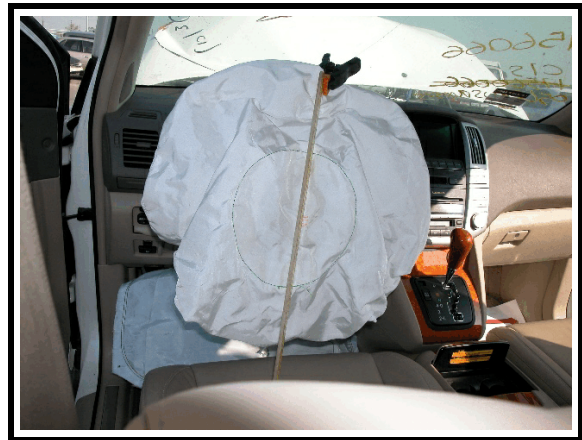
The driver's air bag deployed from the center of the steering wheel hub through Y configuration module cover flaps. The top flap measured 13.0 cm (5.1 in) wide by 8.0 cm (3.1 in) high. The bottom flaps measured 7.0 cm (2.8 in) wide at the top, 4.0 cm (1.6 in) wide at the bottom, and 6.0 cm (2.4 in) high. The deployed driver's air bag measured 58.0 cm (22.8 in) in diameter in its deflated state. The maximum deployed excursion was 33.0 cm (12.9 in). The distance from maximum excursion to the seat back was 30.0 cm (11.8 in). The air bag was tethered by a single internal tether. The tether was attached to a 21.0 cm (8.3 in) diameter circular stitch in the center of the air bag face. Two vertical vent ports were located at the 11 and 1 o'clock aspects of the rear of the air bag. The vent ports were 5.0 cm (1.9 in) high and were 16.0 cm (6.3 in) apart. There were faint specks across the bottom of the air bag face that may have been fabric transfers.

**Figure 6.** Driver's air bag

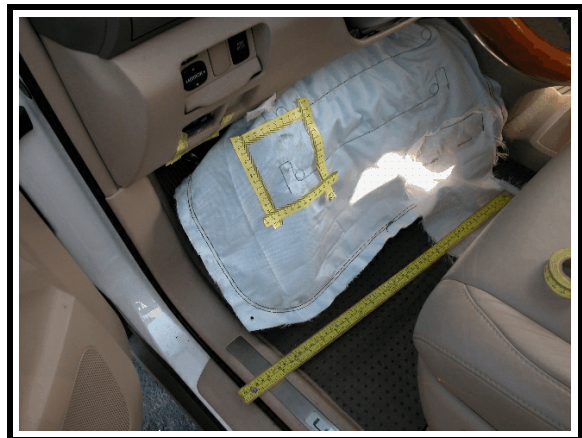
The driver's knee air bag deployed from bottom mount H configuration cover flaps. The top module cover flap measured 24.0 cm (9.4 in) wide by 4.0 cm (1.6 in) high. The bottom flap measured 24.0 cm (9.4 in) wide by 6.0 cm (2.4 in) high. The deployed air bag measured 55.0 cm (21.6 in) wide by 30.0 cm (11.8 in) high. There was a dark scuff on the left upper aspect of the top of the air bag. Its origin is not known.

**Figure 7.** Driver's knee air bag (top)

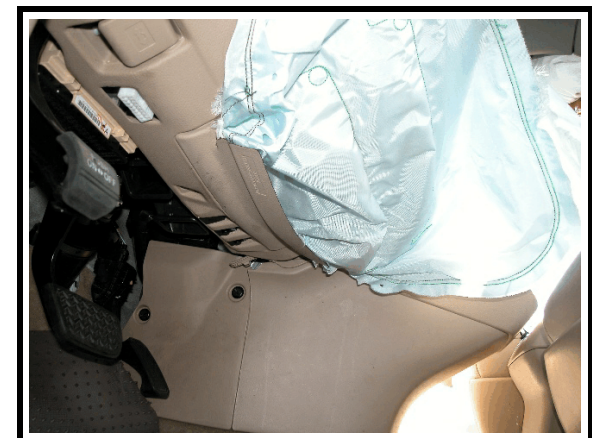
**Figure 8.** Driver's air bag (bottom)
