**CALSPAN ON-SITE CERTIFIED ADVANCED 208-COMPLIANT VEHICLE  
CRASH INVESTIGATION**

**CALSPAN CASE NO: CA05-027**

**VEHICLE: 2005 NISSAN ALTIMA**

**CRASH DATE: MARCH 2005**

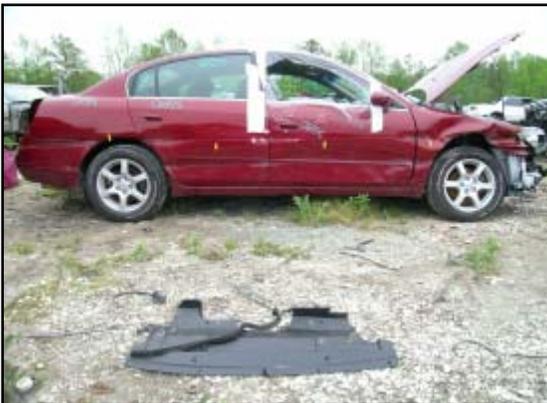
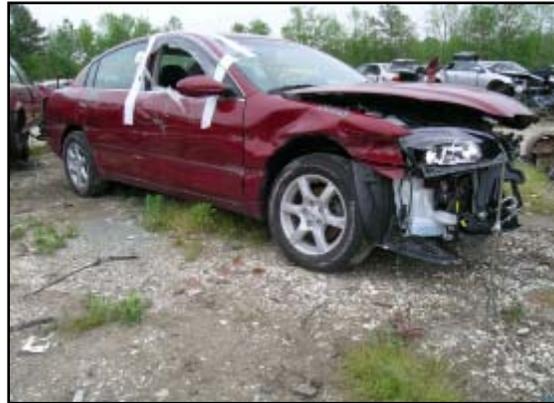
The 2005 Nissan Altima sustained minor severity damage to the front and right side planes from initial guardrail impact (**Figures 2 and 3**). At impact, the right bumper fascia fractured and separated from the vehicle. The bumper fascia was found fractured into four separate pieces at the time of the SCI inspection. The right corner of the fascia exhibited damage from contacting the pavement, which resulted in an abrasion pattern that overlapped the guardrail direct contact damage. Additionally, the bumper beam was removed from the vehicle. The frontal direct damage could not be determined due to the separation and removal of the frontal components. Therefore, the right side sideswipe damage was documented for this event. The direct contact damage began at the front right corner and extended 422 cm (166.5") rearward. The maximum crush measured 8 cm (3.3") and was located on the forward aspect of the right front fender. Six equidistant crush measurements were document at the mid-door level using a combined direct and induced damage length of 422 cm (166.5") and were as follows: C1 = 0 cm, C2 = 1 cm (0.5"), C3 = 2 cm (0.8"), C4 = 3 cm (1.3"), C5 = 3 cm (1.3"), C6 = 8 cm (3.3"). The Collision Deformation Classification (CDC) for this impact was 12-FRES-9.

**Figure 2. Right sideswipe damage from the initial guardrail impact.**

**Figure 3. Front right damage from the initial guardrail impact.**

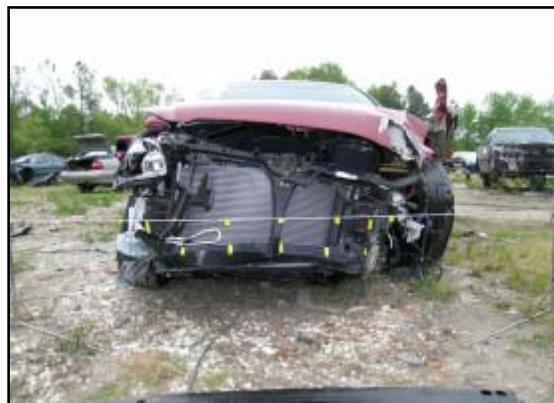
The vehicle sustained moderate damage to the front plane as result of the impact with the left side guardrail (**Figure 4**). The direct contact damage began 35 cm (12.0") left of the centerline and extended left 47 cm (18.5") to the left corner. The maximum crush was 12 cm (4.7") located at the left frame rail. Furthermore, the left wheel engaged the guardrail, which fractured the left front wheel and reduced the left wheelbase 15 cm (5.7"). A crush profile was documented across the lower radiator support using a combined direct and induced damage width of 94 cm (37.0")

**Figure 4. Frontal damage from the second guardrail impact.**

which was as follows: C1 = 12 cm (4.7"), C2 = 4 cm (1.6"), C3 = 0 cm, C4 = 0 cm, C5 = 0 cm, C6 = 3 cm (1.2"). The CDC from this impact was 01-FLEW-1.

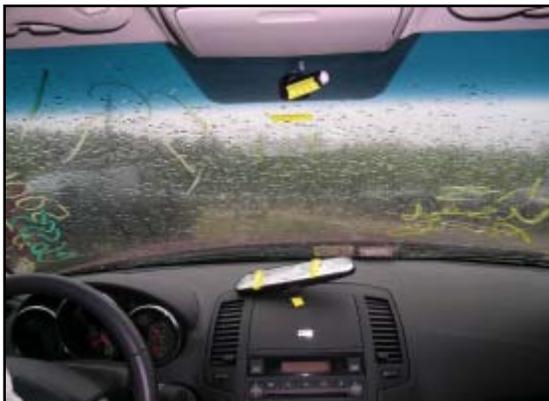
The 2005 Nissan Altima sustained minor interior damage as a result of the air bag deployment and occupant contact points. The driver's occupant contact points consisted of an oily transfer to the rear view mirror from contact with the driver's head (**Figure 5**). The stalk of the rear view mirror was deflected to the right. Additionally, the contact to the rear view mirror resulted in fractures to the center of the windshield at the mounting point for the mirror. The driver's right thigh contacted the center console, which dislodged the trim panel and displaced it to the right (**Figure 6**). The center console mounted emergency brake lever was deflected to the right approximately 2 cm (0.8") from contact with the driver's right hip.

**Figure 5. Rear view mirror contact point.**

The driver partially loaded the right side of the air bag as he continued forward. His head contacted the rear view mirror and deflected the mirror to the right and compressed the mirror against the laminated windshield. The windshield fractured from the mirror contact. A skin oil transfer was noted to the mirror glass.

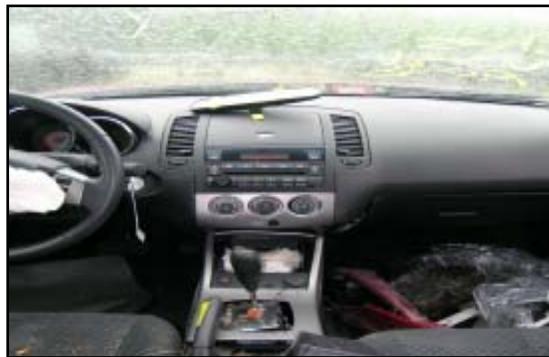
**Figure 6. Center console and emergency brake lever contact points.**

The unrestrained driver initiated a forward and lateral trajectory to his right as he responded to the 1 o'clock impact force. His right thigh and hip contacted the center console and emergency brake lever respectively. Although he was not injured by this contact sequence, his loading deflected these components to the right.

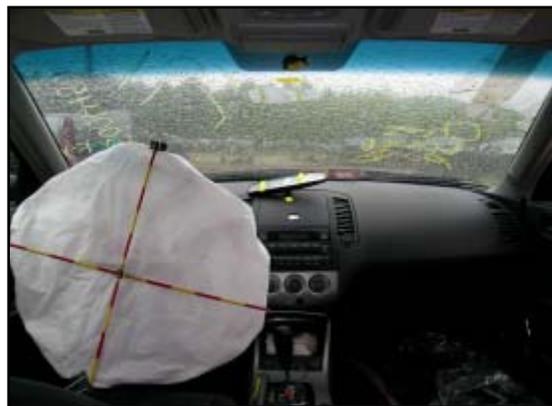
In the subject crash, the driver's frontal air bag deployed. The driver's air bag was conventionally located in the center of the steering wheel hub (**Figure 7**). Two cover flaps concealed the air bag. The upper and lower cover flaps measured 13 cm (5.3") in width at the tear seam. The upper cover flap measured 5 cm (1.8") in height and the lower flap measured 9 cm (3.4") in height. The air bag membrane was 53 cm (21.0") in diameter in its deflated state. Two 3 cm

**Figure 7. Deployed driver's frontal air bag.**

(1.0”) diameter vent ports that were surrounded by 8 cm (3.0”) stitch patterns were located on the rear aspect of the air bag at the 10 and 2 o’clock positions. The air bag was tethered by four 7 cm (2.8”) wide tethers at the 12 and 6 o’clock positions and the 9 and 3 o’clock positions. There were no occupant contact points present on the air bag membrane.

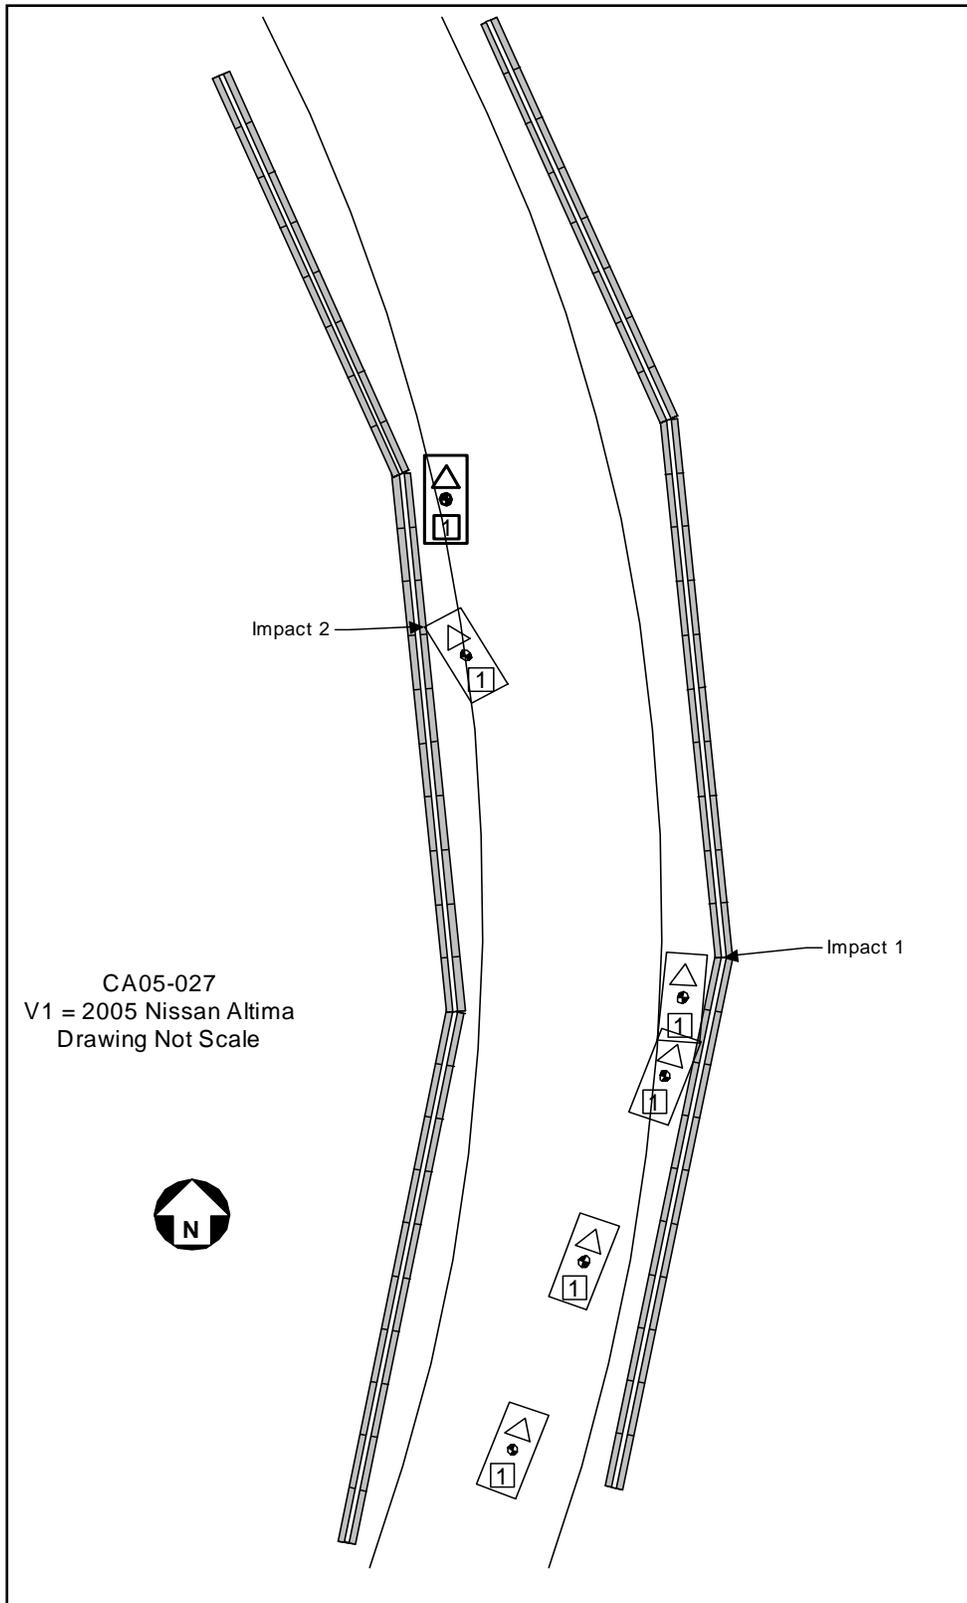
**Figure 10. Scene schematic**

This run-off crash occurred during the nighttime hours of March 2005. At the time of the crash, the weather was clear and the roadway was dry. The crash occurred on a single lane on-ramp to an east/west interstate. The ramp curved left as it approached the interstate and was bordered by W-beam guardrail longitudinal barriers. At the time of the investigation, the Police Accident Report was not available. Therefore, the crash site was not inspected during this on-site investigation. A scene schematic that was derived from the police report is included as **Figure 10** of this report.
