TRANSPORTATION RESEARCH CENTER

ON-SITE CERTIFIED ADVANCED 208- COMPLIANT VEHICLE INVESTIGATION

CASE NUMBER - IN-05-028
LOCATION - MICHIGAN
VEHICLE - 2003 CHEVROLET SUBURBAN
CRASH DATE - July 2005

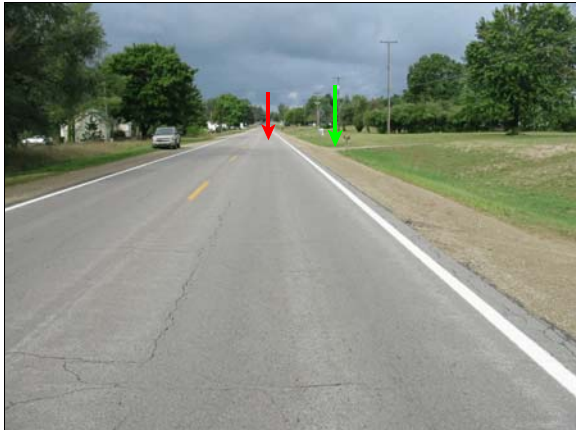
Pre-Crash: The case vehicle was traveling west in the westbound lane (**Figure 1** below), and the driver was intending to continue straight ahead. The EDR data indicated that the case vehicle's travel speed just prior to the crash was 97 km.p.h. (60 m.p.h.). The Silverado was traveling east

Figure 1: Approach of case vehicle westbound to impact, red arrow shows impact area, green arrow shows driveway Silverado was turning into

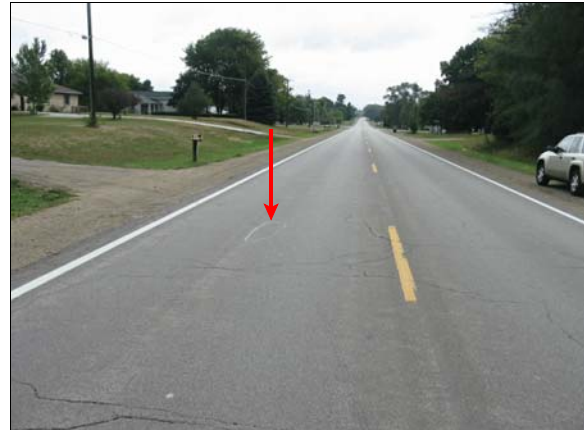
in the eastbound lane (**Figure 2**) and was in the process of turning left into a private driveway. The crash occurred in the westbound lane of the roadway.

Figure 2: Approach of V2 eastbound turning left into driveway, arrow shows impact gouge

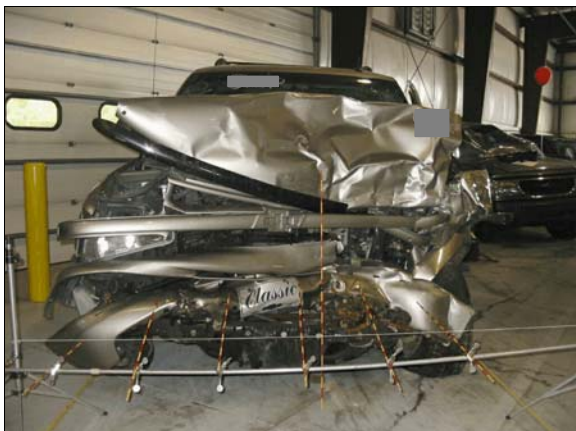
Figure 3: Damage to front of case vehicle from impact with front of Silverado, each increment on rods is 5 cm (2 in)

Crash: The front of the case vehicle (**Figure 3**) impacted the front of the Silverado causing both stages of the case vehicle's driver air bag to deploy. The case vehicle's front right air bag did not deploy because there was no passenger seated in the front right seat. The case vehicle's front right occupant detection system properly determined the absence of an occupant and suppressed deployment of the front right air bag. The impact caused the case vehicle to rotate clockwise and the Silverado rotated counterclockwise. The damage to the case vehicle's left front door indicated that the Silverado's front right bumper corner then impacted the case vehicle's left front door (**Figure 4**).

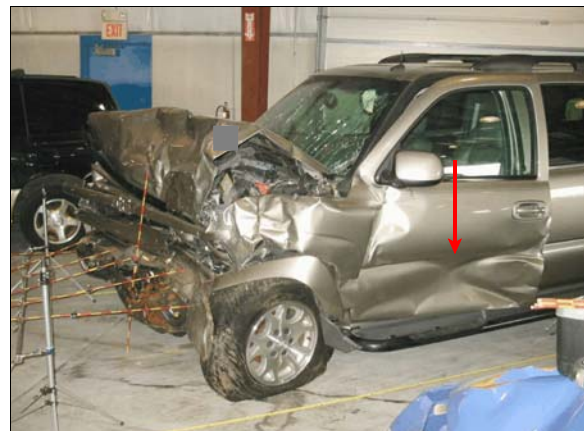
Figure 4: Overview of damage to left front door from impact with front right bumper corner of Silverado

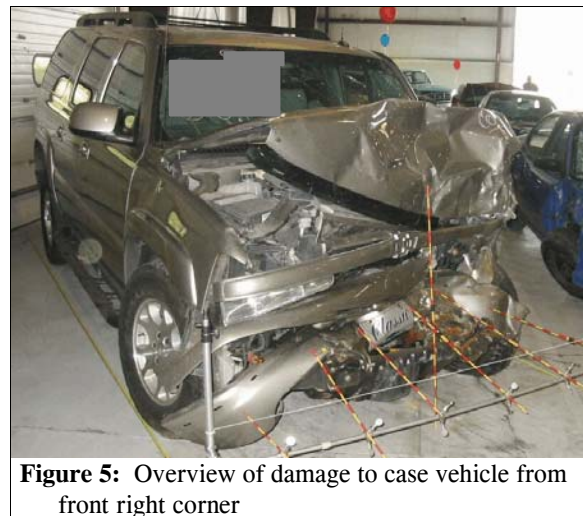
Exterior Damage: The case vehicle's initial impact with the Silverado involved approximately two thirds of the frontal plane (**Figure 5**). The case vehicle's front bumper, bumper fascia, grille, radiator, left fender, left turn lamp and headlamp assemblies and hood were directly damaged and crushed rearward. Direct damage began at the left front bumper corner and extended 122 centimeters (48 inches), along the front bumper. Residual maximum crush was measured as 68 centimeters

Figure 5: Overview of damage to case vehicle from front right corner

(26.8 inches) occurring at C₂. The secondary impact with the front bumper of the Silverado involved the case vehicle’s left front door. The direct damage involved the lower center portion of the left front door. The left front door sheet metal was crushed inward and the door buckled. The table below shows the case vehicle’s front crush profile.

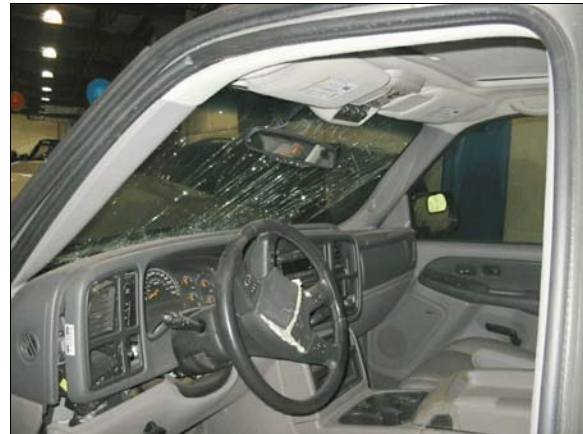
Vehicle Interior: Inspection of the case vehicle’s interior (**Figure 6** and **Figure 7** below) revealed evidence of occupant contact on the left windshield , left “A”-pillar, driver’s knee bolster, and the ignition key was bent forward. Two intrusions were documented to the driver’s occupant space. The toe pan intruded longitudinally 4 centimeters (1.6 inches) and the front left instrument panel cover was dislodged and intruded longitudinally 3 centimeters (1.2 inches). There was no deformation of the steering wheel rim (**Figure 8** below), but the entire steering wheel was tilted forward slightly at the top and the energy absorbing steering column appeared to be slightly compressed.

Figure 6: Overview of steering wheel, windshield and instrument panel

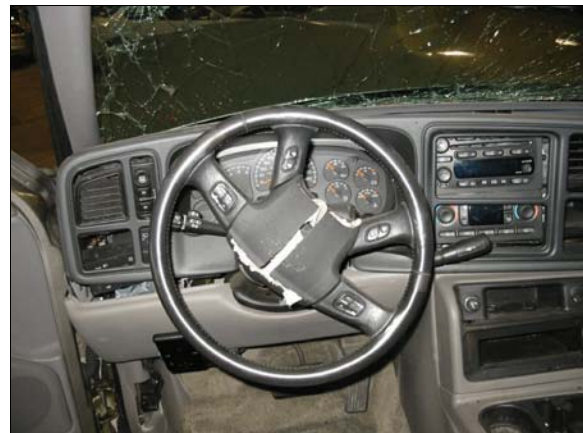
Figure 7: Case vehicle's steering wheel and left and center instrument panel and windshield

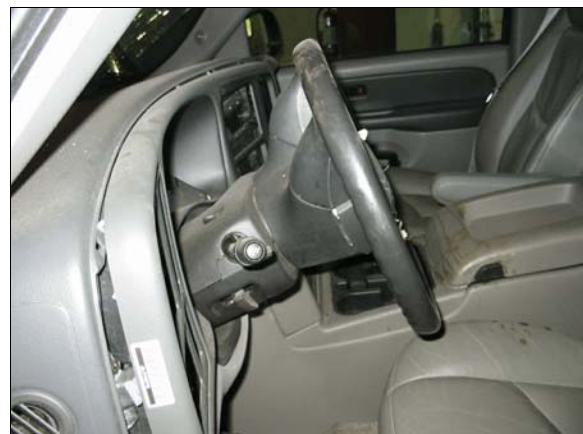
Figure 8: Left side view of steering wheel and steering column

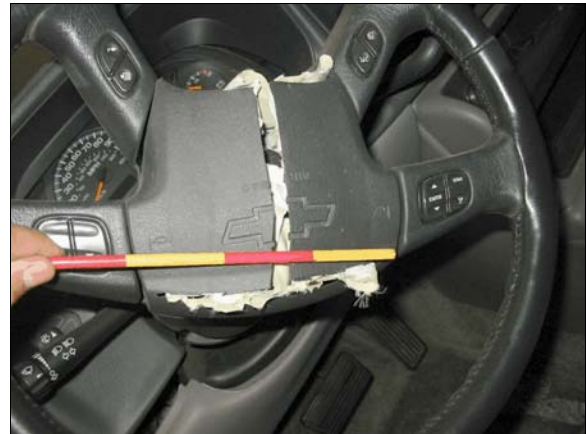
The case vehicle's driver air bag was located in the steering wheel hub. Prior to this contractor's inspection, the air bag had been cut from the air bag module. From what was left, it could be determined that the cover flaps opened at the designated tear points (**Figure 9** below), and there was no evidence of damage during the deployment to the cover flaps. The module cover consisted of symmetrical "I"-configuration cover flaps made of pliable vinyl. Each cover flap was 7 centimeters (2.8 inches) in width at the top and 5 centimeters (2 inches) in width at the bottom. In addition, each flap was 11 centimeters (4.3 inches) in height as measured along the center, vertical tear seam. Due to the removal of the air bag's fabric no information regarding the air bag or the vent ports could be obtained. However, it was determined that there were two tethers, each measuring 9 centimeters (3.5 inches) in width. It is unknown if there was any damage to the air bag's fabric. However, the driver was unrestrained and his kinematics indicate that he impacted the air bag during the crash.

Figure 9: Driver's air bag module flaps, steering wheel is rotated counterclockwise approximately 140 degrees

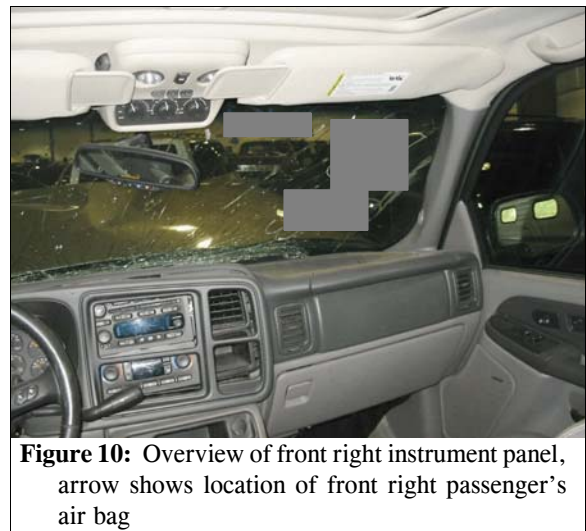
The front right air bag was located in the middle of the instrument panel (**Figure 10** below) and did not deploy as a result of this crash. The case vehicle's front right occupant detection system properly determined the absence of an occupant and suppressed deployment of the front right air bag.

Figure 10: Overview of front right instrument panel, arrow shows location of front right passenger's air bag

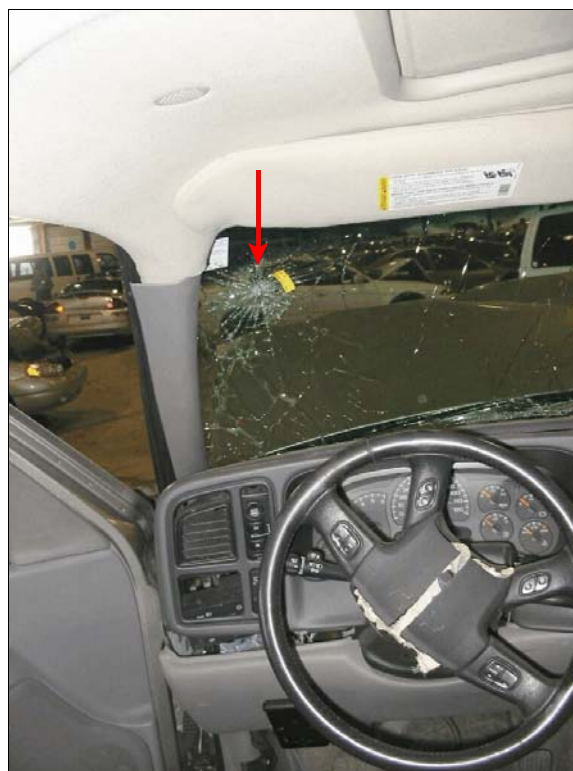
Based on this contractor's vehicle inspection and supported by the EDR data, the case vehicle's driver was not using his integrated, three-point, lap-and-shoulder safety belt system. Inspection of the seat belt assembly showed no evidence of loading. In addition, the vehicle inspection showed that the driver impacted his head on the windshield adjacent to the left "A"-pillar (**Figure 11**).

Figure 11: Overview of driver contacts to windshield (arrow), left "A"-pillar and knee bolster

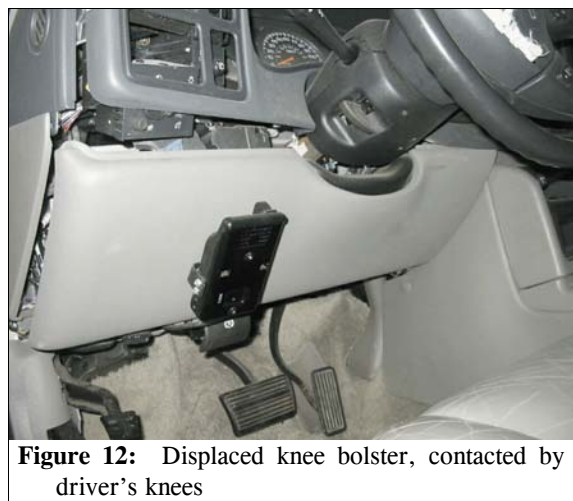
Figure 12: Displaced knee bolster, contacted by driver's knees

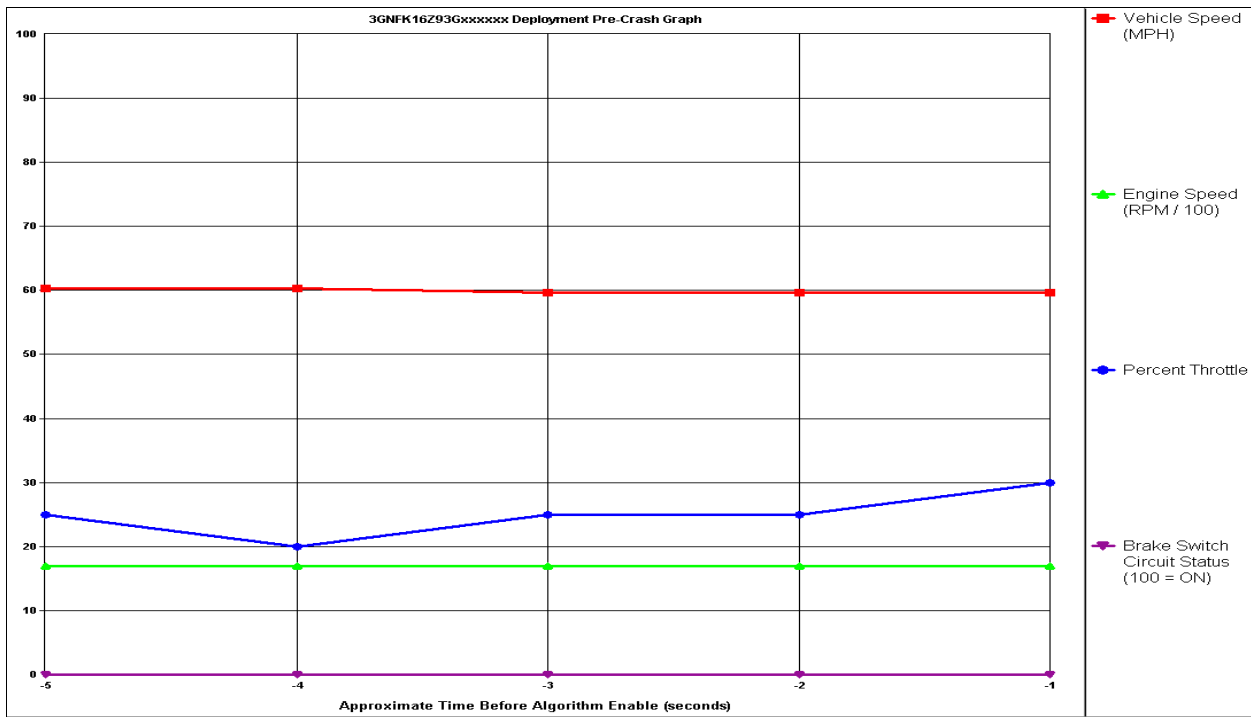
Figure 16: Case vehicle's Deployment Pre-Crash Graph

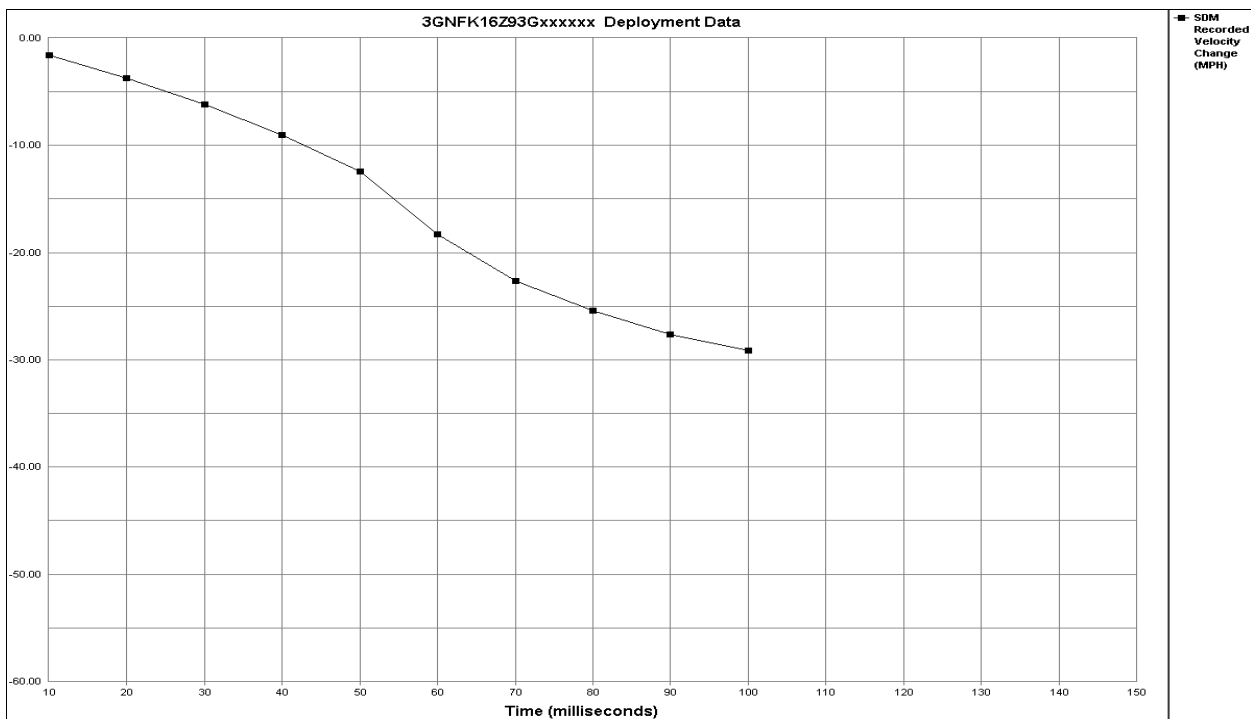
Figure 17: Case vehicle's deployment SDM Recorded Velocity Change graph

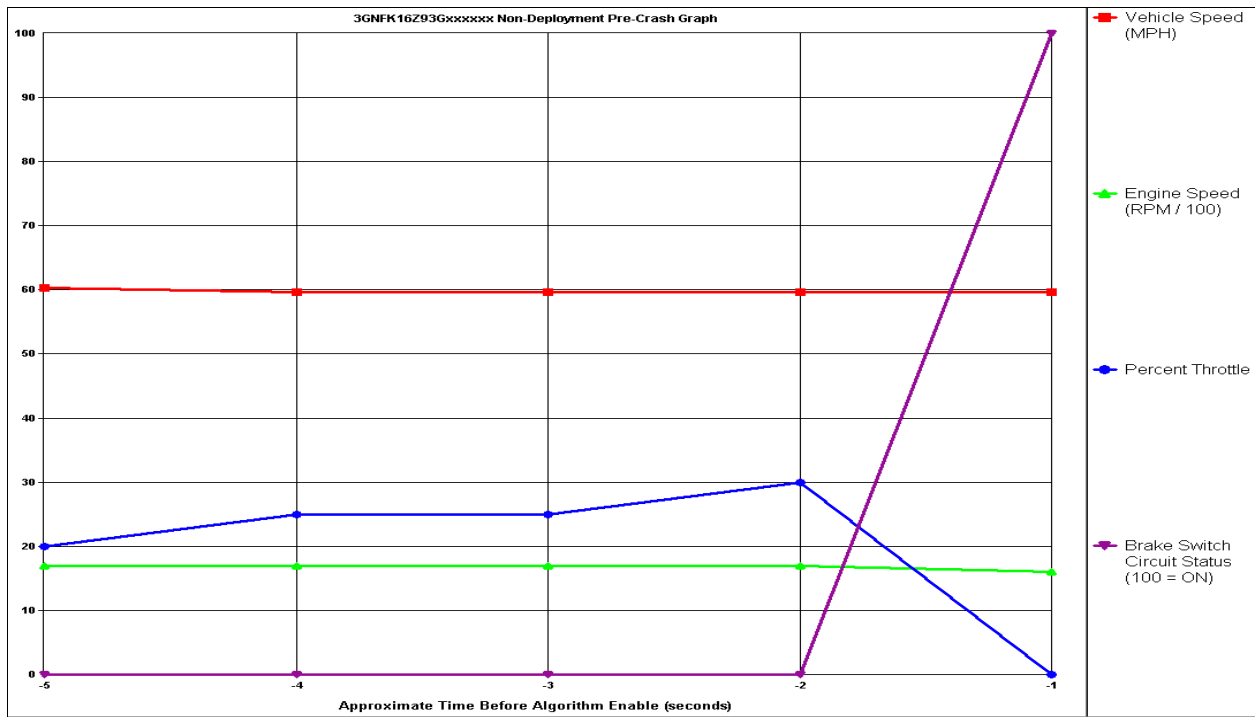
Figure 19: Case vehicle's Non-Deployment Pre-Crash Graph

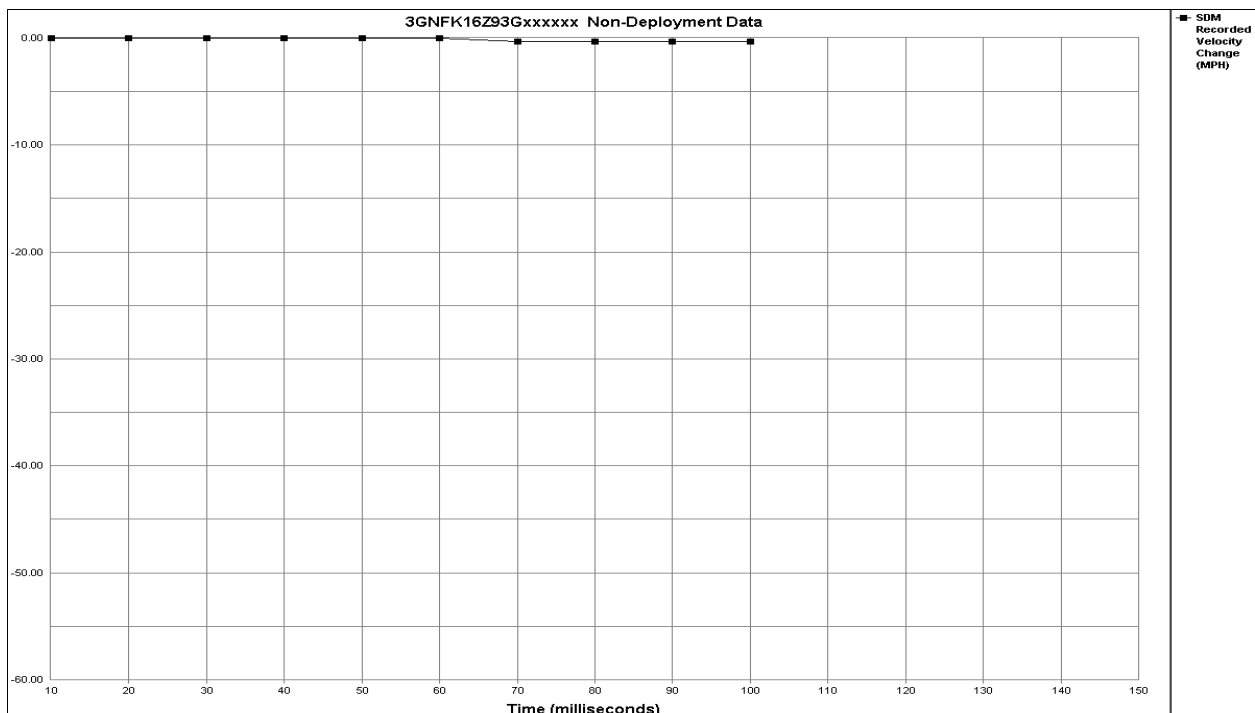
Figure 20: Case vehicle's non-deployment SDM Recorded Velocity Change graph
