**CALSPAN ON-SITE ADULT AIR BAG RELATED FATALITY CRASH
INVESTIGATION**

CASE NO: CA05-029

VEHICLE: 2003 HONDA CIVIC LX

CRASH DATE: MAY 2005

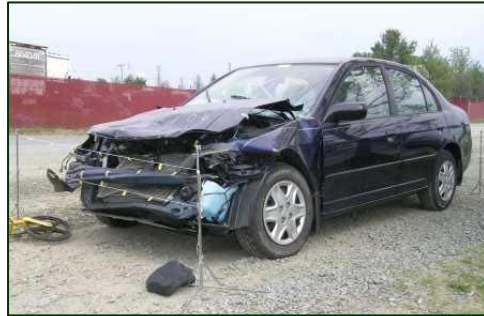
This on-site investigation focused on the severity of the crash and the source of injury that contributed to the death of a 70-year old female driver of a 2003 Honda Civic. The Honda was equipped with dual stage frontal air bags and buckle pretensioners for the driver and front right positions. The driver of the Civic was apparently distracted and failed to detect a stopped 1984 Ford E-350 van-based motor home that was stopped ahead of the Civic's path of travel. The full frontal area of the Civic (**Figure 1**) impacted and partially underrode the rear of the motor

Figure 1. Frontal damage to the 2003 Honda Civic.

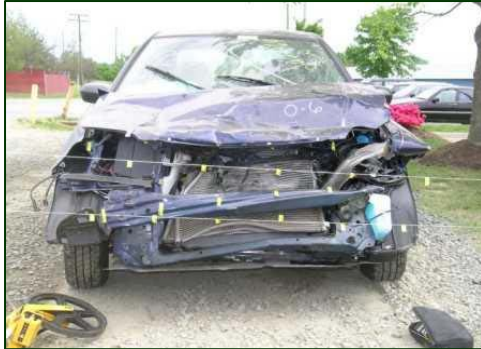
The frontal area of the Honda Civic impacted and partially underrode the rear bumper of the struck motor home. The front bumper fascia was separated from the vehicle and abraded by the road surface; therefore the direct contact damage was documented across the level of the hood face and fenders (**Figure 3**). The damage was full width to the vehicle and measured 144 cm (56.5"). The bumper beam was crushed rearward and displaced upward due to the vertical component of the underride. The upper radiator support also displayed measurable crush which was documented for this investigation. The crush profiles at these levels were as follows (**Figure 4**): Bumper Beam – C1 = 30 cm (11.6"), C2 = 29 cm (11.5"), C3 = 26 cm (10.3"), C4 = 19 cm (7.3"), C5 = 10 cm

(3.8”), C6 = 0 cm; Upper Radiator Support – C1 = 14 cm (5.6”), C2 = 22 cm (8.6”), C3 = 29 cm (11.5”) , C4 = 27 cm (10.6”), C5 = 12 cm (4.75”), C6 = 2 cm (0.9”). The bumper beam crush profile was used for the WINSMASH reconstruction of the vehicle’s delta V. The Collision Deformation Classification (CDC) for this event was 12-FDEW-2.

Figure 3. Frontal damage to the 2003 Honda Civic.

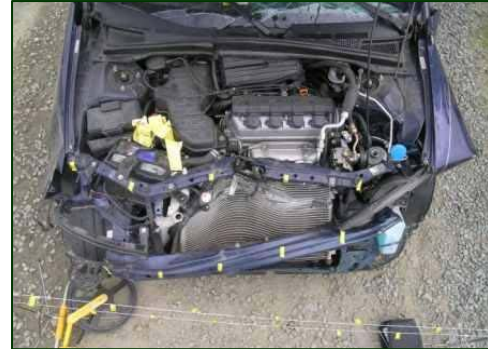
Figure 4. Overhead view of the crush depth at both levels.

A protruding component of the motor home, probably a trailer hitch, penetrated the air conditioning condenser and the radiator of the Civic. These components were not structural; therefore the crush at this level was excluded from the crush profiles.

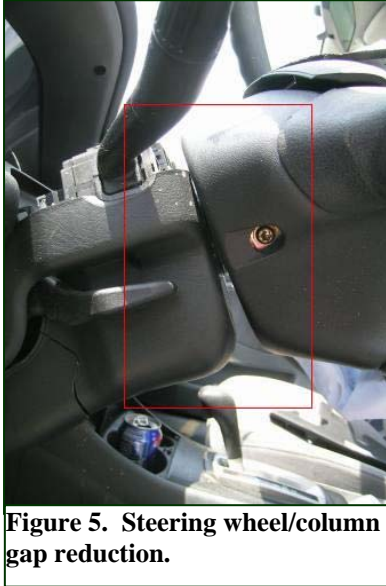
Due to the driver’s presumed forward seat track position, the driver loaded through the deployed driver’s air bag deforming the steering wheel and mounting flange. The gap between the wheel hub and the steering column was closed at the top surface and opened to 1 cm (0.5”) at the bottom (**Figure 5**). The upper steering wheel rim was deformed forward 1 cm (0.4”) at the 12 o’clock sector.

Figure 5. Steering wheel/column gap reduction.

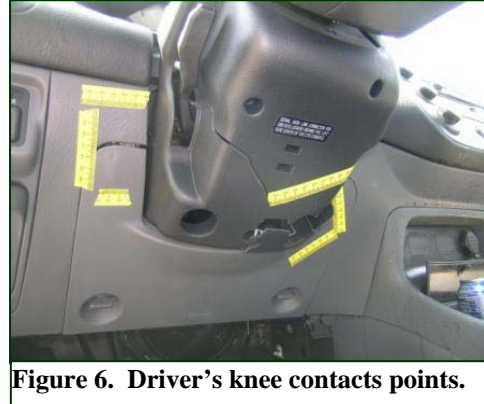
The driver’s left knee contacted the left upper corner area of the bolster panel adjacent to the steering column. This contact scuffed the rigid bolster panel and the mid left

instrument panel 44-48 cm (17.5-19”) left of the vehicle centerline and 29-34 cm (11.5-13.5”) below the upper instrument panel. Her right knee impacted and fractured the steering column cover. The fracture was located 20-33 cm (8-13”) left of center and 28-34 cm (11-13.5”) below the top instrument panel. **Figure 6** depicts both knee contact points.

Figure 6. Driver's knee contacts points.

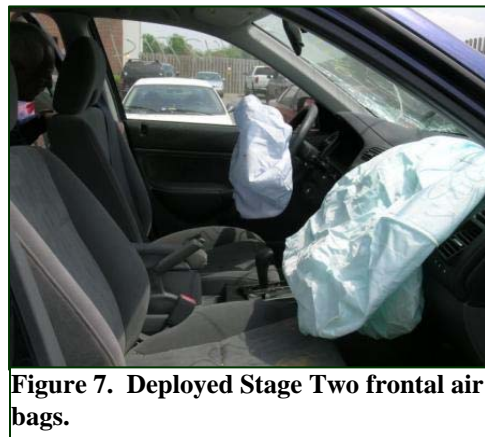
The Honda was equipped with dual-stage frontal air bags for the driver and front right passenger positions. In addition, the Honda was equipped with buckle pretensioners for the front occupant positions. As a result of this front-to-rear crash, the air bags deployed (**Figure 7**) and the driver's pretensioner actuated. The front right seat was unoccupied; therefore the belt system was not engaged to close the buckle switch required to fire the pretensioner.

Figure 7. Deployed Stage Two frontal air bags.

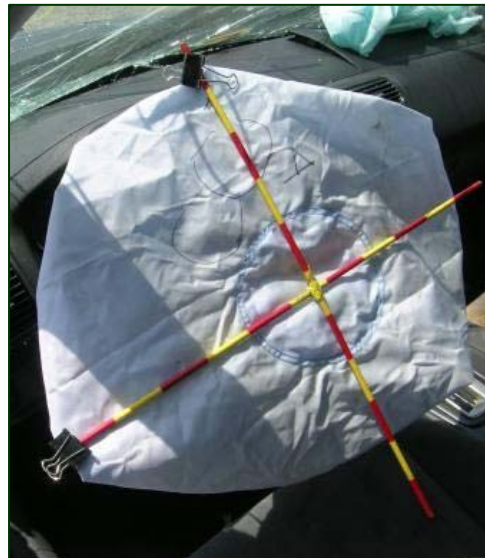
There were several areas on the driver's air bag that contained probable tissue and or body fluid transfers (**Figure 8**). It should be noted that this SCI investigator was the second or third person to examine this air bag. Due to the multiple handling of the air bag, these subtle transfers dislodged from the membrane. Markings on the bag by another investigator identified the locations of these transfers.

Figure 8. Circled areas of suspected transfers on the driver's air bag.

The first area of suspected transfer was located 13 cm (5") above the horizontal centerline and 1 cm (0.5") right of center, extending 3 cm (1") left of center. The second area, which also contained dirt from post-crash handling, was located 8-11 cm (3.25-4.25") above the centerline and 5-8 cm (2-3") left of the vertical centerline. Both transfers were located on the upper left quadrant of the air bag. There was no damage or tears of the bag from the deployment sequence.

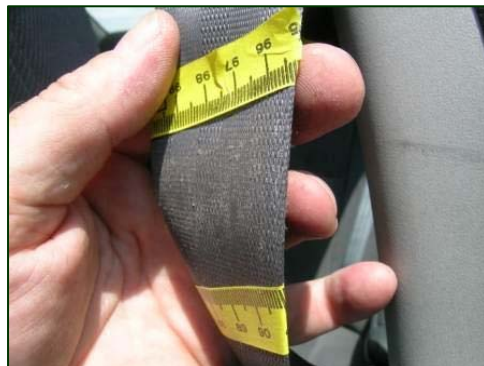
The driver loaded the manual safety belt system in response to the frontal crash forces. Her loading was exhibited by a frictional latch plate transfer on the webbing that was located 104 cm (41") above the floor anchor point. The transfer was 5 cm (1.8") in width. A 4 cm (1.75") diagonally orientated frictional abrasion was noted to the shoulder belt webbing from loading against the D-ring (**Figure 9**). This transfer began 177 cm (69.5") above the referenced anchor point. A third transfer was located on the inside surface of the webbing (side against driver). This transfer appeared to be a subtle fabric transfer from the driver's clothing and located in the vicinity of her left shoulder area. The transfer was located 179-185 cm (70.5-72.75") above the anchor point.

Figure 9. Driver's D-ring transfer.

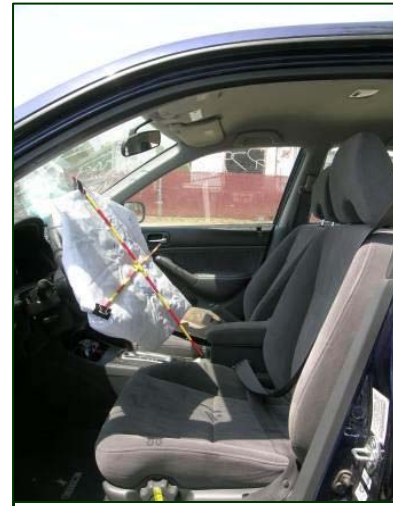
The 70-year old female driver of the Honda Civic was seated in a presumed forward track position based on her demographics. Family members noted that due to her short stature, the driver sat on a pillow in close proximity to the steering wheel rim and the air bag module. She was restrained by the manual 3-point lap and shoulder belt system with the belt positioned over her left shoulder. Belt usage was confirmed by loading evidence at the hard points of the system and a fabric transfer on the webbing in the area of the right shoulder. Prior to impact, the driver braked in an attempt to avoid the crash. **Figure 10** is a lateral view of the driver's position and her forward trajectory. It should be noted that the seat track was moved to the full rear position prior to the SCI investigation. In this figure, the seat track was arbitrarily positioned 8 cm (3") forward of the full rear position.

Figure 10. Lateral view of the driver's position and trajectory.
