**CALSPAN ON-SITE CHILD SAFETY SEAT
VEHICLE CRASH INVESTIGATION**

CASE NO: CA05-030

VEHICLE: 2004 CHEVROLET COLORADO PICKUP TRUCK

CRASH DATE: DECEMBER 2004

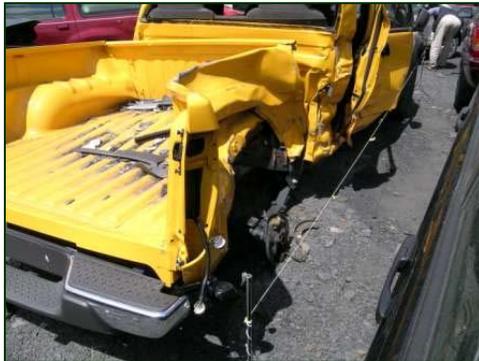
The 2004 Chevrolet Colorado sustained severe right side damage (**Figure 3**) as a result of the impact with the Ford cargo van. Maximum crush was measured at 70 cm (27.5”) located at the mid point of the cargo bed. The direct contact damage began on the right front door 153 cm (60.25”) aft of the right front axle and extended 213 cm (84”) onto the cargo bed, terminating 23 cm (9”) aft of the lower wheel opening. The combined induced and direct contact damage began 55 cm (21.75”) rearward of the right front axle and extended 364 cm (143.25”) to the rear bumper corner. The crush profile (**Figure 4**) was measured at six equidistant points along this damage length. The crush values at the level of the vehicle’s rub strip were as follows: C1 = 26 cm (10.25”), C2 = 67 cm (26.4”), C3 = 58 cm (23”), C4 = 34 cm (13.25”), C5 = 7 cm (2.75”), C6 = 0 cm. The Collision Deformation Classification (CDC) for this impact event was 02-RZEW-4.

Figure 3. Right side damage to the Colorado.

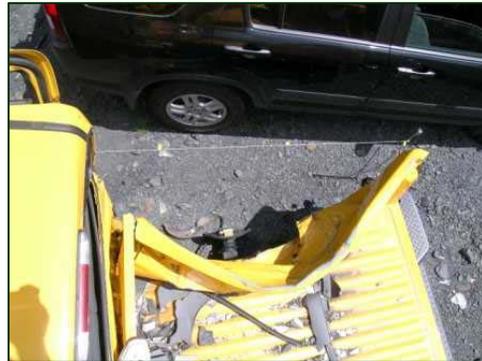
Figure 4. Overhead view of the crush profile.

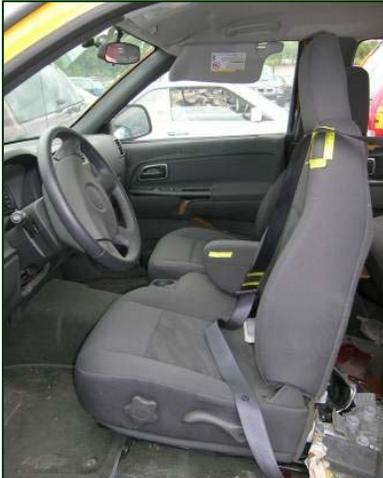
The driver loaded the manual safety belt system with her pelvic region and left arm as she slid out of the shoulder belt and snagged the belt webbing with her left forearm. Loading evidence consisted of frictional abrasions at the latch plate and belt webbing. An additional abrasion/scuff was noted to the upper outboard aspect of the left seat back. The driver contacted and deformed the center armrest 5 cm (2”) to the right as she responded to the lateral crash forces. Her head impacted and fractured the right door panel at the area of the integral armrest. A horizontally oriented fracture of the upper door panel resulted from the exterior deformation of the door. The driver’s seat rotated in a clockwise direction as a result of the crash forces. The rear positioned RFCSS impacted the seat back; however, this engagement did not deform the front seat. **Figure 5** is a lateral view of the driver’s contact points.

Figure 5. Lateral view of the driver's trajectory and contact points.

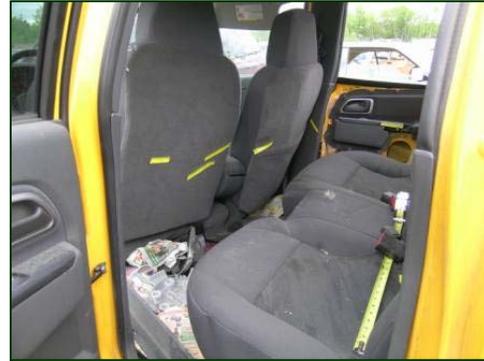
The RFCSS impacted and scuffed the rear aspects of the front seat backs. Laterally orientated scuff marks were present on both seat backs. The infant passenger was ejected from the RFCSS and impacted the right rear door panel. This occupant contact fractured the mid portion of the plastic panel at the area of the armrest. The lower panel was fractured from the exterior deformation and resulting intrusion. This damage is depicted in **Figure 6**.

Figure 6. Lateral view of the rear seat area damage and intrusion.

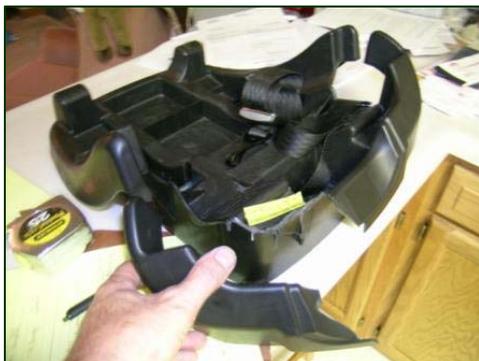
Base Unit – The base unit was fractured at the left side of the LATCH belt path (**Figure 7**). The fracture line extended 15 cm (6") along the back side of the base and 8 cm (3") on the left side. This separated the corner of the base and the back side of the LATCH belt path loop (**Figure 8**). A second fracture line extended 5 cm (2") vertically down the center rear aspect of the base and continued 7 cm (2.8") onto the bottom aspect toward the left.

Figure 7. Fractured base at LATCH belt path.

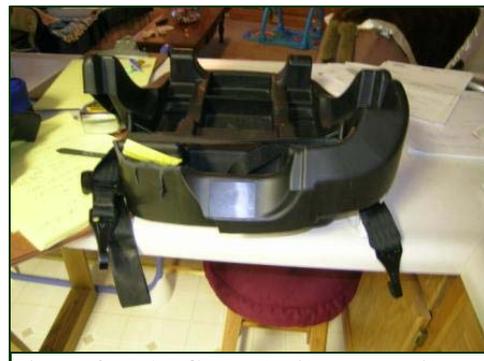
Figure 8. LATCH belt with base unit.

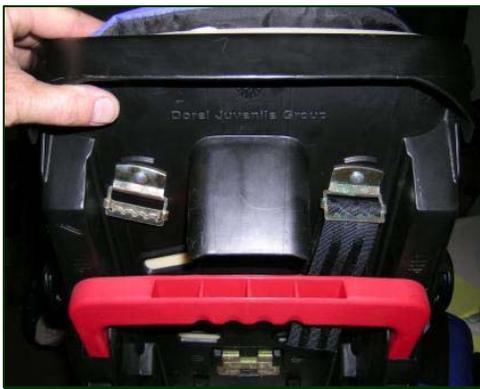
Harness System – The harness straps were not damaged. It was reported that the left (on child) or inboard harness strap (referenced with RFCSS installed in vehicle) separated from the adjustment buckle prior to, or during the crash event. This adjustment buckle (**Figure 9**) did not firmly secure the harness strap in its adjusted position. The saw-tooth locking bar (**Figure 10**) floated which would allow the belt to loosen and/or disengage during vibration associated with vehicle travel, or possibly a crash. This was the scope of the recall campaign for this seat. The term applied to it was “webbing creep”.

Figure 9. Harness adjustment buckles.

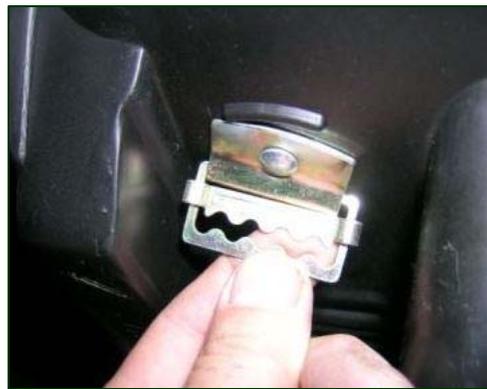
Figure 10. Close-up view of the buckle and saw-tooth locking bar.

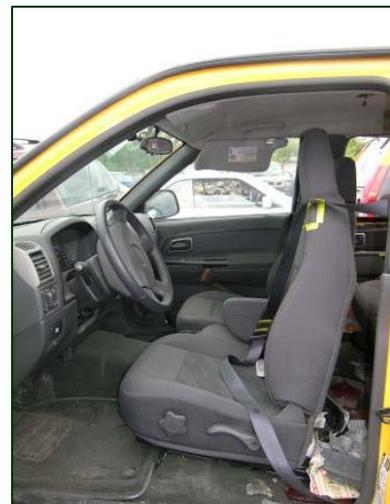
As the driver continued laterally (**Figure 11**), her left forearm snagged the shoulder belt webbing, resulting in comminuted fractures of the left radius and ulna. This

Figure 11. Driver’s trajectory and contact points.

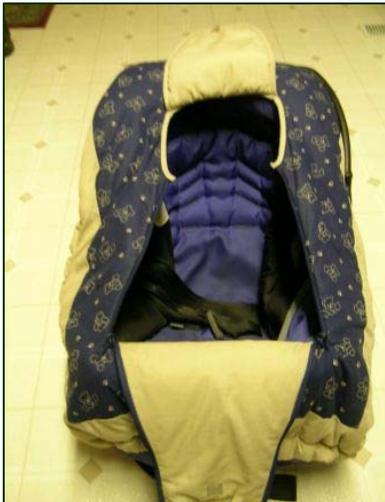
Figure 12. Bunting placed over RFCSS.

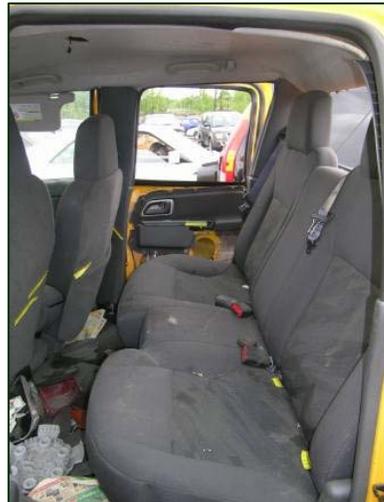
Figure 13. Trajectory of the infant and contact damage to the right rear door panel.

The inboard safety seat harness strap separated from the adjustment buckle, which resulted in a complete ejection of the infant as he responded laterally across the interior of the vehicle. Based on the rotation of the RFCSS, the infant probably rolled to his left as he was ejected from the safety seat. The infant's head impacted and fractured the rear right door panel at the mid point of the armrest (**Figure 13**). Door panel damage was a combination of exterior deformation and infant contact. As a result of this contact, the infant sustained bilateral parietal skull fractures, a left parietal scalp contusion, a left intraparenchymal contusion, left parietal subarachnoid hemorrhage, left intraventricular hemorrhage, and a right subdural hematoma.
