Redesigned Air Bag Special Study/ Vehicle to Object
Dynamic Science, Inc. / Case Number: DS05030
2000 Isuzu Hombre
Colorado
November 2005

1. Report No. DS05030	2. Government Accession No.	3. Recipient Catalog No.	
4. Title and Subtitle Redesigned Air Bag Special Study Investigation		5. Report Date June 26, 2006

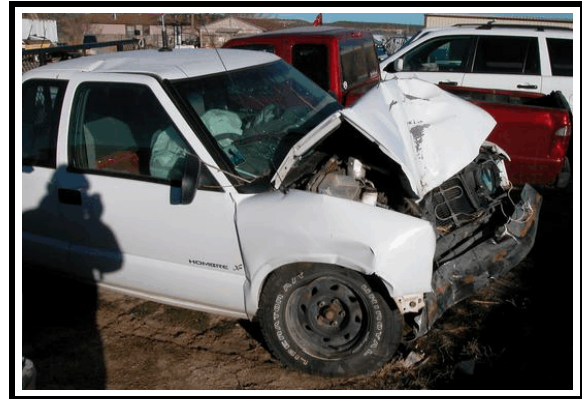
Figure 1. Front right, 2000 Isuzu Hombre

This on site investigation focused on the driver air bag installed in a 2000 Isuzu Hombre pickup (Figures 1-2). The Isuzu pickup was being driven by an unrestrained 47-year-old male. The case vehicle was traveling at a police reported speed of 64 km/h (40 mph). The driver apparently drove off the roadway and traveled approximately 37.0 m (120 ft) before striking a tree that was approximately 3 m (10 ft) off the side of the road. There were no indications that any other vehicles were involved or that the driver took evasive actions. The driver's air bag deployed during the crash. The driver sustained a neck fracture and a ruptured aorta. It appears that the crash went unreported for at least an hour. Once found, the driver was transported to a local hospital at 0215 hours and declared dead at 0316 hours.

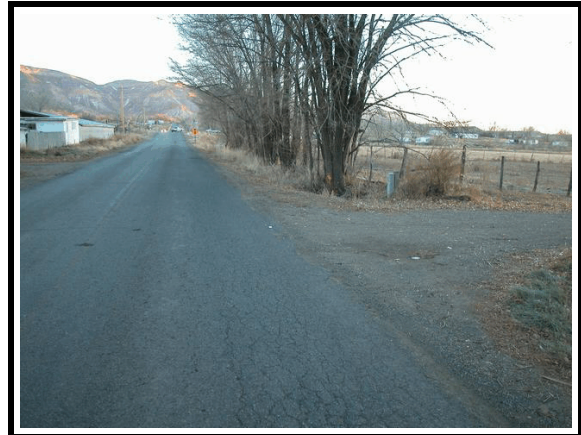
Figure 3. Approach to impact with tree (south)

The 2000 Isuzu Hombre was traveling southbound at an unknown speed (**Figure 3**). The 47-year-old male driver was not wearing the available 3-point manual lap and shoulder belt. The front right passenger air bag cut off switch was in the ON position.

The driver drove off the roadway and traveled approximately 37.0 m (120 ft). There were no indications that any other vehicles were involved or that the driver took any evasive actions.

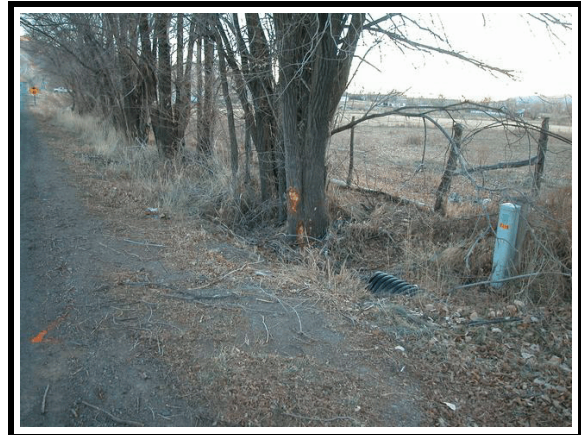
Figure 4. Impact with tree (south)

The vehicle continued down the right side of the roadway before striking a tree that was approximately 3 m (10 ft) off the side of the road (**Figure 4**). Both front air bags deployed at this point. The barrier routine of the WinSmash program computed a total delta V of 44.0 km/h (27.3 mph) based on the Isuzu's frontal crush profile. The longitudinal and lateral components were -44.0 km/h (-27.3 mph) and 0 km/h (0 mph), respectively.

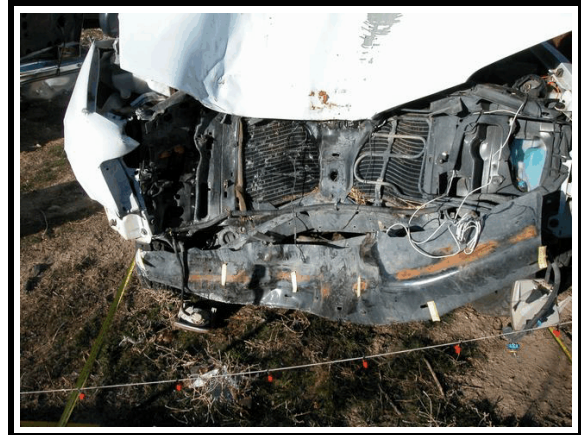
Figure 5. Front bumper, Isuzu Hombre

Damage Description: Sustained moderate front end damage as a result of the impact with the tree (**Figure 5**). The direct damage began 16 cm (6.3 in) from the right front bumper corner and measured 60 cm (23.6 in) laterally along the bumper. The combined direct and induced damage began at the left front bumper corner and measured 109 cm (42.9 in) laterally across the entire front end. The right wheelbase was reduced by 5 cm (1.9 in). The front right tire was restricted. The hood and right fender were deformed. There was remote buckling on the roof at the right B pillar.

CDC:	12FZEW3	
Delta V:	Total	44.0 km/h (27.3 mph)
	Longitudinal	-44.0 km/h (-27.3 mph)
	Latitudinal	0 km/h (0 mph)
	Energy	110,738 joules (81,676 ft-lbs)

Six crush measurements were documented at the bumper level as follows: C1 = 0cm, C2 = 5 cm (1.9 in), C3 = 24 cm (9.4 in), C4 = 57 cm (22.4 in), C5 = 51 cm (20.0 in), C6 = 37 cm (14.6 in).

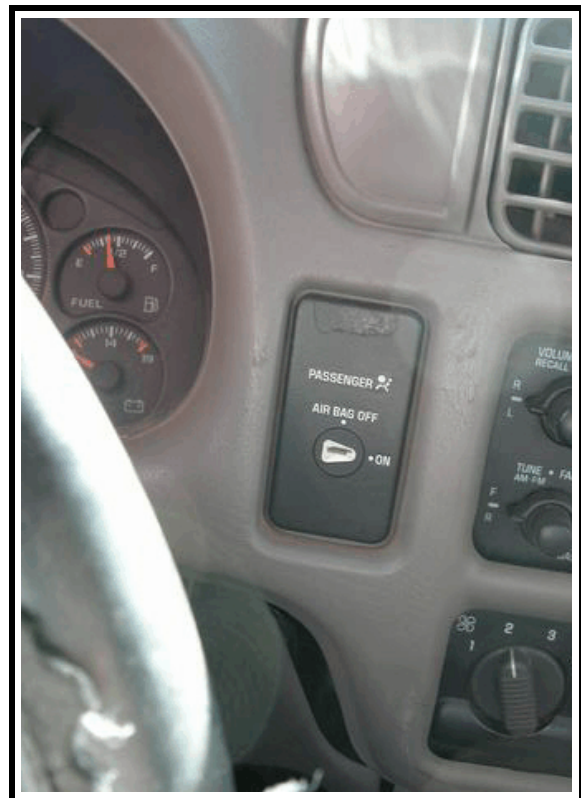
Figure 6. Passenger Air Bag Switch

The 2000 Isuzu Hombre was equipped with redesigned frontal air bags for the driver and front right passenger positions. The passenger air bag switch was in the "ON" position prior to impact (**Figure 6**). Both frontal air bags deployed as a result of the longitudinal deceleration of the Isuzu during the impact with the tree.

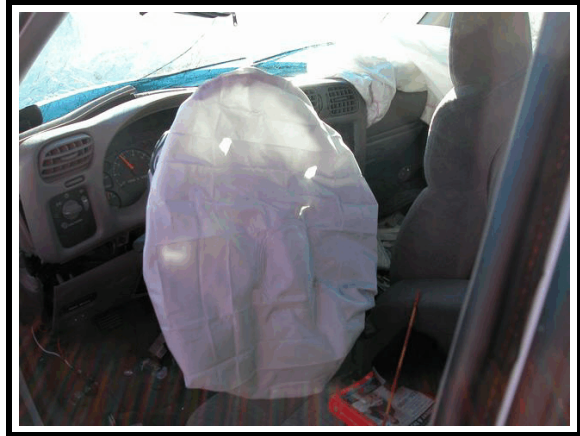
Figure 7. Driver's air bag

The driver's air bag deployed from the center of the steering wheel hub through symmetrical I-configuration module cover flaps (**Figure 7**). Each flap measured 11 cm (4.3 in) in height and 7 cm (2.8 in) in width. The deployed driver's air bag measured 48 cm (18.9 in) in diameter in its deflated state. The maximum excursion measured 24 cm (9.4 in) from the module face. The air bag was tethered by a single internal strap. Two circular vent ports were located at the 11 and 1 o'clock aspects on the rear of the air bag. There were 11 horizontal and 8 vertical folds across the air bag face. There were no indications of occupant contact to the air bag.

<u>Injury</u>	<u>OIC Code</u>	<u>Injury Mechanism</u>	<u>Confidence Level</u>
Ruptured aorta	420206.4,4	Driver's air bag	Probable
Neck fracture	650216.2,6	Driver's air bag	Probable

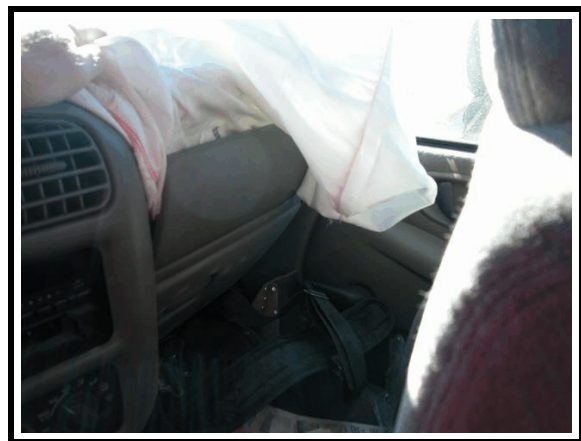
Figure 8. Front right passenger's air bag

The front right passenger's air bag deployed from the front mount module with a rectangular cover flap that was hinged at the bottom (**Figure 8**). The module cover flap measured 32 cm (12.5 in) wide by 12 cm (4.7 in) high. The deployed front right passenger air bag measured 43 cm (16.9 in) from seam to seam laterally and measured 40 cm (15.7 in) high in its deflated state. There were no tethers. Two circular vent ports were located at the 3 and 9 o'clock aspects of each side panel of the air bag. There were no occupant contacts or damage to the air bag or module cover.

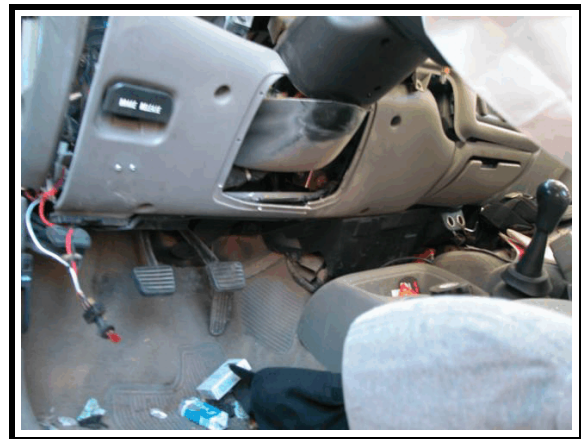
Figure 9. Left lower instrument panel

The 2000 Isuzu Hombre sustained minor damage as a result of occupant contacts and component movement. The left lower instrument panel exhibited faint scuffs on the left side that likely came from the driver's left knee. The lower panel was loose. There were horizontal linear scuffs to the driver's seat back and integral head rest. The scuffs began in the mid line lateral position and extended from left to right at a 45 degree angle. The steering wheel was covered with an after-market rubberized sleeve. The sleeve was partially torn away at the top, but this may have been from usage over time. The steering column was loose but did not appear to have been compressed. The front right seat was jammed in a fully forward position. The distance from the seat back to the instrument panel was 22 cm (8.7 in) and the distance from the back of the seat back to the back of the cab was 80 cm (31.5 in).

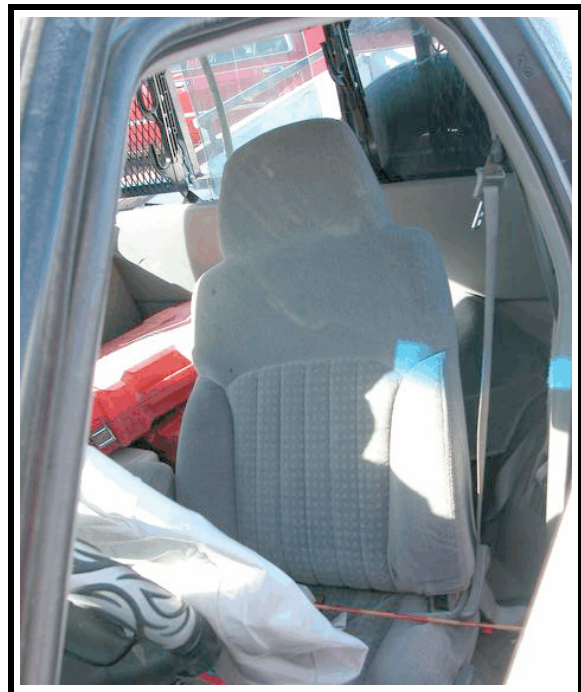
Figure 10. Scuff to back of driver's seat

The 47-year-old driver was seated forward facing, but was likely unconscious based on the lack of evasive maneuvers. He was possibly leaning forward and to the left. He was not wearing the available lap and shoulder belt. The seat back angle was 56 degrees and the seat bottom angle was 8 degrees. The distance from the top of the steering wheel rim to the seat back was 73 cm (28.7 in) and the distance from the bottom of the steering wheel rim was 43 cm (16.9 in). The steering wheel angle was 66 degrees and the center of the hub to the floor was 64 cm (25.2 in). The distance from the top of the instrument panel to the top of the steering wheel was 11 cm (4.3 in). At impact, the frontal air bags deployed. The male driver initiated a forward trajectory while engaging the deploying driver's air bag with his head and chest. It appears that his left knee contacted the lower instrument panel (**Figure 9**). The driver sustained a neck fracture and a ruptured aorta. The driver was forced rearward and his head struck the seat back/integral head restraint. A left to right diagonal scuff was found on the seat back that began at the middle back level and ended on the right side of the head restraint (**Figure 10**).
